**Response to January 31, 2020 Compliance Communication: Notice of Section 20107a of Part 201 Obligations
Former Revere Copper and Brass
5851 West Jefferson, Detroit, Wayne County, Michigan 48209
EGLE Site ID No. 82000136**

**Operation and Maintenance Plan for Security Fencing and Cable Buoys
Around the Riverbank Failure Area
5815-5851 West Jefferson Avenue, Detroit, Michigan**

Operation and Maintenance Plan for Turbidity Curtain, Erosion Control Blanketing, and Erosion Control Berm
Installed at the Riverbank Failure Area
5815-5851 West Jefferson Avenue, Detroit, Michigan

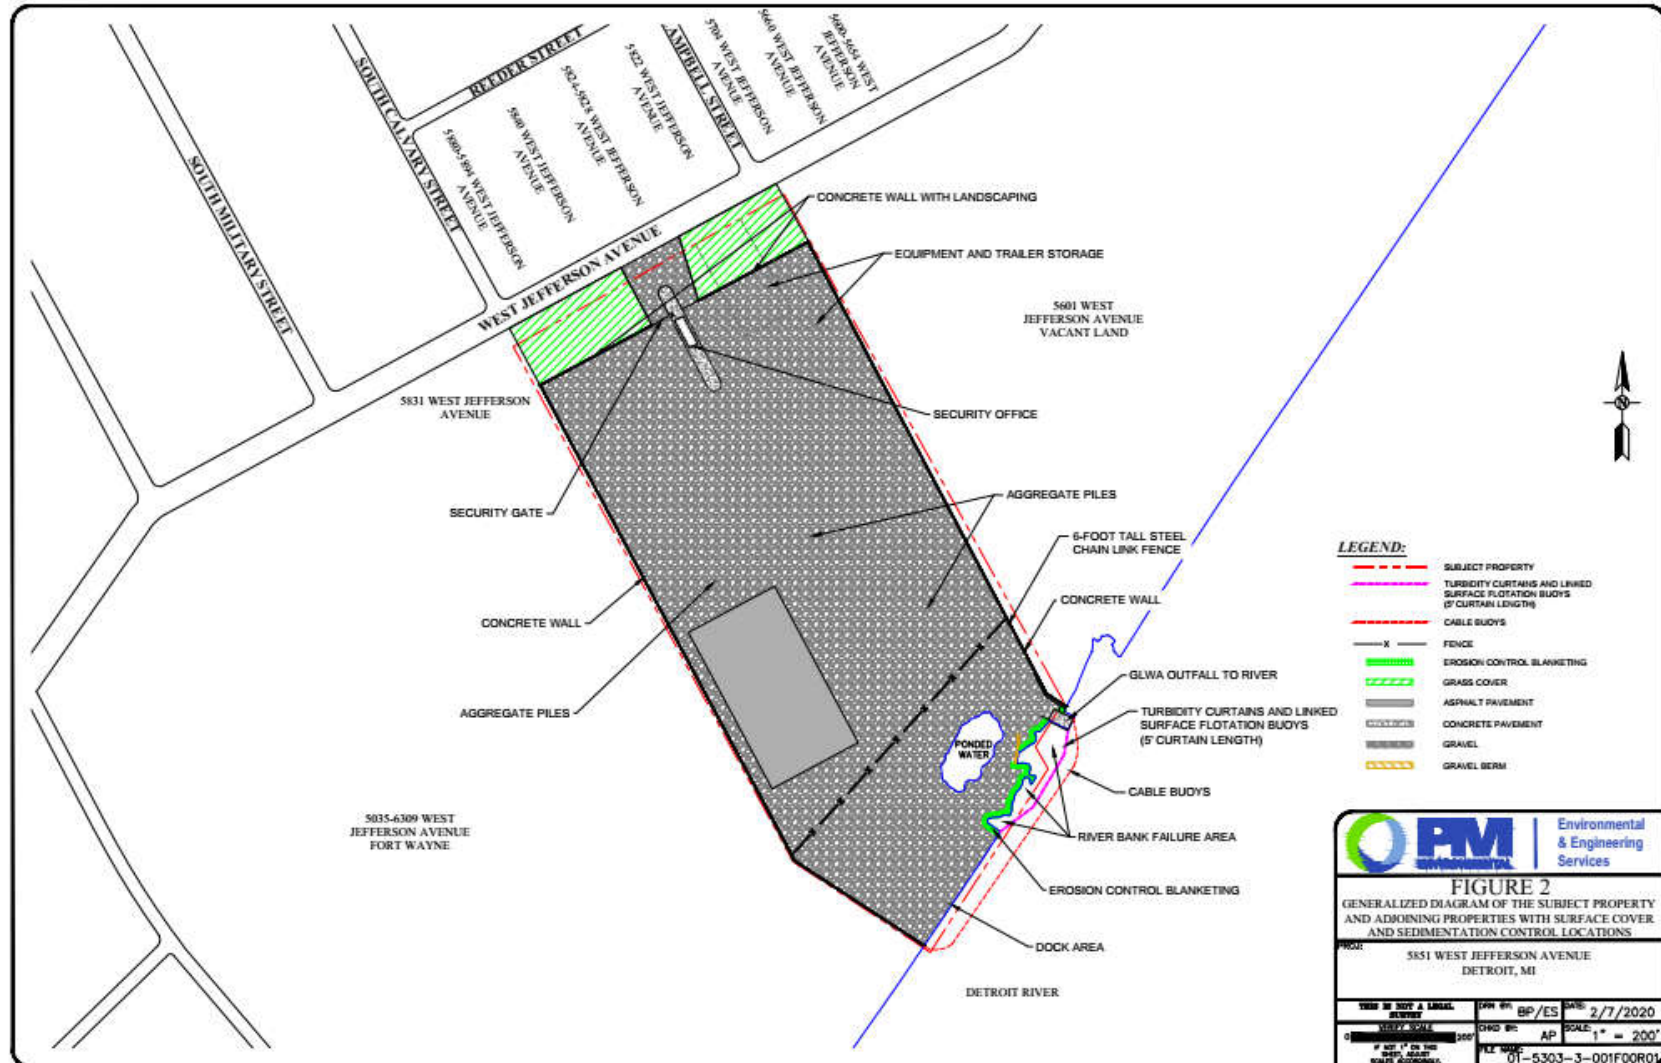
Map of Exposure Barrier Areas

Inspection Form for Turbidity Curtain, Erosion Control Blanketing, and Erosion Control Berm Installed at the Riverbank Failure Area 5815-5851 West Jefferson Avenue, Detroit, Michigan

Turbidity Curtain: On a daily basis, inspect and record the condition of the turbidity curtain installed around the riverbank failure area.

Erosion Control Blanketing: On a daily basis, inspect and record the condition of the erosion control blanketing installed around the riverbank failure area.

Erosion Control Berm: On a daily basis, inspect and record the condition of the erosion control berm installed along the northeast boundary of the pond within the riverbank failure area.
