**FORM EQP 5111 ATTACHMENT TEMPLATE B4
ENVIRONMENTAL ASSESSMENT**

This license application template addresses requirements for an environmental assessment for hazardous waste management units at the Dow Michigan Operations Facility which consists of the Midland Plant facility and the Salzburg Landfill facility.

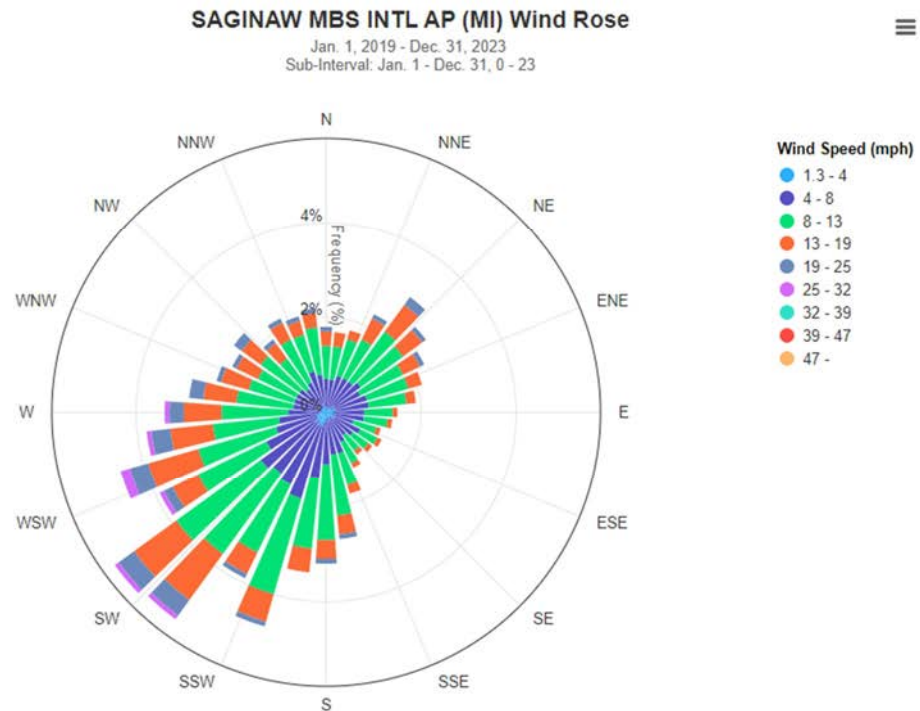
Figure B4-1. Wind Rose for MBS International Airport

SAGINAW MBS INTL AP (MI) - Wind Frequency Table (percentage)

Latitude : 43.5331 Start Date : Jan. 1, 2019 Sub Interval Windows
 Longitude : -84.0797 End Date : Dec. 31, 2023 Start End
 Elevation : 660 ft. # of Days : 1826 of 1826 Date Jan. 1 Dec. 31
 Element : Mean Wind Speed # obs : poss : 43102 of 43824 Hour 0 23
