Surface Condition of Active Networks (SCAN): Assessment Ratings for Shared Use Paths

Michigan Department
of Transportation

Rating Scale Shared Use Paths: Asphalt

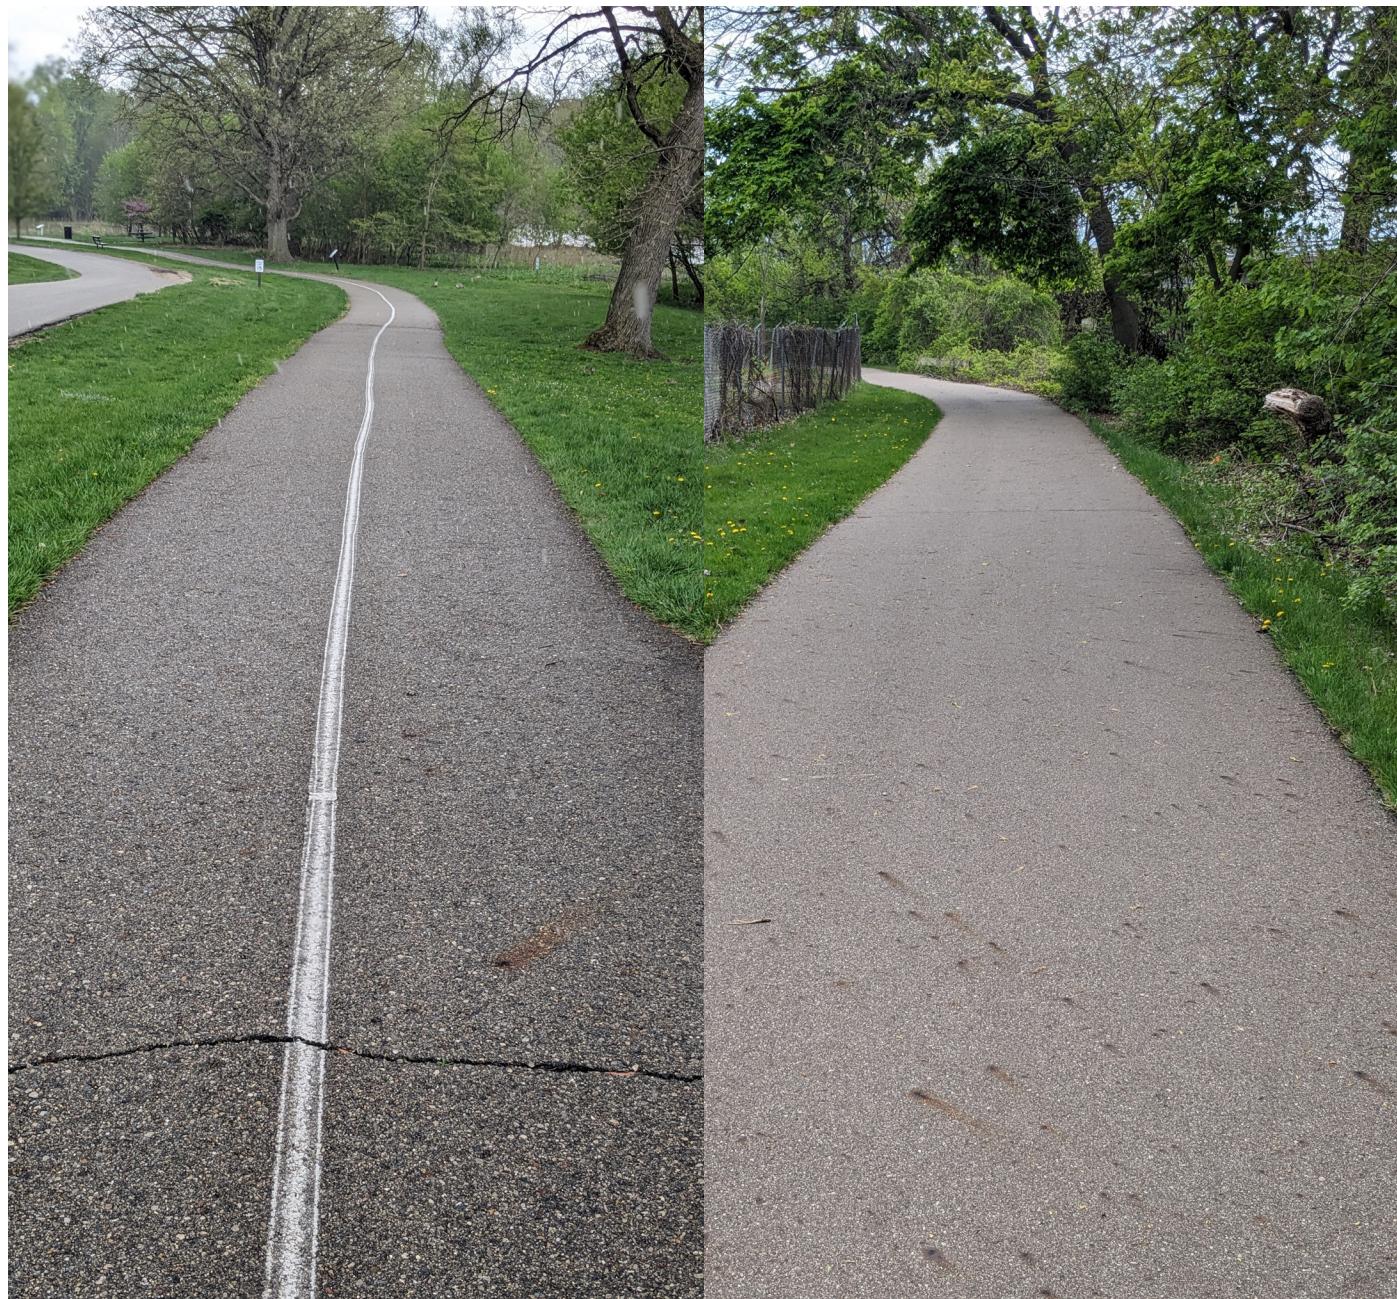
Rating Scale	General Condition and Visible Distress	Treatment Measures
5 Very Good	<p>The pavement is new construction or recent overlay. There is little to no maintenance required.</p> <ul style="list-style-type: none"> • No cracking. • Slight oxidization. 	<ul style="list-style-type: none"> • Fog seal

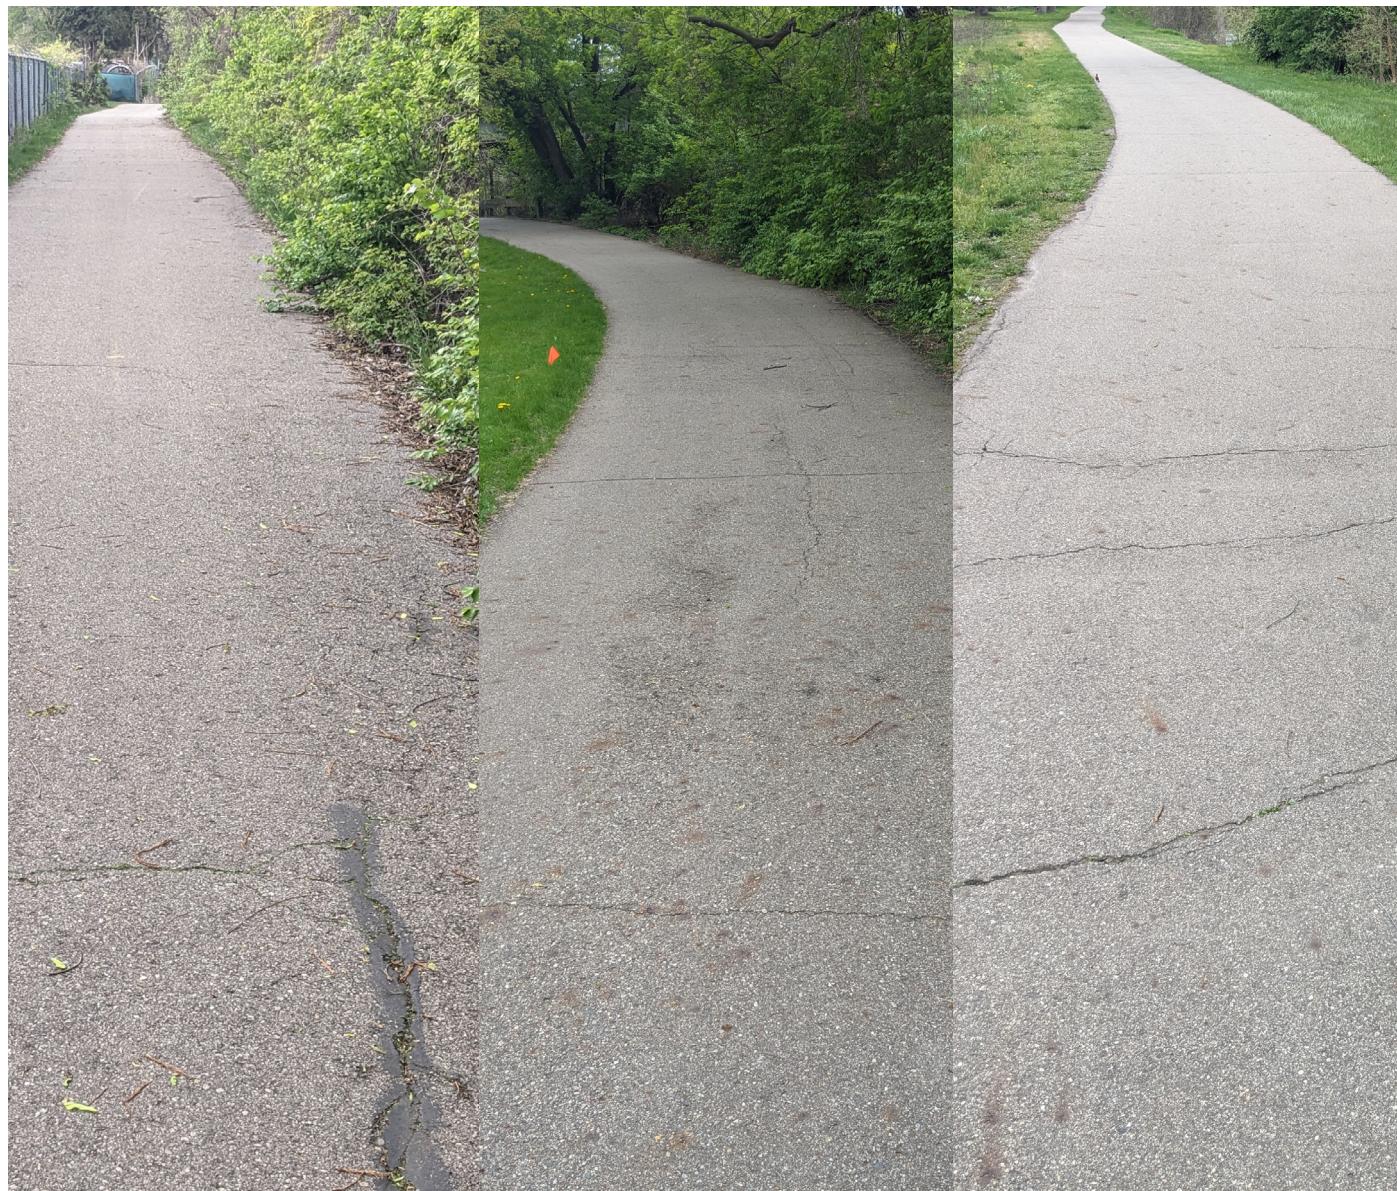
Rating Scale	General Condition and Visible Distress	Treatment Measures
4 Good	<p>The pavement is showing first signs of aging and still in sound structural condition. Maintain with crack sealing and pavement sealing.</p> <ul style="list-style-type: none"> Occasional transverse cracks (10 feet or more apart). Open one-quarter inch or less. Occasional longitudinal cracks. Open one-quarter inch or less. Very slight or no crack heaving (from vegetation) or crack cupping. Very slight or no raveling. Good drainage. 	<ul style="list-style-type: none"> Route and seal cracks (flush fill) Fog seal Micro-surface

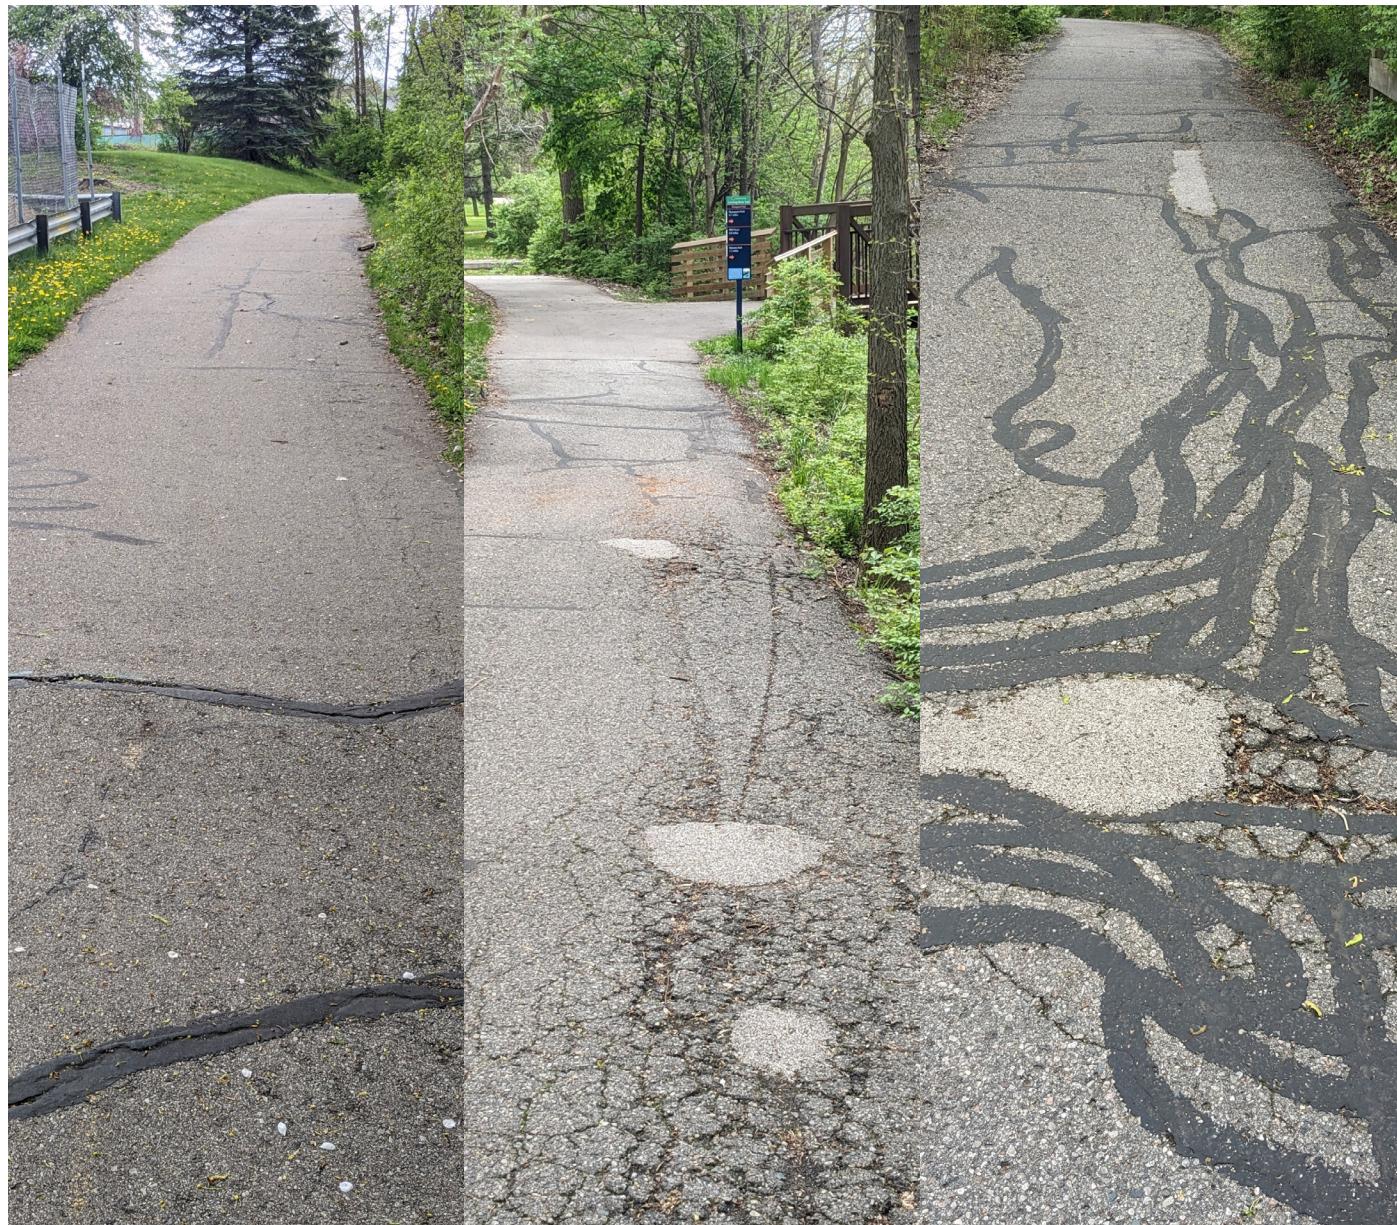
Rating Scale	General Condition and Visible Distress	Treatment Measures
3 Fair	<p>The pavement is showing signs of surface aging and is in sound structural condition. Maintain with crack sealing and pavement sealing. Vegetation management should be reviewed.</p> <ul style="list-style-type: none"> Transverse cracks (some spaced less than 10 feet apart). Open one-half inch or less. Occasional longitudinal cracks. Open one-half inch or less. Moderate crack heaving (from vegetation) or crack cupping less than 1 inch. (Note isolated sites of greater depth.) Uneven profile of less than one-half inch. Note isolated sites of greater depth. Low to moderate raveling. Very slight or no vegetative encroachment. Note isolated sites of poor drainage. 	<ul style="list-style-type: none"> Route and seal cracks (flush fill) Mastic Remove and replace crack heaving/crack cupping locations Micro-surface Clear encroaching vegetation Improve isolated sites of poor drainage

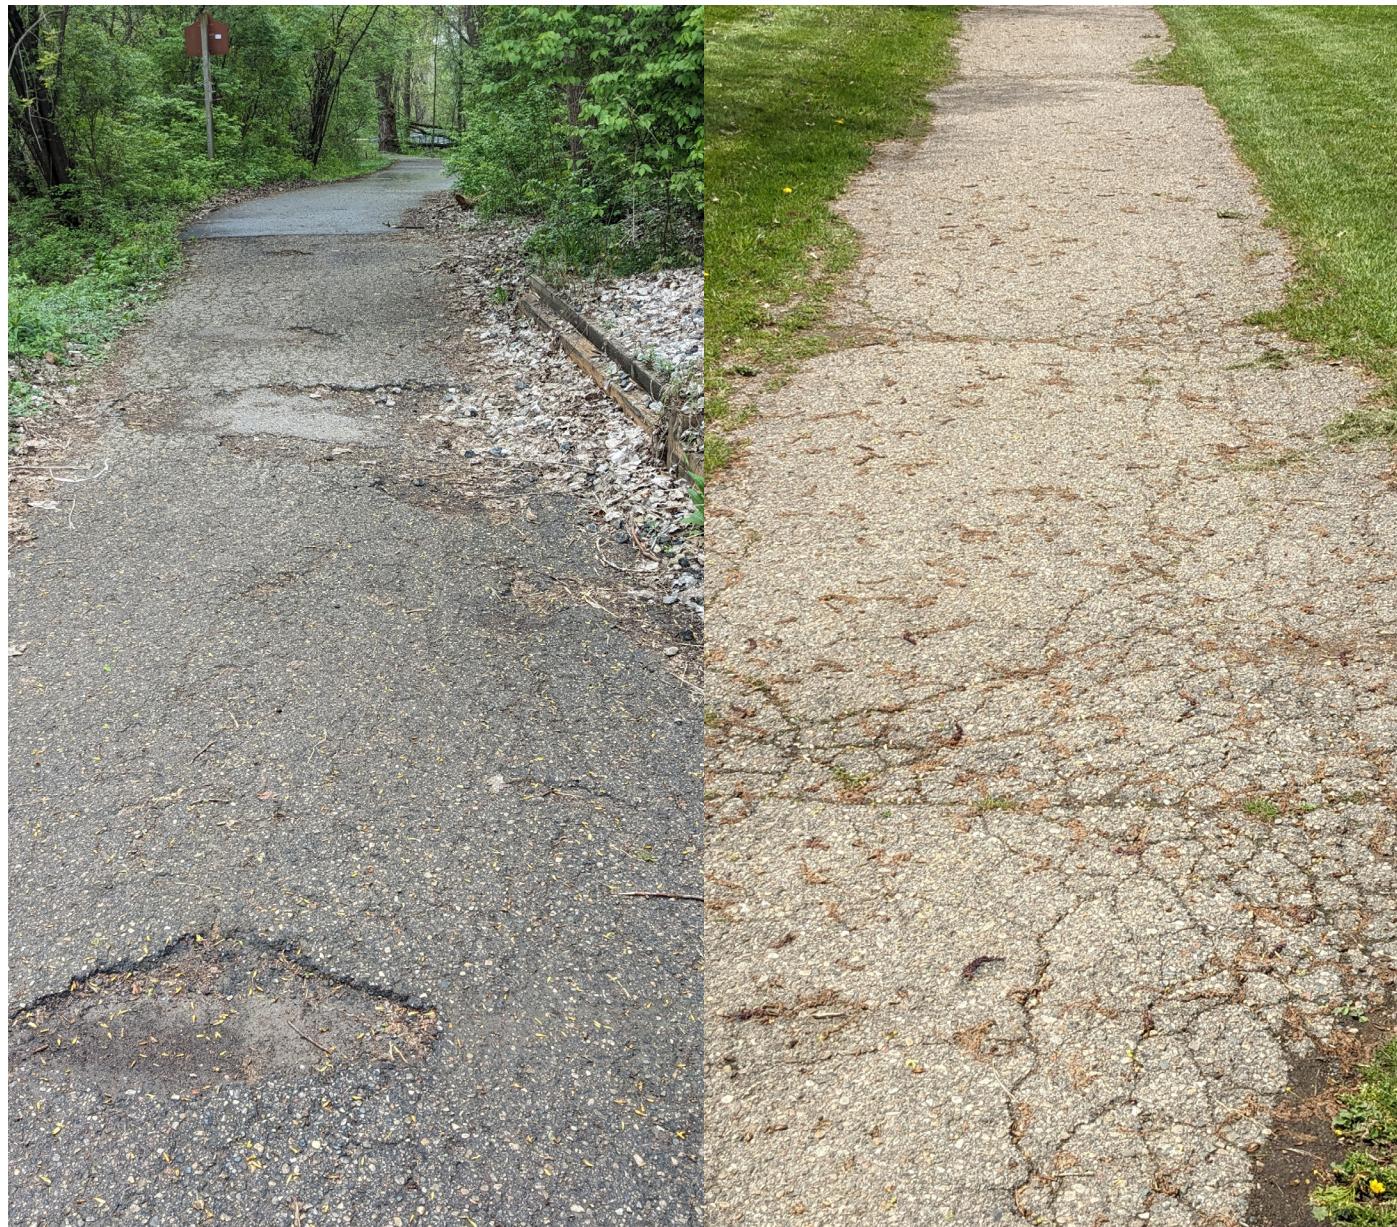
Rating Scale	General Condition and Visible Distress	Treatment Measures
2 Poor	<p>The pavement is showing significant aging. Pavement repairs and patching will be needed prior to an overlay. Vegetation management and drainage should be reviewed.</p> <ul style="list-style-type: none"> • Closely spaced longitudinal and transverse cracks. • Block cracking up to 50 percent of surface. • Some alligator cracking (less than 25 percent of surface). • Moderate uneven profile of one-half to 2 inches. • Severe crack heaving (from vegetation) or crack cupping greater than 1 inch. • Occasional potholes. • Vegetative encroachment on pavement greater than 4 inches. • Poor drainage. 	<ul style="list-style-type: none"> • Remove and replace crack heaving/crack cupping locations • Mastic • Remove and replace crack heaving/crack cupping locations • Micro-surface • Clear encroaching vegetation • Drainage improvements

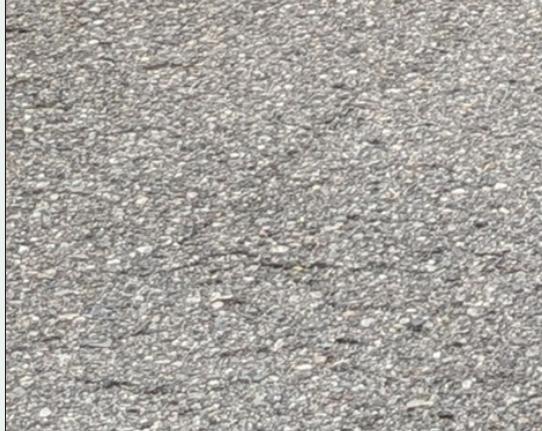
Type	Definition	Example
Raveling	Raveling is the wearing away of the pavement surface caused by the dislodging of aggregate particles and loss asphalt binder. Slight to moderate raveling has loss of fines. Severe raveling has loss of coarse aggregate, ultimately leading to a very rough and pitted surface with obvious loss of aggregate.

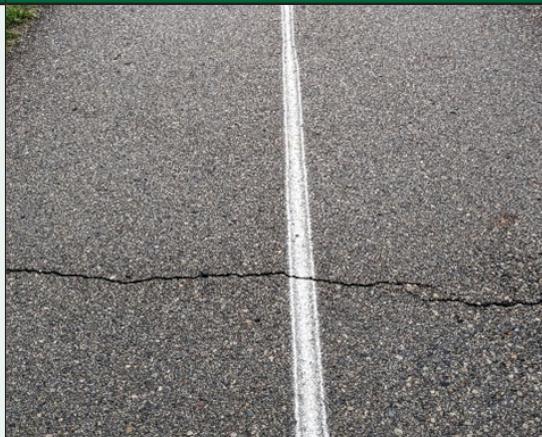
Type	Definition	Example
Transverse	Cracks that are predominantly perpendicular to the pavement centerline. They are often regularly spaced. The cause is movement due to temperature changes and hardening of the asphalt with aging.

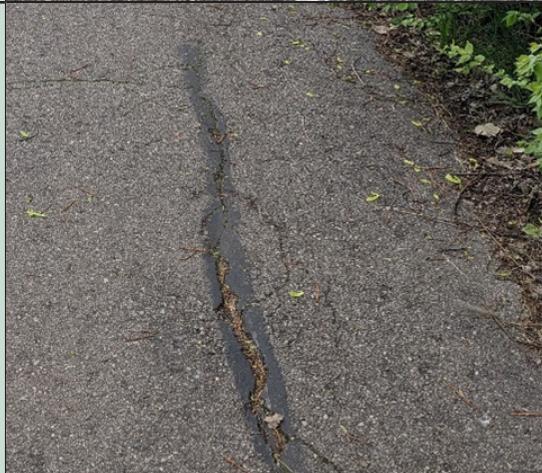
Longitudinal	Cracks predominately parallel to the pavement centerline. Cracks within 1 foot of the edge are caused by insufficient shoulder support, poor drainage or frost action. Cracks usually start as hairline or vary narrow and widen and erode with age. Without crack filling, they can ravel, develop multiple cracks and become wide enough to require patching.

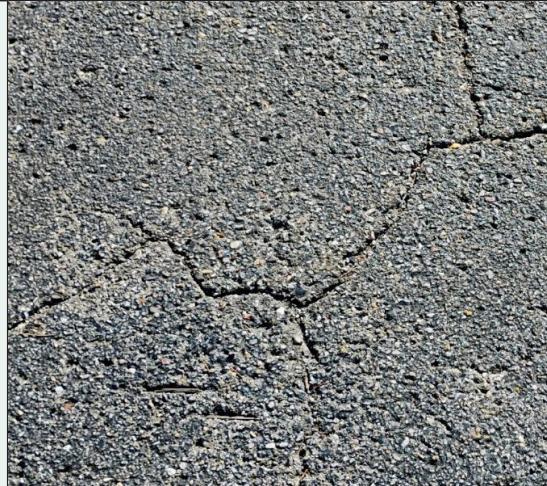
Type	Definition	Example
Block	A pattern of cracks that divides the pavement into approximately rectangular pieces. Blocks may range from 1 foot to approximately 10 feet or more across. The closer spacing indicates more advanced aging caused by shrinking and hardening of the asphalt over time.

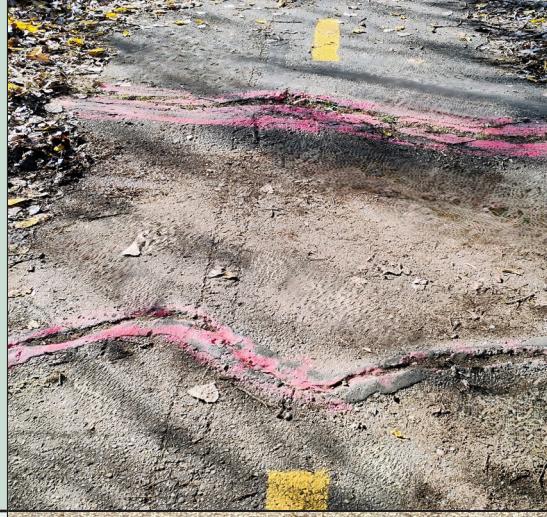
Heaving/Cupping	Heaving is a series of elevated cracks causing an uneven surface, usually caused by underlying tree roots. Cupping is a channel-like depression along a crack caused by the deterioration of the base material. This may be a gentle swale or a fairly severe dip.

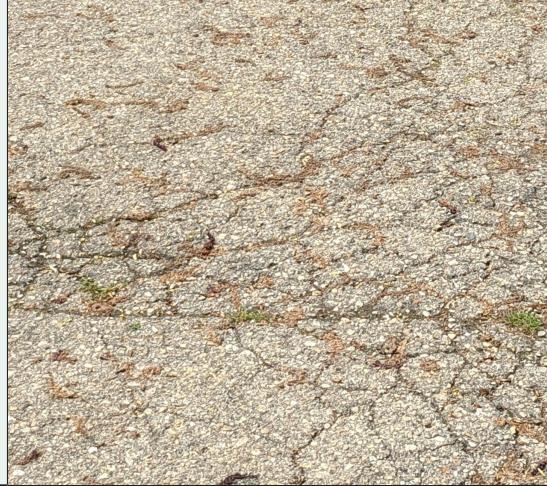
Alligator	A series of interconnected cracks forming small pieces ranging in size from about 1 to 6 inches. On shared use paths, this is often due to inadequate base or subgrade support.

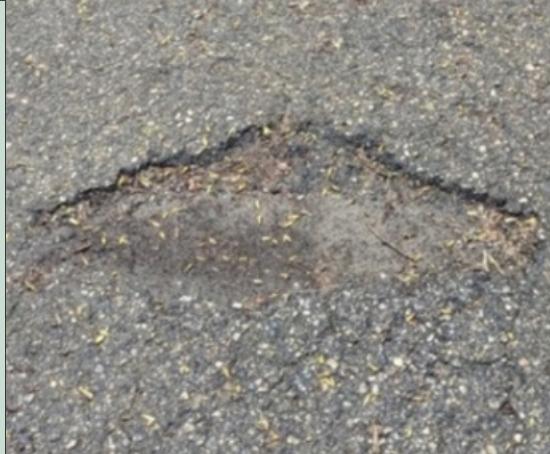
Type	Definition	Example
Potholes	Bowl-shaped holes of various sizes in the pavement surface. Holes and loss of pavement material caused by fatigue and inadequate strength. Often combined with poor drainage.

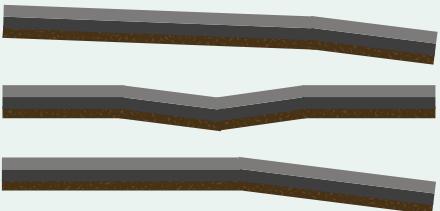
<p>Examples of Unevenness</p>

Uneven Surface Profile	A location where the cross slope deviates from its originally designed and constructed uniform consistent condition, resulting in distortions, poor drainage and/or standing water.	<p>Even</p>

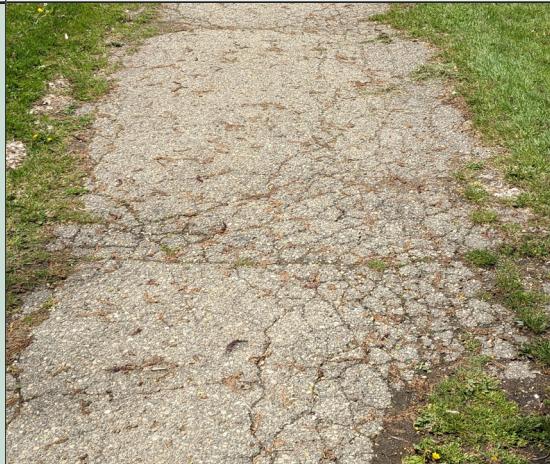
<p>Path Cross Section</p>
Vegetative Encroachment	Refers to the growth of vegetation over an improved surface at ground level. This can reduce useability, create safety hazards and cause premature deterioration.
