Clean Michigan Initiative Nonpoint Source Grant Tracking Code: 2004-0128

Whitney Intercounty Drain Improvement Project April 2005 thru June 2009

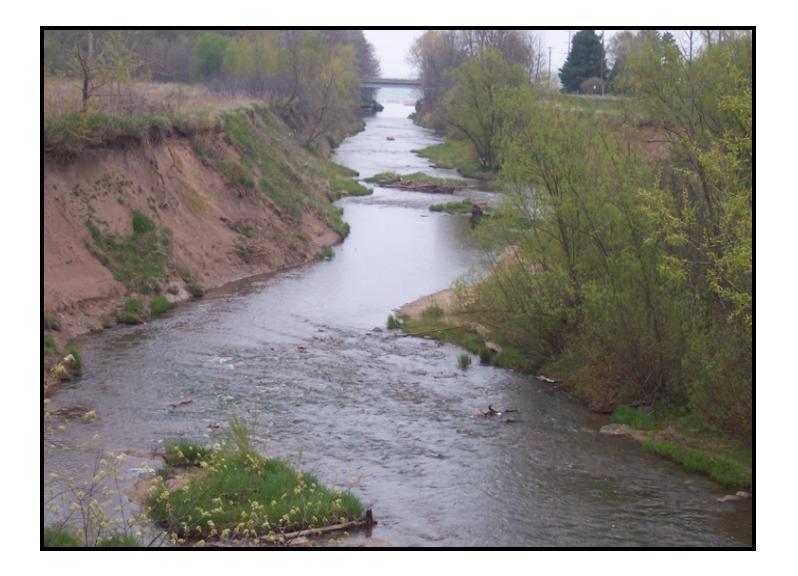
<u>Before:</u> Originally a 3' × 2' channel, excessive erosion, down-cutting, loss of floodplain and instream deposition created the 110' × 40' channel (pictured above). The impaired watercourse contributed the highest sediment bedload of any watershed in the Saginaw Bay region. Due to the excess bank erosion and associated sedimentation, water quality and aquatic habitat was severely degraded, and migration for the many species of fish that use this river for spawning was compromised.

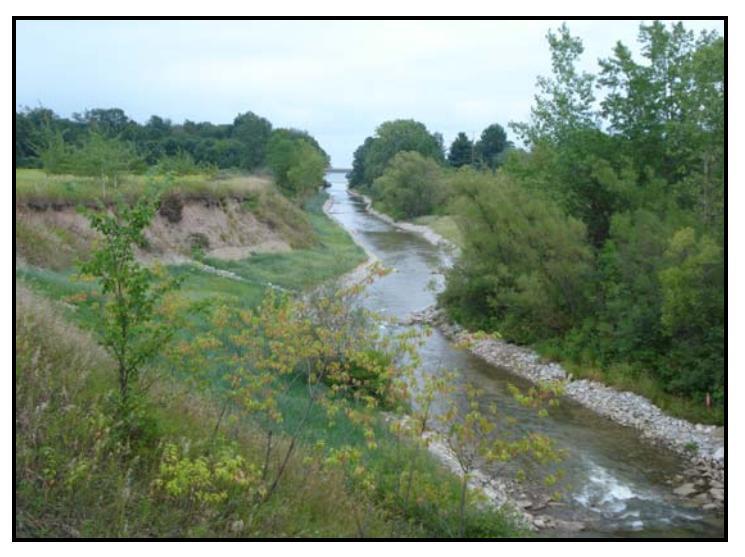
<u>After:</u> A new channel was created through a process of cutting and filling within this portion of the project area. Rock riprap in the form of Newbury Riffles and bank armoring was keyed into the drain bottom and placed up the side of the channel to a height equal to the bank-full elevation. A floodplain shelf was constructed from the top of the new channel banks outward to the sides of the existing valley walls.

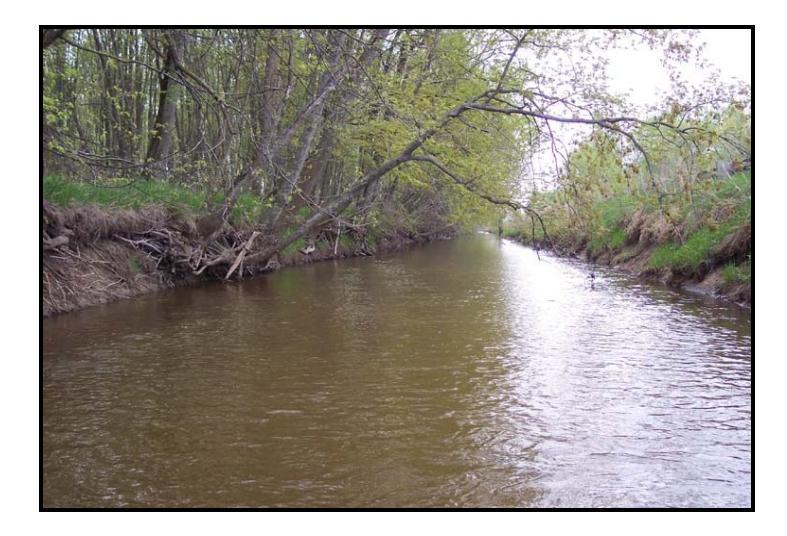
<u>Before:</u> Severe bank erosion was a result of the stream's inability to dissipate flow away from the banks and extreme down-cutting of the drain bed. Channel width was continuing to expand, causing a threat to road stability and adversely impacting aquatic habitat.

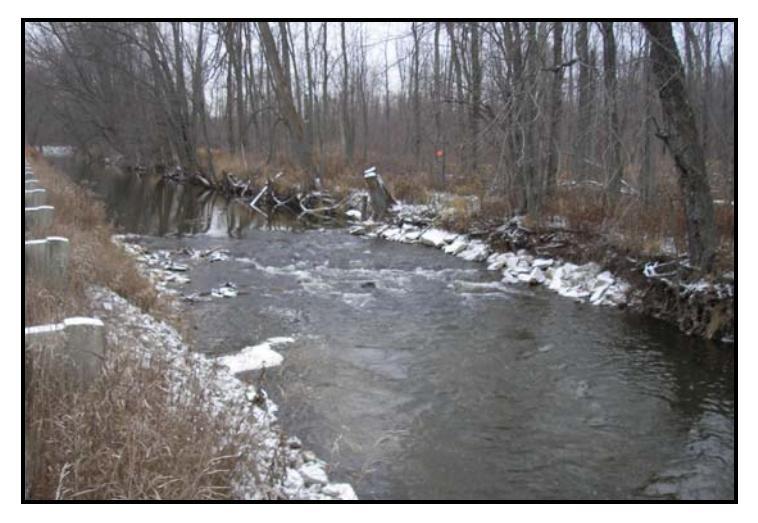
<u>After:</u> Riffle structures were installed to improve water quality by reducing bed and bank erosion, centralizing the flow away from the banks and increasing aquatic habitat diversity.
