SITE INSPECTION REPORT

C & H TAMARACK OPERATIONS

HUBBELL, MICHIGAN 49934

MARCH 10, 2015

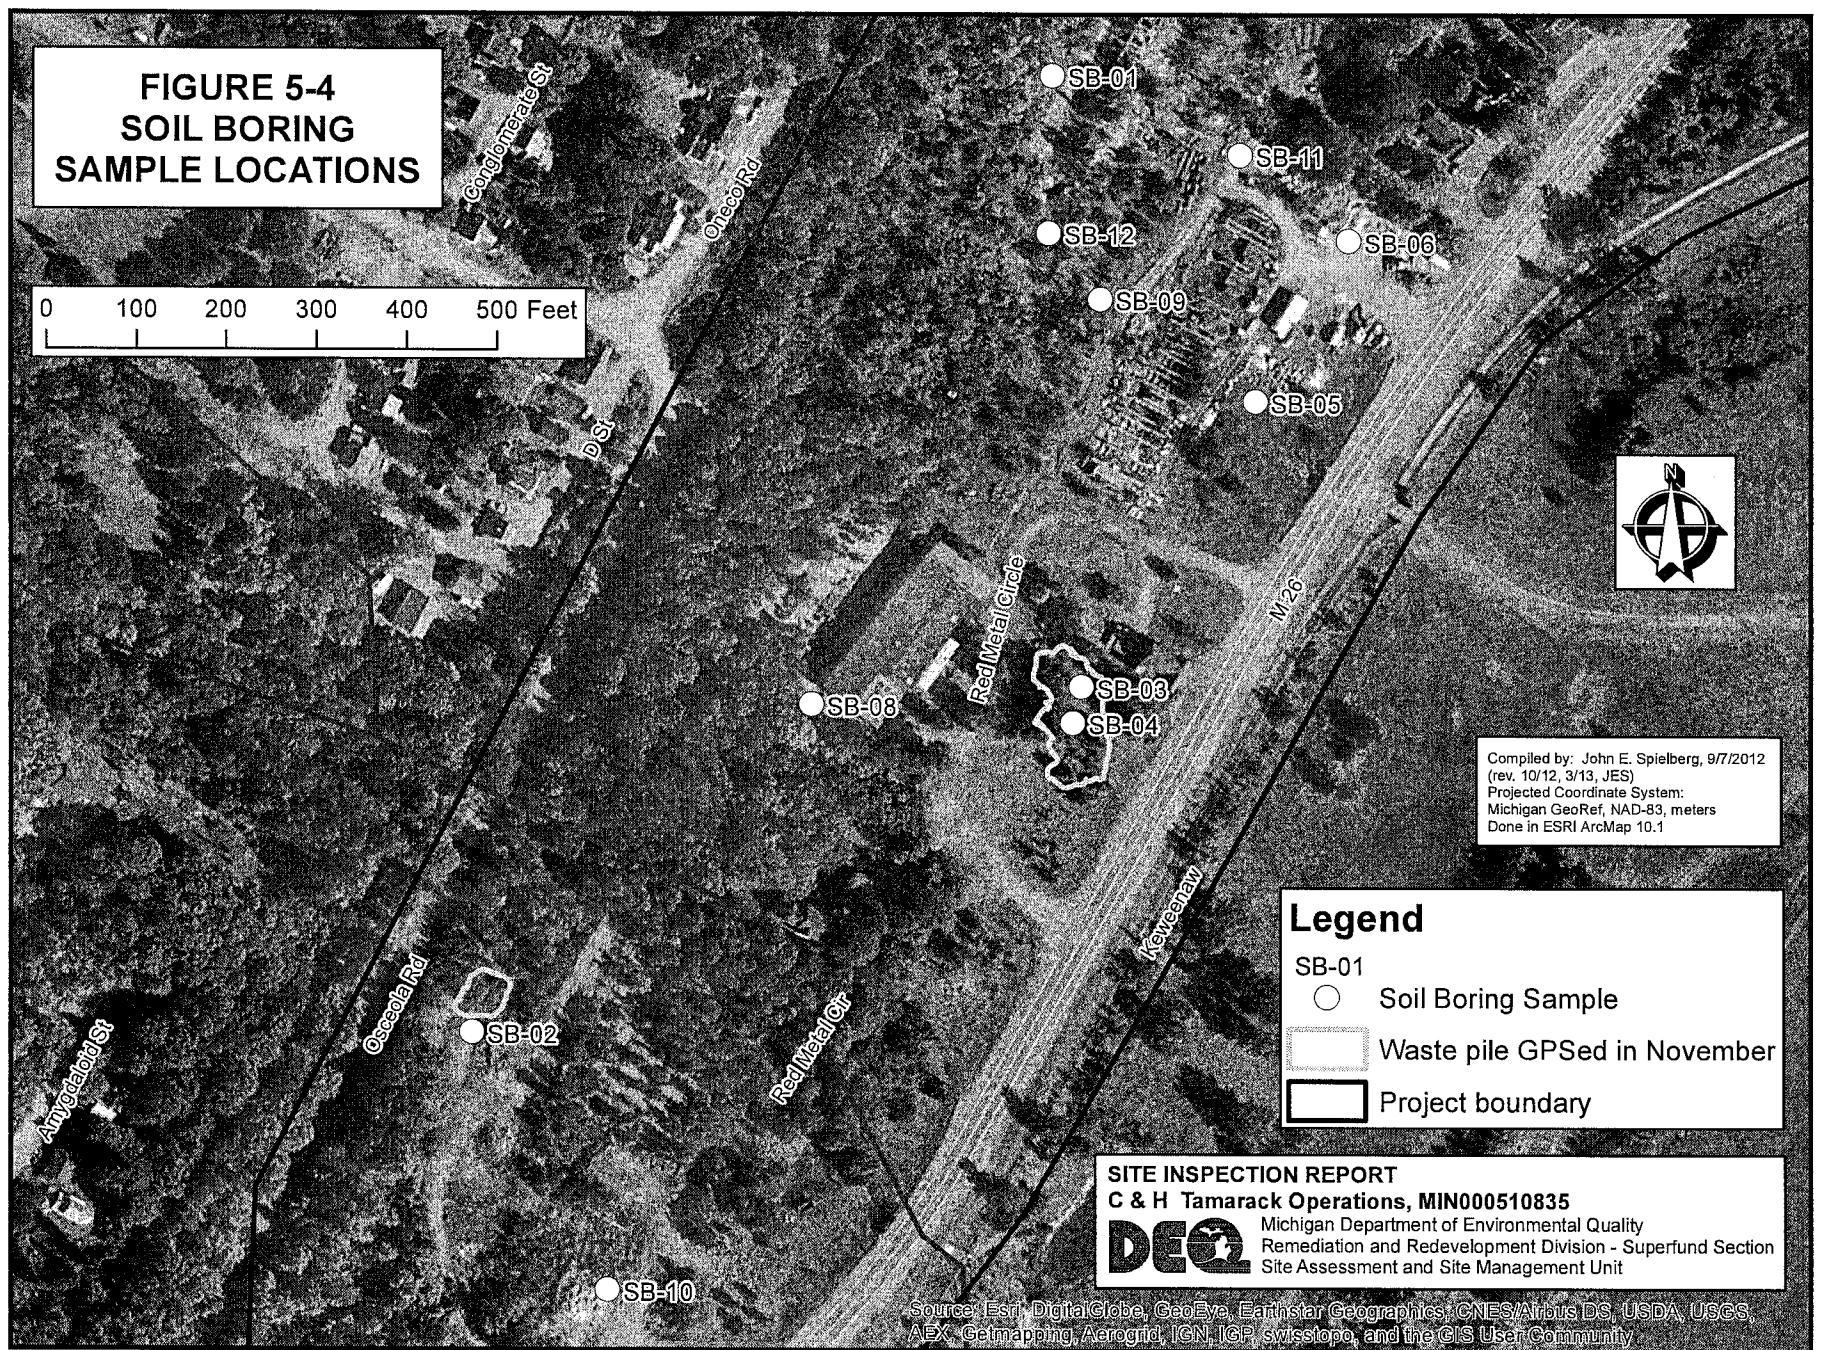
Sources: Feature layers from Michigan Geographic Data Library website; site specific information from MDEQ files and local governments; soil boring sample locations and associated data from GPS data collected by MDEQ staff during field activities, November 8, 2012.

Twelve deep soil samples were collected from 11 individual boring locations around the Site by the investigation team on November 5 or 6, 2012. These samples were collected in order to find buried waste, if present. The locations of these samples are shown on Figure 5-4. Location information, soil boring lithology, and sample descriptions for the soil boring samples can be found in Table 5-3.

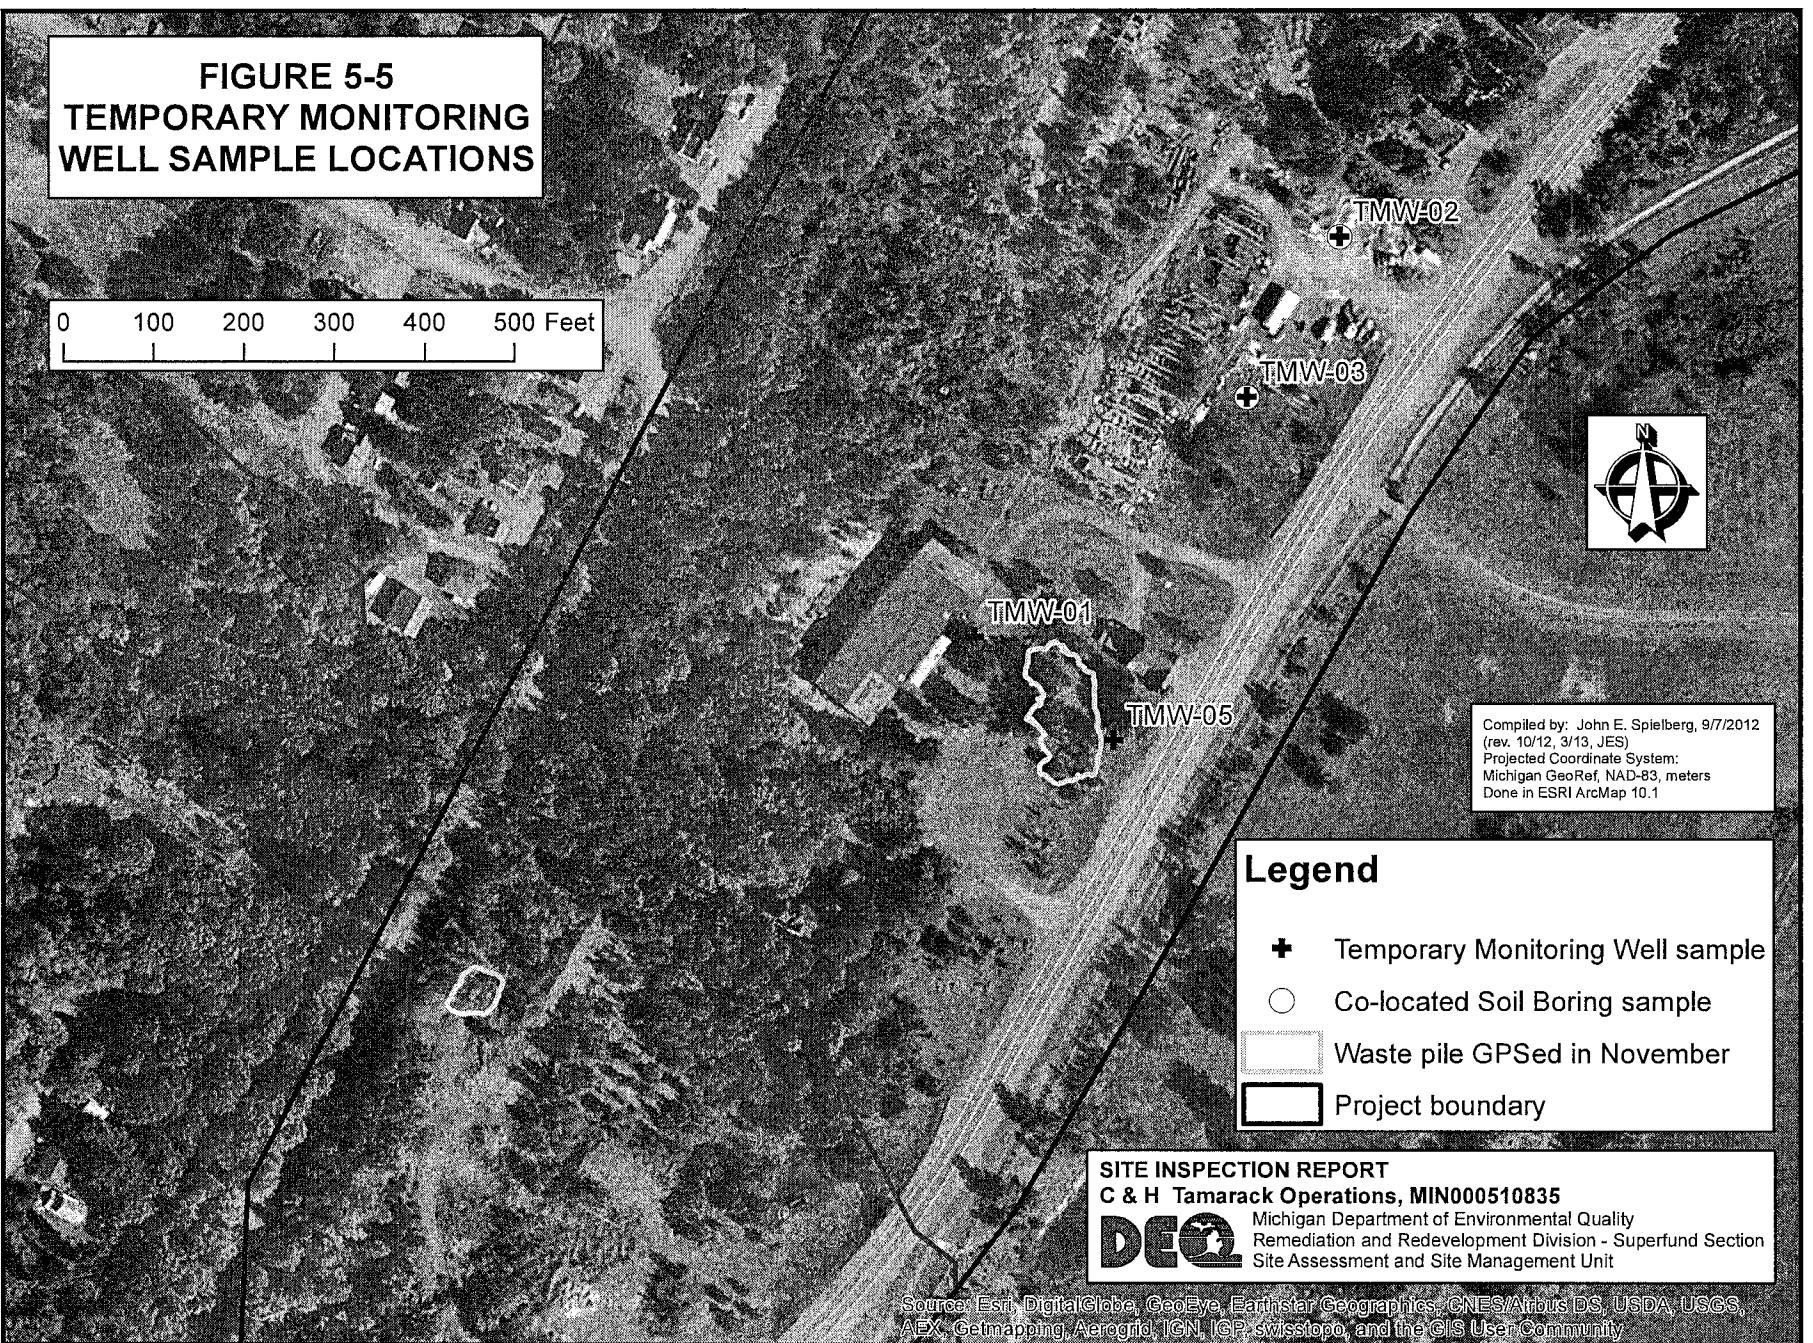
Sources: Feature layers from Michigan Geographic Data Library website; site specific information from MDEQ files and local governments; soil boring sample and temporary monitoring well sample locations and associated data from GPS data collected by MDEQ staff during field activities, November 8, 2012.

Five groundwater monitoring well samples were collected from four temporary monitoring wells to determine whether organic and inorganic contaminants had migrated into the glacial aquifer underlying the Site. The monitoring well sample locations are shown in Figure 5-5. Location information, some basic groundwater parameters, and sample descriptions for the groundwater samples can be found in Table 5-4. Field staff attempted to install background wells northwest of the former regrinding plant, but could not do so due to bedrock refusal of the Geoprobe bit. The Team Leader directed field staff to install a background well hydraulically

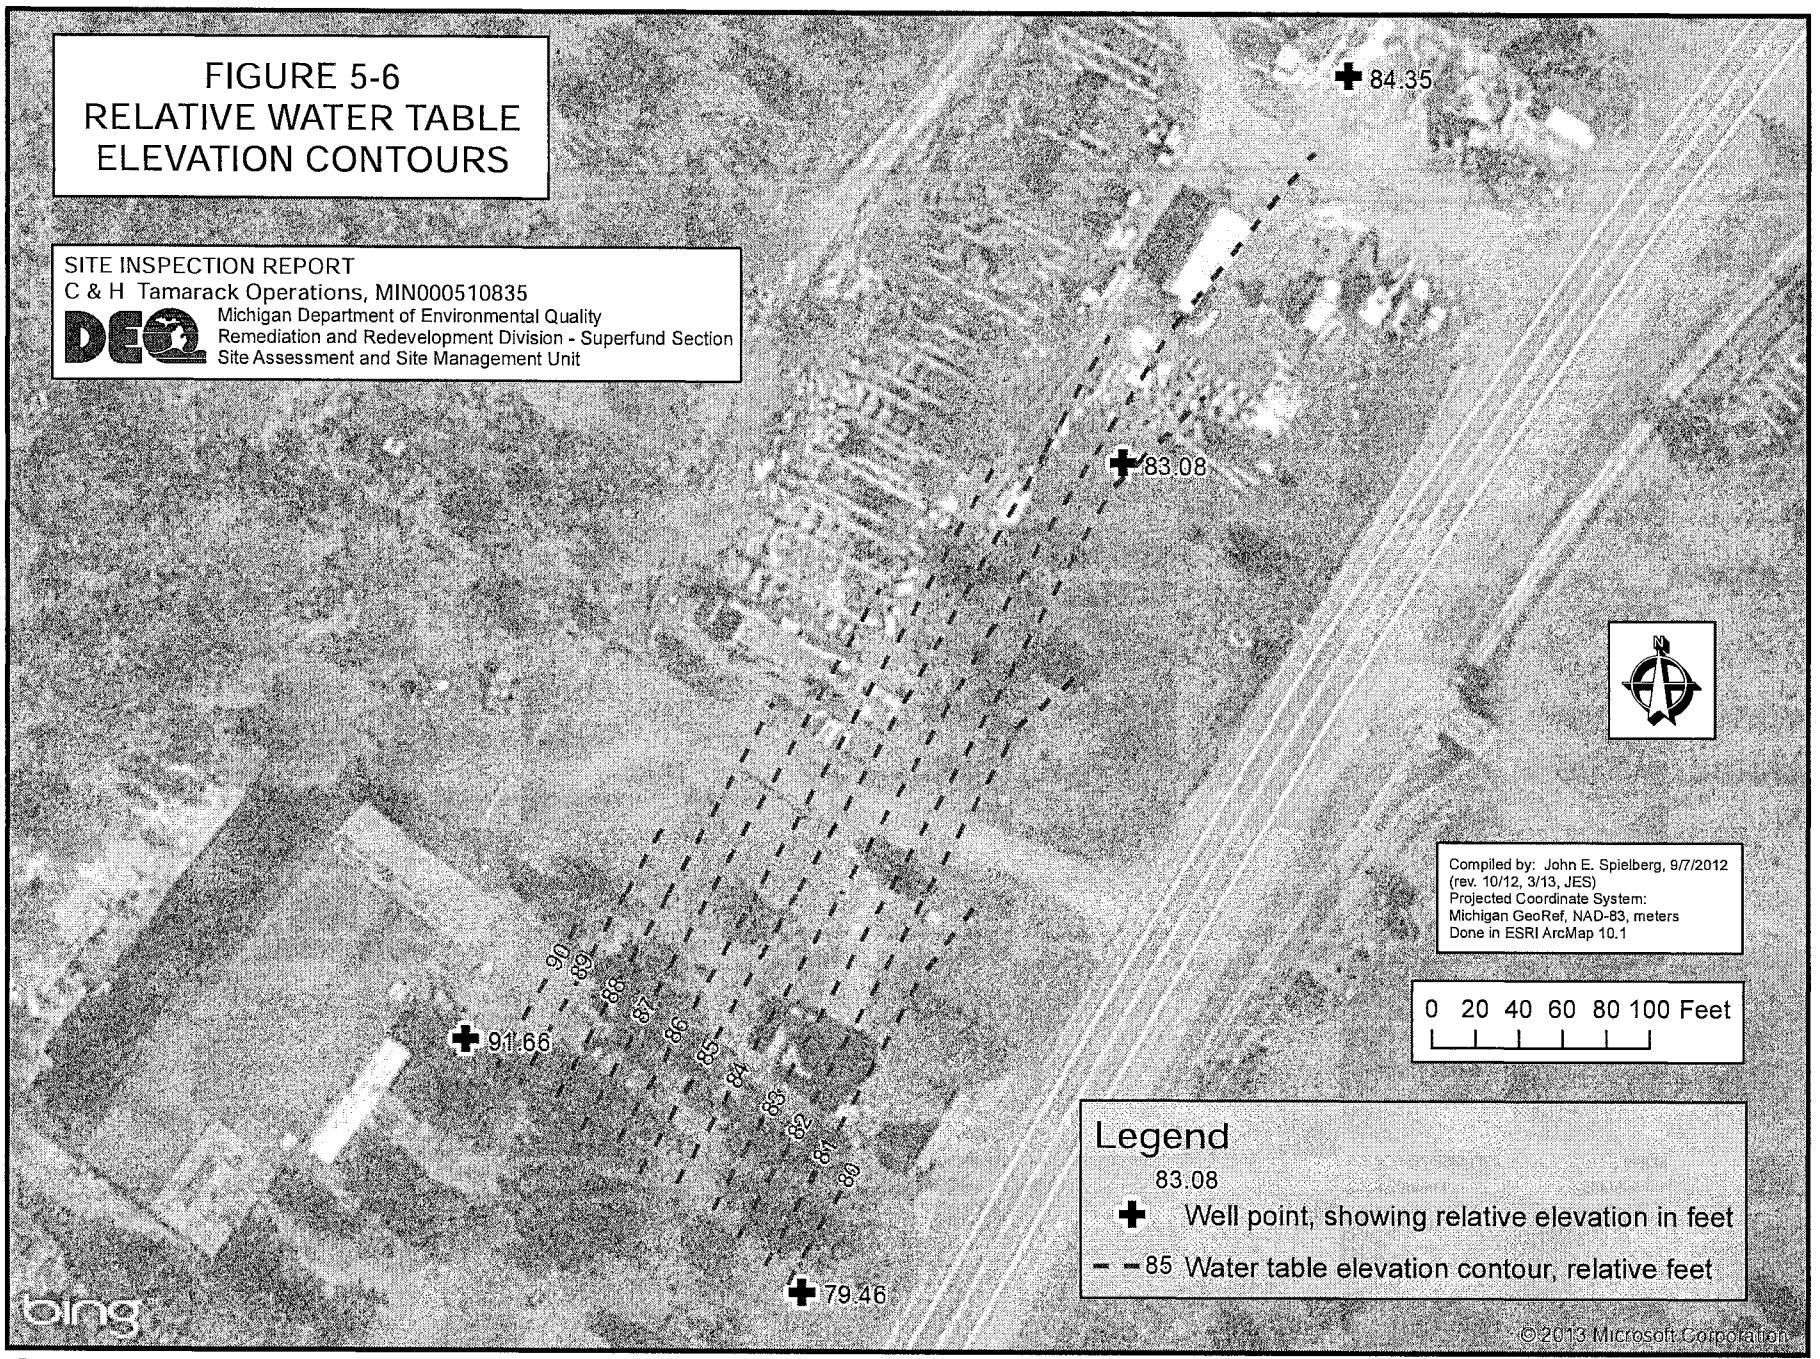
Figure 5-6: Relative Water Table Elevation Contours

Sources: Temporary monitoring well water table data collected by MDEQ staff during field activities, November 8, 2012.

Observed releases in groundwater were only found in the two groundwater monitoring wells installed closest to the former reclamation facility leach plant. Groundwater in this area flows under the remains of the former reclamation plant, possibly picking up contaminants that may have leached out of contaminated soils or waste, and then flows past the two monitoring wells, TMW-02 and TMW-03. Sample TMW-03 had the highest concentration of copper, possibly the result of copper leaching out of the now-buried waste in the south end of the former leach plant, in combination with copper leaching out of copper-containing contaminated soils prevalent in the area.
