Water Resources Division Surface Water Assessment Section

# Biosurvey of the Rifle River Watershed, Michigan

July-August 2019

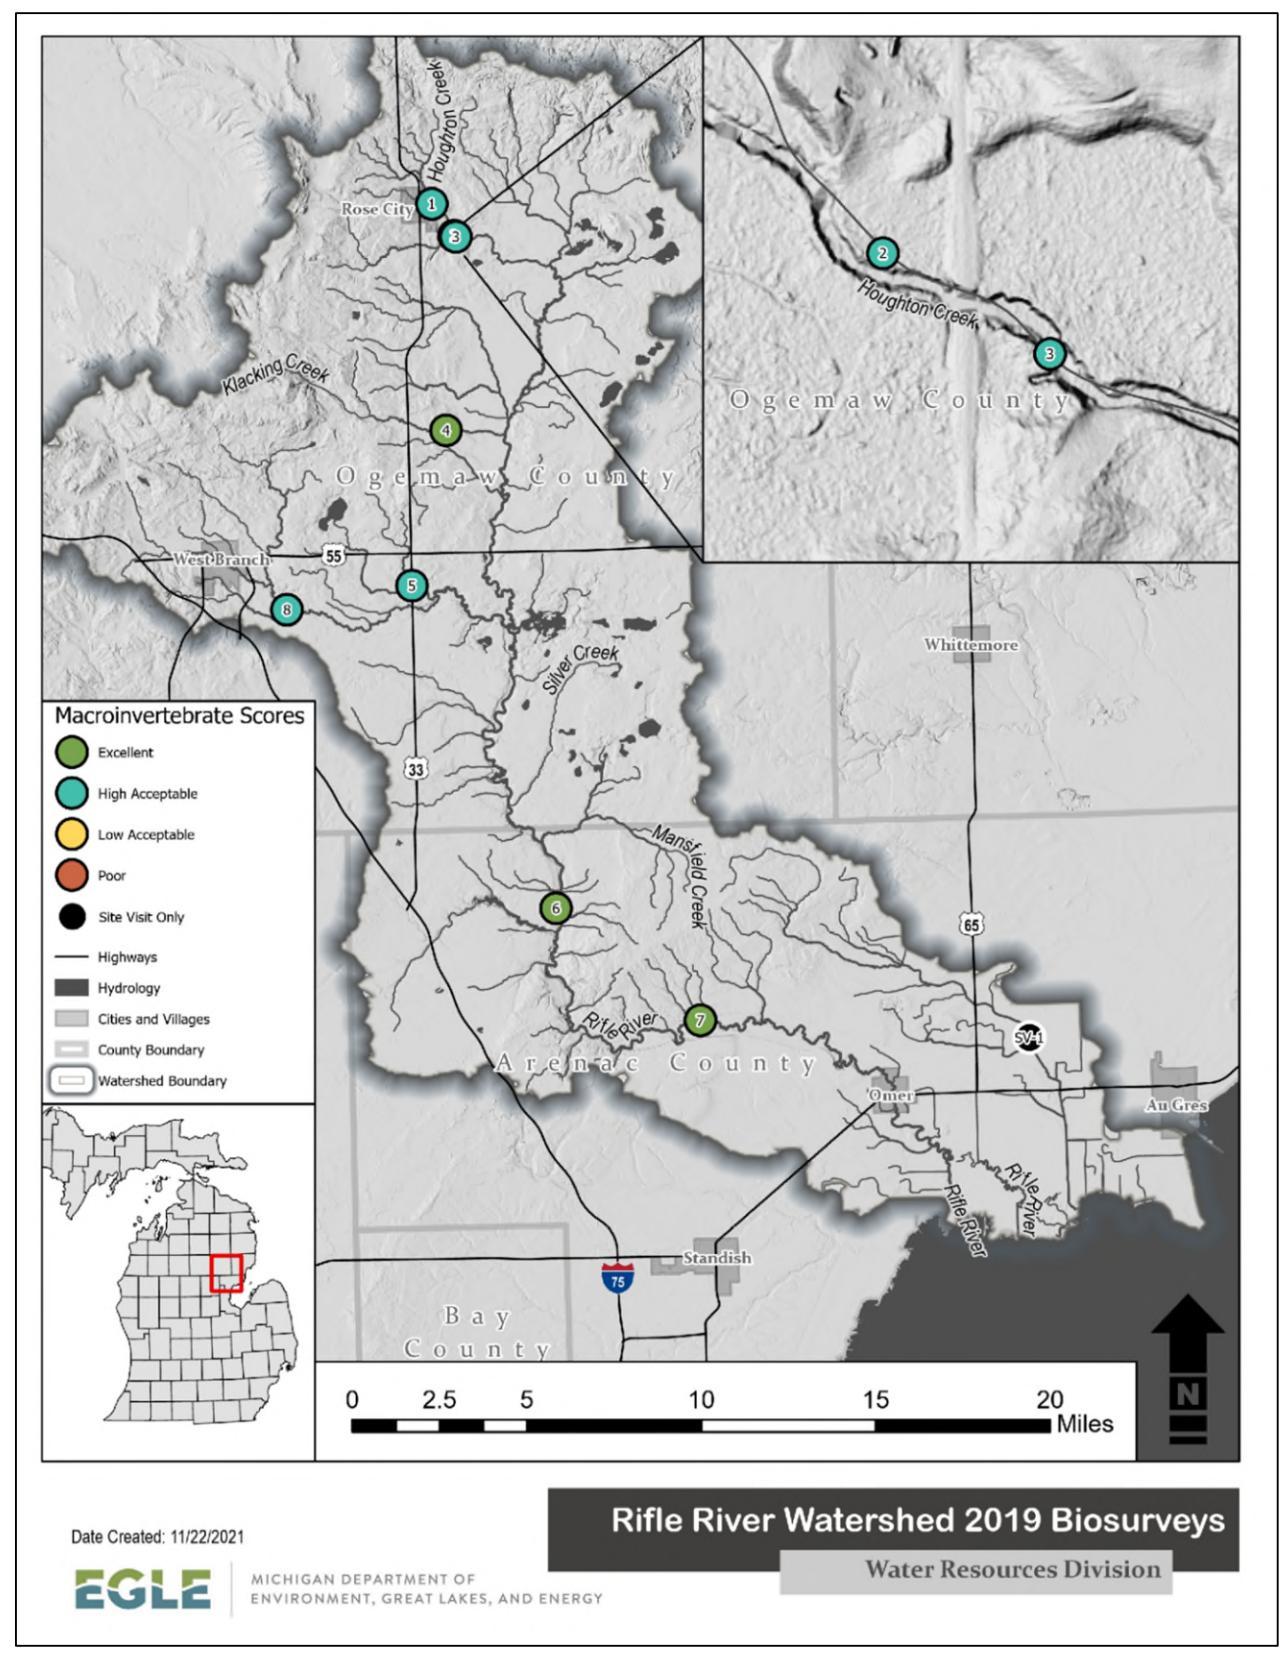
**Figure 1.** Macroinvertebrate ratings for stations sampled in the Rifle River watershed, July-August 2019.

All sampled stations had macroinvertebrate community ratings that were acceptable or excellent (Table 5, Figures 1 and 2). Therefore, the other OIALW designated use was being met at all stations. The coldwater fish community was sampled in Houghton Creek upstream and downstream of Flynn Road and was found to be supporting the coldwater fishery designated use. Detailed results for targeted monitoring sites will be discussed under Goal 3. Habitat evaluations can be found in Table 7; macroinvertebrate evaluations can be found in Tables 8a and 8b; fish community evaluations can be found in Table 9. No water chemistry samples were collected as part of this watershed survey.

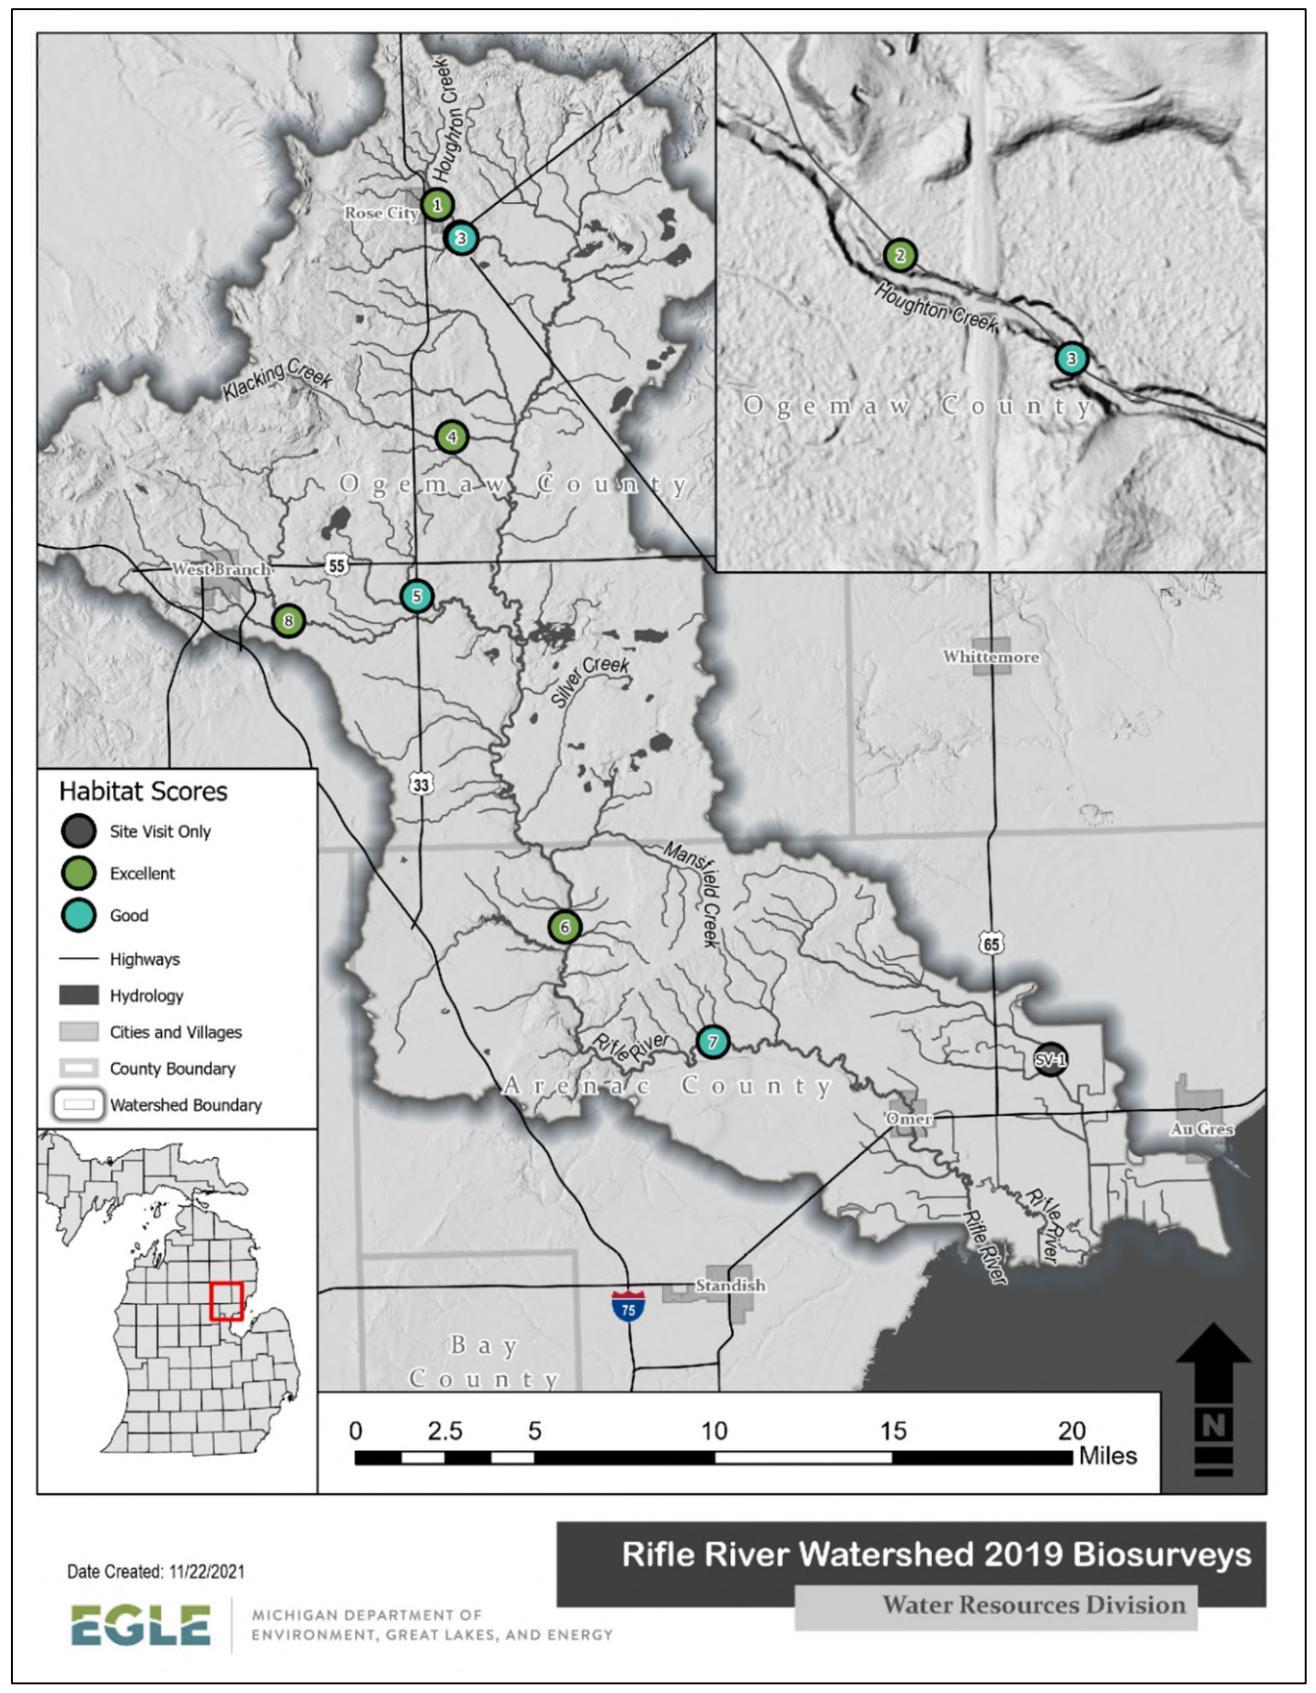
Figure 2. Habitat ratings for stations sampled in the Rifle River watershed, July-August 2019.

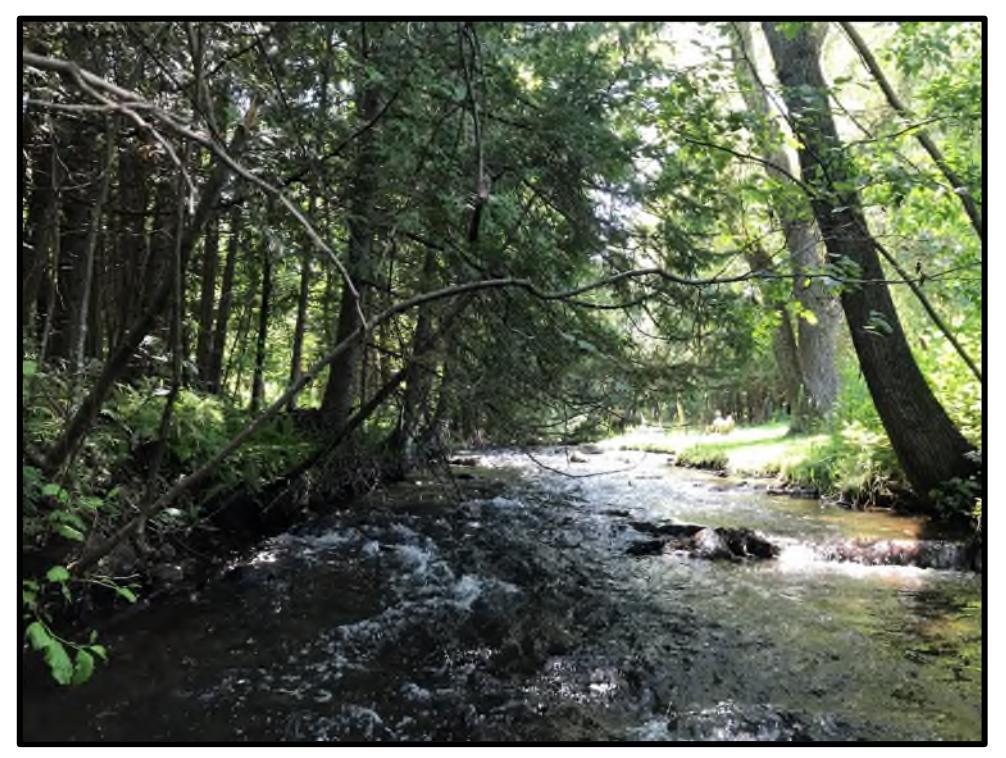
The trend site for Klacking Creek at Morrison Road (Station 4) was sampled as part of this biosurvey. Extensive forests within the riparian corridor supported the habitat quality of the stream. All habitat metrics rated good or excellent, except for the riparian vegetative zone on the left bank, since a small lawn was maintained up to the streambank within the sample reach (Figure 3). Substrate (e.g., gravel, cobble) was not heavily impacted by sediment deposition. Habitat conditions were favorable to sensitive aquatic life, and this site scored the second highest for habitat metrics among all sites in the survey. Unsurprisingly, macroinvertebrate metrics also rated excellent with a score of 6. Twenty-eight aquatic macroinvertebrate taxa were sampled at this location, with over 45 percent of this representation coming from taxa sensitive to pollution. Three families of stoneflies, insects often seen as indicators of high-quality coldwater streams, were sampled at this location.

Figure 3. Klacking Creek looking upstream into the sample reach, photo taken July 31, 2019.

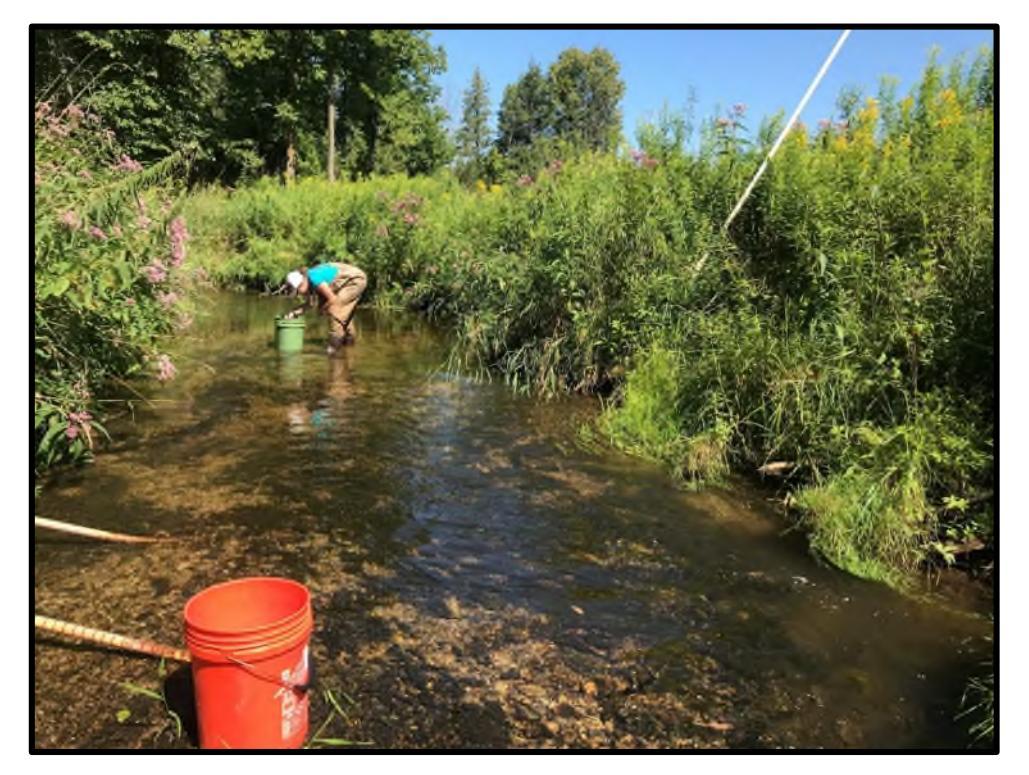
Most of Campbell Creek is protected by a forested riparian corridor, but the area within this status site along the M33 highway (Station 5) was more open with less canopy cover (Figure 4). Perhaps due to the increased availability of sunlight, extensive macrophyte and algal growth were present on the substrate within the sample reach. Substrate availability and embeddedness were negatively impacted by this expression of nutrients. Despite these undesirable habitat characteristics, the other aspects of habitat quality were sufficient to allow this site an overall "good" habitat rating. The macroinvertebrate community also rated within the "acceptable" range with a score of 1. The abundance of Amphipods collected within the

sample reach may indicate degraded water quality conditions. Amphipods in general are tolerant of many forms of water quality impairment and Procedure 51 scoring metrics are negatively impacted when they are the dominant taxa. However, five families of caddisflies (normally indicators of good water quality) were also sampled at this location. It is likely that historical canopy removal activities are affecting conditions at this site.

**Figure 4.** Campbell Creek looking into the sample reach, photo taken August 19, 2019. The M33 highway runs parallel to the stream in the upper right corner of the image.

- 3. The extent of nutrient expression found at Campbell Creek along the M33 highway may exceed WQS. Future monitoring should include a nuisance condition assessment to assess this site.

- 4. Algae and macrophytes were noted in some areas of canopy removal (e.g., Big Creek at N Hale Road and Campbell Creek), consider evaluating several areas in the watershed for nuisance conditions when nutrient guidance is complete.

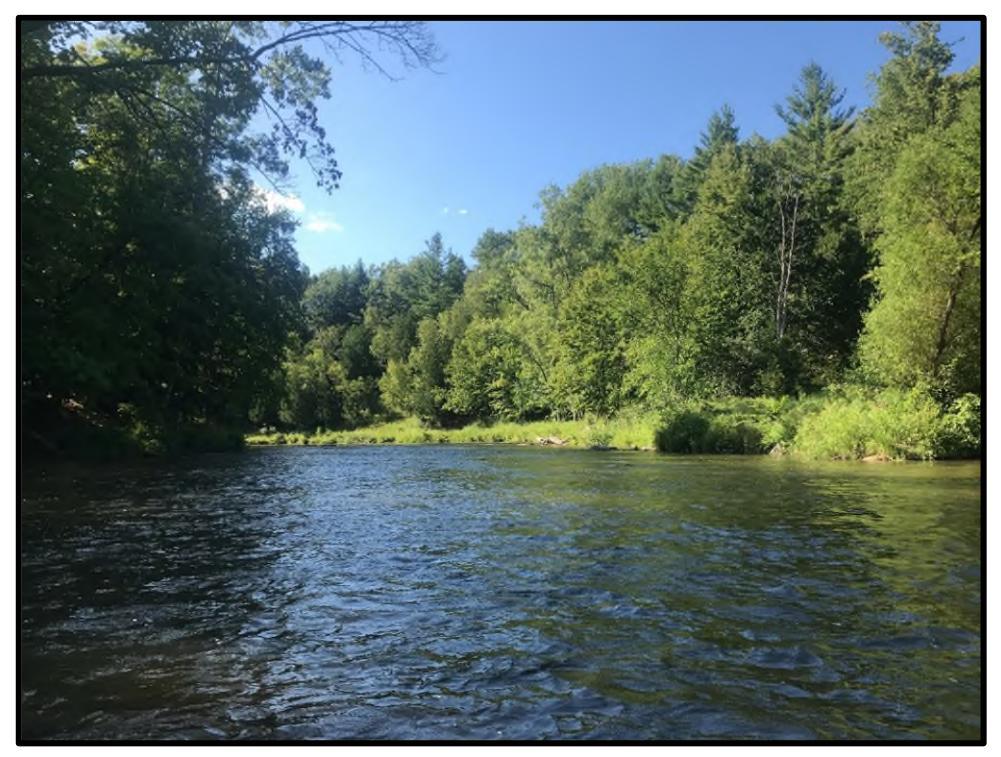
Two sites on the Rifle River were sampled as part of this watershed survey. One status site and one trend site. The status site (at the Grove Road crossing; Station 7) is located about 4 miles upstream from the city of Omer. Here, the river is wide and relatively low gradient, with no obvious modifications to the stream channel or riverbanks (Figure 5). Macroinvertebrates at this site scored "Excellent" and tied for the highest overall score with Klacking Creek at a score of 6. The macroinvertebrate community was robust, both in overall abundance and in diversity of sensitive taxa. Habitat quality scored "Good"; the in-stream habitat and surrounding riparian corridor were reflective of natural conditions. Some erosion issues along the right bank precluded an excellent habitat score.

Figure 5. The Rifle River at Grove Road, photo taken August 19, 2019.

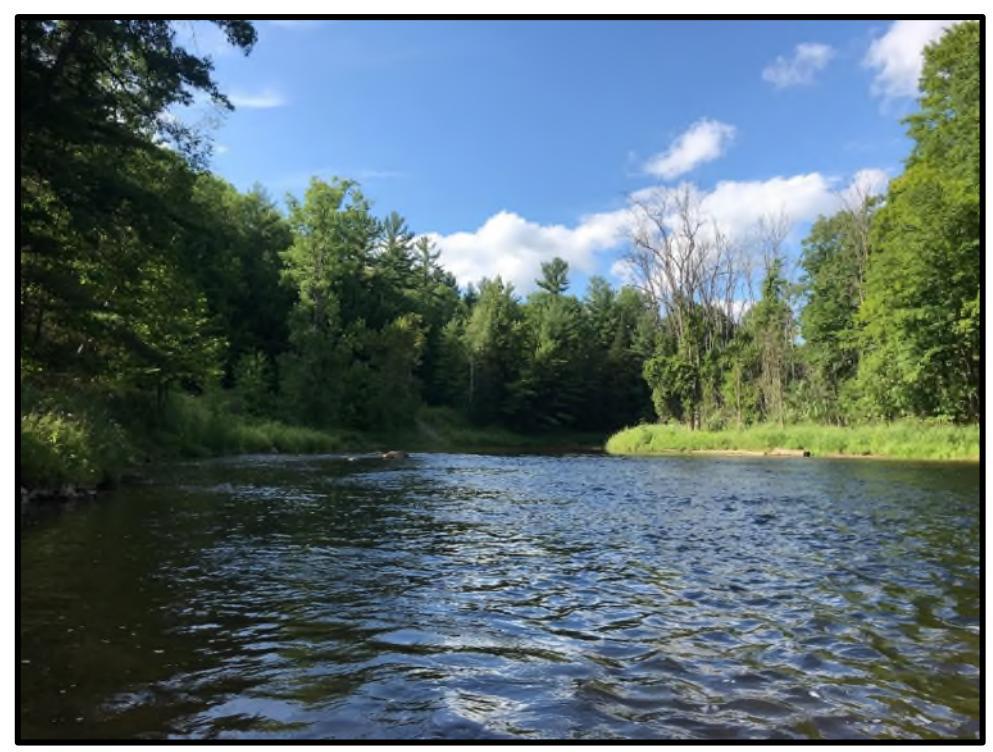
The trend site (at N Forest Lake Drive; Station 6) also scored well in both the habitat and macroinvertebrate metrics. Results were comparable to prior surveys from 2009 and 2014 in both overall metric ratings (excellent or acceptable) and macroinvertebrate species diversity,

resulting in a macroinvertebrate metric score of 5. As was the case with most of the upper Rifle River, the riparian buffer zone was dominated by natural vegetation and forests or wetlands (Figure 6). Substrate was primarily cobble or gravel; stream morphology consisted of long runs interspersed with cobble and boulder riffles. Some bank erosion was visible toward the downstream section of the sample reach, where a small park interrupts the otherwise continuous riparian forest corridor. Minor nutrient expression was evident as macrophyte growth amongst the cobbles.

Figure 6. The Rifle River at N Forest Lake Drive, photo taken July 31, 2019.

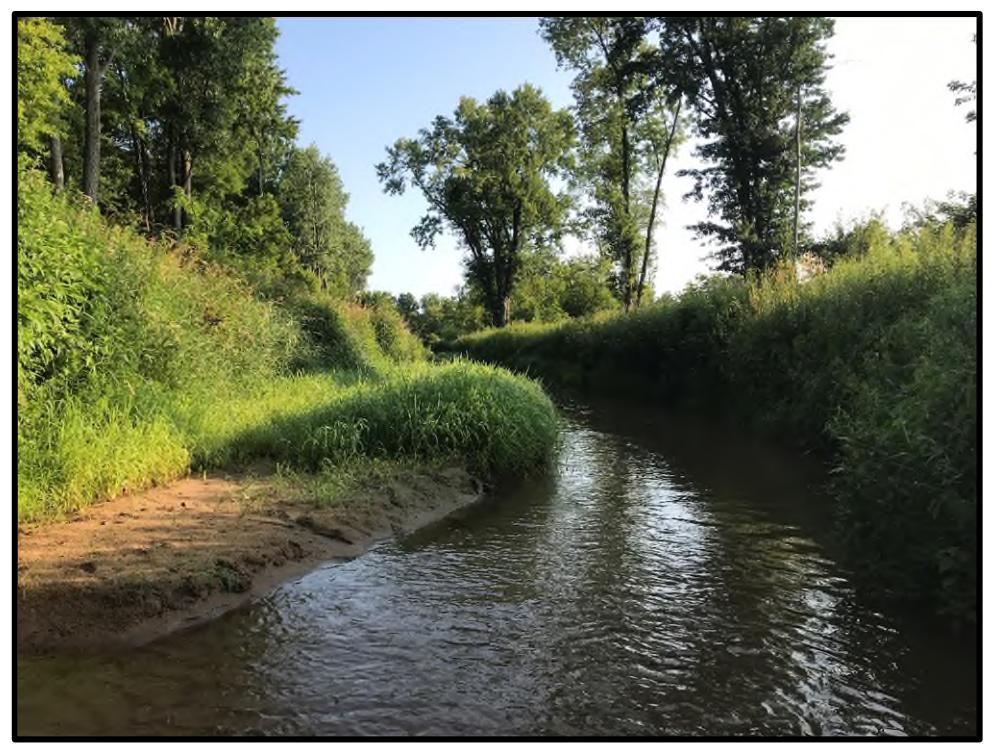
The previous watershed report (Noffke, 2015) indicated that Big Creek along Jose Road was heavily impacted by row crop agriculture and sand deposition, though macroinvertebrate biosurvey results at and upstream of Jose Road, collected between 2004 and 2014, ranged between +1 (acceptable; at Jose Road in 2014) and 0 (acceptable; ~ 3 miles upstream at Lehman Road in 2004) to +5 (excellent; at the most upstream sampled location, Maple Ridge Road in 2009) (Kohlhepp, 2005; Cooper, 2011; and Noffke, 2015). A site a few miles downstream of Jose Road (i.e., Big Creek Drain at the corner of Big Ck Rd and Manor Road) scored lower acceptable (i.e., -2) in 2009. EGLE received a request to conduct a site visit to this stream during the 2019 biosurvey field season to determine whether conditions had improved. Five locations were given quick site visits: Jose Road, S Crawford Road, N Hale Road, N Walker Rd, and Maple Ridge Road. Big Creek is a channelized system with poor to marginal habitat quality when surveyed in prior reports. Unfortunately, these conditions have not improved since the last cycle. The dominant substrate throughout the entire stretch was

sand, which completely overlies the native substrate in many areas, though at some locations (e.g., N Walker Road) there were gravel and cobble moderately abundant. Furthermore, large depositional sand banks were present along the inside bends of the stream (Figure 7, near Jose Road). The sedimentation was up to 3 feet thick in some locations (especially near Jose Road). The stream traveled along an agricultural field, where it was artificially channelized with little to no canopy cover (Figure 8, near N Hale Road). Most of the stream/drain from S Crawford Road, down through Jose Road, and then downstream until Lake Huron, cuts through existing or former wetlands. The combination of local geology being a flat clay and sand lake plain (from historically larger Great Lakes; Albert, 1995) with channel dredging, over-widening, and low gradient may all be contributing to the abundance of loose sediments in the channel near Jose Road. Site visits at upstream road locations revealed that loose sand deposits became less thick, and that gravel and cobble were occasionally present. Some algal growth was observed at N Hale Road. The road crossing culvert has degraded over time and drops off slightly into the downstream segment; it may be a hindrance to fish passage (Figure 9, N Hale Road). Overall, little to no improvement has been made to habitat quality within and around Big Creek.

**Figure 7.** Big Creek upstream of the Jose Road crossing, photo taken August 1, 2019. Note sand deposition on the inside bank.

- 5. Extensive sand deposition and turbidity were visible on Big Creek at Jose Road where the site visit occurred. Nutrient expression and a degraded culvert that may be a hindrance to fish passage were observed at Big Creek at N Hale Road. Nonpoint source staff should further investigate stream impacts and make efforts to inform nearby landowners of agricultural best management practices. A targeted survey should be conducted in the future to determine whether this site is meeting WQS, preferably with the assistance of a geologist or river restoration specialist to assess the sedimentation issues.

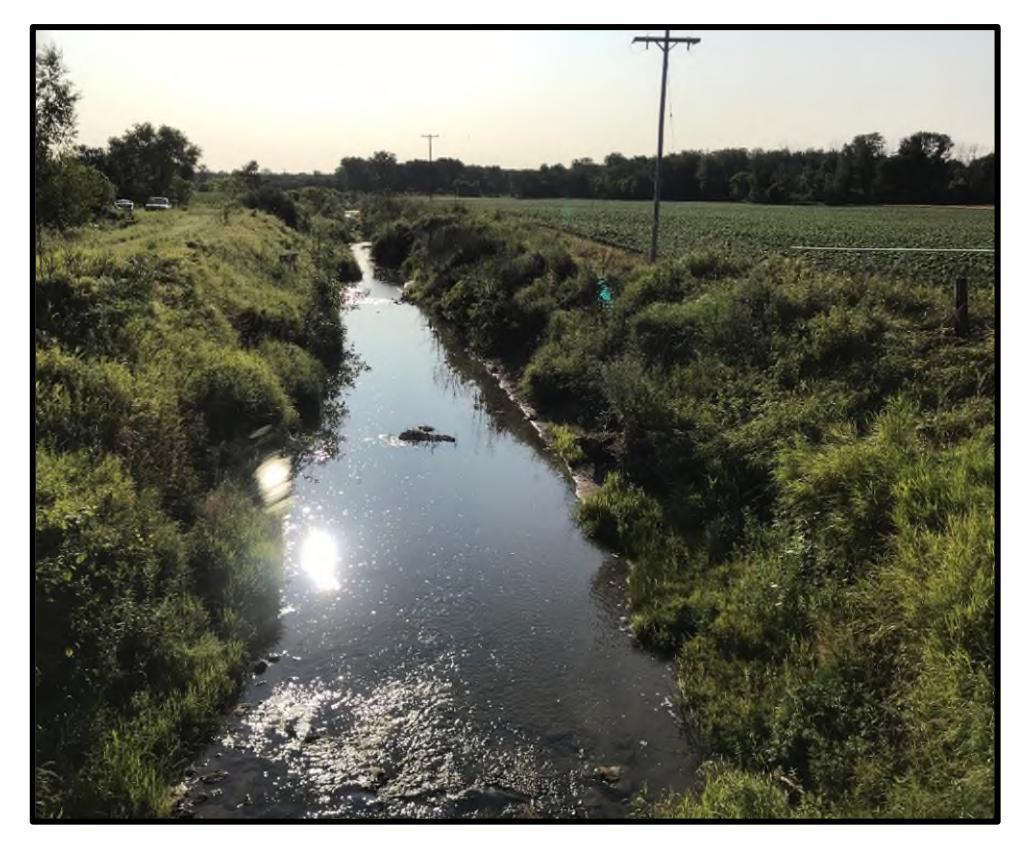
Figure 8. Big Creek downstream of N Hale Road, photo taken August 1, 2019.

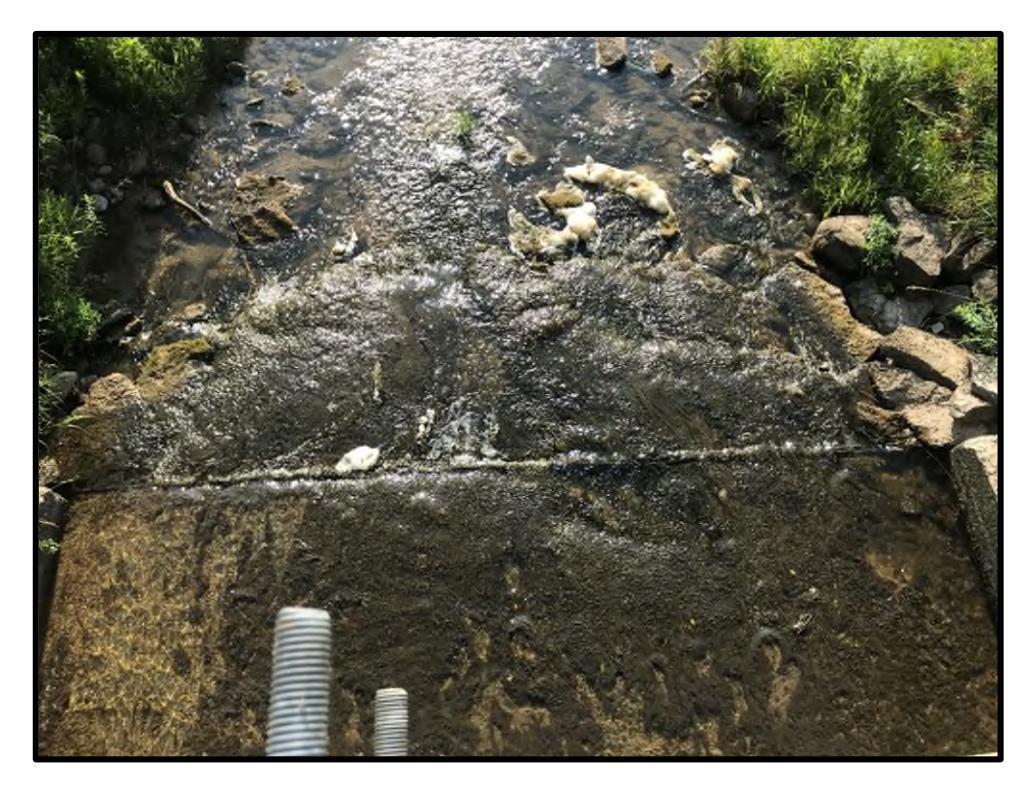
Figure 9. The Big Creek culvert at N Hale Road, photo taken August 1, 2019.

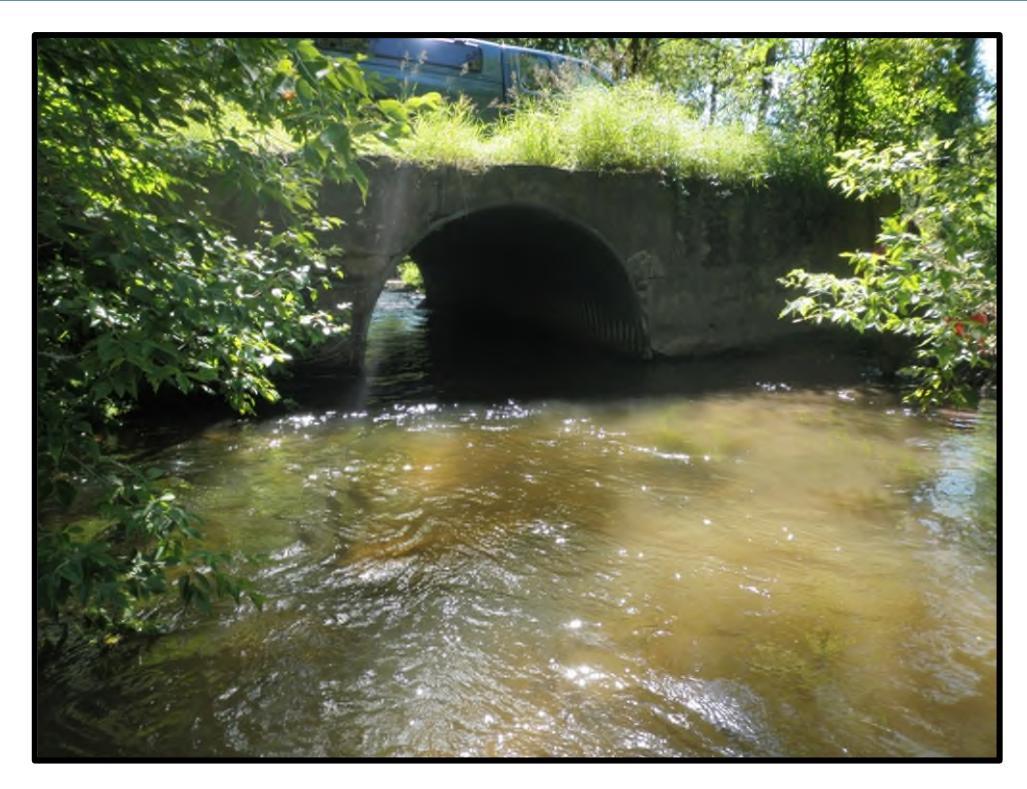
A follow-up survey was conducted upstream and downstream of the Flynn Road crossing to evaluate stream conditions after the replacement of an undersized culvert that took place after the 2014 cycle (Targeted Monitoring Request [TMR] Request #2019217). The old culvert and earthworks support structure (Figures 10 and 11) were completely removed and replaced with a wooden bridge (Figure 12). Fish, macroinvertebrates, and habitat characteristics were surveyed and compared to 2014 values. Habitat quality was generally similar; however, unlike 2014, habitat metrics rated better in the upstream sample reach when compared to downstream (Table 6). Embeddedness scored lower in the downstream segment, which may be a legacy effect of disturbance and construction activity during culvert replacement. Canopy cover and bank stability were good or excellent. Macroinvertebrate community scores were also similar to 2014, both rating acceptable. The number of sensitive taxa found upstream of the road crossing decreased from 11 to 6, while the number of sensitive taxa downstream of the road crossing remained the same at 8. As in 2014, the fish community was sampled above (Figure 13) and below (Figure 14) the Flynn Road crossing during this survey. Both locations again met coldwater fishery standards due to the abundant presence of Rainbow and Brown Trout. In 2014, one Brook Trout was sampled in the downstream segment. In 2019, no Brook Trout were sampled at this location. Comparison of the fish and macroinvertebrate communities in the upstream and downstream segments, respectively, indicate that the culvert replacement did not substantially improve biological indices in the area immediately surrounding the road crossing. However, in 2014, only two fish species (brown trout and mottled sculpin) were observed upstream of the road. In 2019, a third species (banded killifish) was observed upstream of the road and in abundance (163 individuals). So, it is possible that banded killifish benefitted from the culvert replacement – perhaps due to more natural channel dimensions or improved flow conditions. It is important to note that these near-culvert biological surveys were not intended to be a thorough examination of possible improvements to watershed scale biological community conditions that may be affected by improved stream continuity at this single location. Moreover, fish that benefitted from the culvert replacement may have moved to locations other than near Flynn Road.

**Figure 10.** Houghton Creek upstream of Flynn Road in 2014, before the culvert replacement. Note partial impoundment of water and undersized culvert impeding flow.

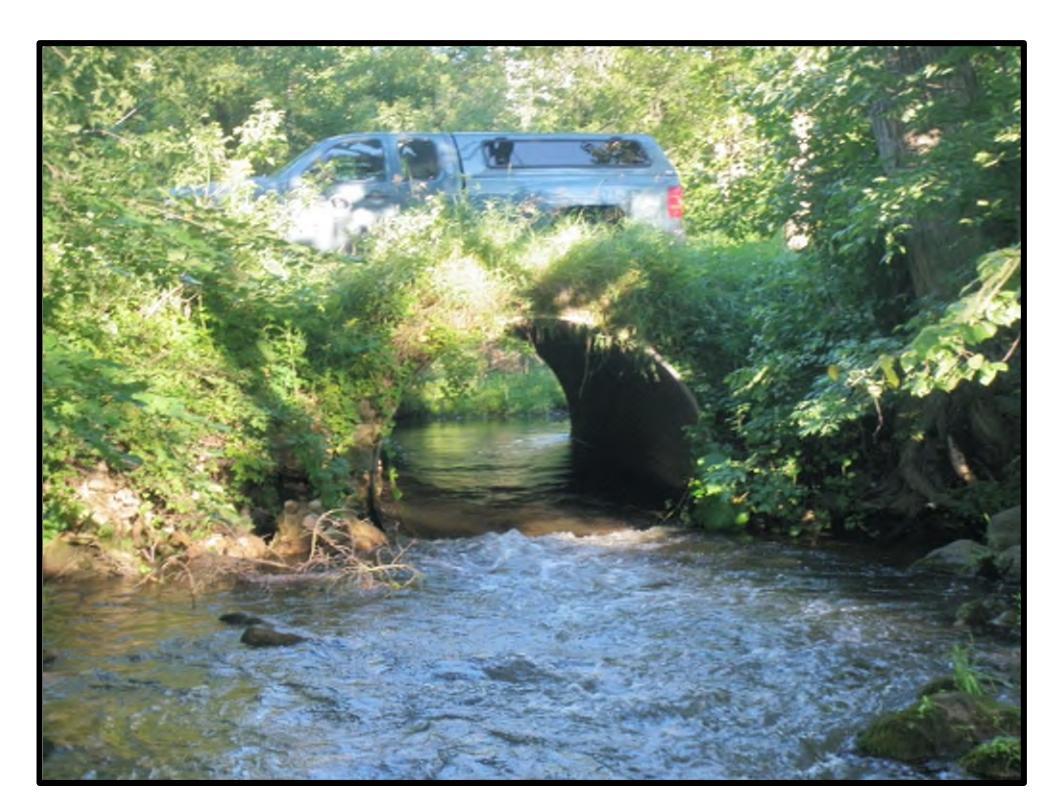
Figure 11. Houghton Creek downstream of Flynn Road in 2014, prior to culvert replacement.

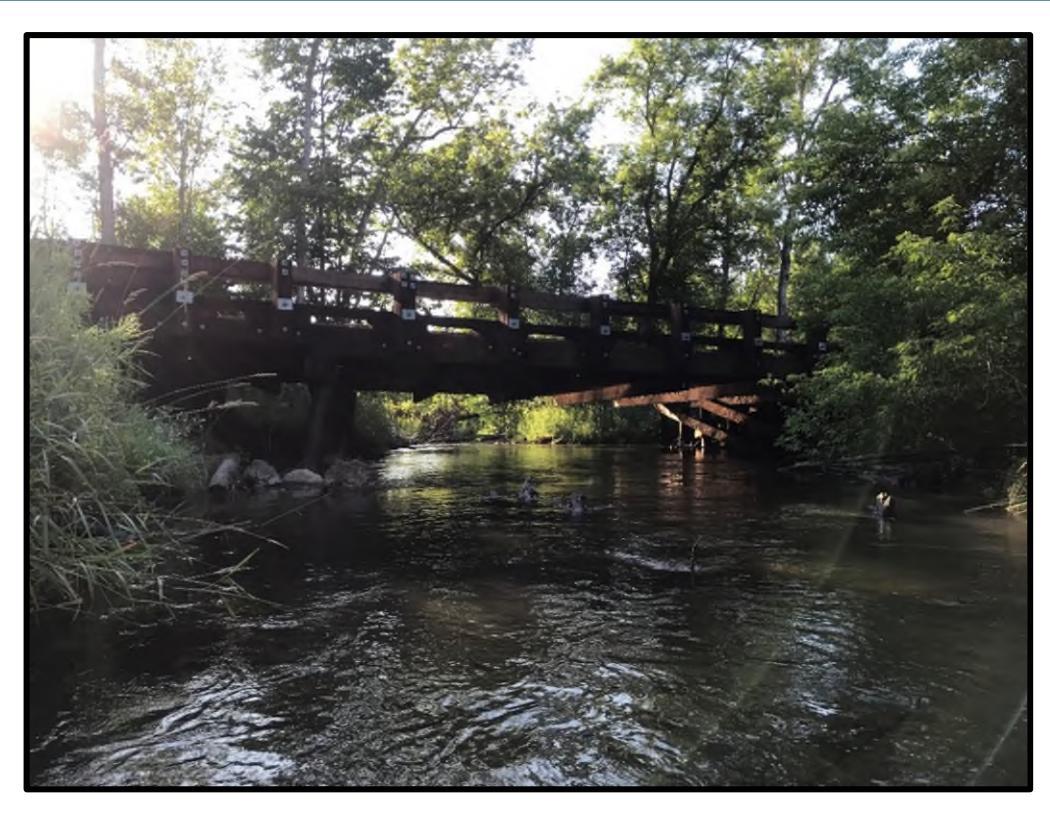
**Figure 12.** A new bridge built over Houghton Creek at Flynn Road, photo taken July 30, 2019.

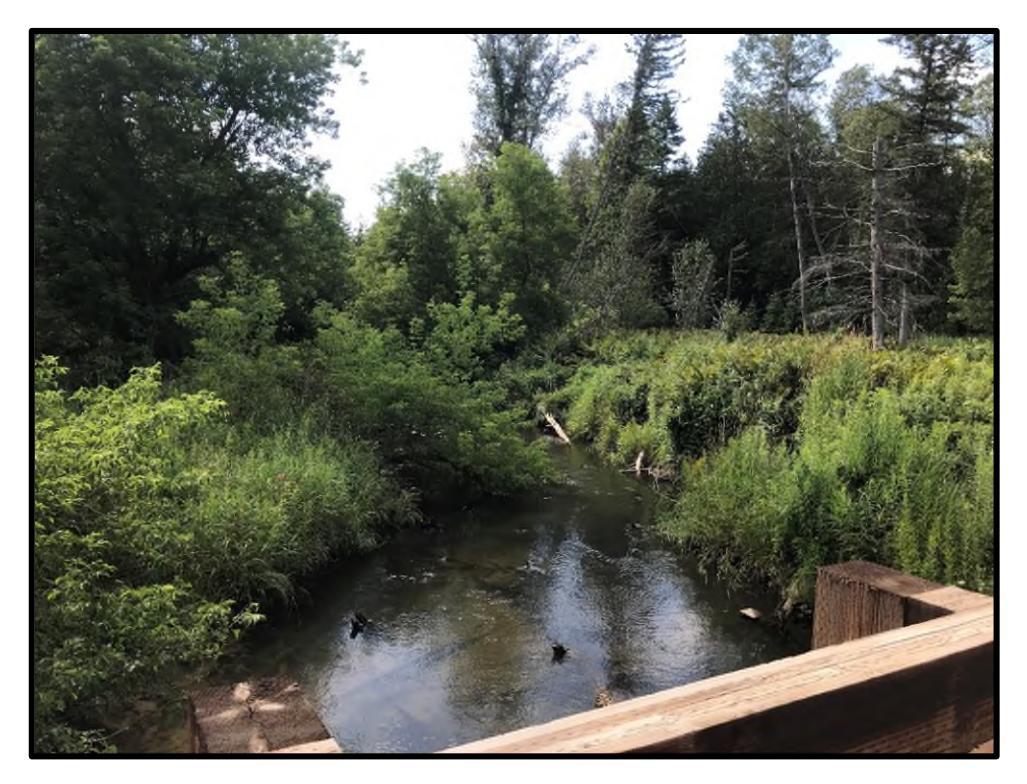
Figure 13. Houghton Creek at Flynn Road (facing upstream), photo taken July 30, 2019.

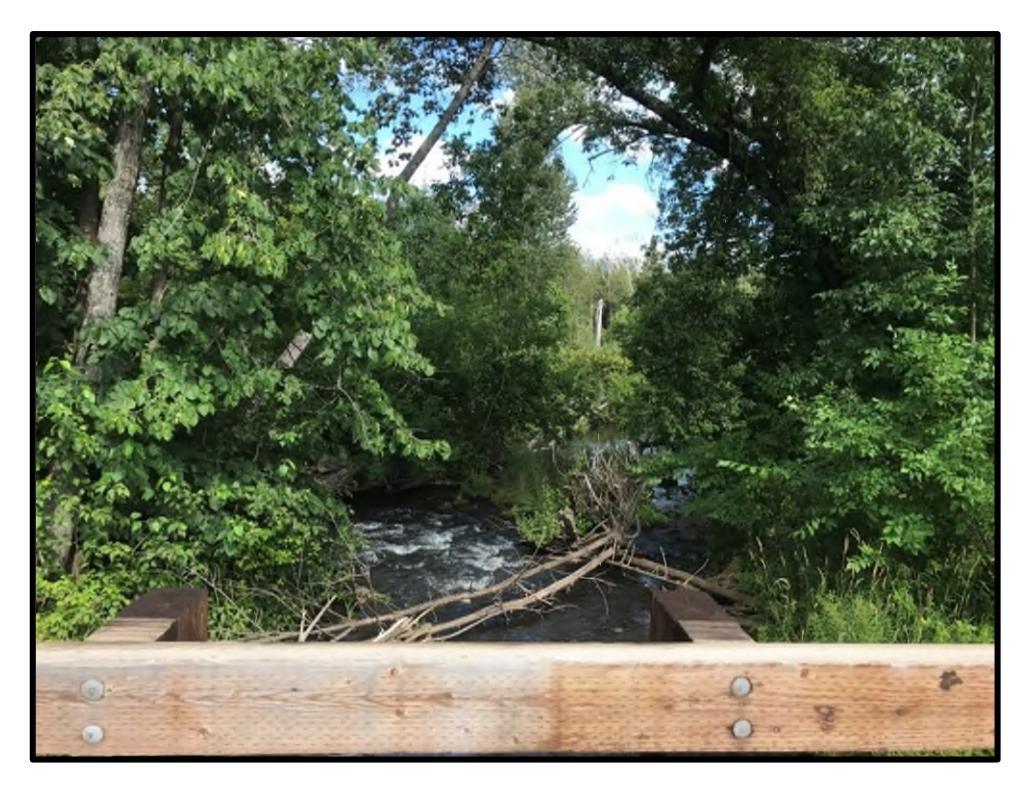
Figure 14. Houghton Creek at Flynn Road (facing downstream), photo taken July 30, 2019.

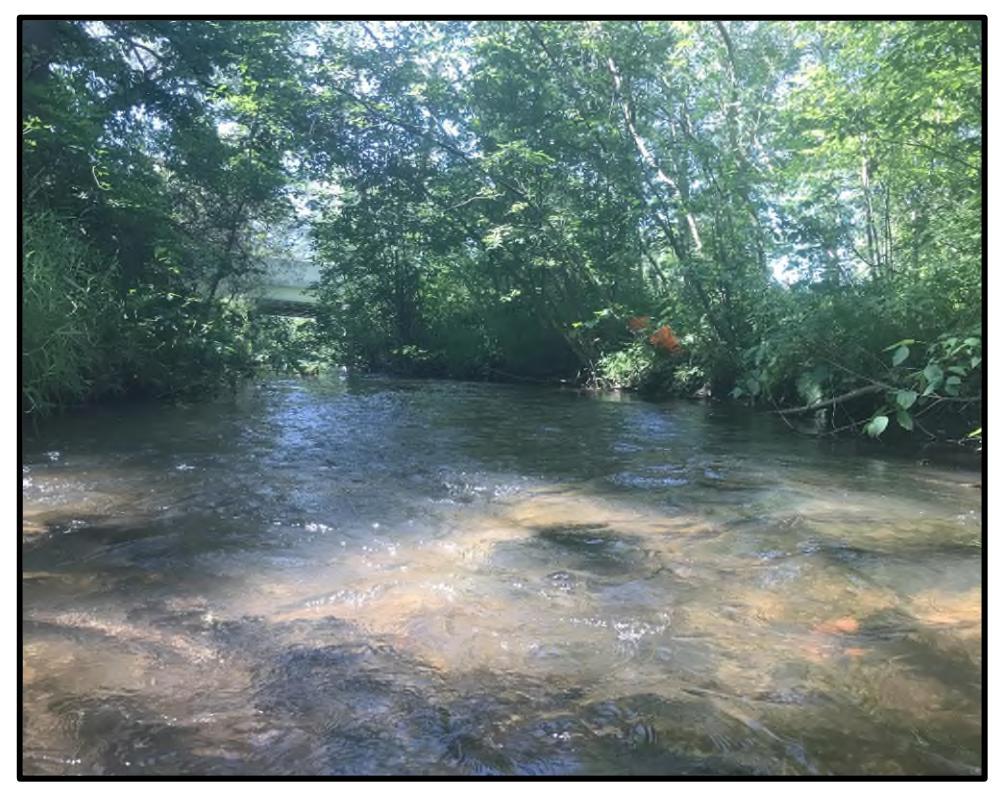
A request was also submitted to sample macroinvertebrates and examine substrate in Houghton Creek at Rose City Road (TMR Request #2019218). An old, deteriorated dam upstream of this site is being considered for removal. The dam has occasionally discharged sediment from the upstream impoundment into Houghton Creek due to failing infrastructure. Dam removal may result in a pulse of considerable sedimentation into the stream; a follow-up survey may be warranted in the event of dam removal. Habitat here was excellent (receiving the highest score for habitat metrics among all sites) with very little embeddedness and lots of available substrate for aquatic fauna. This location was surrounded by mixed forest with superb canopy cover and variable riffle-pool habitats (Figure 15). Flow was stable with little evidence of flashiness. Macroinvertebrates scored "acceptable" with a score of 3 and an abundance of caddisfly and true fly taxa. Other sensitive taxa (mayflies, stoneflies) were also present.

Figure 15. Houghton Creek at Rose City Road, photo taken July 31, 2019.

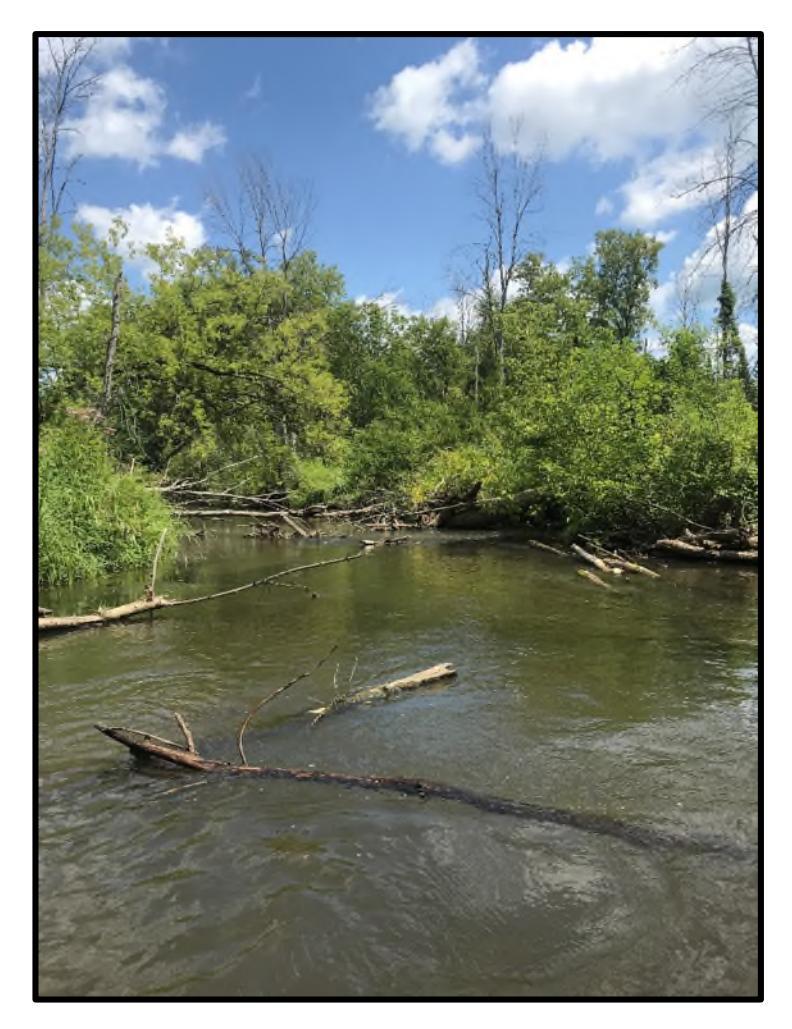
EGLE Permits Section staff conducted a targeted biosurvey (TMR Request #2019234) within the Rifle River watershed during the 2019 field season on the West Branch Rifle River at Simmons Road. The goal of this survey was to examine stream conditions immediately downstream of a WWTP outfall. Macroinvertebrate diversity rated acceptable with a score of 4. Sensitive taxa comprised 33 percent of all individuals sampled. An abundance of Physid snails were also recorded at this site. Habitat scored excellent according to the 'glide/pool' scoring criteria. Most other streams within the survey fell into the 'riffle/run' criteria given the steep gradients and cobbly substrates common throughout the Rifle River watershed. Nonetheless, some issues with turbidity were noted. Woody debris was a common habitat feature throughout the sample reach (Figure 16). WWTP effluent appeared to have negligible impact on stream conditions at this location.

Figure 16. The West Branch Rifle River at Simmons Road, photo taken August 7, 2019.
