Line 5 Straits of Mackinac (East Leg)
Enbridge Energy Limited Partnership
20 inch Crude Oil Pipeline

Executive Summary

A full survey of the Enbridge Energy Limited Partnership Line 5 Straits of Mackinac (East Leg) pipeline was successfully completed by GE Oil & Gas, PII Pipeline Solutions on the 9th of May 2008.

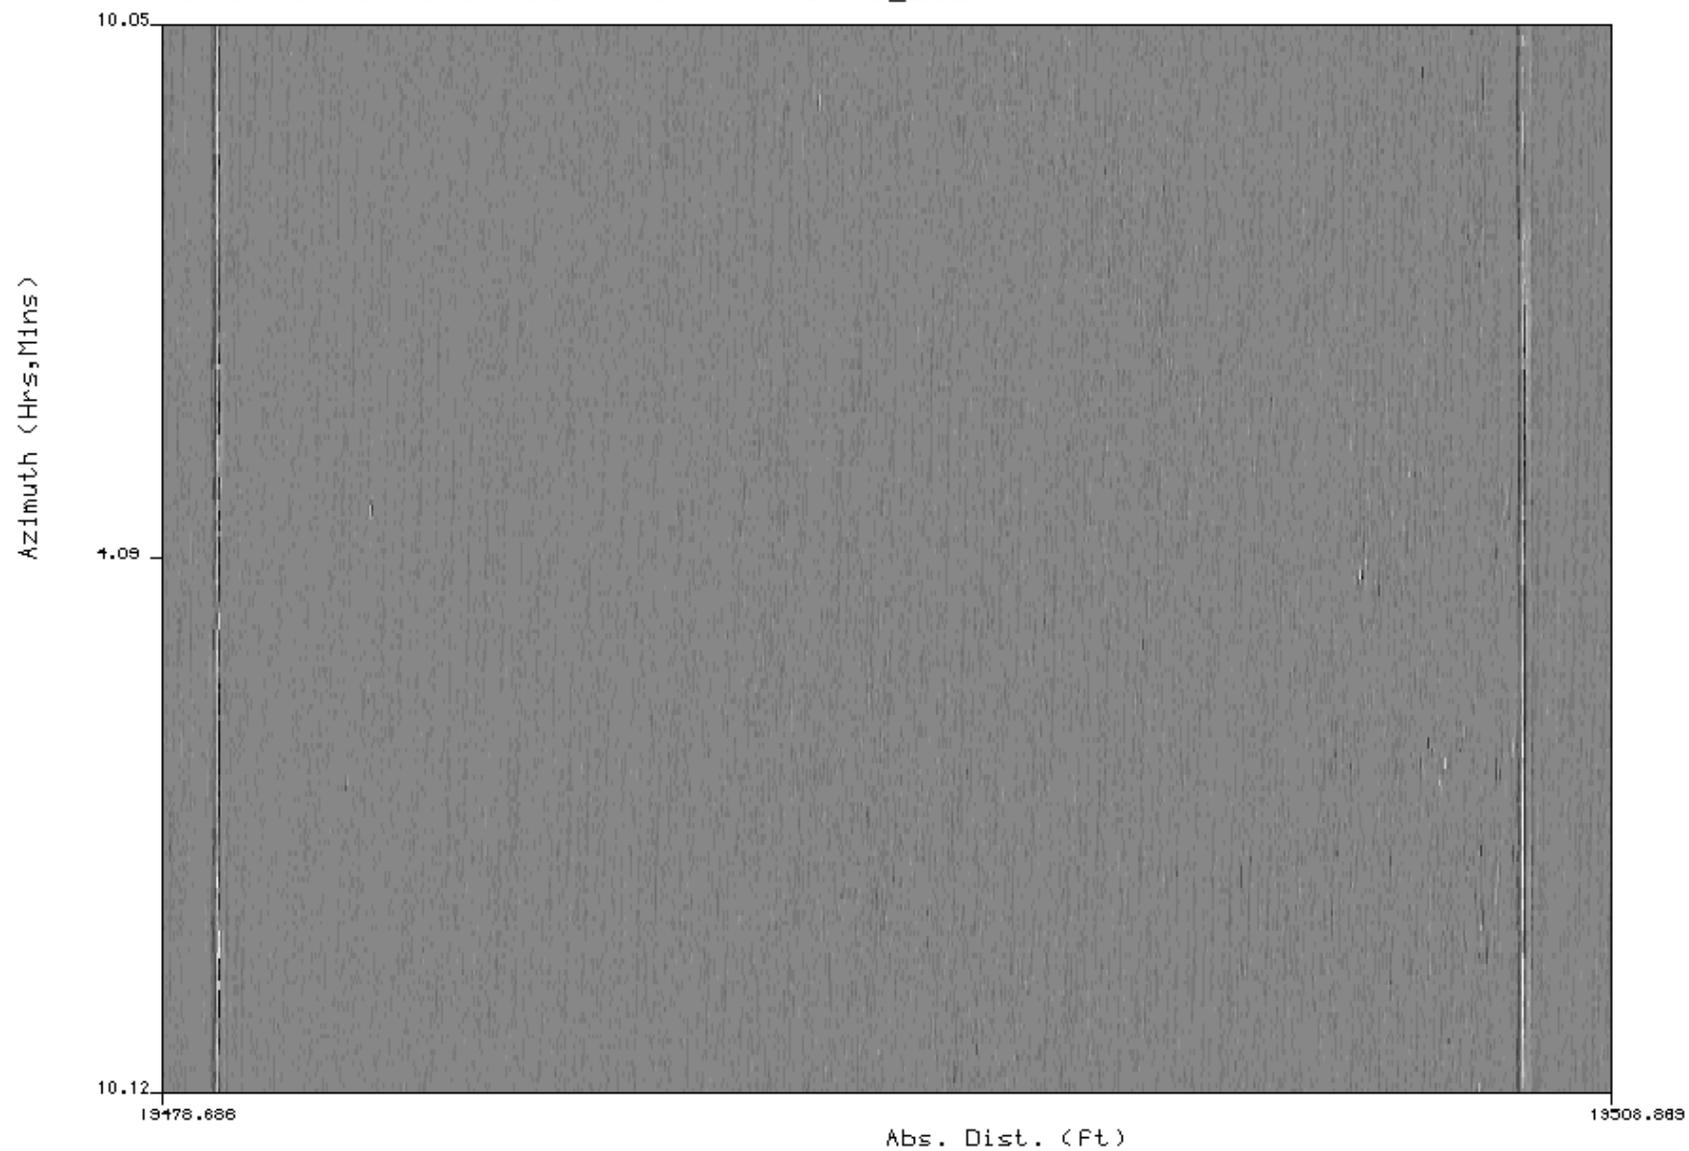
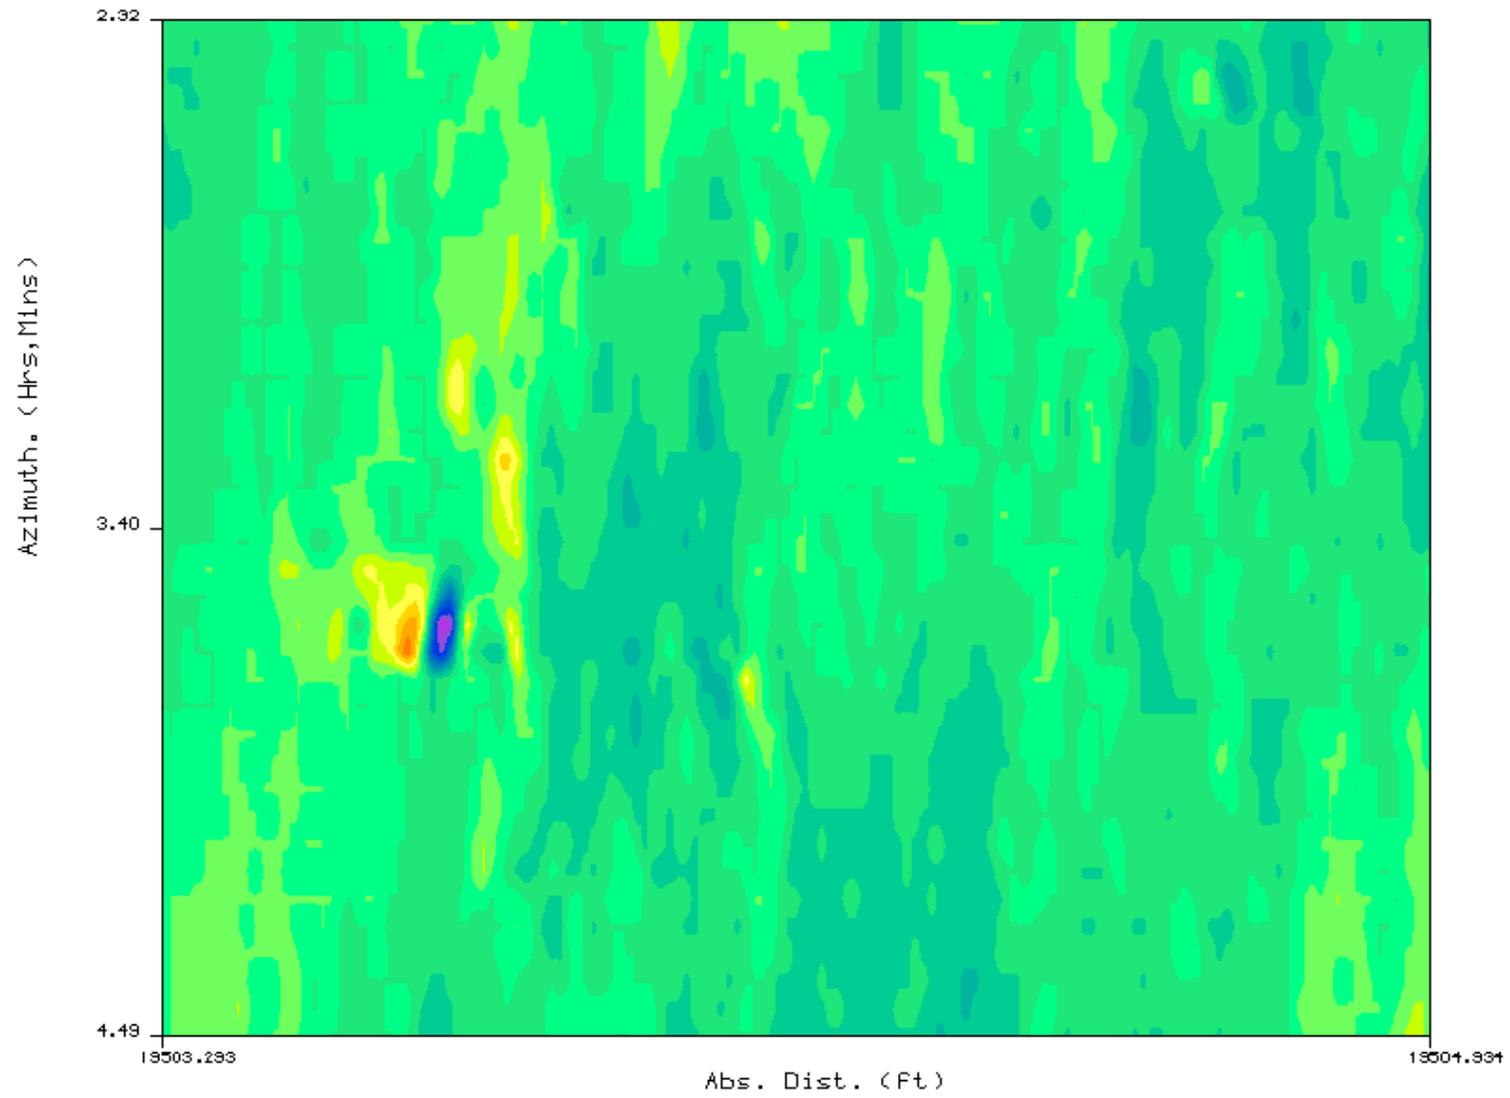
Feature 13 Overview Plot 109170_20B

Feature 13 Detail Contour Plot 109170_20B

Feature Description

Type:	External Mill/Manufacturing Fault
Orientation:	10:35 (o'clock)
Axial length:	12.8 in
Circumferential width:	7.3 in
Depth - Peak:	31% WT
- Average:	16% WT
Feature Selection Rule:	8
Nominal Pipe wall thickness for spool:	0.812 in
Absolute Distance from Launch:	20356.745 feet

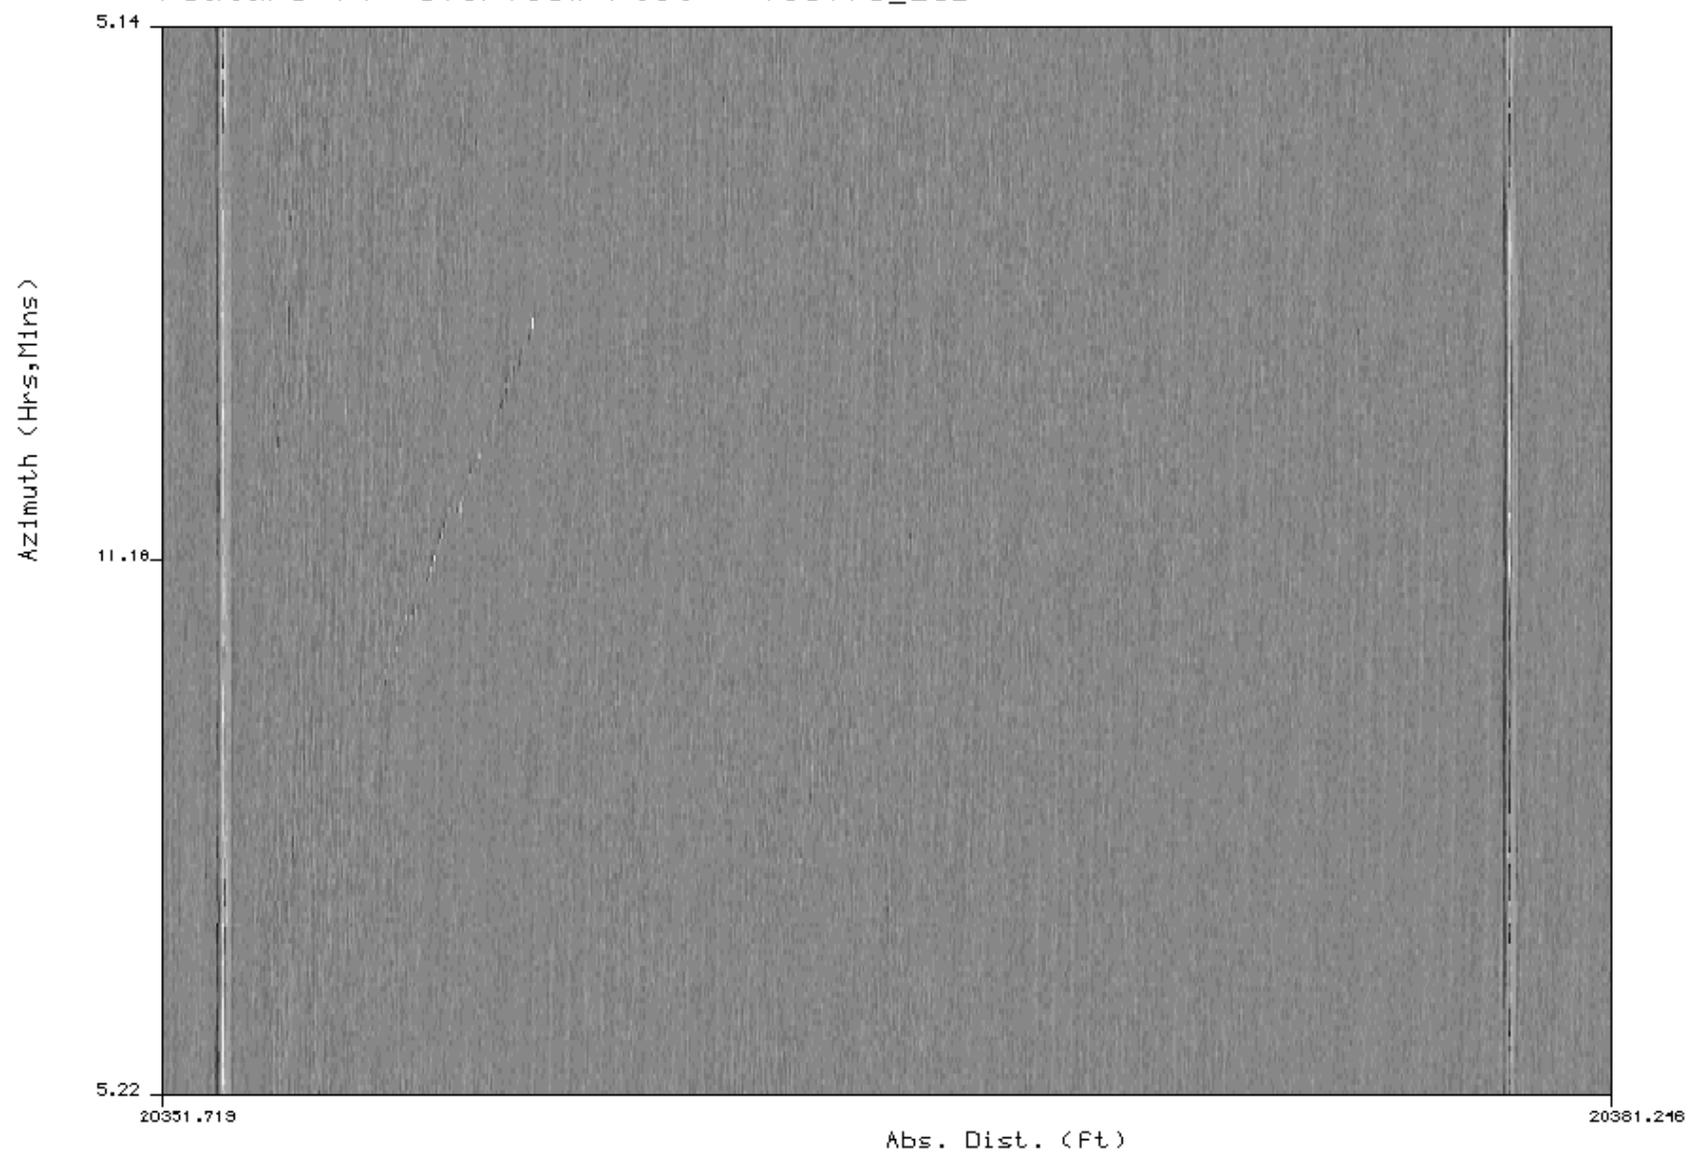
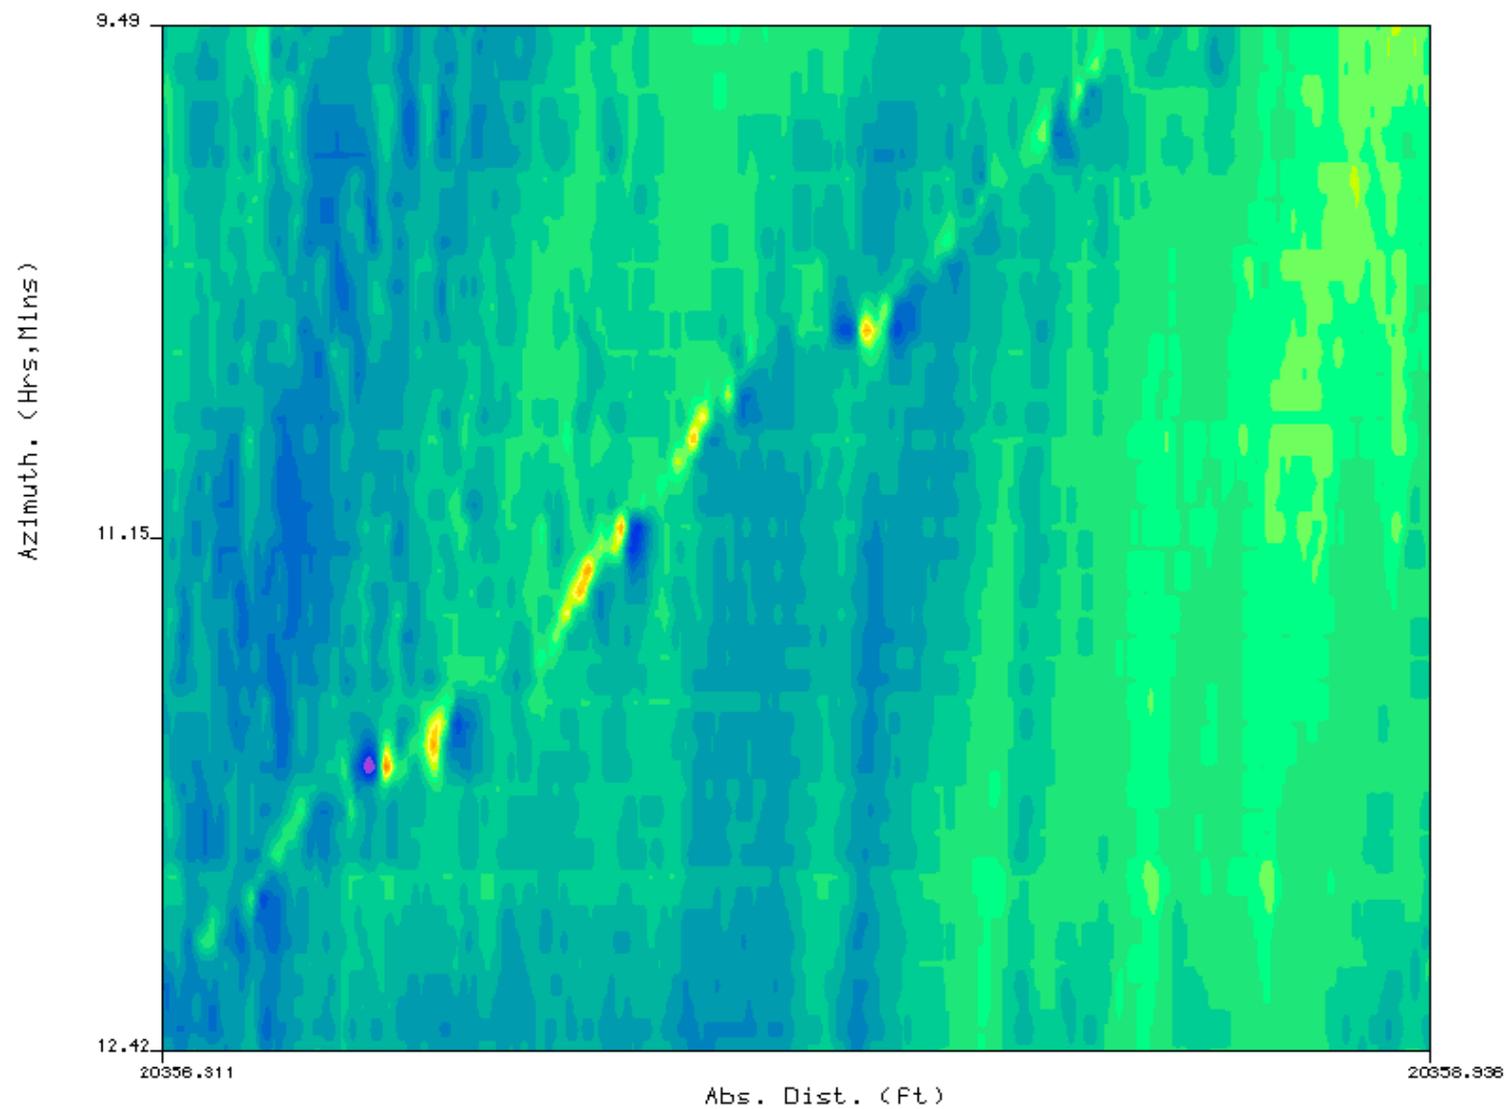
Feature 14 Overview Plot 109170_20B

Feature 14 Detail Contour Plot 109170_20B

Feature Description

Type:	External Mill/Manufacturing Fault
Orientation:	04:20 (o'clock)
Axial length:	7.8 in
Circumferential width:	5.7 in
Depth - Peak:	35% WT
- Average:	19% WT
Feature Selection Rule:	8
Nominal Pipe wall thickness for spool:	0.812 in
Absolute Distance from Launch:	21280.515 feet

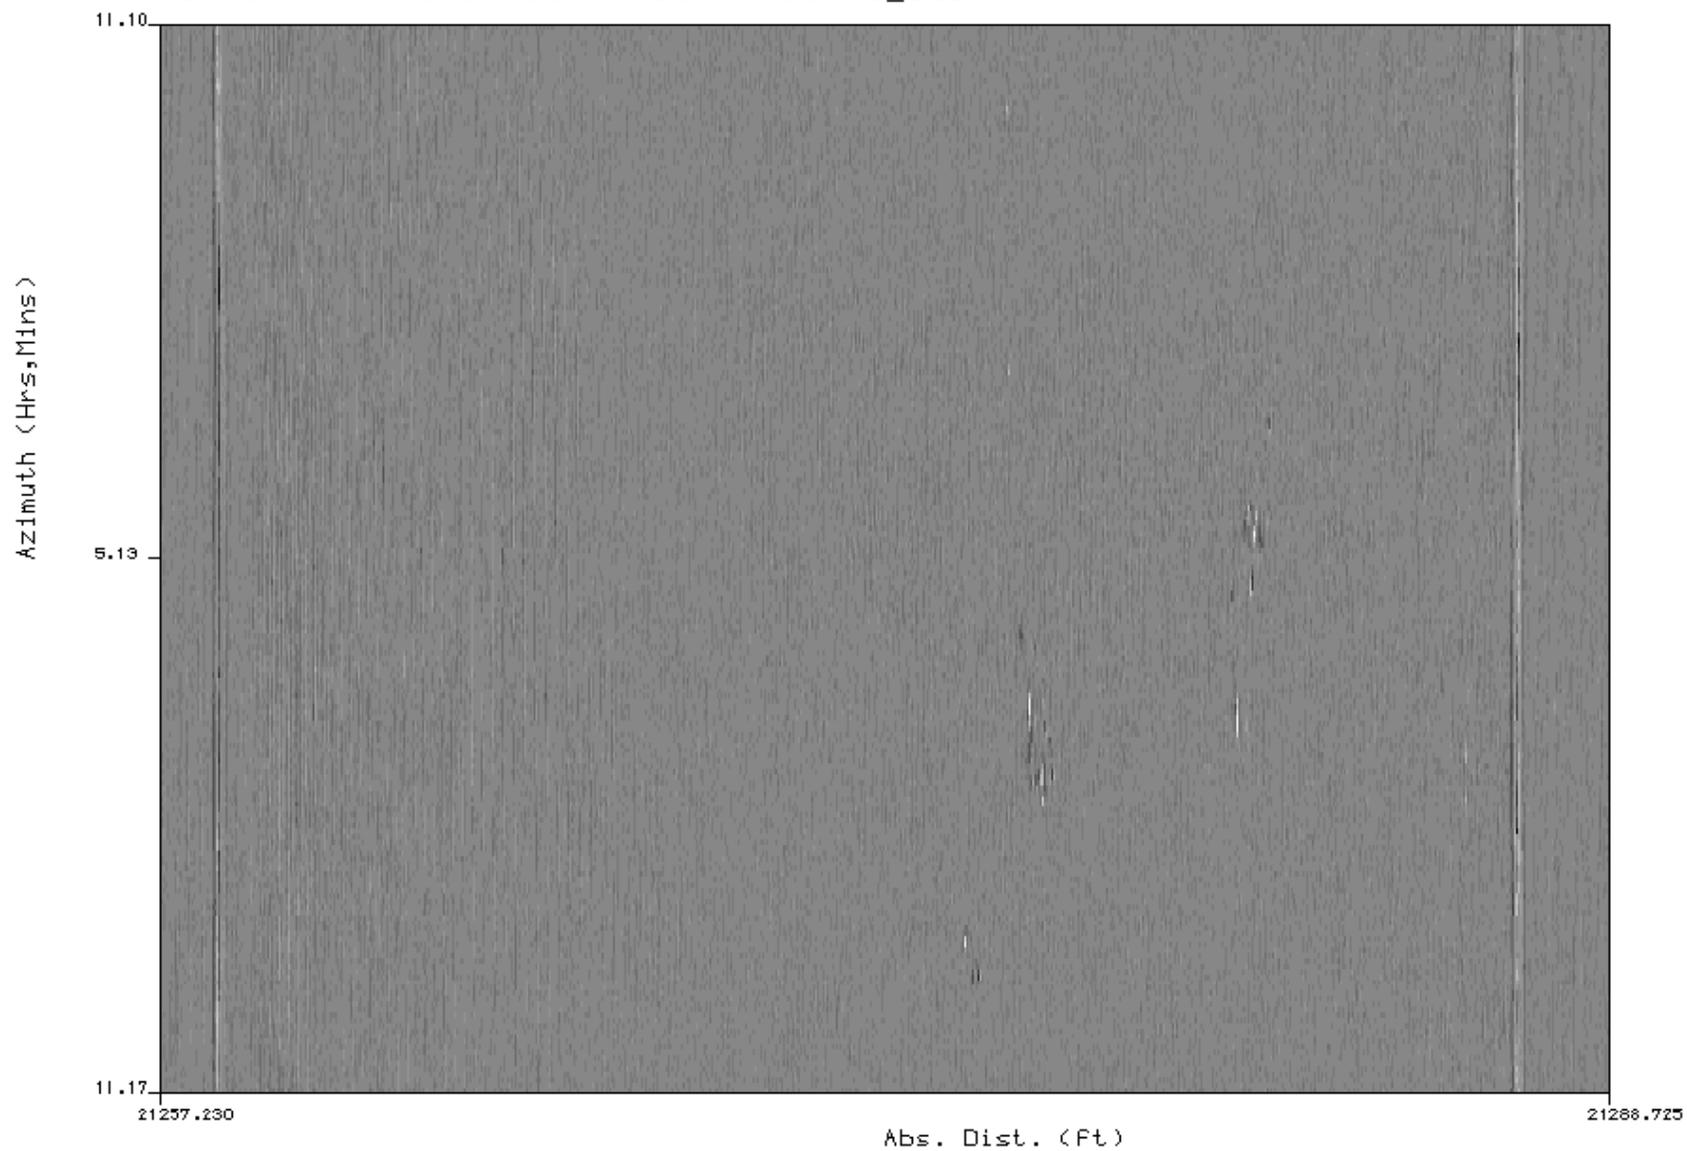
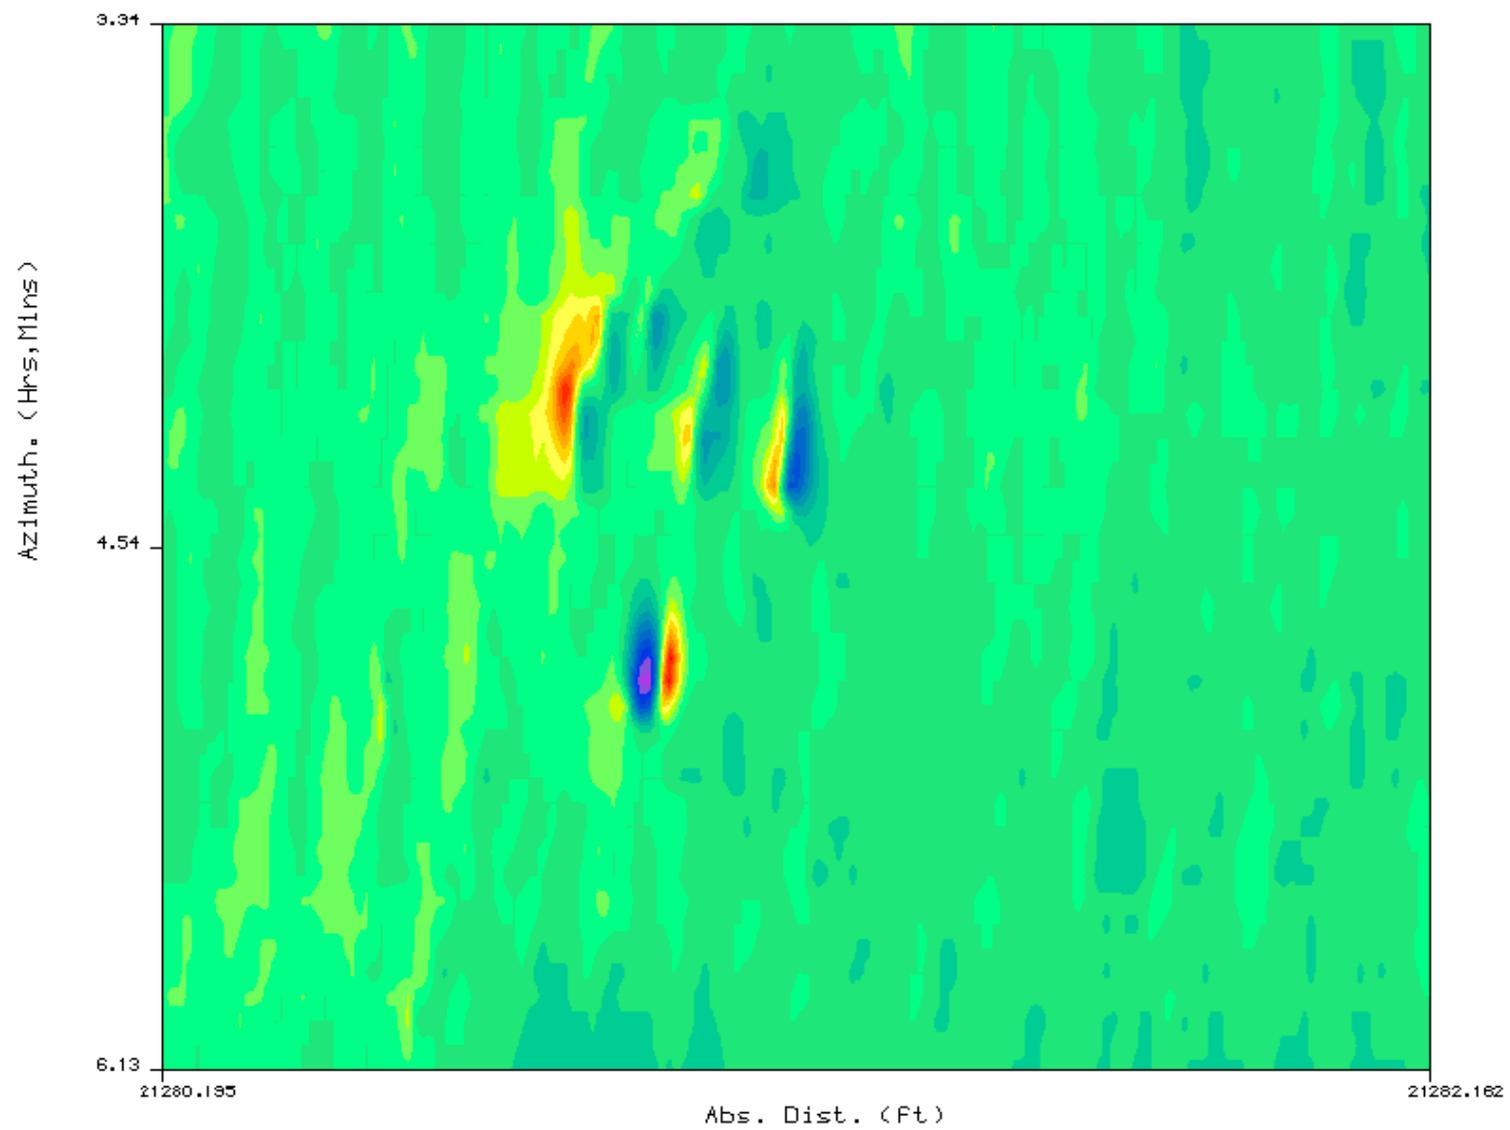
Feature 15 Overview Plot 109170_20B

Feature 15 Detail Contour Plot 109170_20B

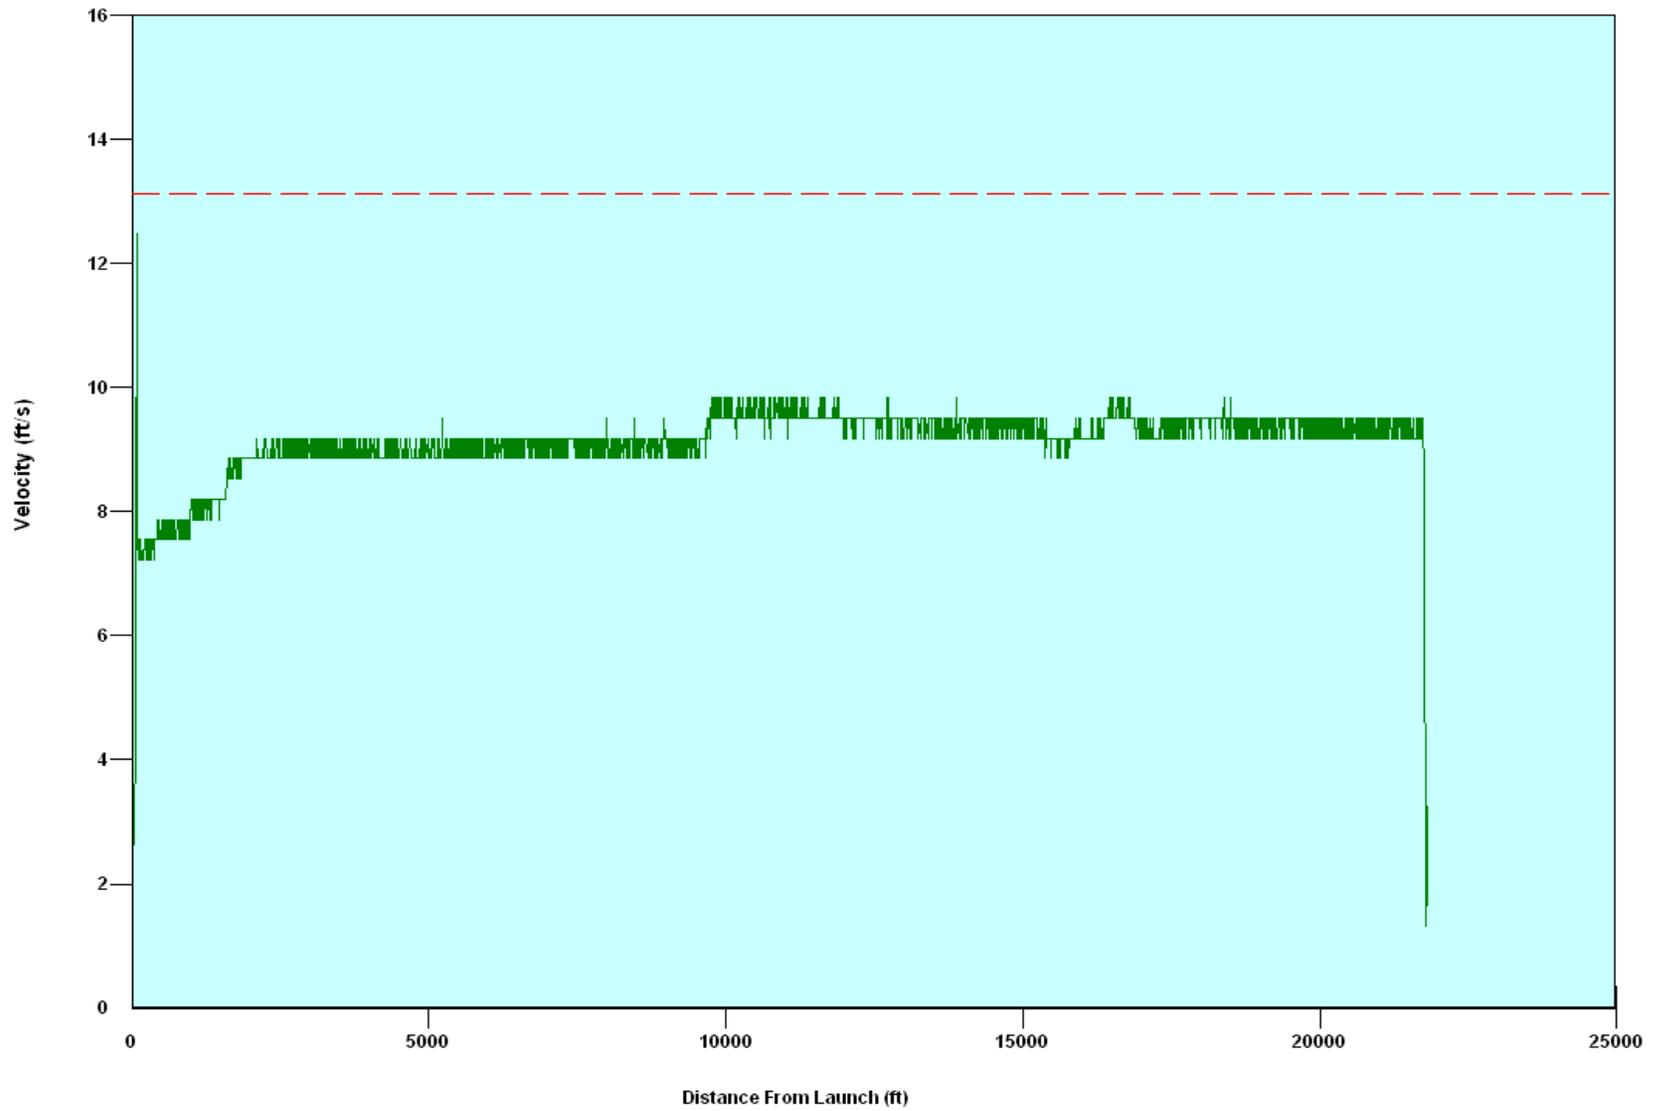
Contractual Maximum Velocity

The red line on the velocity plot indicates the specified maximum velocity for the inspection vehicle. If the vehicle exceeds the specified maximum velocity then the performance of the inspection vehicle may be degraded.

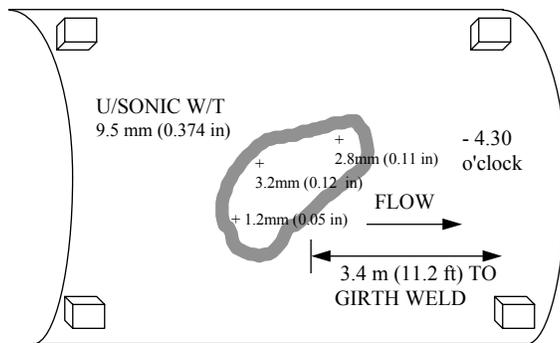
Figure 1: Example of Rubbing

The rubbing technique has a definite advantage over photographic recording methods in that it is possible to record all subsequent measurements directly on the rubbing in the appropriate location e.g. each individual pit depth in multiple pitting. Refer to Figure 1 for the example.

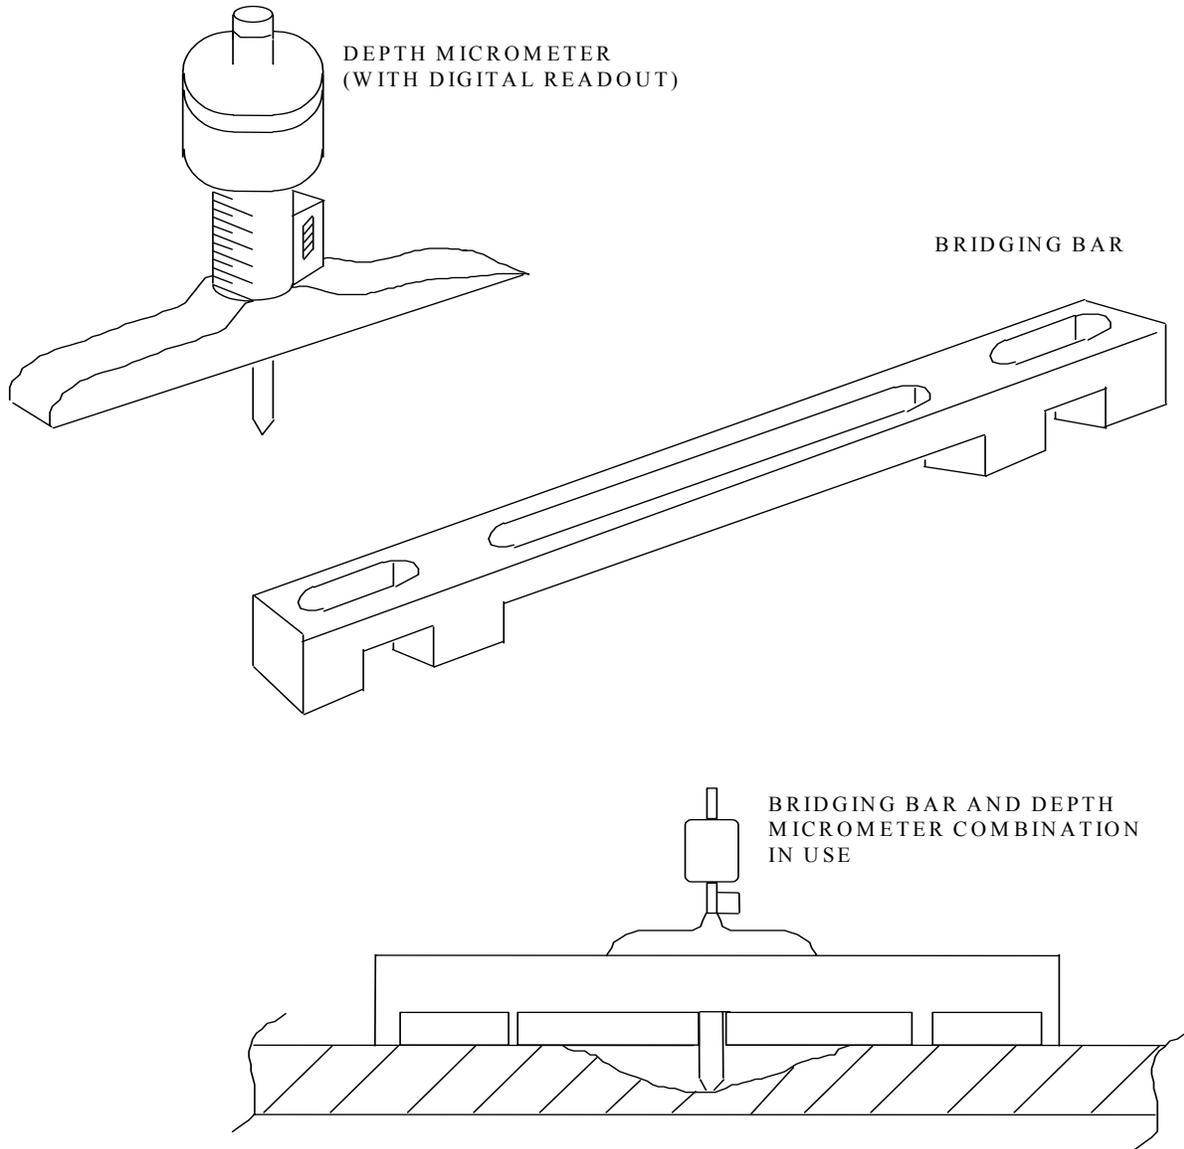
Figure 2: Typical Micrometer and Bridging Bar Arrangement

It is recommended that the micrometer anvil be ground to a taper with a tip diameter of approximately 0.04 inches. This will enable entry into the small diameter pitting and concave surfaces found at the bottom of most metal loss features.

A pit gauge is not recommended because of its potential inaccuracy of up to 0.08 inches. A depth micrometer has a resolution of better than 0.002 inches.

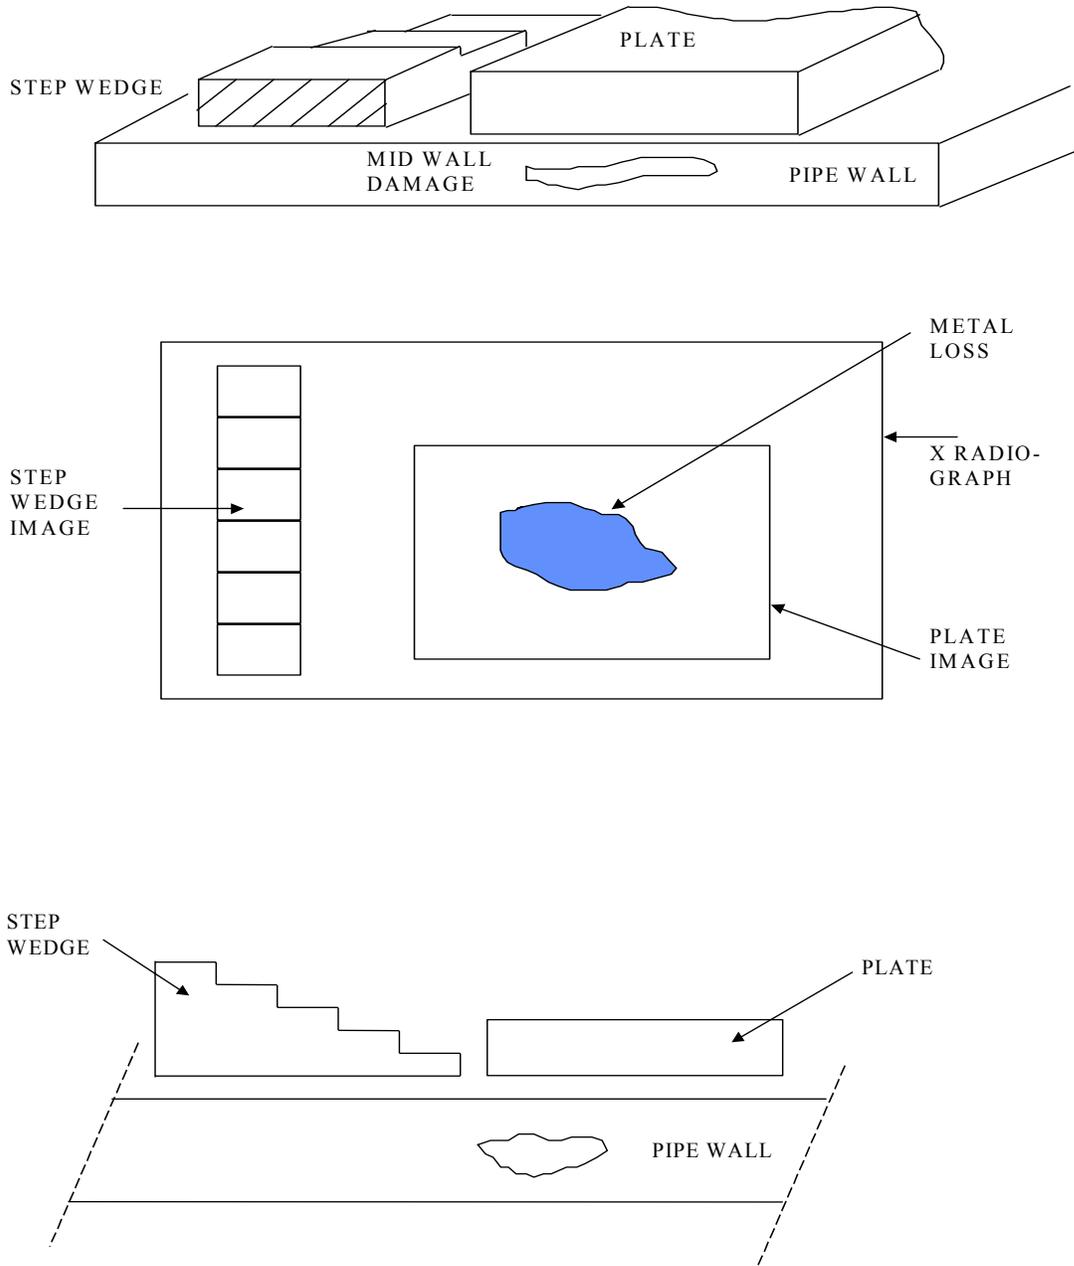
Figure 3: Typical Arrangement for X-ray Technique

Gamma radiography is not recommended since this technique is relatively insensitive to metal loss. Depending on wall thickness and the diameter of the pipe a sensitivity of approximately 10% of wall thickness can be achieved using gamma-ray techniques whereas X-ray techniques can achieve a sensitivity of better than 2% of wall thickness.

- (1) Locate area of metal loss using ultrasonic or Double Wall Single Image (DWSI) X-ray techniques.
- (2) Place plate of known thickness over the metal loss area or deepest part of the metal loss. The plate thickness must be equal to or greater than the damage through-wall thickness.
- (3) Place an ultrasonic step wedge on the pipe surface the adjacent to the metal loss but on sound pipe.
- (4) Carry out DWSI X-radiography aiming for a density of approximately 3 on the parent plate.

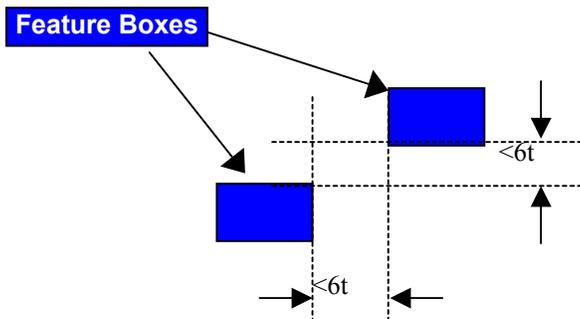
Example of Feature Boxes that Interact

Feature Boxes must be within 6 Wall Thicknesses ($6t$) in both directions.
