**PHASE II SAMPLING REPORT
FOR
DETROIT LEAD ASSESSMENT PROJECT
COMMODITY METALS – 1641 CANIFF STREET
HAMTRAMCK, WAYNE COUNTY, MICHIGAN**

WESTON SOLUTIONS OF MICHIGAN, INC.

September 2006

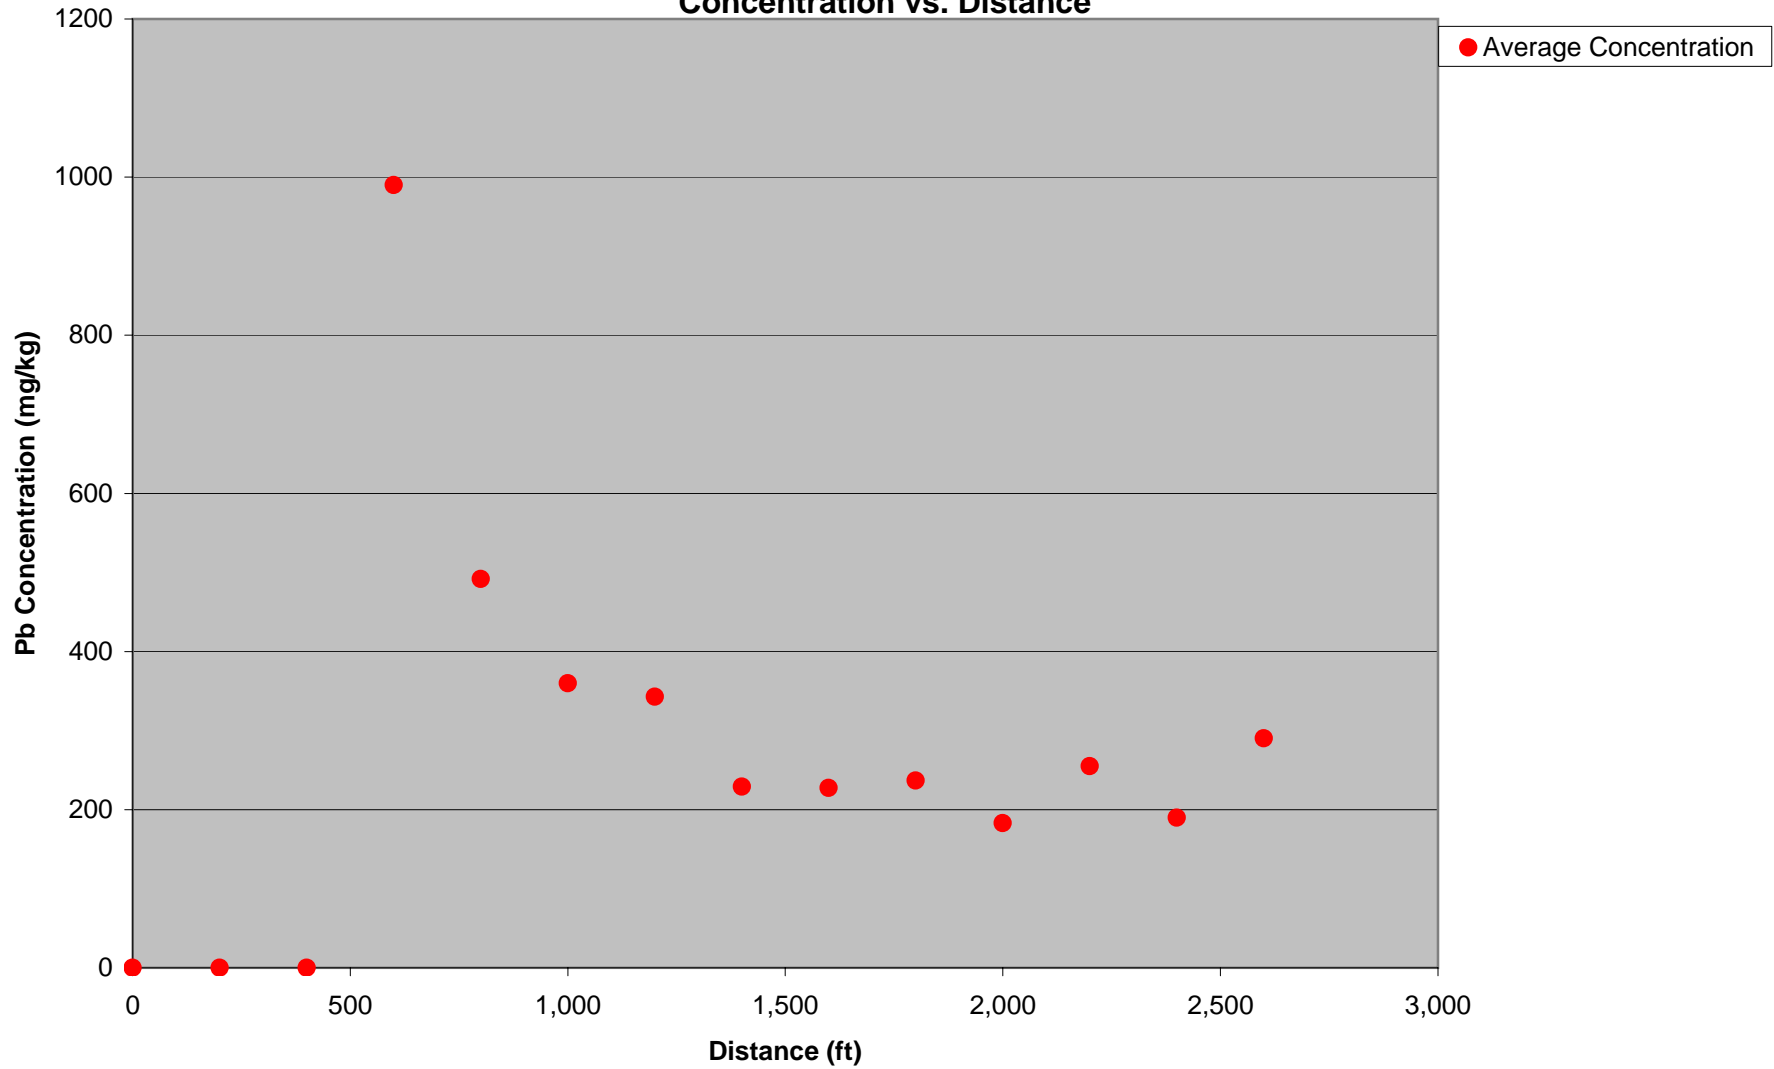
Figure 3-2
Continental/Federated Metal
Concentration vs. Distance

To determine the distribution of the lead concentrations in soils as the distance from the suspected source area increases, WESTON graphed the lead concentrations versus distance for both the MDEQ and the Wayne County data sets. A linear regression analysis of the data confirms that a statistically significant decreasing trend ($p=0.000$ for unsieved and $p=0.0573$ for sieved samples) of lead concentrations in soils exists, as distance from the area of interest increases. As a result, conclusions can be made with the certainty that the data sets are representative of the conditions present. The distance versus concentration graph is shown on the attached **Figure 3-2** in **Appendix A**. The sieved samples collected by WESTON and the unsieved samples collected by Wayne County are plotted separately. This figure shows a steeper slope for the sieved data than the unsieved data, which would be expected if aerial deposition were a significant contributing factor. This is caused by the larger airborne particles of lead “falling out” closer to the source (the stack). It should be noted that the graph of the unsieved data indicates lower overall concentrations than the sieved trend line. This may have occurred due to the depth of samples (if collected lower than 3 inches below ground surface), or location (if collected in disturbed areas). However, assuming all of the Wayne County samples were collected in the same manner, the trend of a lesser slope is significant in determining the presence of aerial deposition, when compared against the sieved data set.

Where air transport of particulate occurs, it is expected that the largest impacts on the soil through aerial deposition of particulate will occur closest to the source and that the magnitude of the impact will tend to decrease as a function of distance from the source. In addition, it is expected that the spatial pattern of soil impacts will tend to be elongated in the predominant downwind direction. Thus, the Phase II investigation was designed to determine if an off-site transport of airborne particulate has occurred, by examining the spatial pattern of soil contaminant concentrations as a function of distance from the source in a downwind direction. As seen in **Figure 3-1** in **Appendix A**, concentrations of lead greater than the screening level occur within the primary downwind envelope.

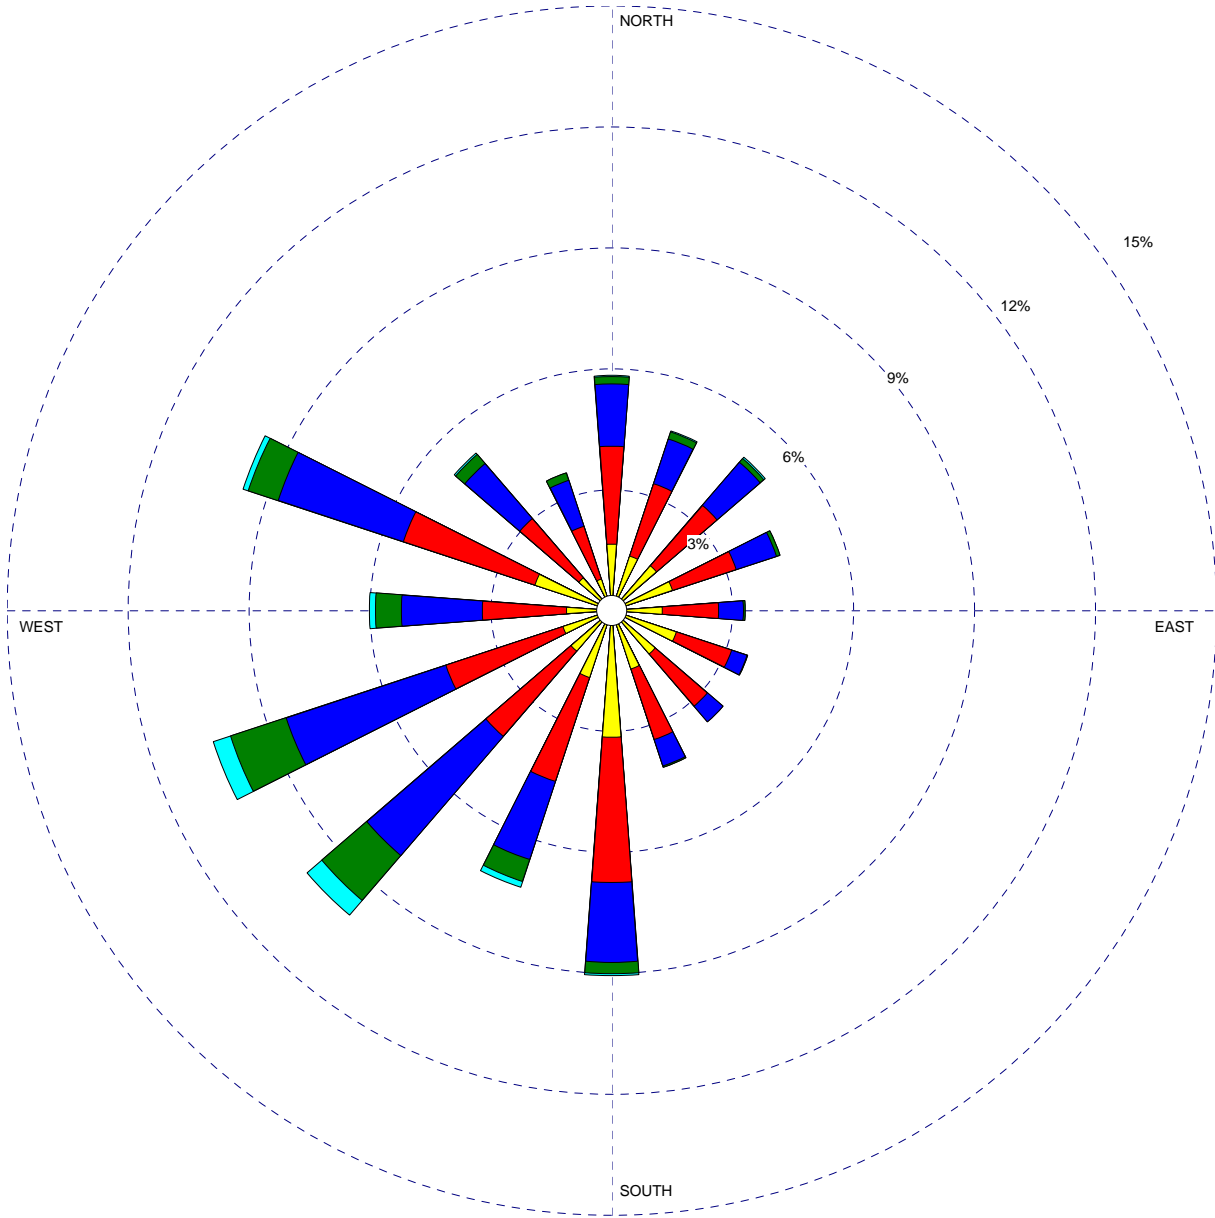
WIND ROSE PLOT

During Phase II soil sampling activities, downwind parcels were chosen based on the mean wind direction from 1984 to 1991 for the Detroit Metropolitan area. A copy of the wind rose plot is provided in **Appendix C**. The wind rose plot showed a prominent northeast wind direction in the Detroit Metropolitan area. If smelting operations occurred, lead in soils resulting from aerial deposition would be found downwind in the northeast direction from the suspected source area. Parcels ranging from 500 ft to 2,300 ft in the northeast direction were sampled, as close to the mean downwind direction of the suspect source area. Elevated lead concentrations were found in the downwind direction of the suspected source area. A detailed analysis of downwind concentrations is contained in **Section 3.4 Spatial Analysis**.

<p>Wind Speed (m/s)</p>		DATE 2/3/2003	Weston Solutions, Inc.
	DISPLAY Wind Speed	UNIT m/s	Years 1984-1991
	AVG. WIND SPEED 5.06 m/s	CALM WINDS 3.67%	
	ORIENTATION Direction (blowing from)	PLOT YEAR-DATE-TIME 84 85 86 87 88 89 90 91 January 1 - December 31 Midnight - 11 PM	ATTACHMENT C

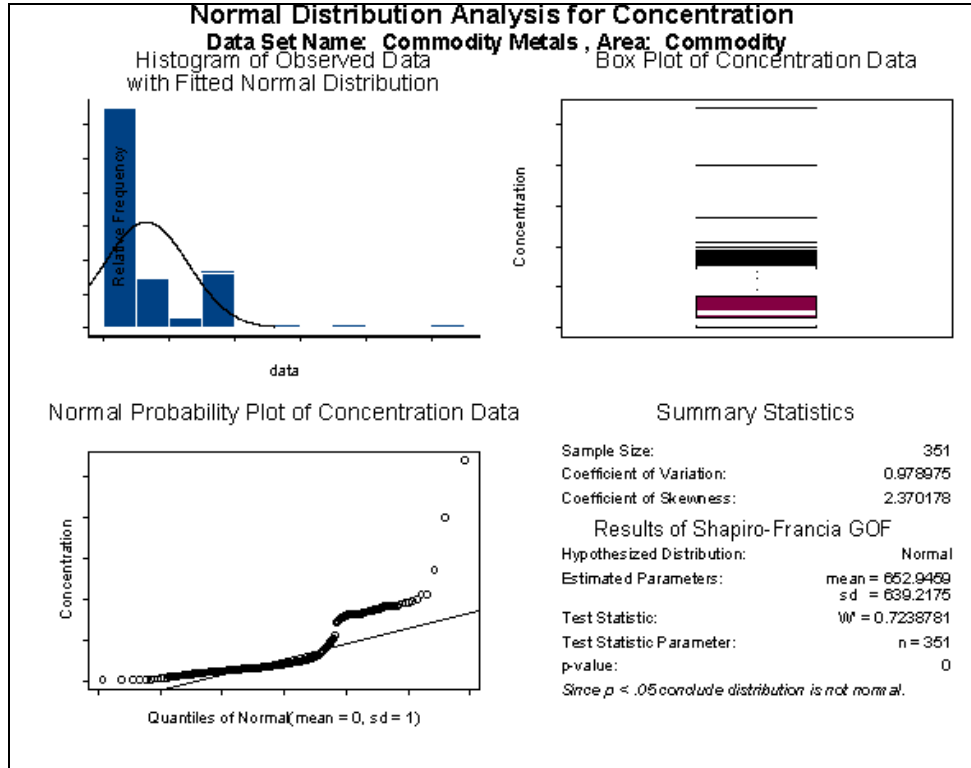
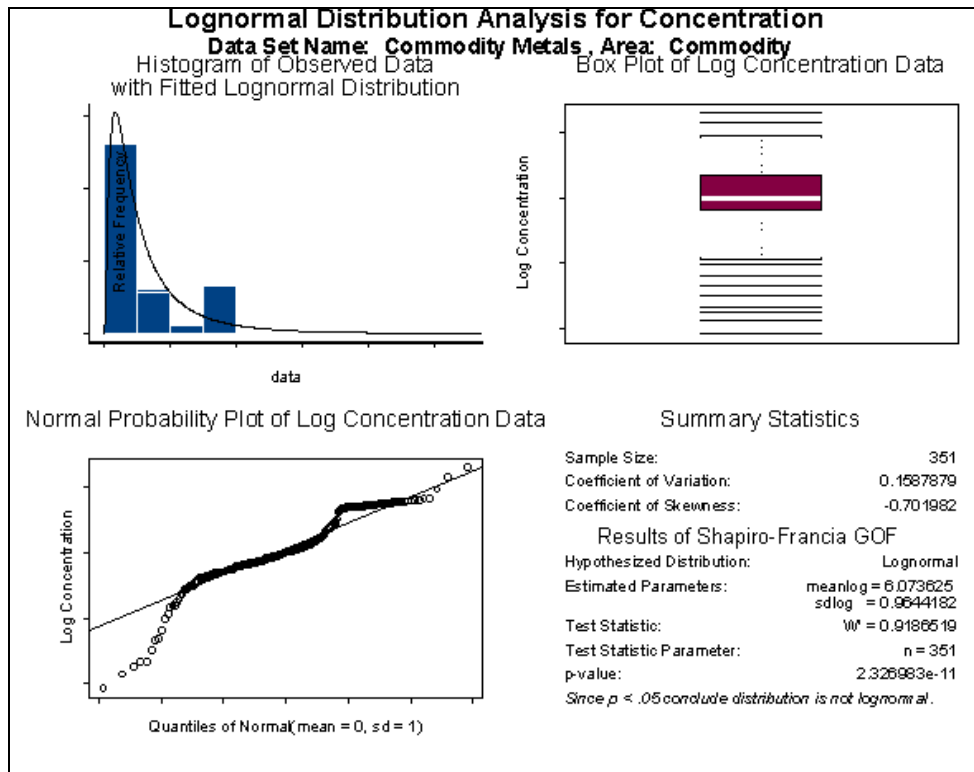
COMMODITY METALS STATISTICAL DISTRIBUTION

Analytical data was entered into a spreadsheet and then processed using the MDEQ online statistical interface for Part 201 evaluations. As shown on the distribution analysis figures included in **Appendix D**, the log mean is 6.0 mg/kg, which is comparable to the 5.6 mg/kg identified downwind during the Phase I investigation. In addition, the relative frequency histogram (**Appendix D**), and the Box Plot of Log Data indicate the data are evenly distributed across the data set. Comparison of the recent analytical results against the Phase I upwind samples indicates the lead concentrations are sufficiently different from each other, both in mean concentration and distribution, to conclude that the data represent separate conditions (i.e. upwind is expected urban concentrations and downwind have been influenced by another source).
