Michigan's
Nonpoint Source
Program

Tracking code: #2004-0130

Kingfisher Bluff Innovative Storm Water Demonstration Project

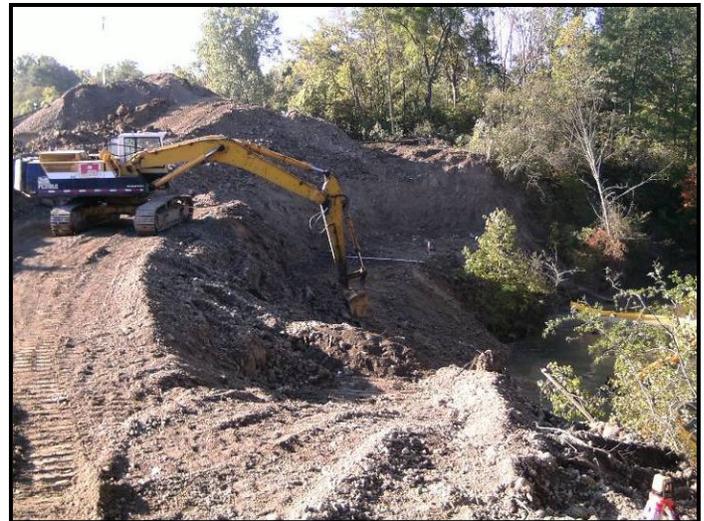
Grading of the bluff for stabilization

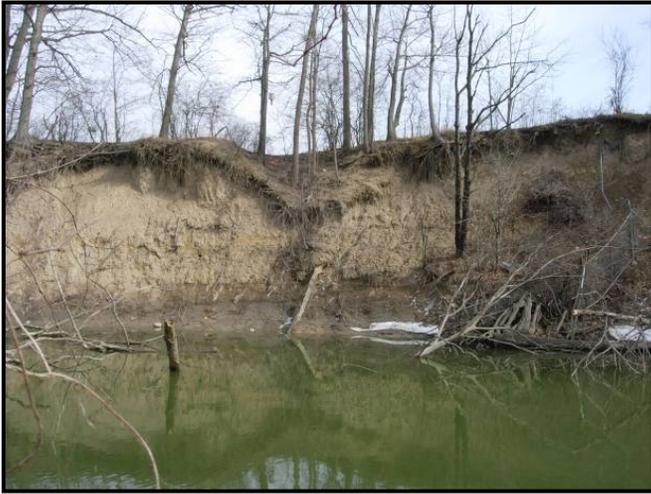
Bluff Before: Bank Erosion contributing heavy sedimentation to the river.

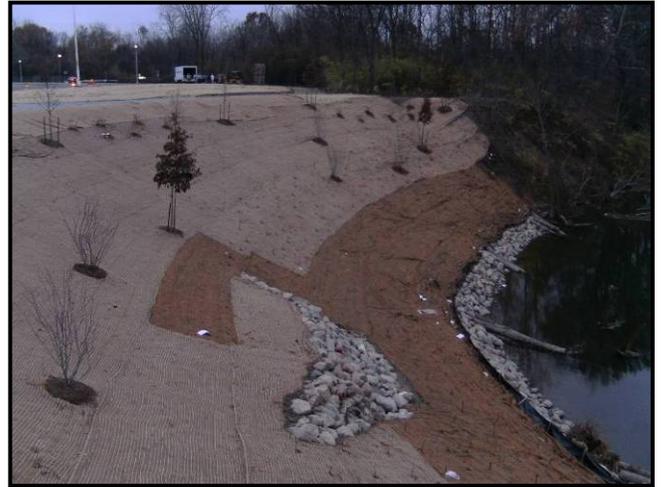
Bluff After: Bank stabilization with pullback slope, boulder toe, live stakes, and native vegetation cover.

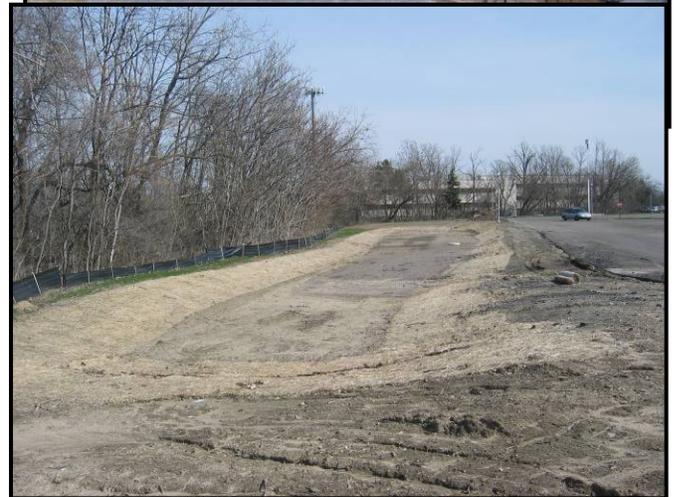
Parking Lot Site After: Bioretention basin to capture the parking lot runoff.
