2014 MICHIGAN ARCHAEOLOGY POSTER TEACHER COMPANION

Photo Mosaic of *Pewabic*

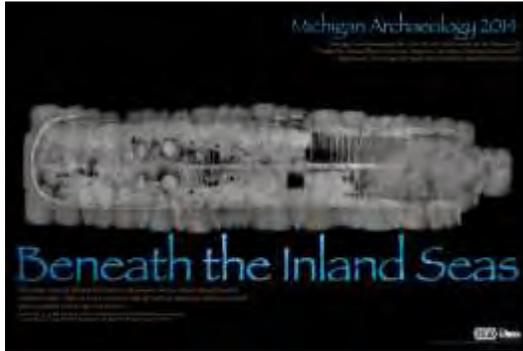
The photograph of the *Pewabic* shipwreck that appears on the poster is a photo mosaic. A series of photographs were taken by a diver who swam above the wreck from one end to the other. The photos were then put together to create a single image.

Key parts of the vessel have been labeled with definitions below.

Transom

The stern that usually overhangs the rear end of the boat and supports the steering mechanism and rudder.

Tow Bitts

A bitt, or post, to attach a line to tow another vessel or to be towed from the stern.

Engines

The machines that powered the ship. *Pewabic*'s engine was powered by steam.

Boilers

Tanks that contained water heated to produce steam to run the engine. Coal fires heated the water.

Coal Scuppers

A shoot to pass coal through to get it into the bunker or to the boiler.

Hogging Arch

A large wooden truss to stiffen the boat longitudinally and thus prevent the vessel from hogging or sagging at either end.

Cargo Hatch

The opening into the cargo hold

Deck Beams

These are the remains of the support members for the decking.

Cargo Hold

The part of the ship where goods are kept. This is where the copper ingots were stored while being transported.

Broken Bow

Pewabic's bow was broken during collision with the vessel *Meteor*.

Lake Bottom

The fuzzy "tooth-like" parts of the photo are actually the lake bottom. The irregular edge is created by the joining of each photograph to create the mosaic.

Within the remaining portion of the wreck, however, many features of the *Pewabic* are still visible. Although salvors broke through the deck to reach the copper in the hold, some of the deck remains intact in the central part of the vessel. Both engines and boilers are still in place. As part of this teacher's guide, there is a copy of the poster image on the website that includes labels identifying various components of the vessel. In the poster image, the bow of the vessel is to the right and the stern is to the left.
