## Ford Center Water Quality Management Demonstration Area

2008-2012

This project involved the improvement of 31 sites on the Michigan Technological University, Ford Center and Research Forest at Alberta, located 9 miles south of L'Anse in Michigan's Upper Peninsula. Fifteen of these sites, representing a variety of techniques, are located along or near MI Snowmobile Trail 8 near the Sturgeon River, and Bocco, Ogemaw, and Plumbago Creeks. Interpretive signs have been constructed that describe what water quality improvements were made at particular locations in these often visited areas.

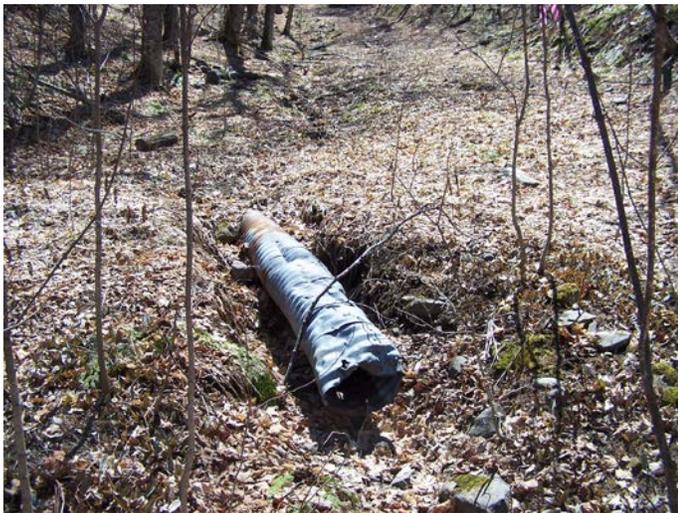
**Site 40 Before:** Culvert washed out; erosion from large gullies formed on forest road, with surface flows towards Sturgeon River.

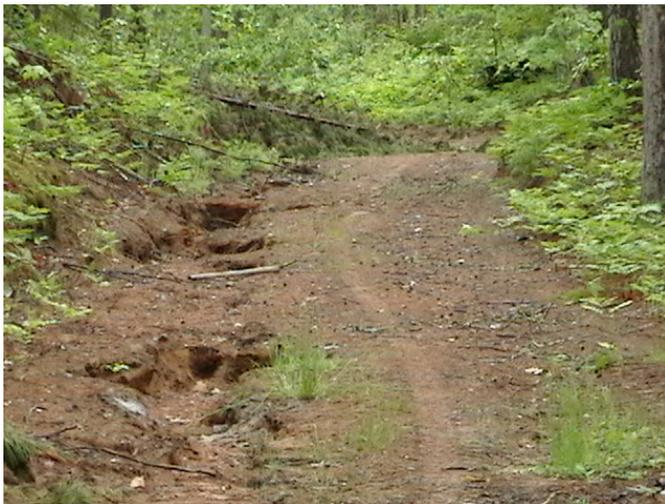
**Site 35 Before:** Heavy erosion from washouts on forest road, with sediment and surface water flowing towards Ogemaw Creek.
