Michigan Department of Environmental Quality  
Remediation and Redevelopment Division

# **2017 Pilot Project**

## **Statewide Assessment of Restrictive Covenants**

Evaluating the effectiveness of restrictive covenants at 90 properties across Michigan

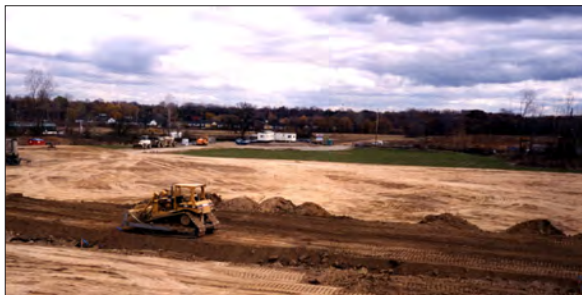
*Construction of a soil cover (exposure barrier) over the former Linden Road Landfill in Flint Charter Township (Genesee Co.).*

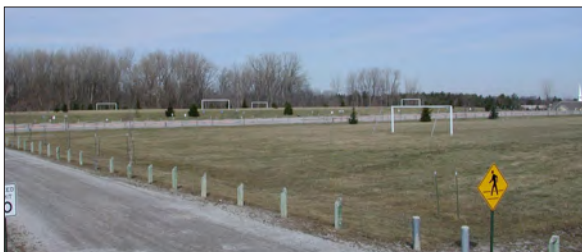
*Saturday morning soccer games are played on the site of the former Linden Road Landfill. A restrictive covenant is recorded on the property deed to prohibit excavation or other soil disturbance activities below the cover.*

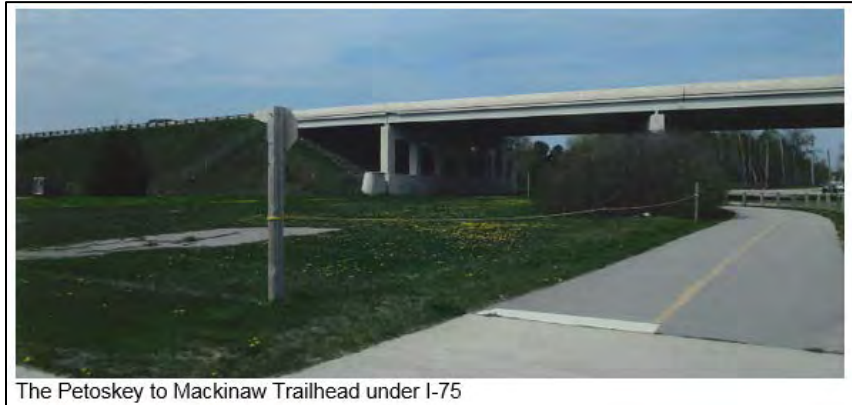
The Petoskey to Mackinaw Trailhead under I-75

The property was the disposal location of approximately 10,110 cubic yards of cinders and contaminated soil from the adjacent railroad depot and roundhouse. The contaminated materials were covered with top soil and seeded.

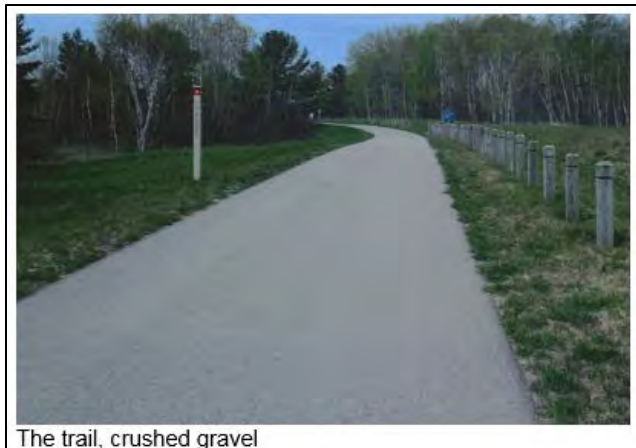
The trail, crushed gravel
