Notes from the desk of Amy Keranen

Abandoned Mining Wastes Project– Torch Lake Open House 2020

2019 Removal Actions Completed

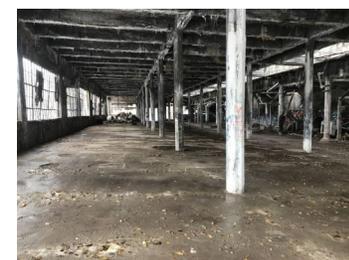
EPA ERB initiated removal of ACBM, wastes and abandoned containers in 2018 and completed the cleanup in Spring 2019– [EPA project documents](#) are on their website. EGLE is now directing the property owners to properly manage the remaining risks. The photo above shows how the ruins looked before the cleanup. The photo to the right shows it after the cleanup was completed.

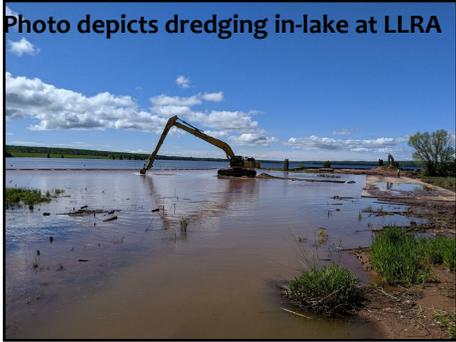
LLRA Sediments

Previous studies offshore of the Lake Linden park showed sediments contaminated with PCB and metals were still present in the lake. Based on these findings and under an agreement with the EPA, Honeywell conducted studies, developed a plan and removed the 1,578 cubic yards of the most highly contaminated shallow, near-shore sediments in 2019. The EPA project website includes links to [LLRA project documents](#).

Clean backfill was placed in the dredged area to reduce the potential for exposure to the remaining contaminated sediments. The remaining contaminated sediments in the LLRA removal footprint and offshore in deeper water are being evaluated for remediation by Honeywell and EPA’s GLNPO.

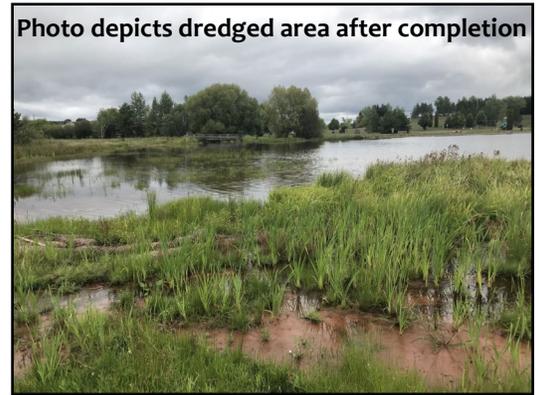
C&H Mineral Building Waste Piles and Asbestos Removed

Prior AMW project studies conducted at the C&H Mineral Building, located between Lake Linden and Hubbell identified risks posed by PCBs, metals, ACBM, wastes piles and abandoned containers. ACBM that had fallen and/or blown off the roof of the Mineral Building and was present on the ground, including outside of the fence in the Michigan Department of Transportation (MDOT) M-26 right of way (ROW) that includes a wide paved shoulder used heavily by local residents for recreational purposes.

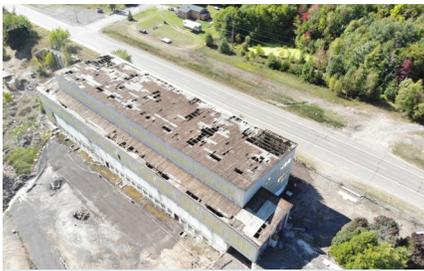
Mineral Building roof after removal

In response to the EPA and EGLE directives, in 2018 Silver Shore removed 11.41 tons of ACBM from the roof of the C&H Mineral Building and the ground surface near the building and in the MDOT ROW. At the same time, under an agreement with EPA, Honeywell and Silver Shore secured the site with fencing, conducted sampling and developed a cleanup plan.

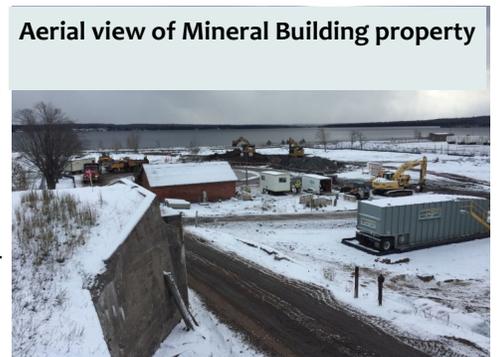
Aerial view of Mineral Building property

In 2019 Honeywell, in partnership with GLNPO, removed and disposed of over 15,000 tons of PCBs, metals and asbestos contaminated wastes from the property to address sources of contamination to Torch Lake. Also in 2019, Honeywell and Silver Shore removed surface soils and residual ACBM from the MDOT ROW adjacent to the site. Documentation of the removal activities was provided to the WUPHD for their review. The WUPHD lifted the [advisory](#) in June 2020.

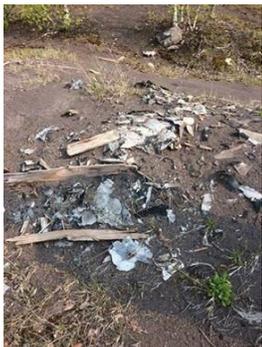
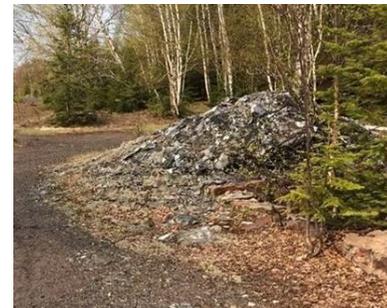
In 2019, as requested by EGLE, EPA ERB conducted an assessment of the Gay Stamp Mill ruins and identified potential threats including but not limited to: human health risks in the event of direct contact with metals contaminated surface soils and waste piles; and inhalation of particulates and asbestos. The EPA ERB plans to remove the metals contaminated materials and ACM, but the timing of the project start is in question until COVID-19 issues resolve. In order to avoid exposure to these hazardous substances, it is recommended the public not enter these privately owned properties.

The photos to the left and right show various asbestos containing waste piles at Gay, MI

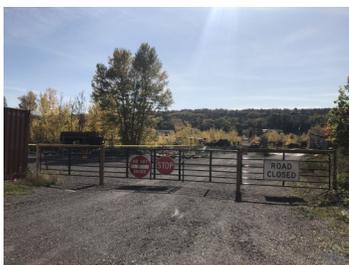
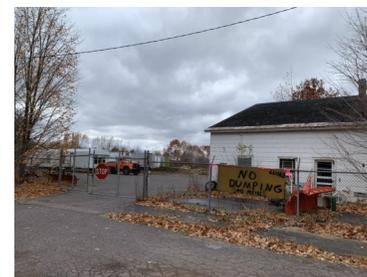
The photos to the left and right show the gates and posting to keep people off private property in the Ripley and Dollar Bay areas.
