# RESEARCH SPOTLIGHT

**REPORT NAME:** Evaluation of Bridge Decks Using Non-Destructive Evaluation (NDE) at Near-Highway Speeds for Effective Asset Management – Implementation for Routine Inspection (Phase III)

**RESEARCH REPORT NUMBER:** SPR-1617C

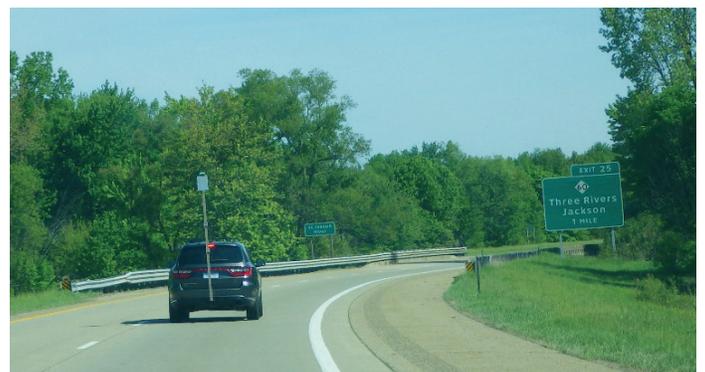
The 3DOBS vehicle-mounted camera system captures detailed data on bridge deck condition at near-highway speeds.

moving vehicle, the camera captures a series of high-resolution images of the bridge deck. Sophisticated image analysis software allows inspectors to detect cracks at early stages, when maintenance can prevent the onset of significant structural degradation.

(35.5 megapixels at up to 60 frames per second) and orientation-in-space data at near-highway speeds up to 45 mph. The typical data collection time for an average-sized bridge deck was 30 minutes or less. With the post-processing software, inspectors can generate two types of output: a 2-D mosaic, defined as a stitched image that combines many individual images, or a computationally more intensive 3-D model of the bridge deck.
