MICHIGAN DEPARTMENT OF ENVIRONMENTAL QUALITY
WATER RESOURCES DIVISION
JUNE 2016

STAFF REPORT

BIOLOGICAL SURVEY OF THE SHIAWASSEE RIVER WATERSHED
MIDLAND, GRATIOT, SAGINAW, SHIAWASSEE, GENESEE, AND LIVINGSTON COUNTIES
JUNE-SEPTEMBER 2015

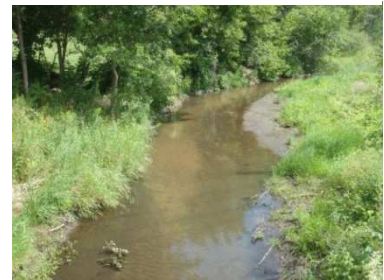
Marion Genoa Drain (Fisk Road) looking upstream 2015 (Reach that was sampled)

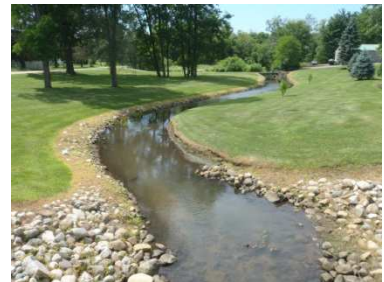
Marion Genoa Drain at Fisk Road looking downstream (Not sampled in 2015)

immediately downstream of this crossing, has been modified by removal of riparian vegetation (via mowing and potentially spraying), and addition of riprap along the banks of the drain. A pipe, presumably leading from a treated pond directly to the stream was observed.

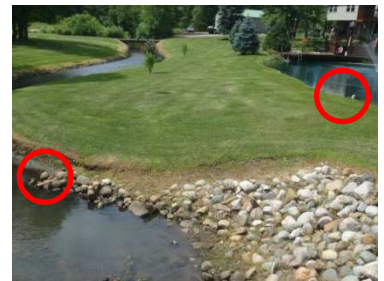
Marion Genoa Drain looking at downstream location of pipe

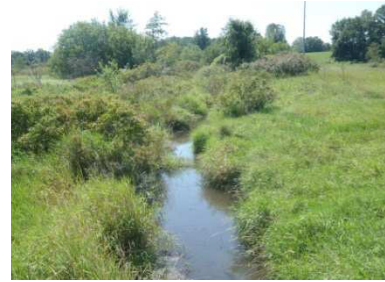
Unnamed Tributary to Indian Lake (Faussett Road) 2015

An unnamed tributary to Indian Lake, southwest of Linden, flows from Faussett Lake to Indian Lake (Yellow River Drain is an outlet of this lake). This tributary was sampled at Faussett Road in 2015 (~0.5 miles downstream of the Faussett Lake impoundment) and found to have Acceptable (-4) macroinvertebrates and Marginal (89) habitat conditions. This site had very poor substrate and in-stream habitat conditions with excessive sedimentation (~2 to 2.5 feet of silt/muck with 1 to 3 inches of clear water on top for most of the reach). Twenty-three taxa were present at this site; however, the poor habitat conditions were reflected in the macroinvertebrate community with amphipods making up 78% of the community, and no Ephemeroptera, Plecoptera, or Tricoptera (EPT) found. Additionally, invasive curly leaf pondweed and Chinese mystery snails were present at this site. This site should be monitored during the next cycle to determine if conditions further degrade.

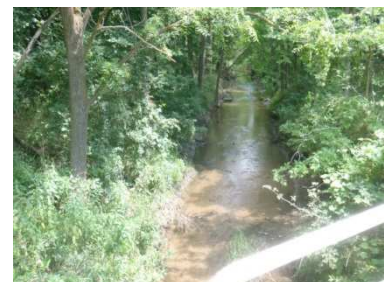
Pratt Drain (Geek Road) 2015

Pratt Drain (aka Hovey Drain) is a small tributary to Holly Drain, which is a tributary to the Shiawassee River near Vernon, Michigan. Two sites on this drain were surveyed in 2015, one at Geek Road and one at Garrison Road (~0.3 miles apart). Both sites had Acceptable macroinvertebrate communities (Geek: -4; Garrison: -3), and Good habitat conditions (Geek: 127; Garrison: 148). The greatest difference in habitat conditions between the

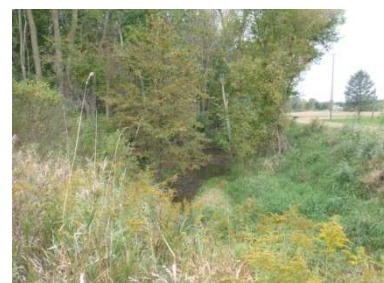
Pratt Drain (Garrison Road) 2015

two sites was in sediment deposition. The upstream site was dominated by sand substrate resulting in substrate instability and accounting for the lower score for sediment deposition at this site. The upstream site also had sand substrate but contained fair amounts of woody debris, coarse particulate organic matter, gravel, cobble, and other stabilizing characteristics. Amphipods dominated both sites (Geeck: 78%; Garrison: 52%); however, Garrison Road had ~10% greater tricoptera composition, likely due to the increase in available habitat, which led to the slightly higher score at this site. Although both sites are quite impaired biologically, the site at Geeck Road especially, should be monitored during the next cycle to determine if conditions change. This site has clearly been straightened and dredged in the past and may improve with time.

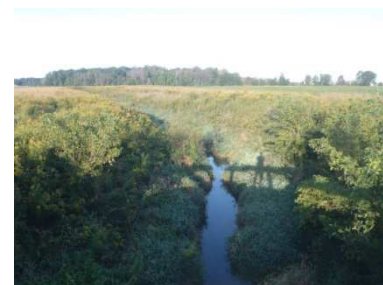
The Bad River originates south of Ithaca, Michigan, and flows east, where it joins the Shiawassee River near St. Charles, Michigan. Twelve sites were sampled in the Bad River watershed in 2015. The only site on the mainstem Bad River was sampled near its origin at Blair Road. The macroinvertebrate community at this site was considered Acceptable (-3) with 24 taxa present, but contained very few EPT taxa, and was dominated by chironomids (48%). This site also had Marginal (84) habitat as expected for an agricultural ditch that has been channelized, straightened, and has little riparian vegetation.

Bad River at (Blair Road) 2015

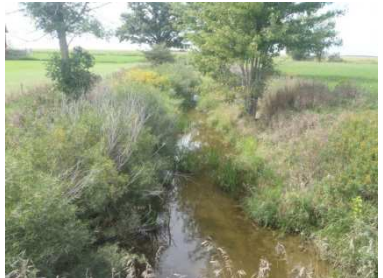
Shad Creek (McClelland Road) 2015

Downstream of the road crossing, riparian vegetation has been removed and the stream is a typical agricultural ditch.

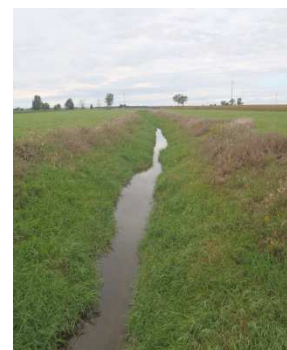
Beaver Creek is a major tributary to the Bad River. It originates northeast of Ithaca and flows roughly east where it joins the Bad River just downstream of St. Charles (below the confluence with the South Fork Bad River). Two status sites were surveyed in this tributary in 2015, one near the headwaters at Blair Road and one in the middle section of the creek at Hemlock Road. The upstream site at Blair Road is a small agricultural ditch that has been channelized. This site had an Acceptable (-3) macroinvertebrate community and Marginal (61) habitat conditions. Very few EPT taxa were found and the community was dominated by corixids (41%, surface-air breathers made up 64% of the community). In-stream habitat was poor with sand and silt covering most available habitat and heavy deposits of fine sediment. Additionally, riparian habitat was nearly nonexistent. A small amount of invasive curly leaf pondweed was also found at this site.

Beaver Creek (Blair Road) 2015

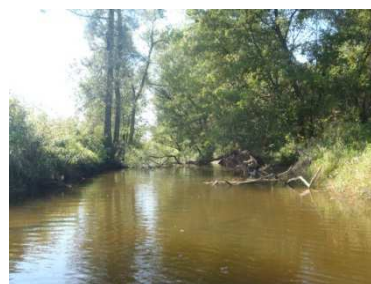
The downstream Beaver Creek site at Hemlock Road had much better in-stream and riparian habitat, which likely led to a better macroinvertebrate community. This site had a good variety of in-stream habitat and scored Good (113) overall. Macroinvertebrates scored Acceptable (2) with many more taxa present including 2 additional ephemeroptera taxa, 4 additional tricoptera taxa, and a more even community overall. An extensive amount of invasive rusty crayfish were found at this site.

Beaver Creek (Hemlock Road) 2015

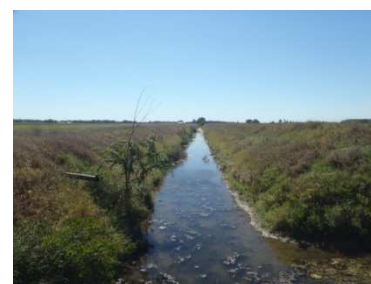
Carson Drain is a tributary to Pickerel Creek, which is a tributary to the Bad River downstream of St. Charles. Carson Drain is a highly altered system and has been straightened over much of its course. One status site was surveyed on Carson Drain in 2015 immediately upstream of its confluence with Pickerel Creek (Ryan Road). This site had an Acceptable (-2) macroinvertebrate community with 23 taxa present, and only about 3% surface air breathers. Habitat was Marginal (78), but in-stream vegetation was abundant likely driving the abundance of Coenagrionidae at this site (~70% of the community). Much of the in-stream vegetation at this site consisted of invasive curly leaf pondweed.

Carson Drain (Ryan Road) 2015

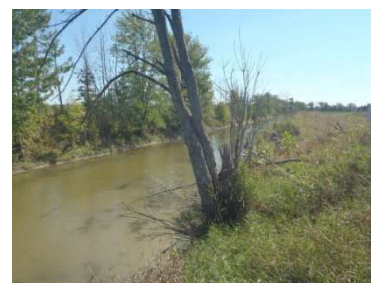
Downstream of the confluence of Carson Drain and Pickerel Creek, Pickerel Creek continues north for approximately 1.5 miles before emptying into the Bad River. One site was surveyed on this tributary in 2015 at Hulien Road. This section of the creek is straightened, channelized, diked, and borders the west side of the Shiawassee State Game Area. This site had an Acceptable (-3) macroinvertebrate community and Marginal (92) habitat conditions. This reach was characterized by moderate sediment deposition, little riparian vegetation, with few mature

Pickerel Creek (Hulien Road) 2015

trees, and a fairly uniform channel. Water level fluctuations appear to be common (likely both controlled via pumps and natural). This site is also an access point to the State Game Area and signs of human traffic were evident. Although aquatic invasive species were not prevalent at the time of this sampling effort (some Eurasian watermilfoil present), this may be a moderate risk aquatic invasive species site.

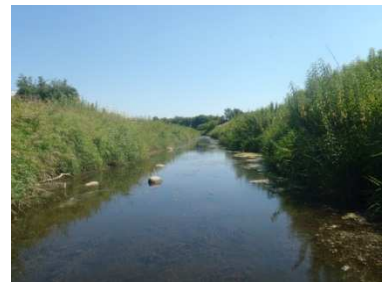
Handy Creek drains into Whitmore Drain near Hemlock, Michigan. Whitmore Drain then flows northeast to Nelson Run and then Swan Creek. One site on Whitmore Drain near the confluence with Nelson Run was surveyed in 2015 at Tittabawassee Road. This site was a straightened ditch with little riparian habitat. Macroinvertebrates scored Acceptable (-3) with 22 taxa present, low percent surface air breathers and a moderate percentage of isopods, snails, and leeches (13%). However, this site was also dominated by chironomids and had few EPT taxa. Habitat conditions were characterized as Marginal (87). Invasive rusty crayfish were extensive at this site.

Whitmore Drain (Tittabawassee Road) 2015

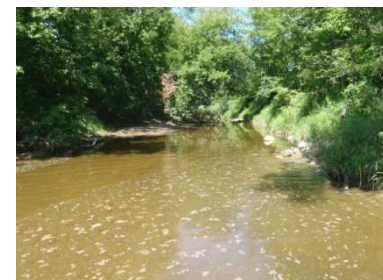
One status site on Swan Creek was surveyed in 2015 at Gleanor Road. This site had an Acceptable (-1) macroinvertebrate community with 19 taxa present, 20% tricoptera composition, low percent isopod, snail, leech composition (3%), and low percent air breathers (1%). However, this site also had low ephemeroptera composition, and was dominated by chironomids (33%). Rusty crayfish also made up approximately 23% of the community at this site; however,

Swan Creek (Gleanor Road) 2015

abundance was likely underestimated due to the inefficiency of sampling crayfish with dip nets. Visual estimation of rusty crayfish abundance within this 300-foot reach was easily over 100 individuals. Freshwater mussels were also very abundant at this site and made up roughly 9% of the community (may have also been underestimated). Habitat at this site was characterized as Good (106) and contained a good mix of in-stream habitat; however, most of it was unavailable for macroinvertebrate colonization due to siltation.

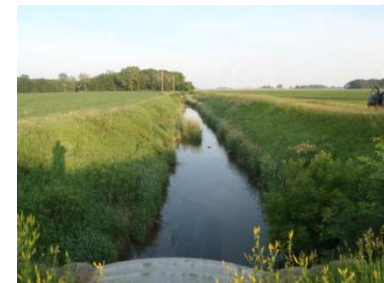
Beaver Creek at Ransom Road is a straightened, channelized, glide/pool stream in the upper end of the Bad River watershed. This site had Poor macroinvertebrates (-7) in 2010 and Marginal habitat conditions (64). However, in 2015 this site had Acceptable (-1) macroinvertebrates and Marginal habitat conditions (75). Much of the improvement in the macroinvertebrate community was due to a ~22% increase in ephemeroptera, and a ~14% decrease in percent isopod, snail, leech composition, along with the presence of 8 additional taxa in 2015. Surveys were conducted in early June and water temperatures were identical in both years; however, water levels were substantially lower in 2015. There was also much less aquatic vegetation present in the reach in 2015 (50% vs 100% of reach with aquatic vegetation). Both the amount of water and

Beaver Creek (Ransom Road) 2010

Beaver Creek (Ransom Road) 2015

prevalence of aquatic vegetation may have influenced sampling efficiency in 2010. In 2015, a moderate number of rusty crayfish were also noted at this site.

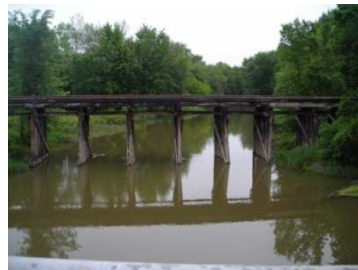
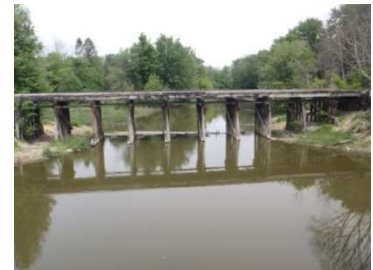
Swan Creek is a large, low gradient, depositional, pool/glide system. This reach is listed as impaired due to unknown causes (040802030407-04) and macroinvertebrates scored Poor (-7) in 2010. The river also scored Poor (-5) in 2015 with improvements in percent of surface air breathers and number of ephemeroptera taxa (addition of only 1 family). However, there were also declines in the number of tricoptera taxa present. Habitat scored slightly higher in 2015 and was characterized as Good (117) as opposed to Marginal (100) in 2010. In both years, water levels made it difficult to effectively sample all available habitats and scores may not be indicative of the river as a whole.

Swan Creek (Schomaker Road) 2010

Swan Creek (Schomaker Road) 2015

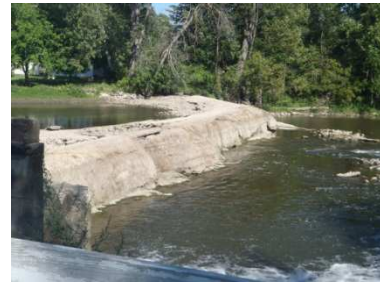
The Corunna dam is a 6-foot high, deteriorating dam that was built in the 1840s for mill operation. The FOSR are leading the effort to remove the dam. In anticipation of the dam's removal, the FOSR requested that "before" conditions upstream and downstream of the dam be documented to provide baseline data prior to dam removal. The SWAS conducted a Procedure 51 biological survey downstream of the dam, in the area most likely to be adversely affected by removal, in order to establish this baseline. Biological assessments were not completed upstream of the dam due to the impounded nature of the river and the lack of suitability of Procedure 51. The site downstream of the Corunna Dam had an Excellent (5) macroinvertebrate community and was characterized as having Good (132) habitat conditions.

Corunna Dam, September 2015

The greatest NPS concerns noted in 2015 were the Corunna dam and the Michigan (Hanson) Brick Plant Bridge. Removal of the Corunna dam would open up approximately 30 additional mainstem river miles and many tributaries between Corunna and Byron to fish passage. Modification or removal of the Michigan Brick Plant Bridge would allow more natural flow, increased fish passage, and improved navigation.

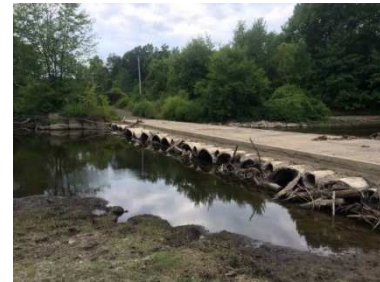
In response to a targeted monitoring request from the FOSR to investigate the impacts of an old bridge structure on stream communities, SWAS staff visited a site near the Michigan (Hanson) Brick Plant east of Owosso in August 2015. The bridge was built across the river to connect Hanson Brick Plant property on both sides of the river; however, it is unknown if the bridge is currently used. The bridge is made of many small culverts and spans the entire width of the river. SWAS staff found that the bridge is likely an impediment to both navigation and flow, although navigation appears to be possible during high flows through a side channel. This bridge may also impede fish passage following debris build up. The bridge was reported to the MDEQ, NPS Unit, on August 20, 2015.

Brick Plant Bridge, August 2015
