# Biosurvey of the Pigeon River and Cherry Creek Watersheds, Michigan

June-August 2018

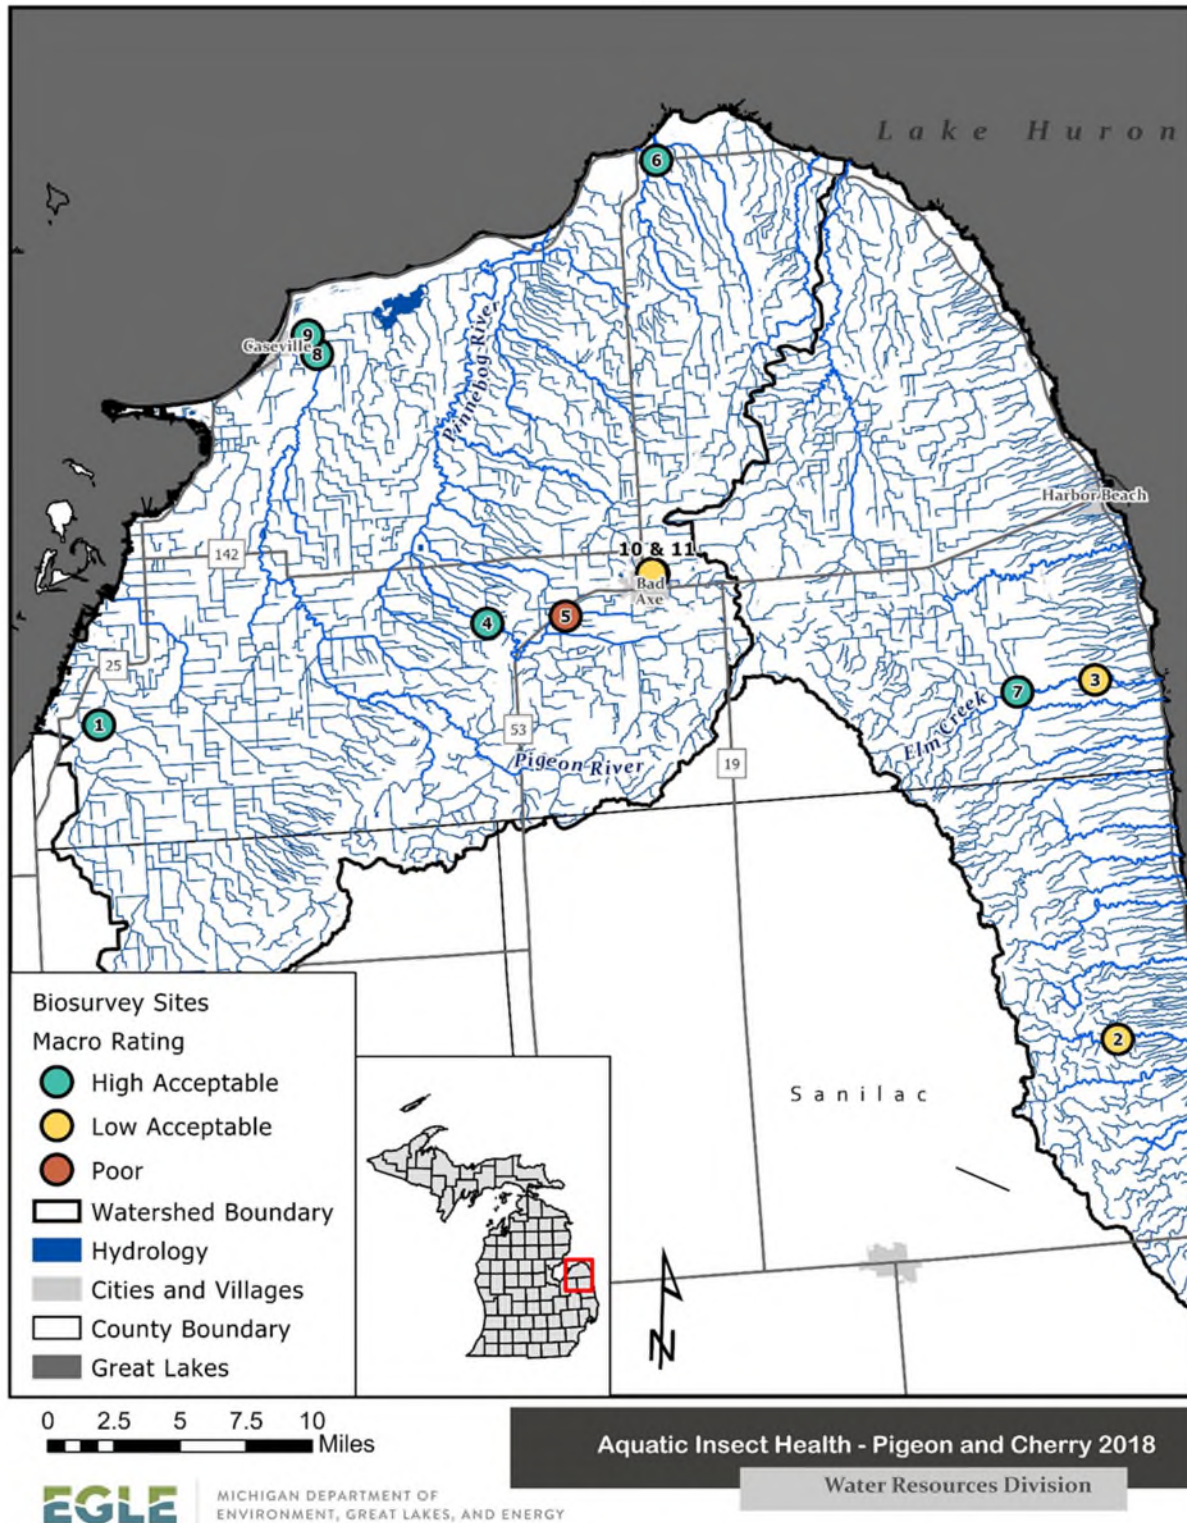
Figure 1. Pigeon River and Cherry Creek sites, 2018. Colored dots represent 2018 aquatic macroinvertebrate community station ratings of high acceptable (green), low acceptable (orange), and poor (red). Scores can also be found in Table 3.

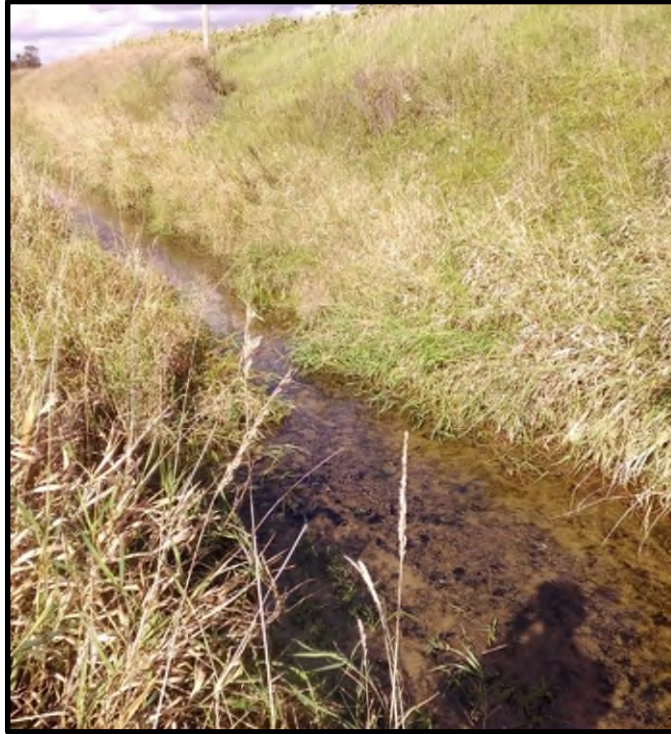
Figure 2. Pinnebog River at McMillan Road.

Station 5 (Pinnebog River at McMillan Road) was channelized historically, producing a linear reach with steep banks surrounded by agricultural fields. The riparian zone was limited to grasses, and the stream substrate was comprised of fine silt, sand, and senescing algae, providing limited habitat for macroinvertebrate colonization (Figure 2). Procedure 51 results reflected these observations, scoring “poor” for both the habitat (receiving only 48 out of a potential 200 points) and the macroinvertebrate community (receiving a -5). The “poor” macroinvertebrate score was driven by the community being dominated by pollution tolerant taxa. For example, stoneflies and most families of caddisflies and mayflies are among the most sensitive taxa found in streams and are therefore considered indicators of disturbance if

absent. There were no stoneflies or caddisflies present at this site, and the single mayfly found was in a family that is often found in disturbed streams. Isopoda (aquatic pillbugs), Gastropoda (snails), and Hirudinea (leeches) are tolerant taxa and are considered indicators of disturbance when found in high numbers. These three taxa made up 37 percent of the sample, with isopods being the dominant taxa in the sample at 31 percent.

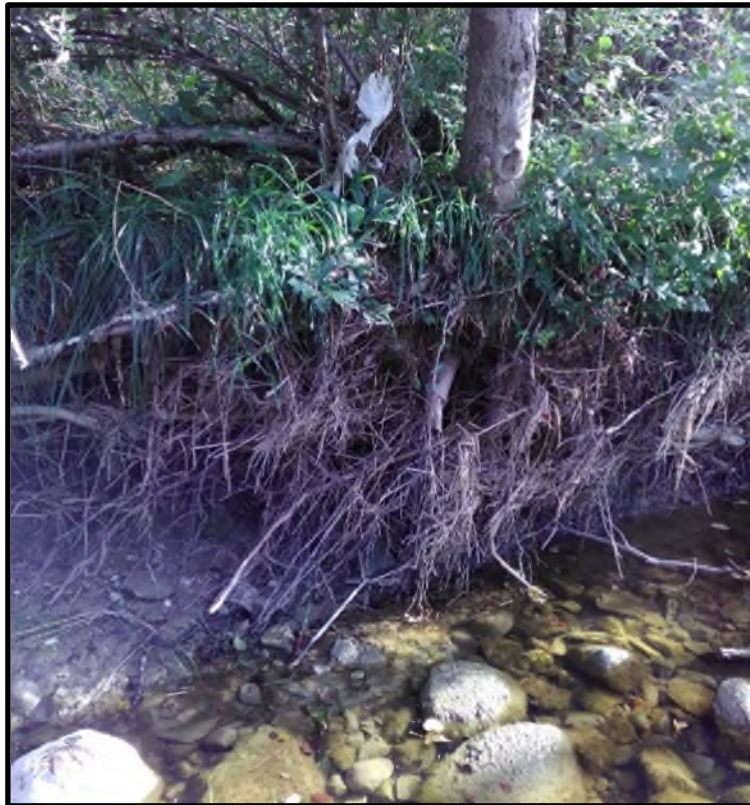
Figure 3. Elm Creek at Eppenbrock Road.

Station 7 (Elm Creek at Eppenbrock Road) was also surrounded by agricultural land. However, habitat in the immediate vicinity of the sample reach demonstrated good overall conditions. There was no evidence of channelization and substrates were comprised of a mix of sand, gravel, cobble, and boulders. Stream banks had visible scarring demonstrating precipitation-driven, flashy hydrology resulting from poorly draining soils and upstream agricultural land cover. However, tree roots from the riparian zone were stabilizing banks and

woody debris was present throughout the sample reach (Figure 3). Similar to Stations 5 and 6, stoneflies were absent and there was a low abundance of mayflies. There were five families of caddisflies found, with Helicopsychidae being the dominant family within the order Trichoptera at 91 percent. However, physid snails made up 27 percent of the sample overall, suggesting nutrient enrichment in this reach. Isopods, snails, and leeches again made up a high proportion of the macroinvertebrate community at 36 percent. One unidentified juvenile unionid mussel was present, suggesting local reproduction in this reach. The macroinvertebrate community at this location reflected improved habitat, relative to other stations, and scored as acceptable.

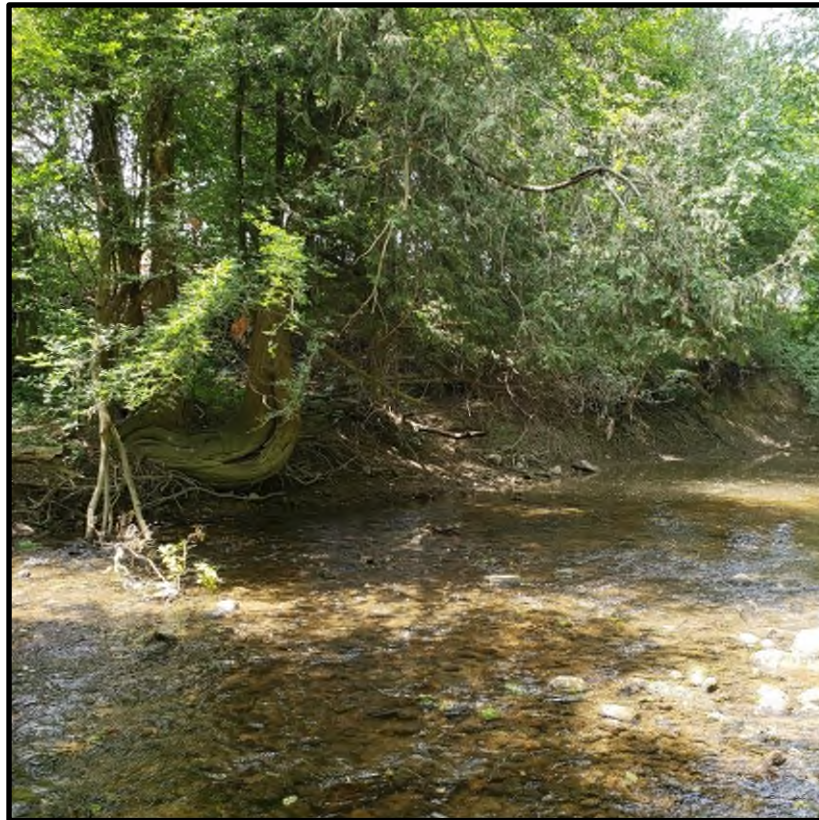
Figure 4. Pinnebog River at Grassmere Road.

toward the low range of acceptable. Of particular note amongst the trend sites was Station 4, Pinnebog River downstream of Grassmere Road. This location achieved the highest habitat score of any site visited during this survey. Substrate was dominated by gravel and cobble in a shallow riffle conducive to epifaunal colonization (Figure 4). A modest riparian buffer comprised of trees and woody shrubs was also present, providing canopy cover and shade to the river. Moreover, several sensitive taxa (e.g., caddisflies, stoneflies) were detected at this location, indicating that the diversity of the aquatic macroinvertebrate community benefited from the favorable habitat conditions. Habitat and macroinvertebrate community scores for all trend sites can be found in Tables 3, 6a, and 6b.
