**Federal Section 319
Nonpoint Source Grant**
Washtenaw County

Huron River Storm Water Demonstration Park

September 1, 2000 through July 31, 2004

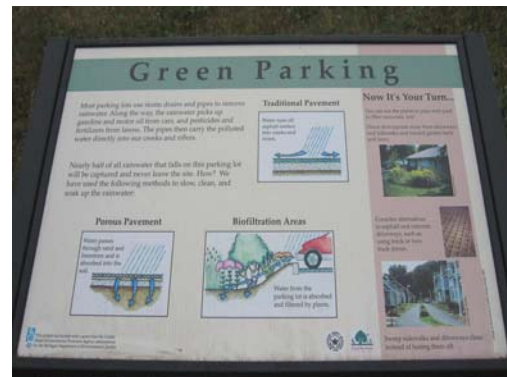
Above: The entrance to the Storm water Demonstration Park. Water flows to modular pavement, which promotes infiltration. **Top Right:** Traditional pavement on right draining into an infiltration area. **Lower Right:** Native vegetation used throughout the park to soak up storm water.

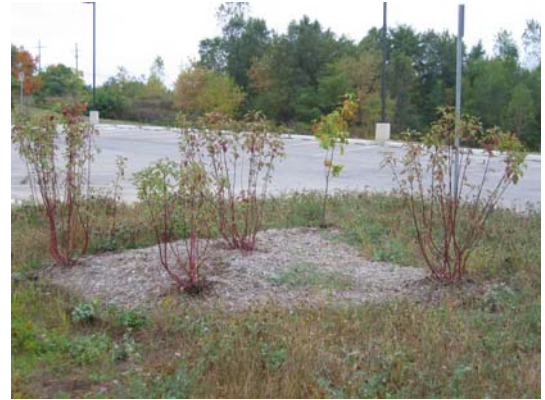
Above: This detention basin holds and treats storm water from traditionally paved parking lot. **Right:** A rock-lined channel and grade stabilization structure slows down the flow of water and prevents the channel from eroding. Water discharges into an infiltration area.
