Figure 1 - Area Base Map, Wurtsmith Air Force Base, Oscoda, Michigan
 (Figure Adapted from Air Force 1993)

Figure 2 - IRP Sites Wurtsmith Air Force Base, Oscoda, Michigan
 Figure adapted from Air Force 1993

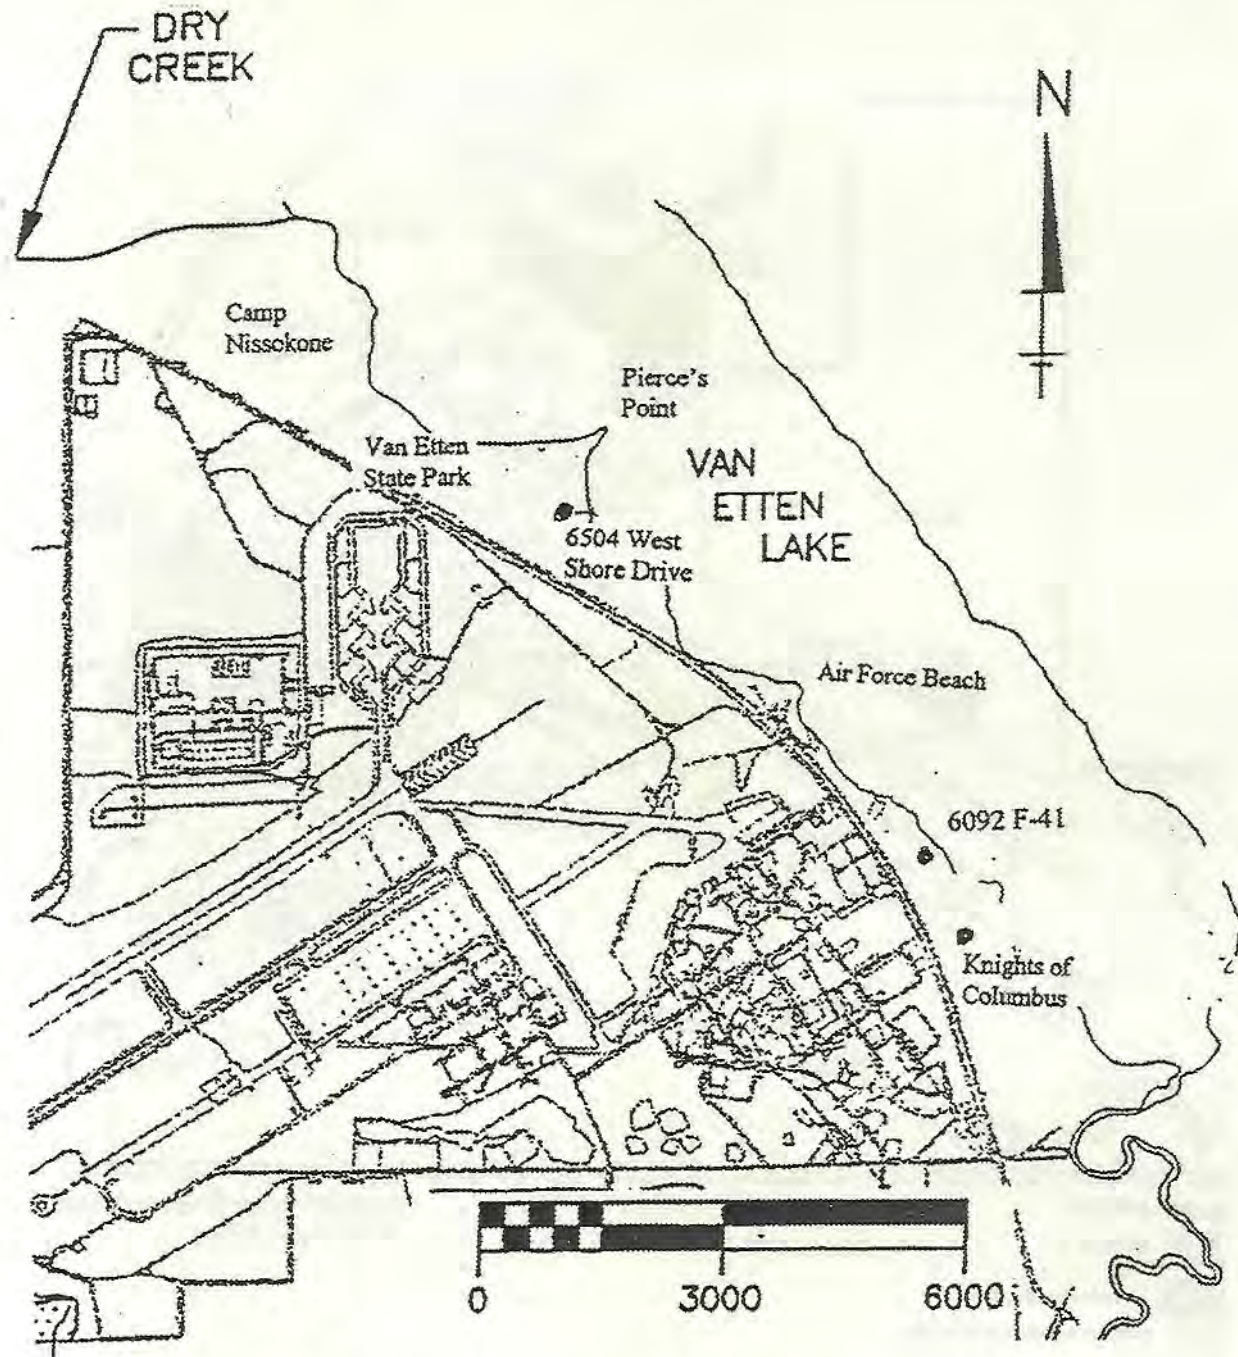
Figure 3 - Locations of Off-base Properties Situated Along Van Etten Lake's Shoreline, Wurtsmith Air Force Base, Oscoda, Michigan
 Figure adapted from AFBCA, 1999j; AFCEE, 1996b)
 Note: Locations depicted for off-base properties are approximate.)

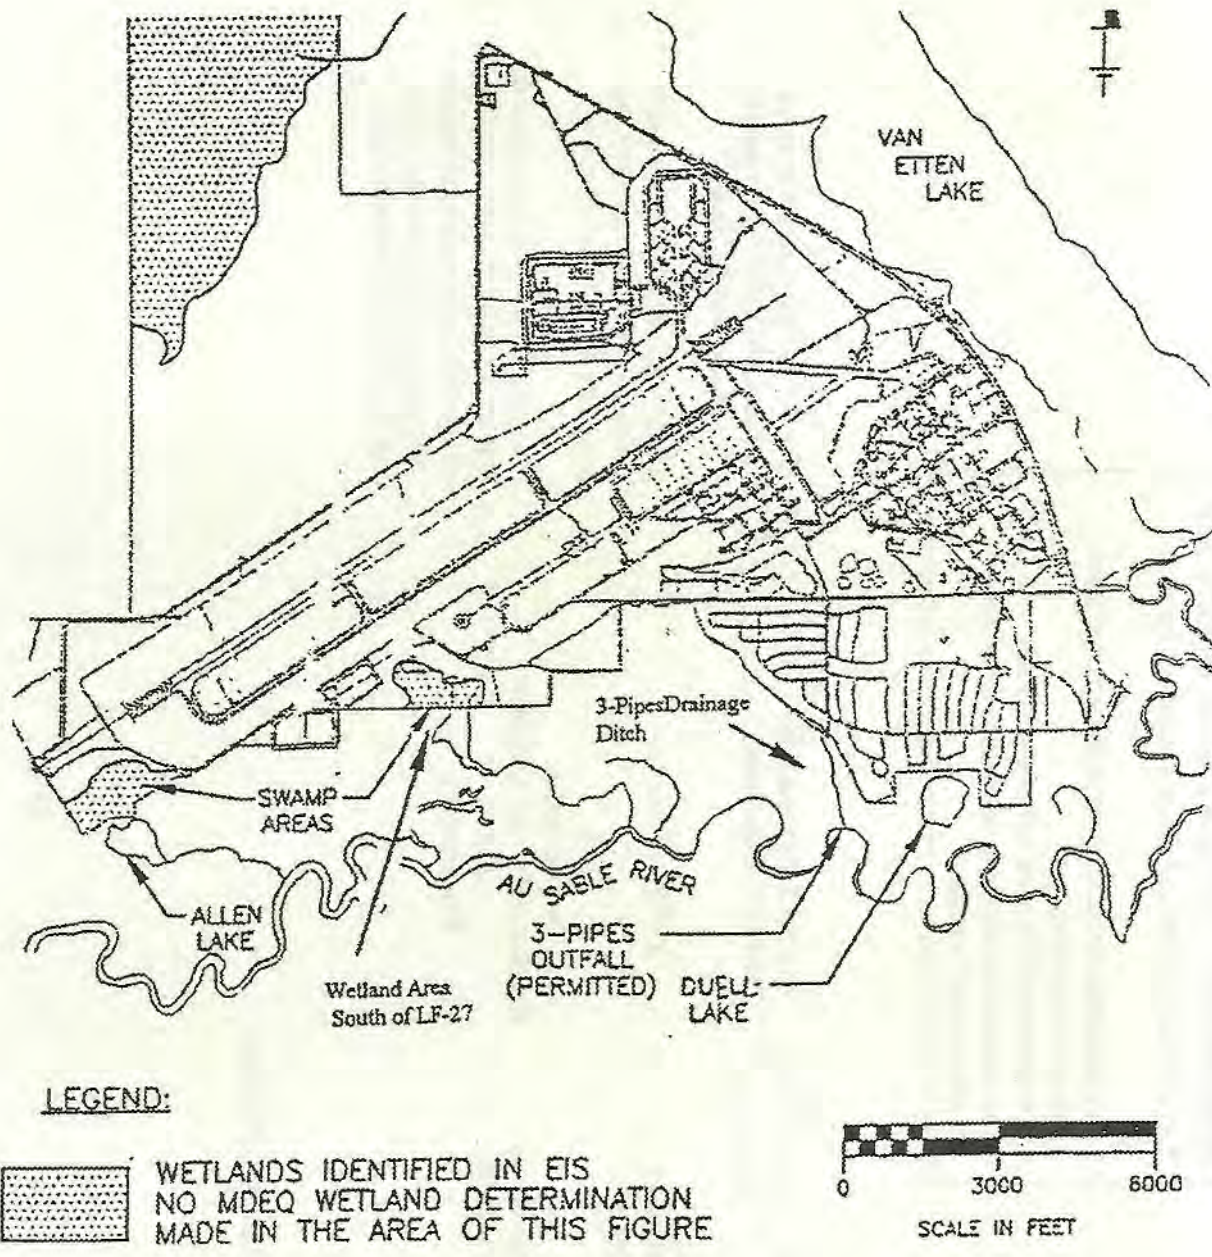
Figure 4 - Surface Water Bodies, Wurtsmith Air Force Base, Oscoda, Michigan
 (Figure adapted from AFCEE 1996b)

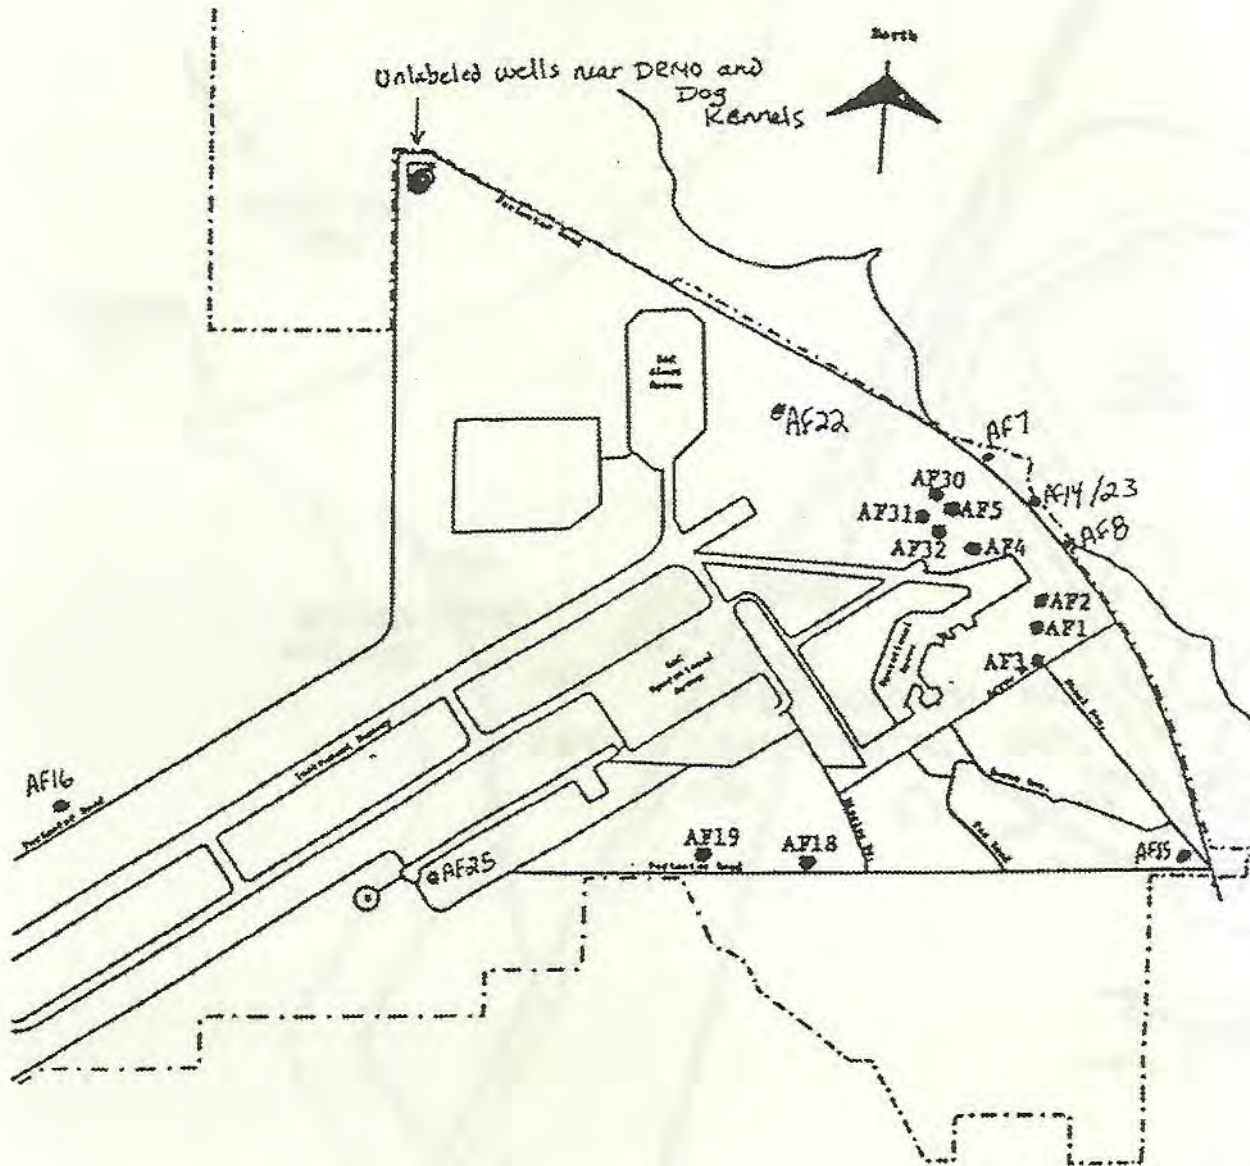
Figure 6 - USAF's Water Supply Wells, Main Water Supply Wells and Area-Specific Wells, Wurtsmith Air Force Base, Oscoda, Michigan
Figure adapted from Ayres, 1990)

1. Approximate locations of supply wells are depicted.
2. USAF's main water supply wells: AF1, AF2, AF3, AF5, AF18, AF19, AF30, AF31 and AF32.
3. USAF's area-specific wells: AF7, AF8, AF14, AF15, AF16, AF22, AF23, and two unlabelled wells.

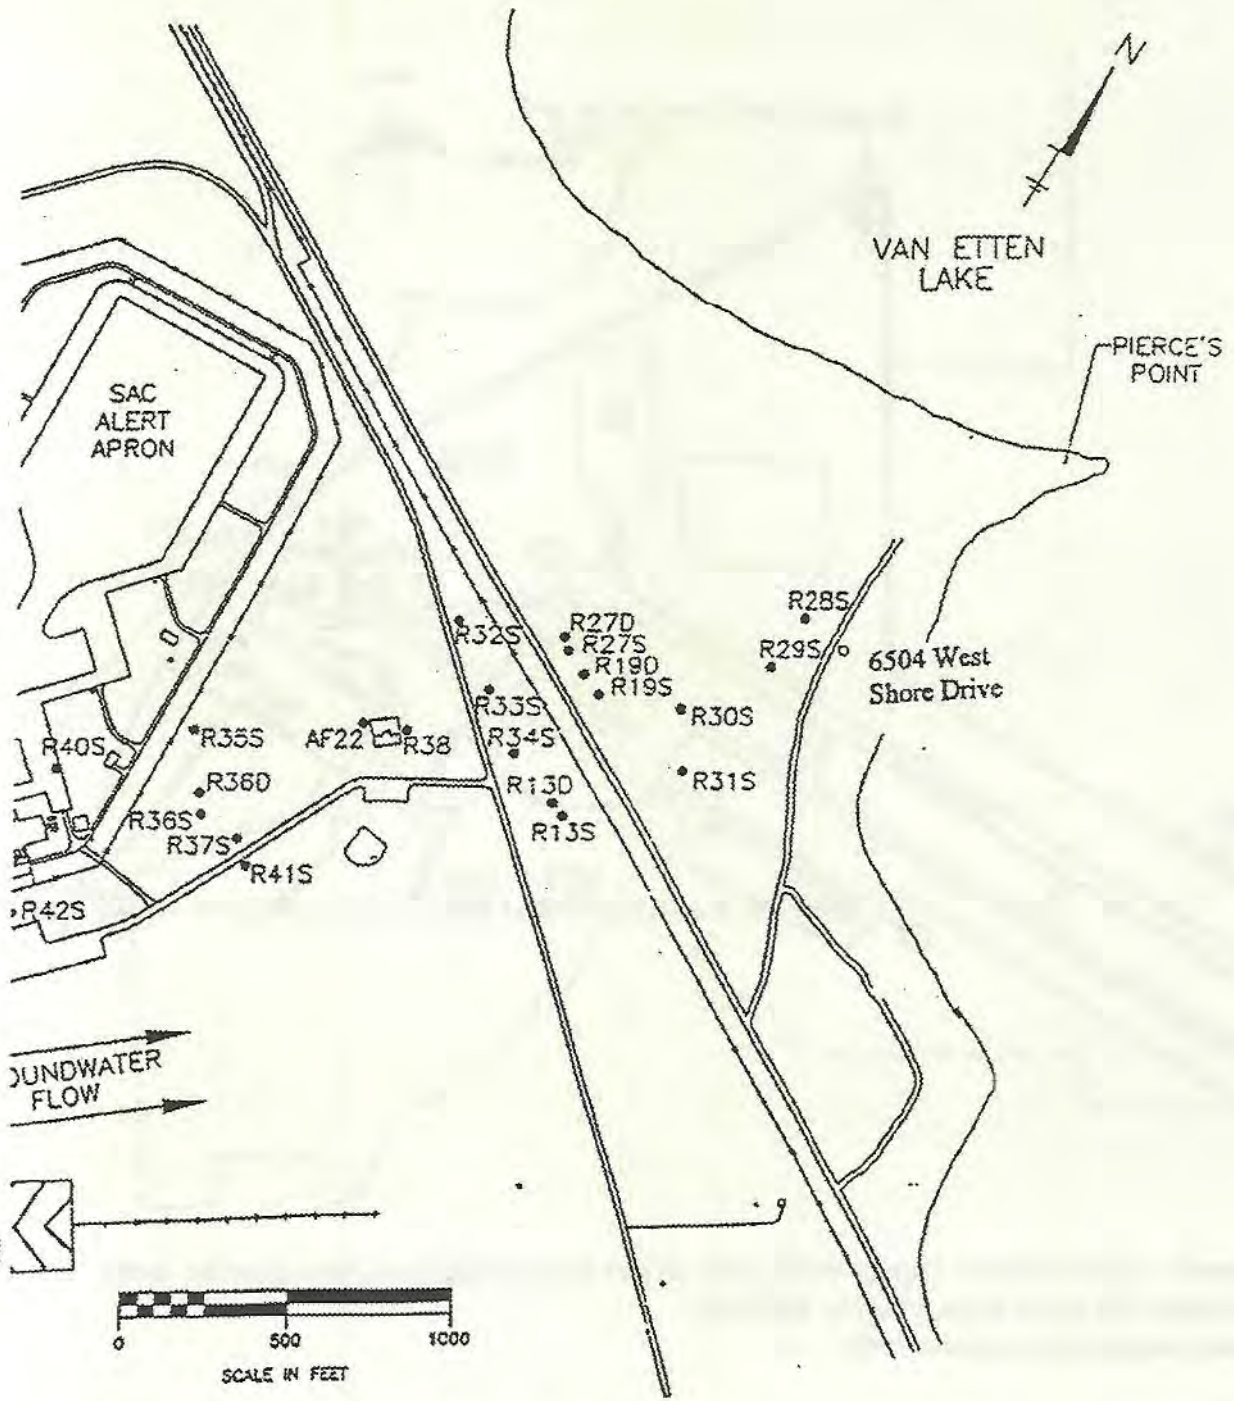
Figure 7 - Monitoring Wells Located Near Pierce's Point, Wurtsmith Air Force Base, Oscoda, Michigan
 Figure adapted from AFCEE, 1996e

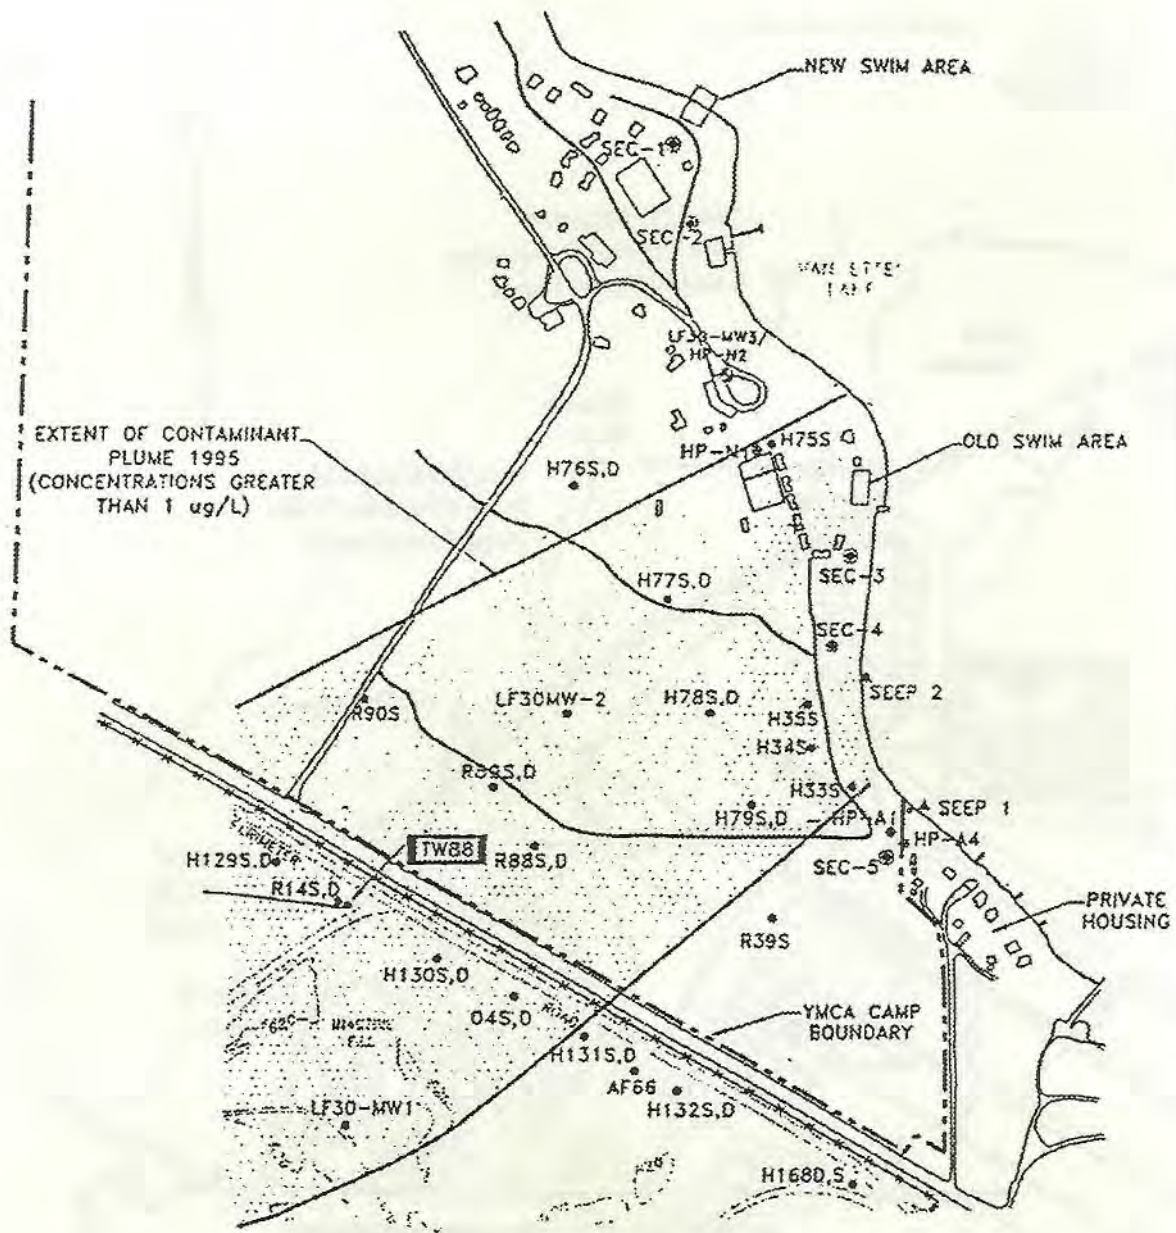
Figure 8 - Camp Nisskone's Swimming Areas and Seep Areas, Wurtsmith Air Force Base, Oscoda, Michigan
 Figure adapted from AFBCA 1999h

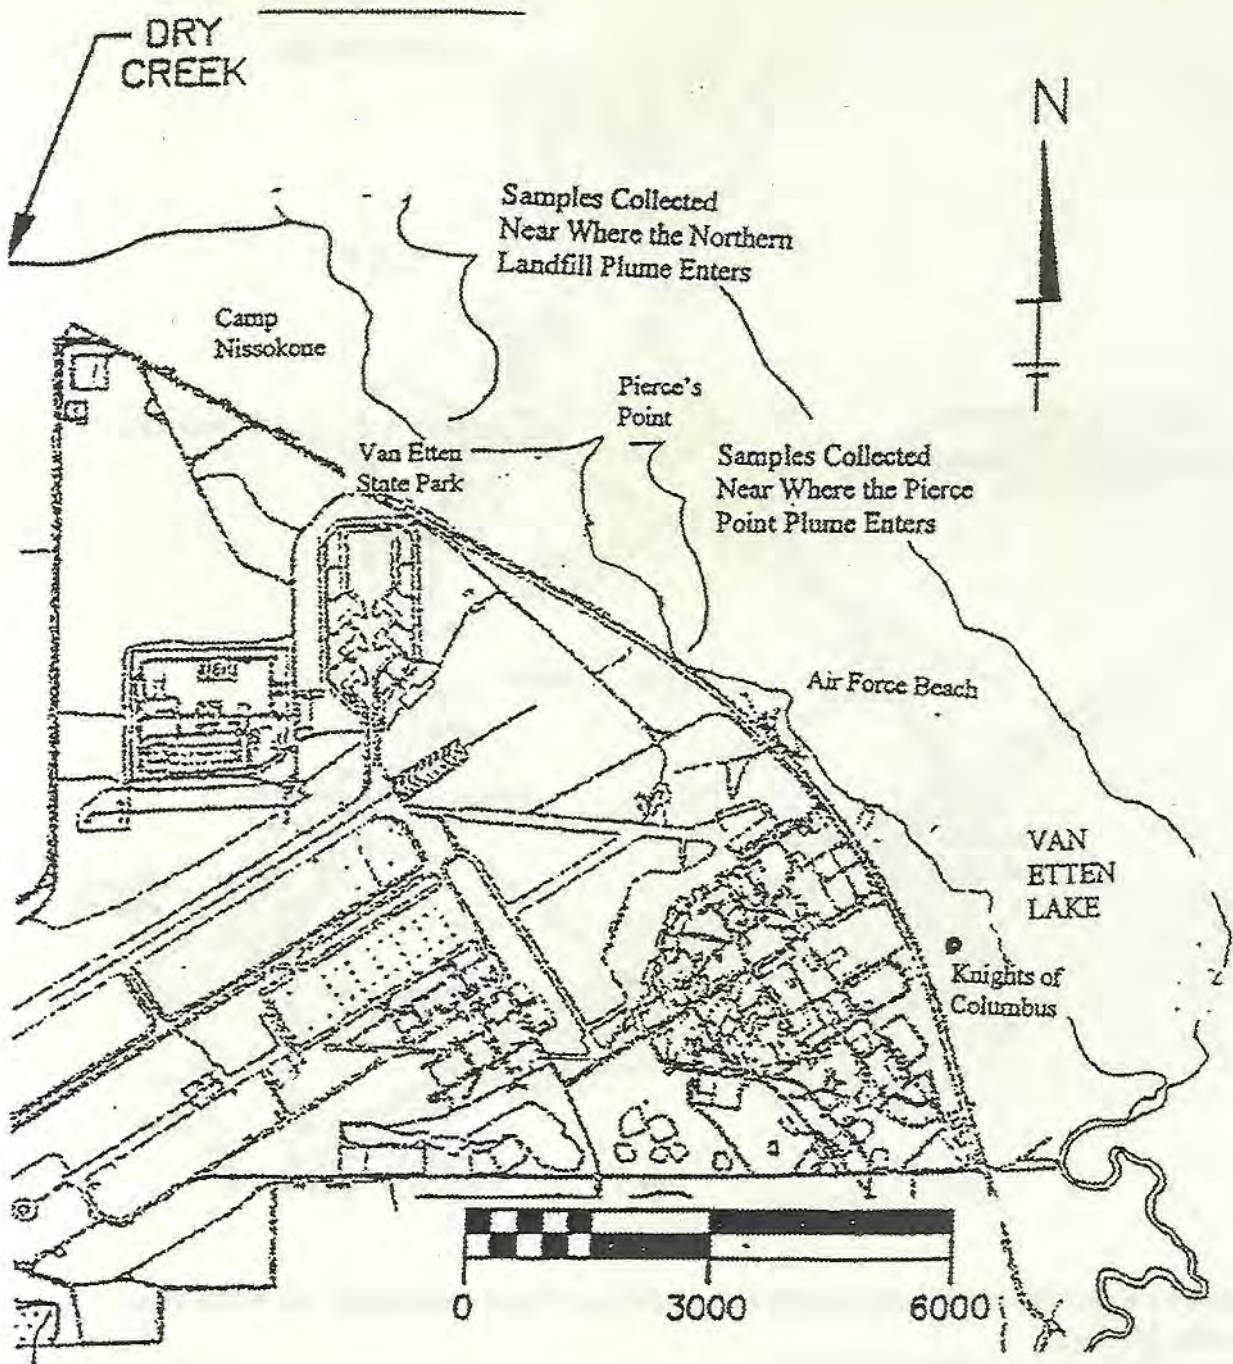
Figure 9 - Sampling Locations at Van Etten Lake, Wurtsmith Air Force Base, Oscoda, Michigan
 Figure adapted from AFCEE, 1996b
