MICHIGAN STRUCTURE INSPECTION MANUAL BRIDGE INSPECTION

CHAPTER 5

ROUTINE AND CONDITION BASED IN-DEPTH INSPECTION

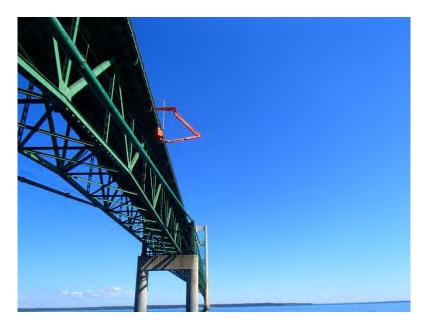
Figure 5.02.01 Utilization of an Under-Bridge Inspection Unit during Routine Inspection

A routine inspection is defined by the NBIS as a regularly scheduled inspection consisting of observations and/or measurements needed to determine the physical and functional condition of the bridge, to identify any changes from initial or previously recorded conditions, and to ensure that the structure continues to satisfy present service requirements. All elements of the bridge must be visually inspected at a distance that is close enough to determine the overall condition and to detect deficiencies. When portions of primary members are not visible from the ground or water surface then specialized equipment such as a platform bucket truck or under-bridge inspection unit should be used to gain visual access to the elements (see Figure 5.02.01).

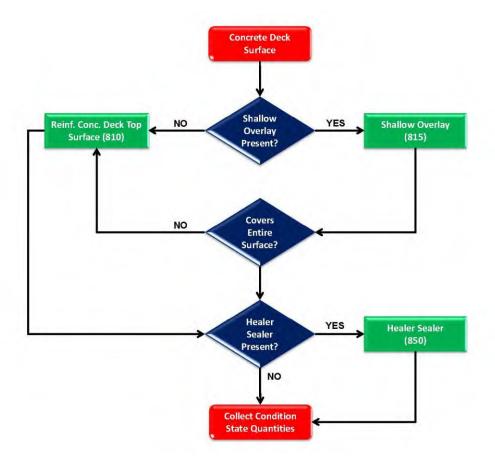
Figure 5.05.01 Element Collection Process for Concrete Surfaces

A flowchart illustrating the process of determining the applicable elements for concrete deck surfaces has been provided for clarification (see Figure 5.05.01). All of the elements displayed are ADEs that were created for improved deterioration modeling, analysis, and planning efforts. Quantities and condition state information are linked to other NBEs or BMEs that are reported to FHWA on an annual basis. The data provided must be accurate as it will be evaluated during future quality assurance and NBIP reviews.

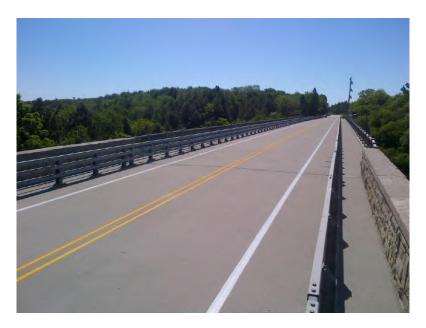
Figure 5.05.02 Thin Overlay Applied to Preserve the Surface of Cut River Deck Truss

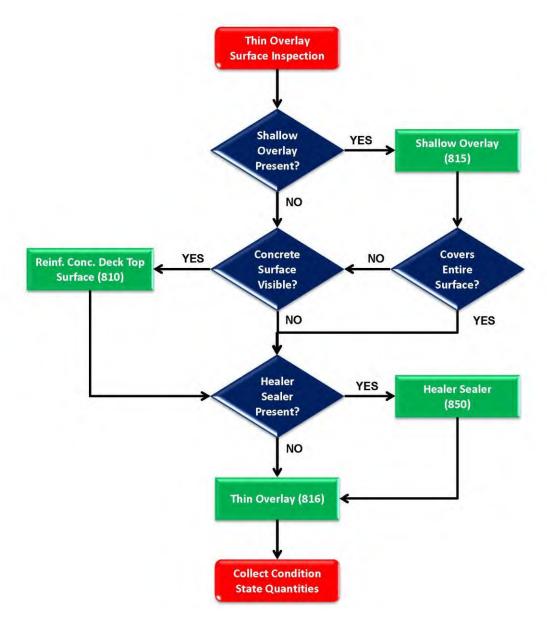
Figure 5.05.03 Element Collection Process for Thin Overlay Surfaces

A flowchart illustrating the process of determining the applicable elements for the majority of concrete decks which utilize a thin overlay for preservation has been provided for clarification (see Figure 5.05.03). All of the elements shown are ADEs that were created for improved deterioration modeling, analysis, and planning efforts. Quantities and condition state information are linked to other NBEs or BMEs that are reported to FHWA on an annual basis. The data provided must be accurate as it will be evaluated during future quality assurance and NBIP reviews.

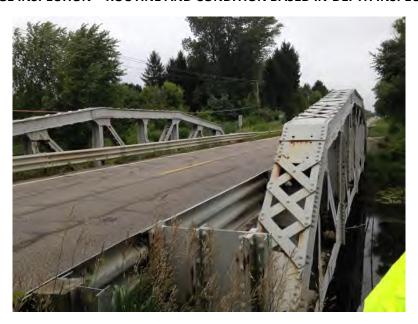
Figure 5.05.04 HMA Wearing Surface applied to the concrete deck of a Pony Truss Programmed for Replacement

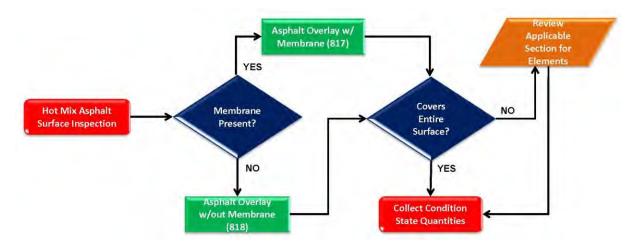
Figure 5.05.05 Element Collection Process for HMA Surfaces

A flowchart illustrating the process of determining the applicable elements for the majority of concrete decks which utilize a thin overlay for preservation has been provided for clarification (see Figure 5.05.05). All of the elements shown are ADEs that were created for improved deterioration modeling, analysis, and planning efforts. Quantities and condition state information are linked to other NBEs or BMEs that are reported to FHWA on an annual basis. The data provided must be accurate as it will be evaluated during future quality assurance and NBIP reviews.

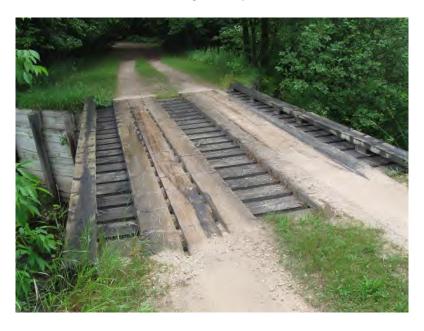
Figure 5.05.06 Timber Running Planks Protecting Timber Deck

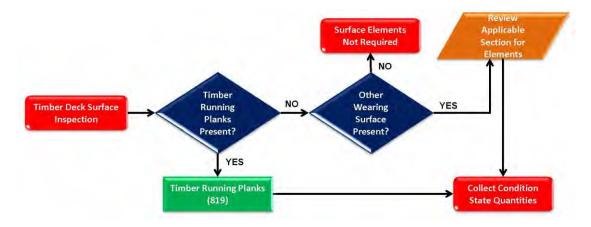
Figure 5.05.07 Timber Deck Element Top Surface Collection Process

Element level information shall be collected for the surface of timber decks using the Michigan Bridge Element Inspection Manual elements and condition states only when a wearing course is present. If the deck has sacrificial layer of lumber on the top surface then condition state quantities for Element 819 (Timber Running Planks) shall be collected. When the timber deck has a bituminous or concrete overlay present refer to the appropriate section for the additional type(s) of material present. A flowchart illustrating the process of determining the applicable elements for timber deck surfaces is provided for clarification (see Figure 5.05.07). The element shown is an ADE that has been created for improved deterioration modeling, analysis, and planning efforts. Quantities and condition state information are linked to an NBE that is reported to FHWA on an annual basis. The data provided must be accurate as it will be evaluated during future quality assurance and NBIP reviews.

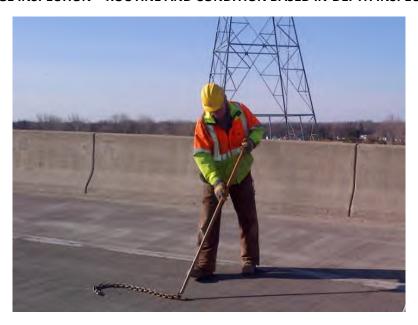
Figure 5.05.08 Sounding Shallow Overlay Using Chain-Drag Method

The majority of in-depth inspections will require sounding the surface with a hammer or chain drag, and marking delaminated, spalled, and cracked areas so they are visible in photographs (see Figure 5.05.08). The surface shall be inspected for all of the defects identified in the appropriate material specific condition state tables in the Michigan Bridge Element Inspection Manual. In addition, the joints, railings, and other elements that may be accessed closely during the closure of lanes should be reviewed. Permanent marking paint is not recommended unless repairs are anticipated to be completed in a timely fashion. Thin overlay and HMA wearing surfaces generally do not require in-depth inspection as defects in the materials are often detected from the shoulder of the structure. Occasionally, accelerated deterioration or loss of aggregate for thin overlay surfaces may warrant tensile rupture testing, skid resistance measurements, or other hands-on interaction (see Figure 5.05.09). The need to perform a detailed inspection of HMA is even less common although ground penetrating radar and other specialized non-destructive techniques are occasionally used on large structures.

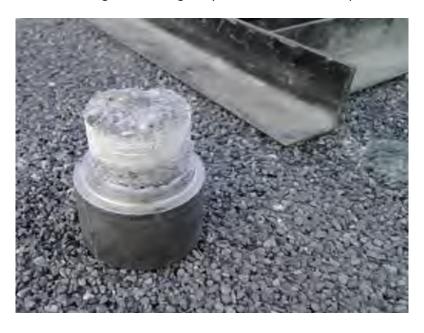
Figure 5.05.09 Thin Overlay Tensile Rupture Test Sample

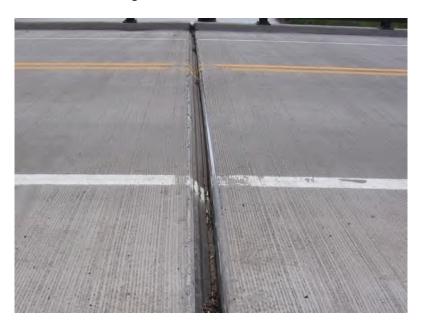
Figure 5.06.02 Full Depth Strip Seal

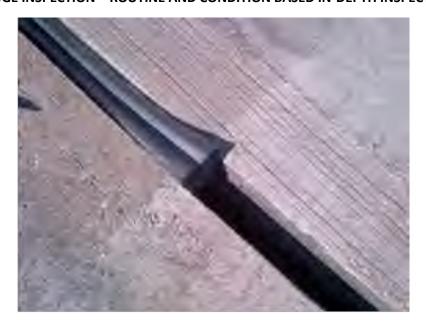
Figure 5.06.04 Compression Joint Seal

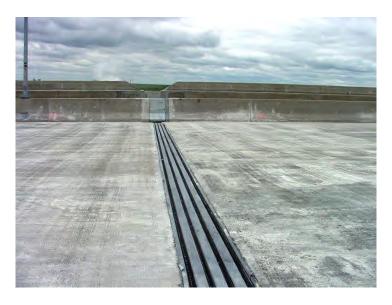
Figure 5.06.05 Assembly Joint with Seal

Assembly joints with seals are commonly referred to as modular joints and are installed in areas where expansion and contraction exceed 4 inches (see Figure 5.06.05). Due to the width and multiple devices utilized, they are very susceptible to impact damage from snowplows which may cause cracked welds and decreased performance.

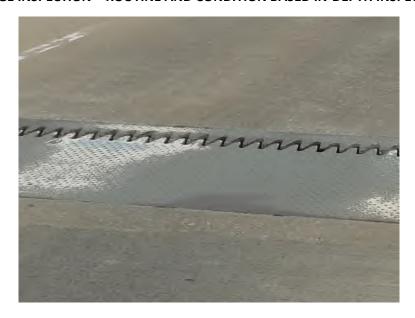
Figure 5.06.07 Assembly Joint without Seal

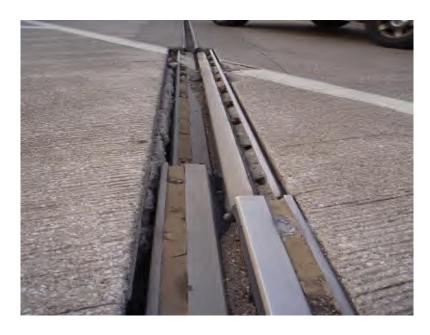
Figure 5.06.10 Mixed Joint Consisting of Elements 300 and 306

In rare circumstances a joint may consist of two or more mixed types of systems (see Figure 5.06.10). This usually occurs when temporary repairs are completed to prevent additional deterioration prior to a scheduled rehabilitation project. It may also happen when permanent repairs were affected by weather or mobility limitations. The applicable length for each element should be coded to accurately reflect the condition and quantity of the systems employed.

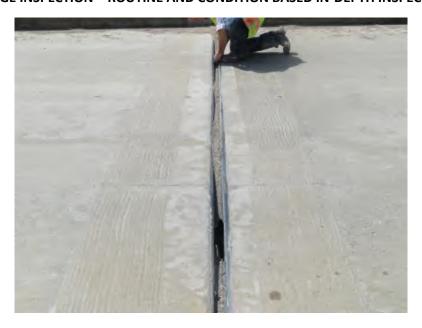
Figure 5.06.12 In-Depth Inspection of Full Depth Strip Seal Gland Failure

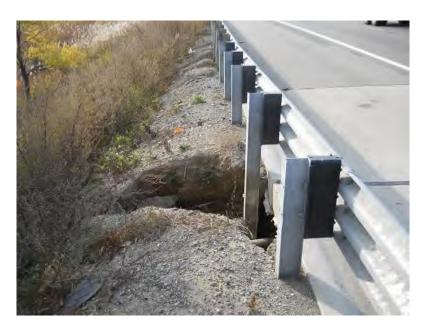
Figure 5.07.02 Erosion Induced By Missing Pressure Relief Joint Material

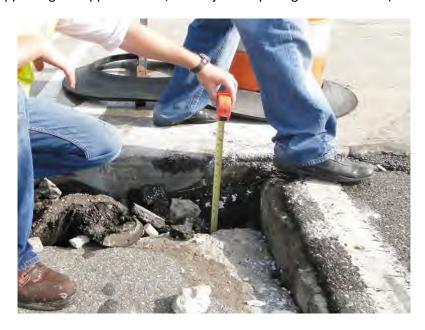
Figure 5.07.03 Failed Approach Slab Resulting from Erosion of Backfill

One of the most common failures for other joints occurs where the superstructure is fixed at the abutment. Pourable materials are traditionally used in these locations because movement is minimal. However, these types of joints are prone to accelerated deterioration and require consistent maintenance to prevent damage. Loss of seal adhesion may cause costly damage to the substructure, loss of engineered fill supporting the approach slab, and adjacent spalling of the surface (see Figure 5.07.03).

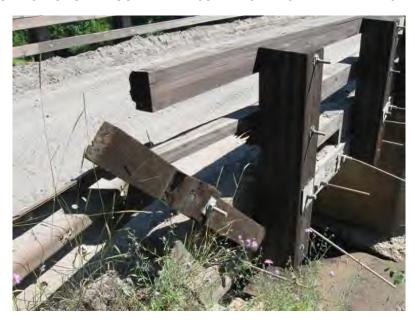
Figure 5.08.25 Timber Railing Damage at the Transition Connection

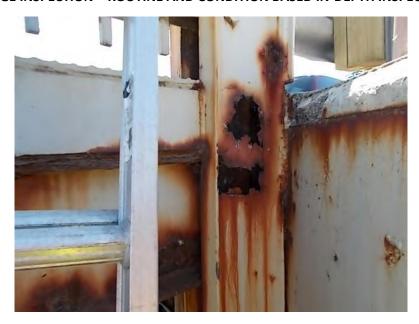
Figure 5.08.26 Steel Railing Posts in Condition State 4 Require Documented Review

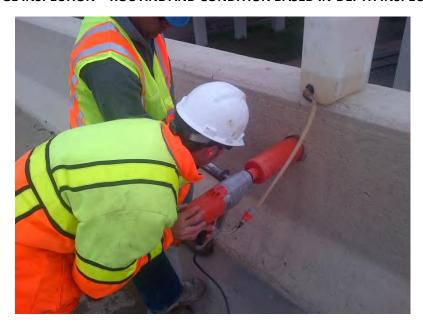
Figure 5.08.27 Coring Concrete Railing for ASR Testing

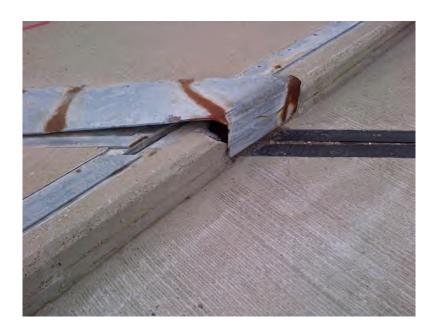
Figure 5.09.01 Damaged Steel Sliding Plates Present a Hazard for Pedestrians

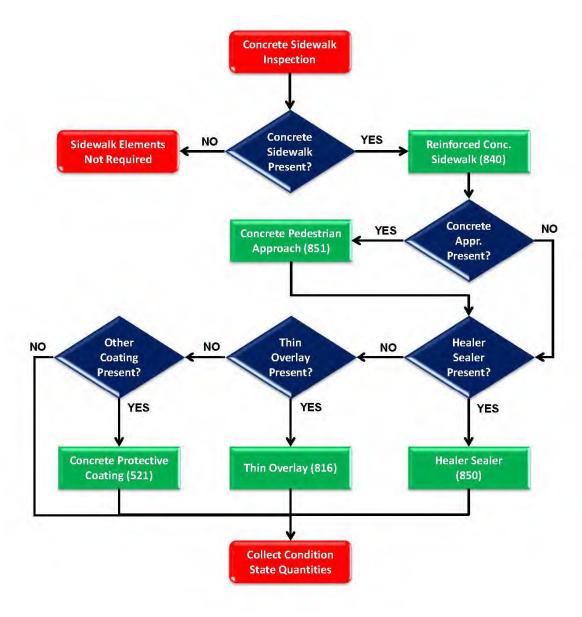
Figure 5.09.02 Deck Element Collection Process for Concrete Sidewalks

A flowchart illustrating the process of determining the applicable elements for concrete deck surfaces has been provided for clarification (see Figure 5.09.02). All of the elements shown are ADEs that were created for to improve pedestrian safety and determine the deterioration of sidewalks with and without preventive measures applied. The data provided must be accurate as it will be evaluated during future quality assurance reviews

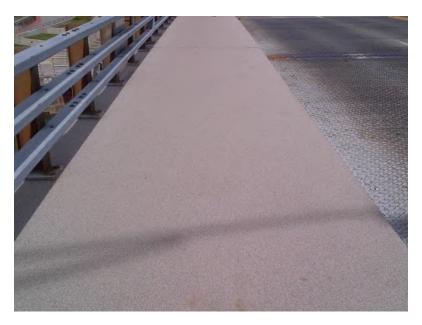
Figure 5.09.03 Concrete Filled Steel Grid with Wearing Surface

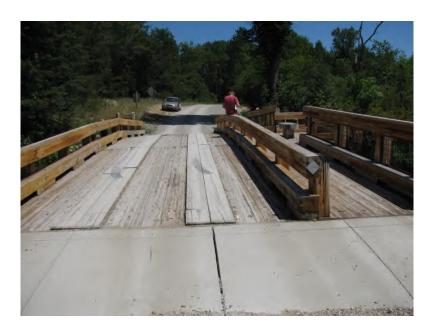
Figure 5.09.05 Designated Pedestrian Walkway on Nail Laminated Deck

Aesthetics, cost, and the availability of materials are examples of the benefits that lead to the use of timber for as-constructed sidewalks and curbs (see Figure 5.09.05). The material may also be used as a retrofit in conjunction with sidewalk brackets due to its low weight to strength ratio. Conversely, durability concerns that exist for insect and fire damage usually limit installations using the material where long-term serviceability is required. The team leader shall perform the procedures listed for routine inspection, and review Chapter 7 of the BIRM for additional considerations during the inspection. Sidewalks may consist of one or more materials, and the most severe deterioration should control the assigned ratings.

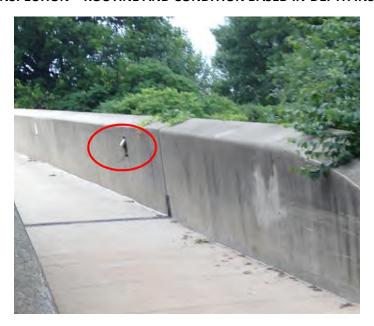
Figure 5.09.06 Damaged Steel Electrical Junction Box Cover May Injure Pedestrians

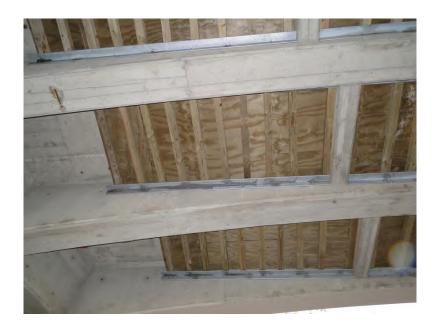
Figure 5.10.01 Tee Beam Superstructure with Plywood False Decking

Observations during the inspection of the deck bottom surface allow for an improved understanding of the overall condition of the deck and permit judgment for the recommended installation of a system to protect motorists and pedestrians from potential hazards or to perform other corrective actions. The team leader must inspect the area for signs of deterioration and the existence of any materials that may separate from the surface prior to the next scheduled routine inspection. Further investigation may be required at locations where false decking was previously installed or to confirm suspected deficiencies (see Figure 5.10.01).

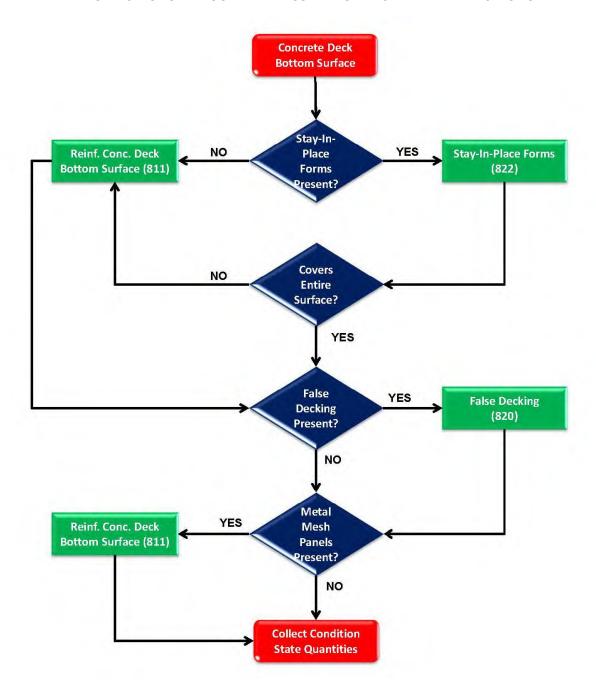
Figure 5.10.03 Element Collection Process for Concrete Deck Bottom Surfaces

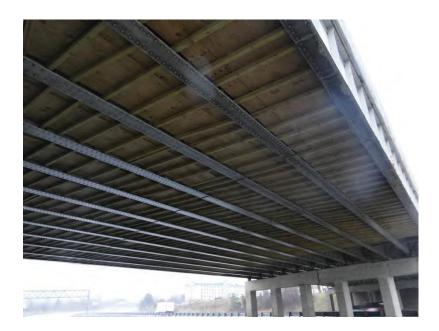
Figure 5.10.04 Structure Where Plywood False Decking Coverage Requires In-Depth Inspection

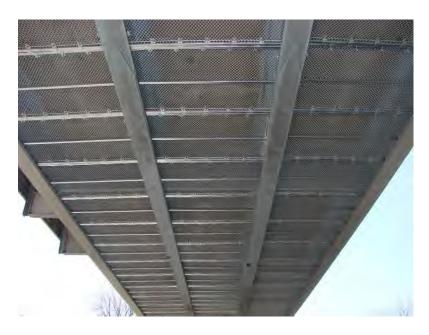
Figure 5.10.05 Typical Maintenance Sheeting

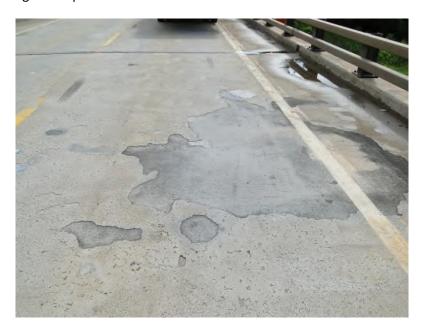
Figure 5.11.01 Deteriorated Thin Overlay with No Defects Observed in the Structural Deck

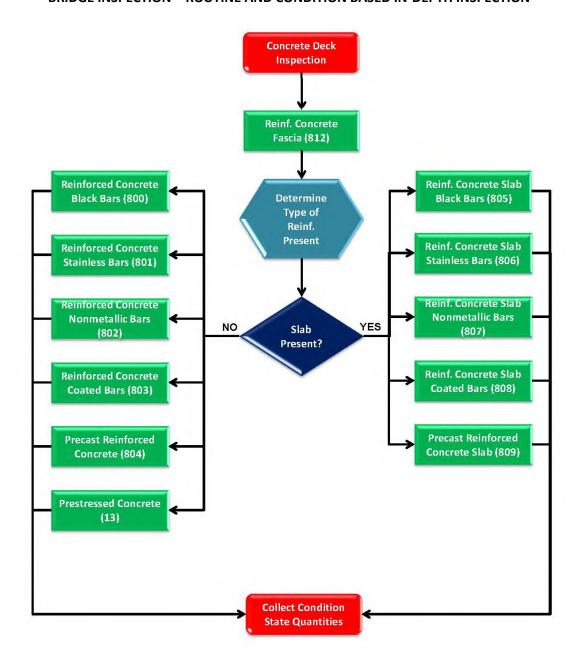
Figure 5.11.03 Concrete Deck Element Collection Process

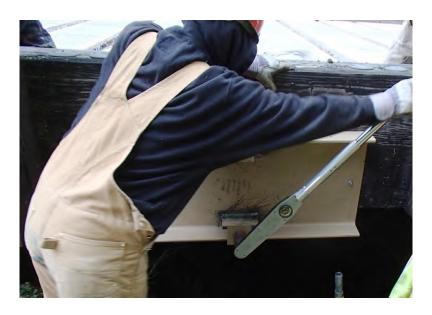
Figure 5.11.05 Post Tensioning Glulam Deck Panels

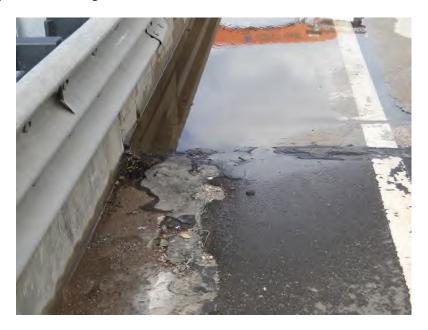
Figure 5.12.01 Ponding Water Near the Reference Line

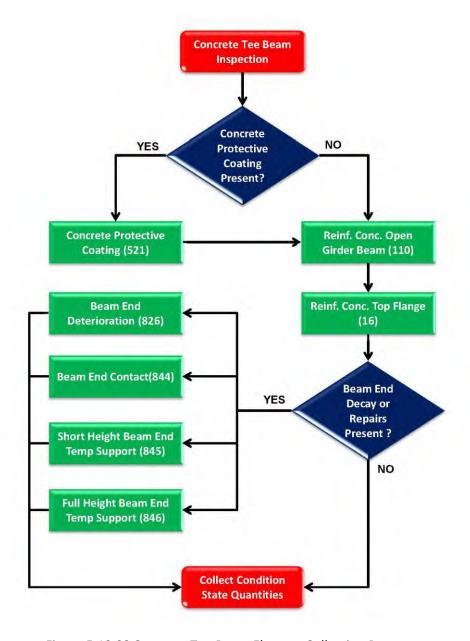
Figure 5.13.02 Concrete Tee Beam Element Collection Process

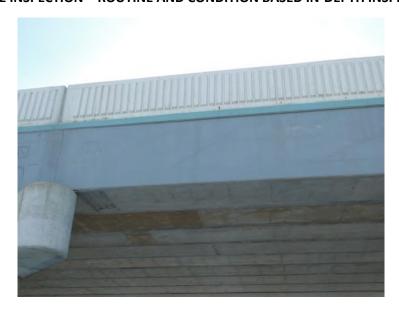
Figure 5.13.03 Concrete Surface Coating on Side-by-Side Box Beams

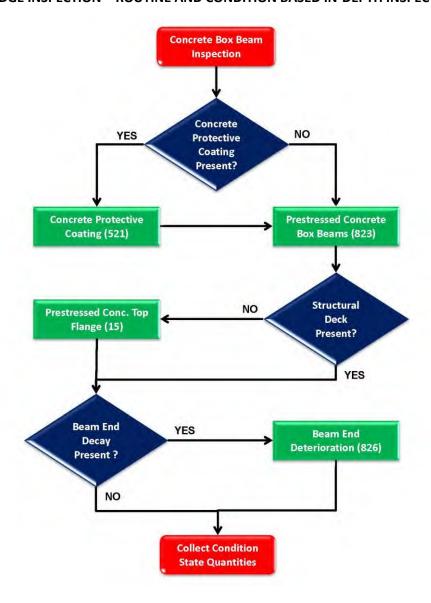
Figure 5.13.04 Concrete Box Beam Element Collection Process

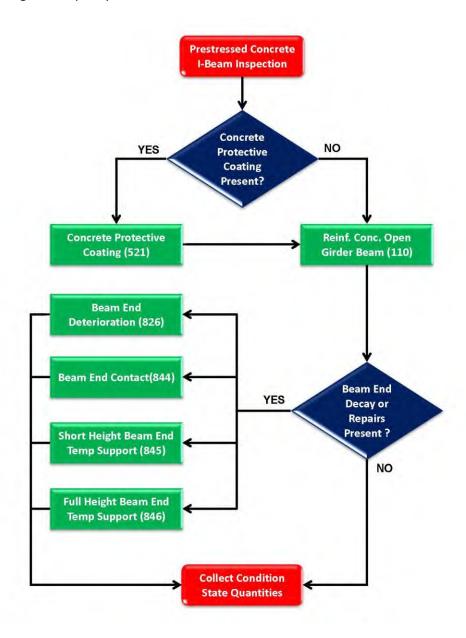
Figure 5.13.05 Prestressed Concrete I-Beam Element Collection Process

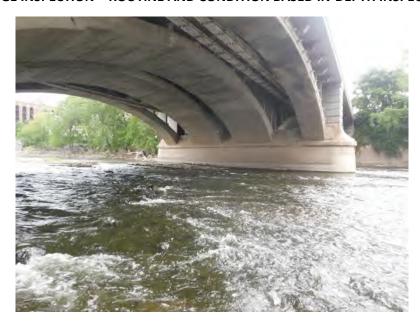
Figure 5.13.06 Open Spandrel Concrete Arch with Multiple Ribs

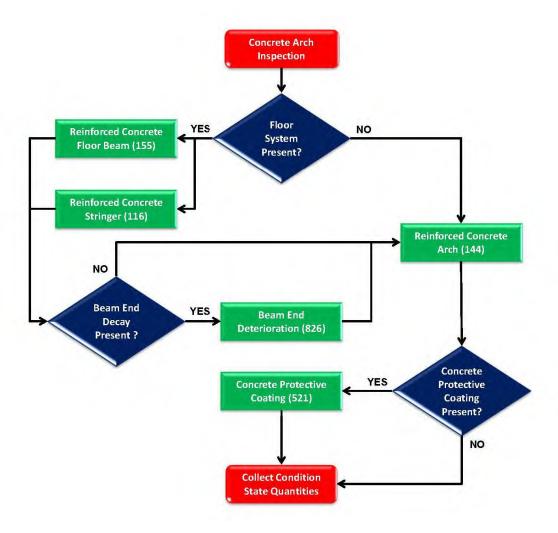
Figure 5.13.08 Reinforced Concrete Arch Element Collection Process

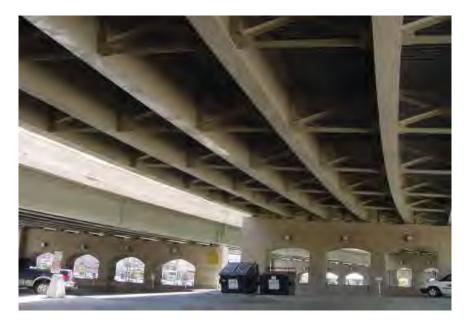
Figure 5.13.09 Curved Steel Plate Girders with Primary Cross Frame Diaphragms

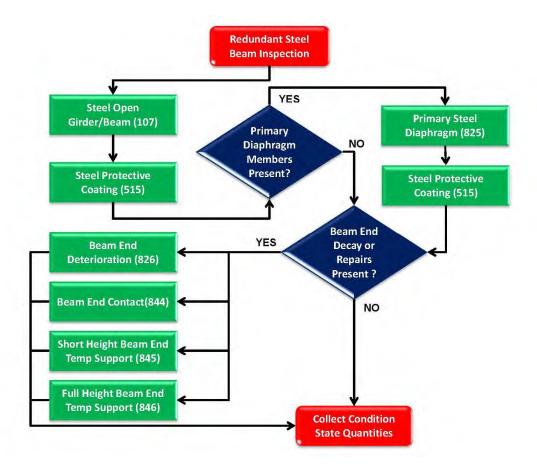
Figure 5.13.10 Load Path Redundant Steel Superstructure Element Collection Process

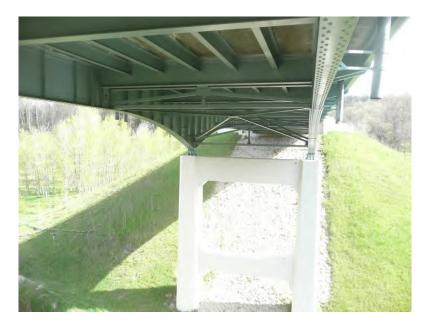
Figure 5.13.11 Non-Redundant Fracture Critical Two Girder Superstructure System

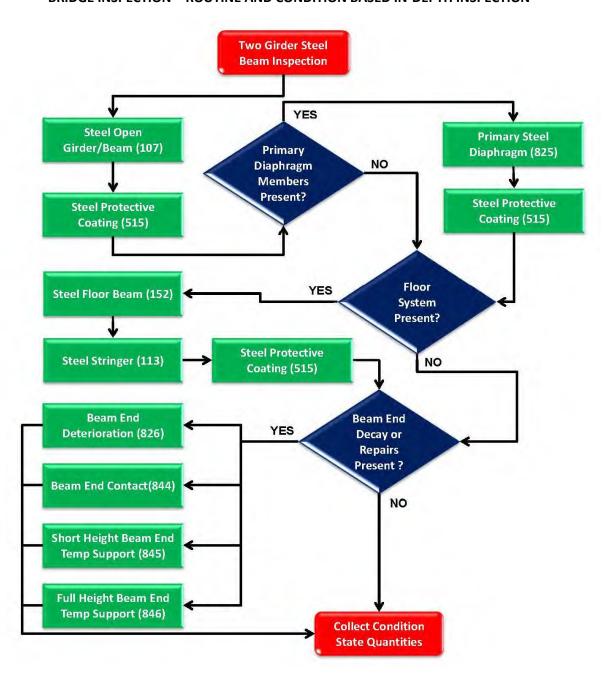
Figure 5.13.12 Two Girder Steel Superstructure Element Collection Process

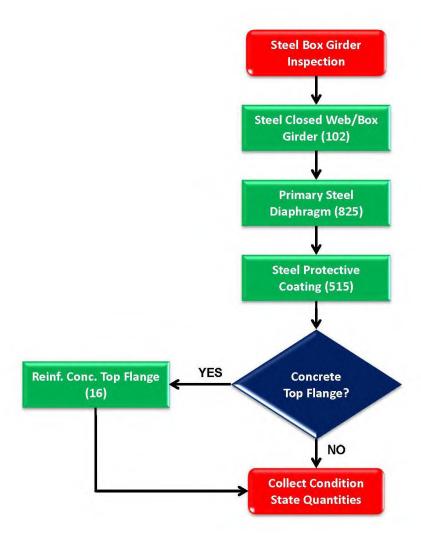
Figure 5.13.13 Steel Box Girder Element Collection Process

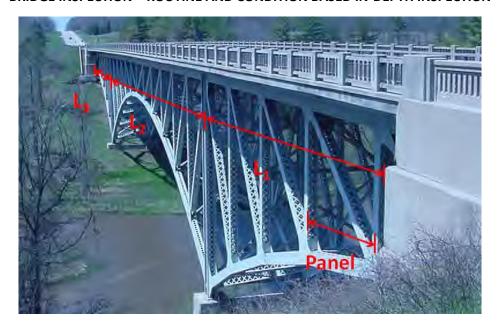
Figure 5.13.14 Horizontal Length along the Traveled Way Must Be Used for Trusses

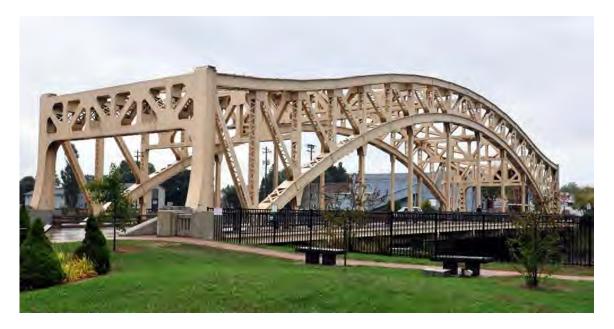
Figure 5.13.16 Steel Through Arch with Fracture Critical Floor Beams and Suspension Hangers

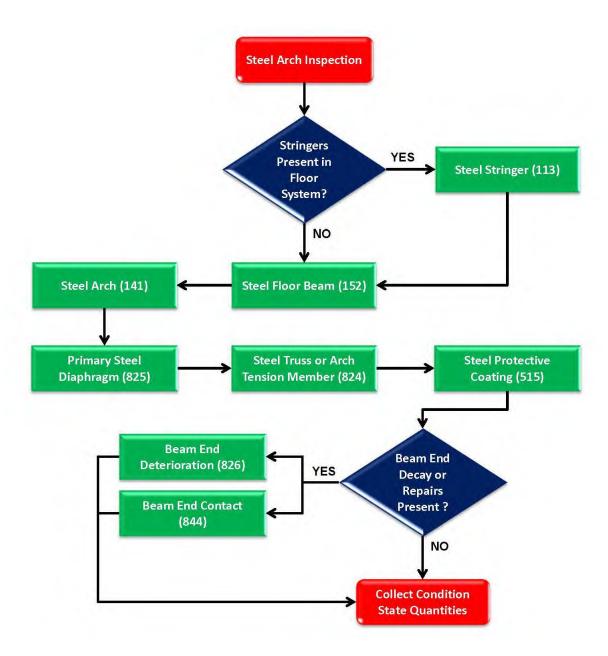
Figure 5.13.17 Steel Arch Element Collection Process

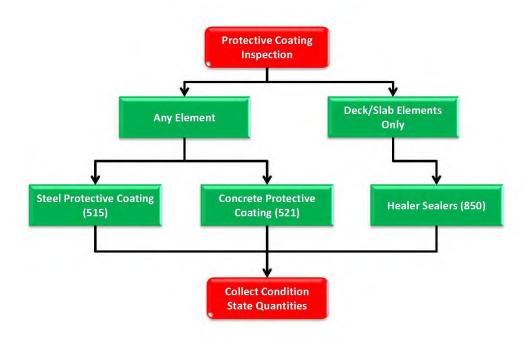
Figure 5.14.06 Protective Coating Element Collection Process

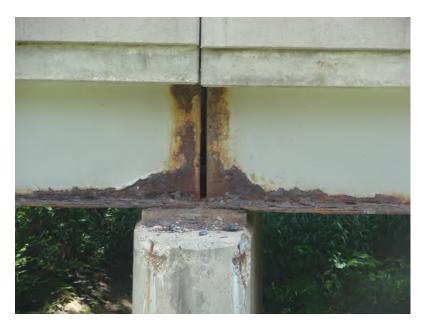
Figure 5.15.01 Identification of Beam End Corrosion Requires In-Depth Inspection

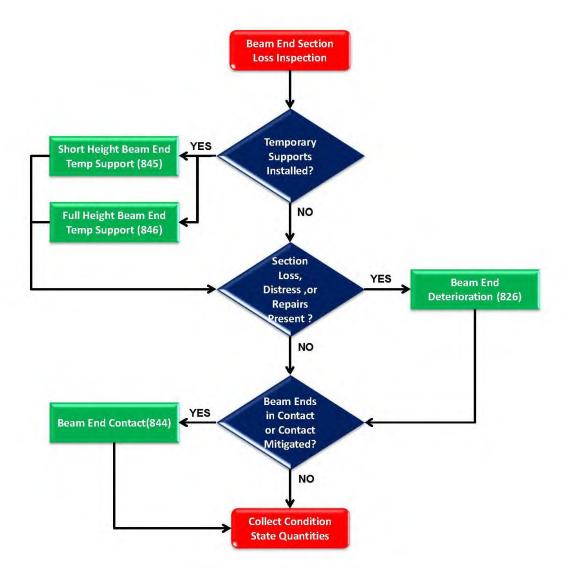
Figure 5.15.02 Elements Related to Section Loss Collection Process

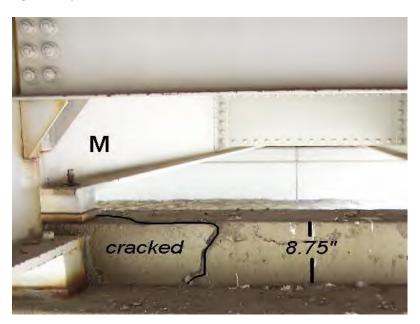
Figure 5.16.01 Cracked Bolster Prompts Planning for Temporary Supports

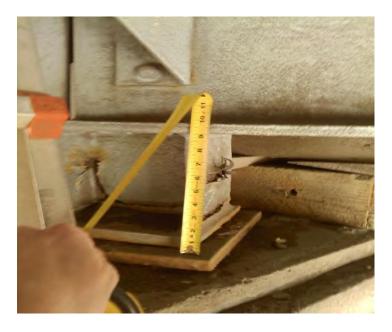
Figure 5.16.08 Cracked H-Bearing Necessitates Detailed Inspection

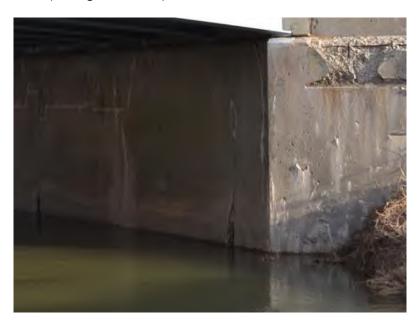
Figure 5.17.01 Abutment with Monolithic Wingwall Deterioration included with Rating of Abutment

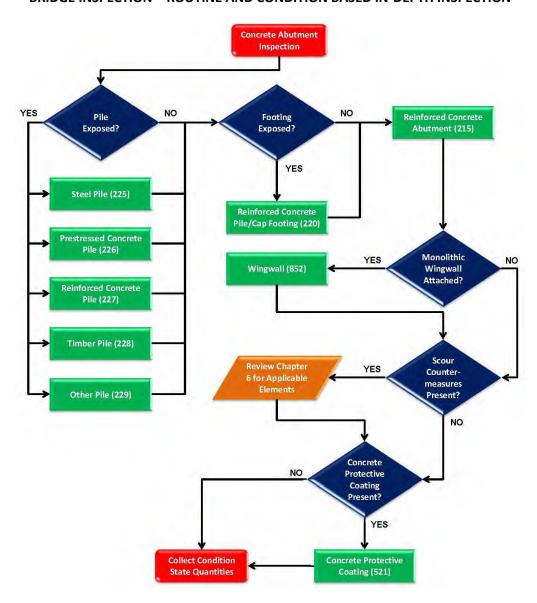
Figure 5.17.02 Concrete Abutment Element Collection Process

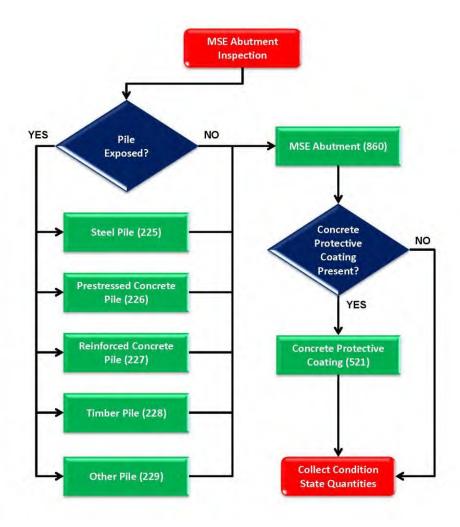
Figure 5.17.03 MSE Abutment Element Collection Process

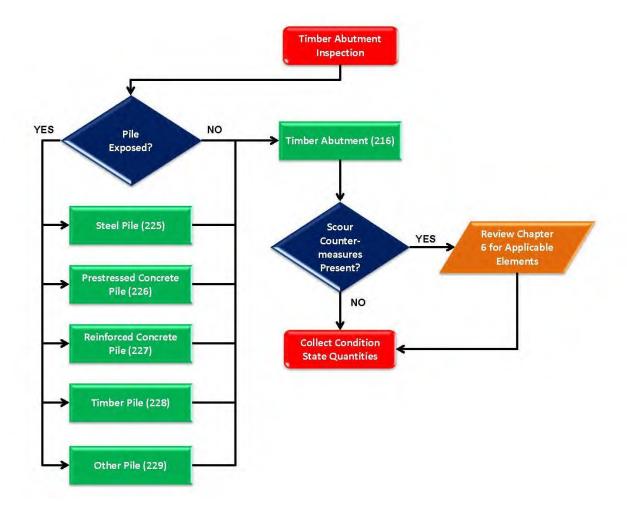
Figure 5.17.05 Timber Abutment Element Collection Process

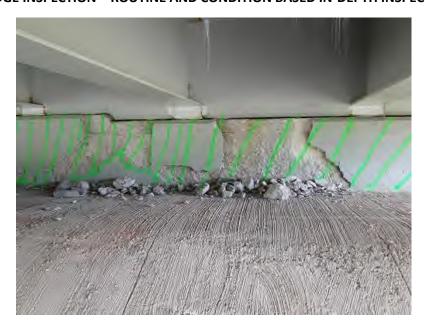
Figure 5.17.06 Severe Abutment Spalling Caused by Pavement Pressure

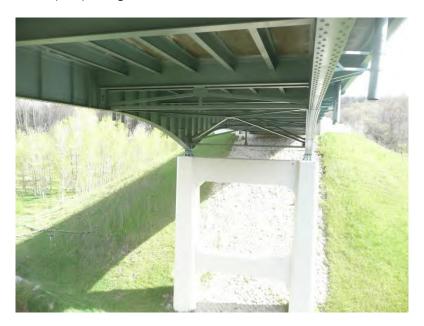
Figure 5.18.01 Two Column Pier Supporting Fracture Critical Structure

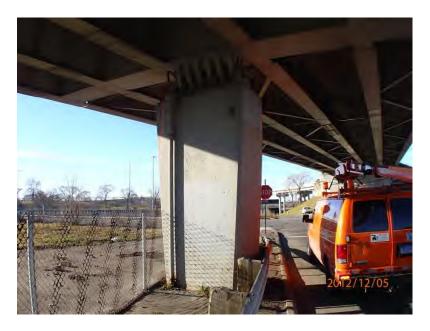
Figure 5.18.02 Element 234 Reinforced Concrete Column

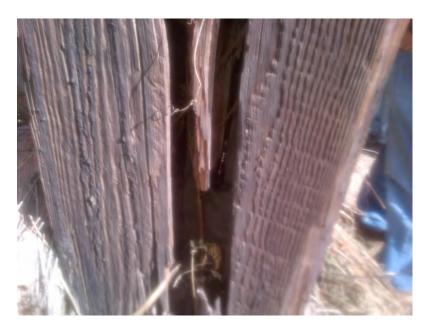
Figure 5.18.05 Hollow Timber Column

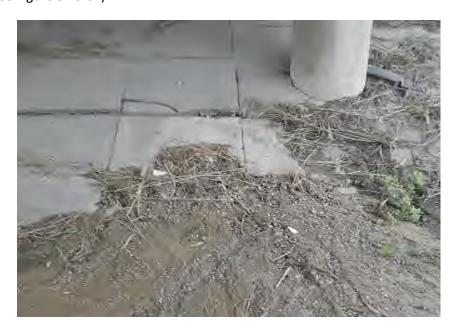
Figure 5.19.01 Loss of Approach Roadway Embankment Fill

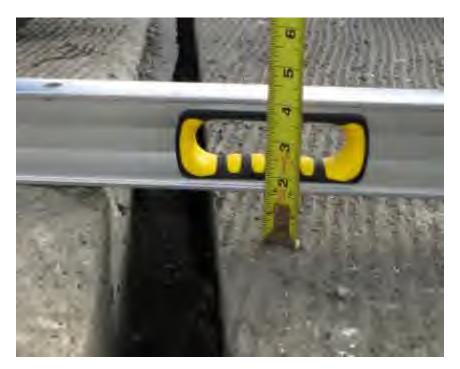
Figure 5.20.01 Approach Slab Settlement at Pavement Seat

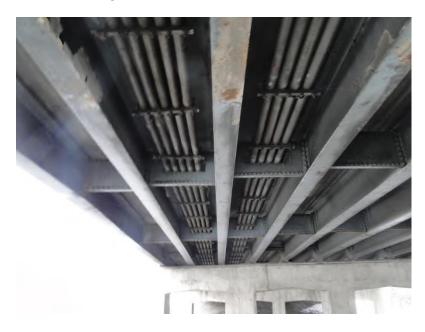
Figure 5.23.01 Telephone Conduit Banks with overhead Adhesive Anchors

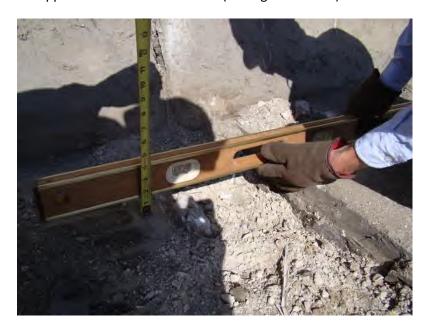
Figure 5.25.01 Settled Approach Basin Full of Debris
