MIASM UPDATE – SEPTEMBER 2023

MICHIGAN ANCILLARY STRUCTURE INSPECTION MANUAL (MiASIM)

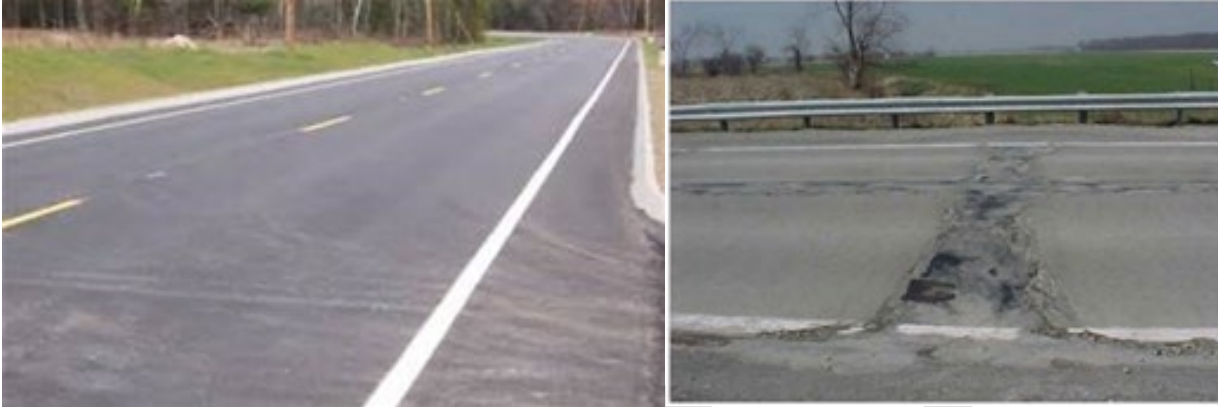
Figure 8.2.3: Approach roadway, without observable distress (left), clear distress over culvert (right)

Issues observed in the approach roadway can often be an indicator for culvert performance; however, they can equally be unrelated. Because of this, it is important for inspectors to evaluate the relationship between any identified approach roadway distress and culvert distress whenever possible.

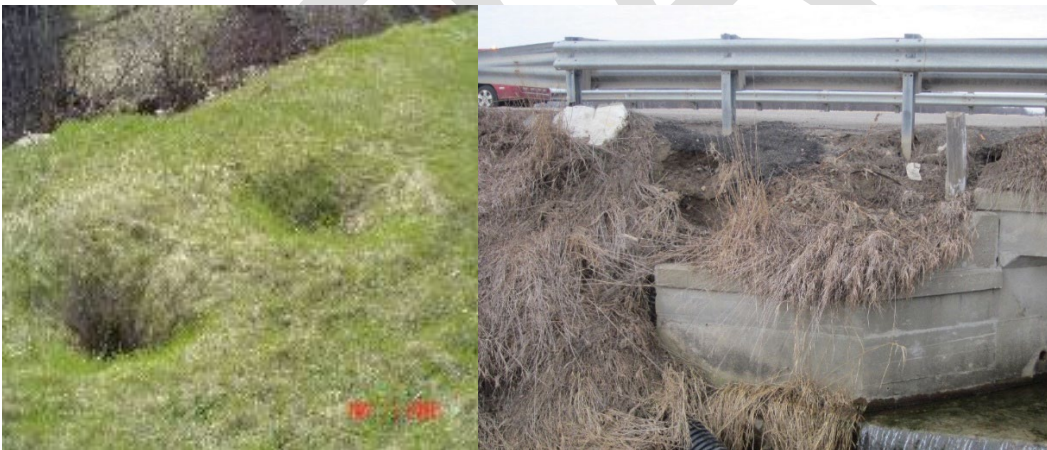
Figure 8.2.10: Example of embankment issues due to piping (left) or erosion (right)

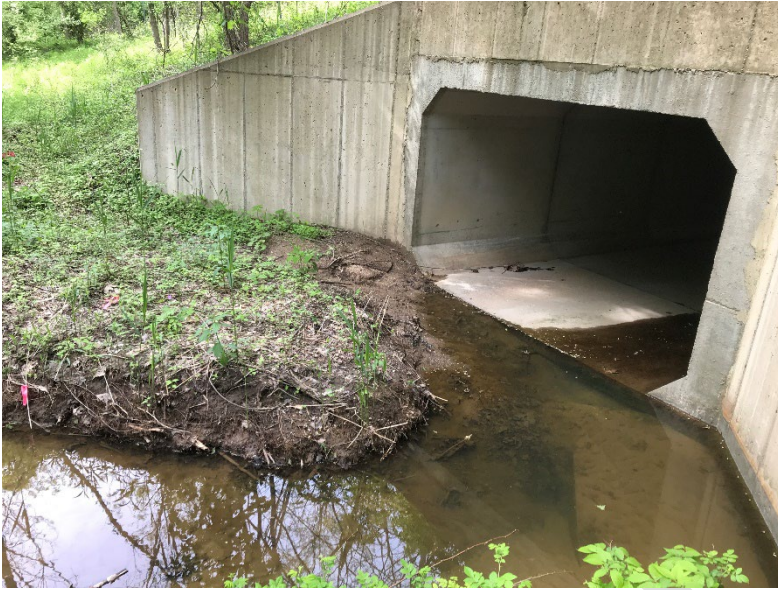
Figure 8.2.13: Stream channel poor horizontal alignment

Check for erosion and indicators of changes in the direction or location of the stream channel. Plan-view sketches and site photographs are used to document the condition and horizontal alignment of the channel relative to the culvert barrel at the time of inspection. The alignment is critical for a three-sided culvert which may be susceptible to failure due to scour. Abrupt changes in stream horizontal alignment (bends) retard flow and cause increased erosion along the outside of the bend, damage to the culvert and end treatments, and increased sedimentation along the inside of the bend. Where sharp channel bends exist at either the inlet or outlet of a culvert, check for sedimentation and erosion.

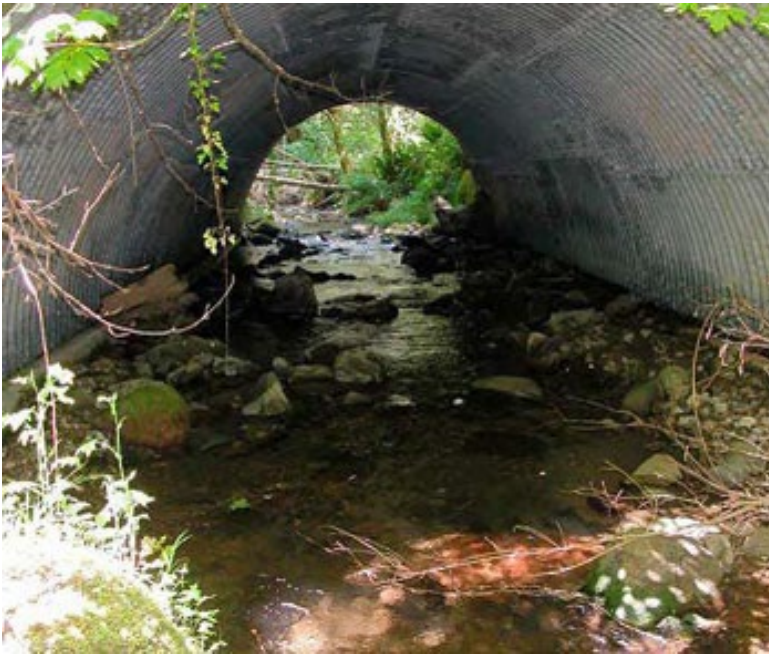
Figure 8.2.18: Intentional natural streambed

Note some culverts may be designed with fill in the bottom (invert) to create a more natural stream bed for fish. Identify these culverts to distinguish intentional fill from debris accumulation.

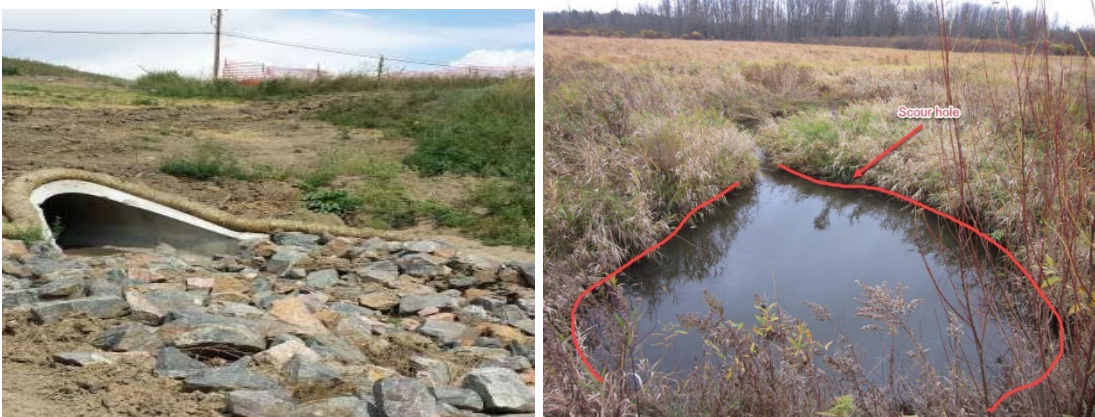
Figure 8.2.20: No scour (left), scour hole (right)

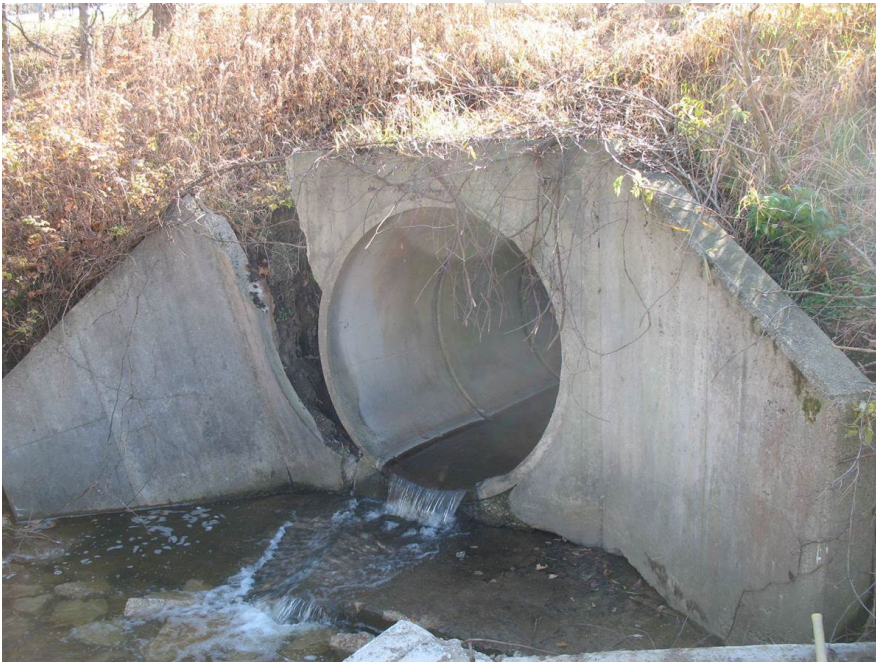
Figure 8.2.4.4.26: Concrete foundation and wingwall damage due to scour

Culvert scour consists of three types of scours: stream degradation, contraction scour, and local scour. Stream degradation is long term changes in the streambed elevation due to natural or human-induced causes, which can affect the reach of the river near the culvert. Contraction scour is removal of material from the bed and banks across all or most of the channel width, resulting from the contraction of the flow area. Local scour is removal of bed material from around the culvert foundation. Local scour is caused by the acceleration of flow and vortices resulting from flow around an obstruction.

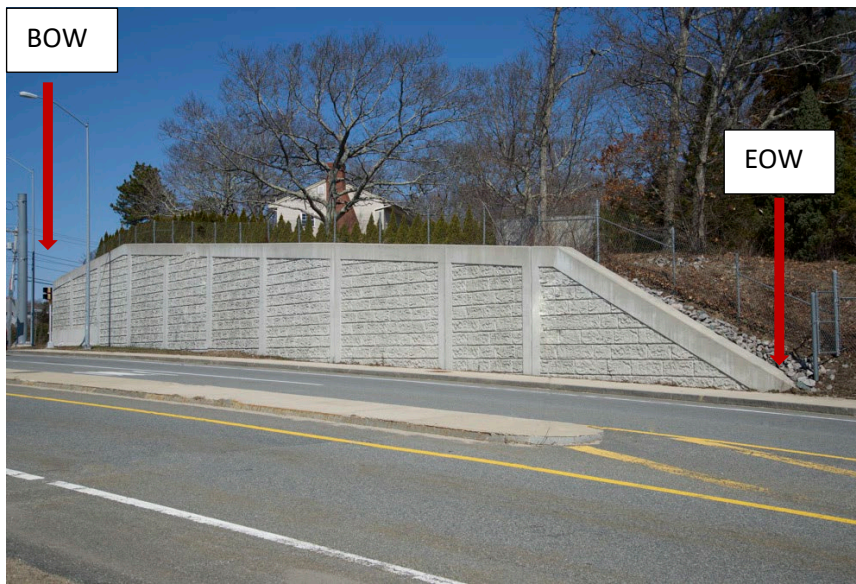
Figure 8.3.7: Typical wall facing inspection limits

The wall facing inspection shall identify the facing type of material and the associated distresses with the facing type. Inspect the wall facing from the top of the wall (below any copings) to the top of the foundation or to the top of finished grade. Embedded and buried portions of walls are not subject to condition inspection since they are not visible.

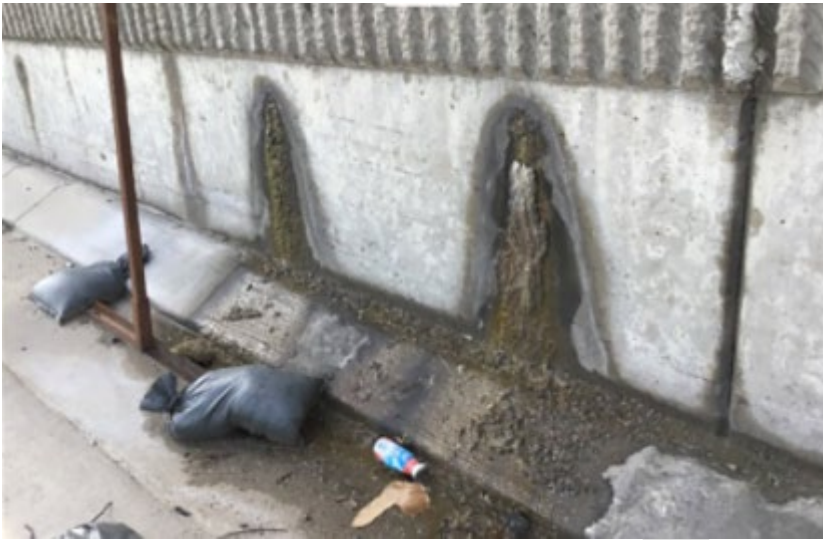
Figure 8.3.12: Retaining wall concrete abrasion

Inspect the wall for signs of concrete abrasion, including the loss of cement paste and the exposure of the underlying aggregate. Document on the location and extent of any abrasion on the surface of the wall face.

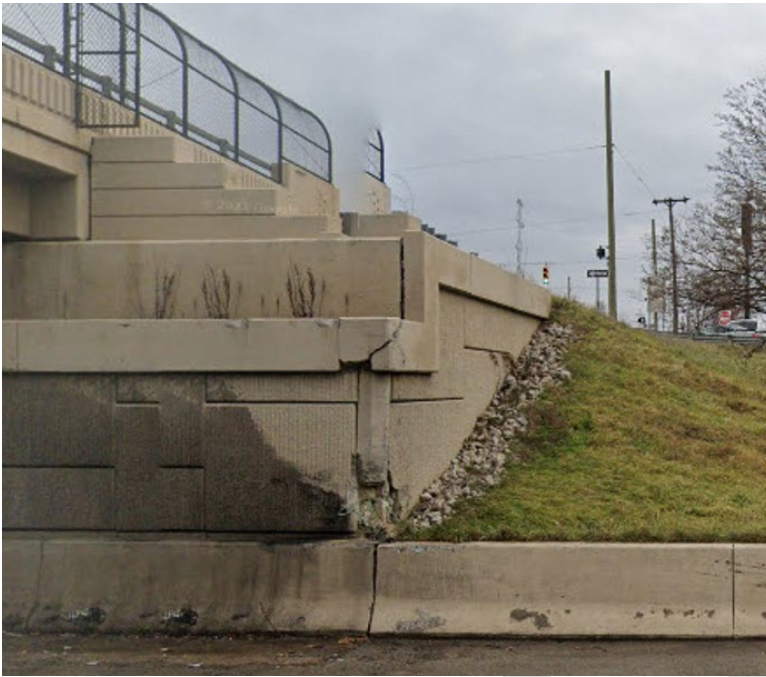
Figure 8.3.16: Impact damage

Inspect the wall system for vehicular impact damage. Document the location and degree of damage.

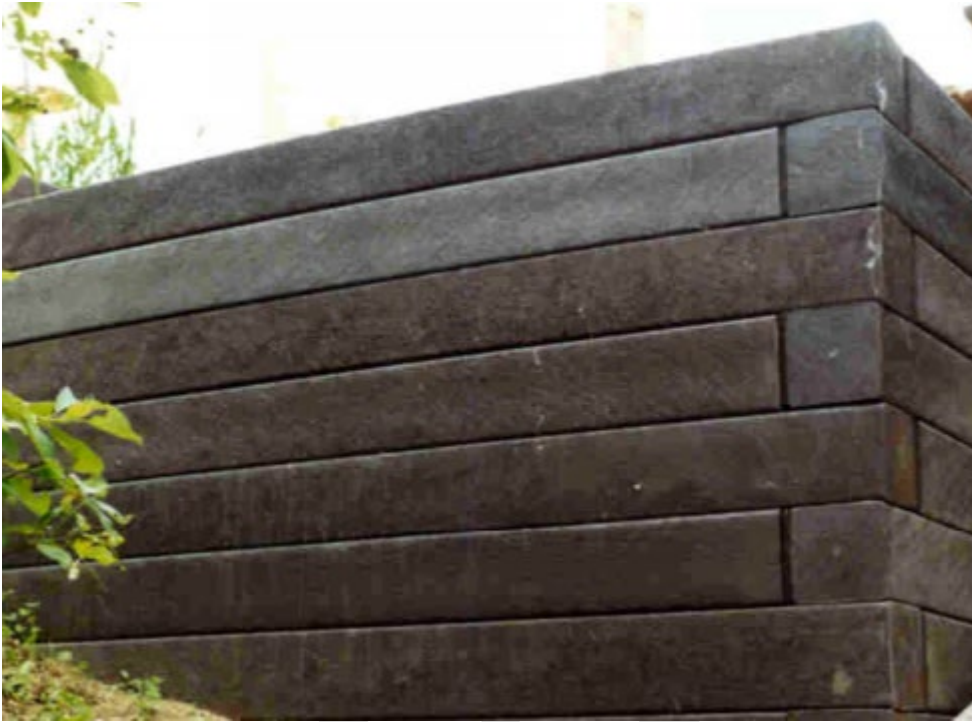
Figure 8.3.34: Plastic/vinyl lumber wall

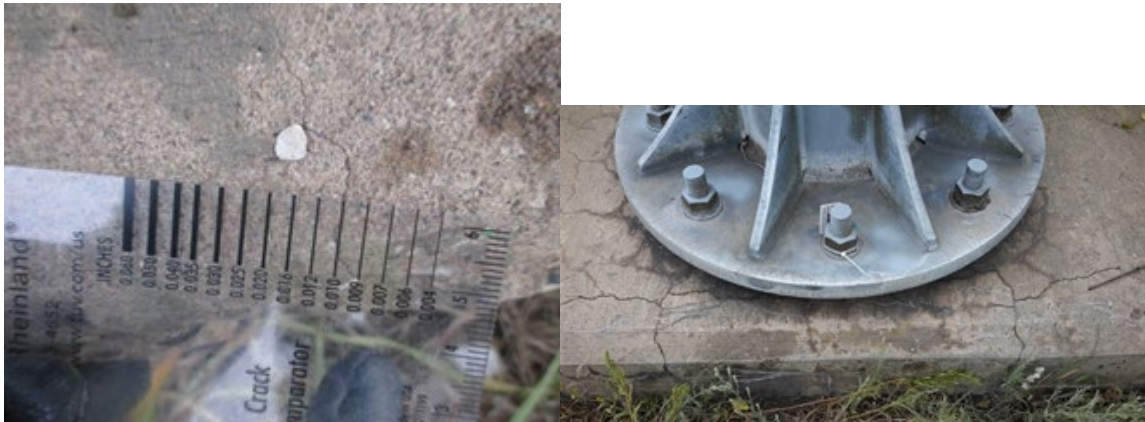
Figure 8.4.5: Truss or cantilever structure foundation, minor cracking measured with a crack comparator (left), significant cracking (right)

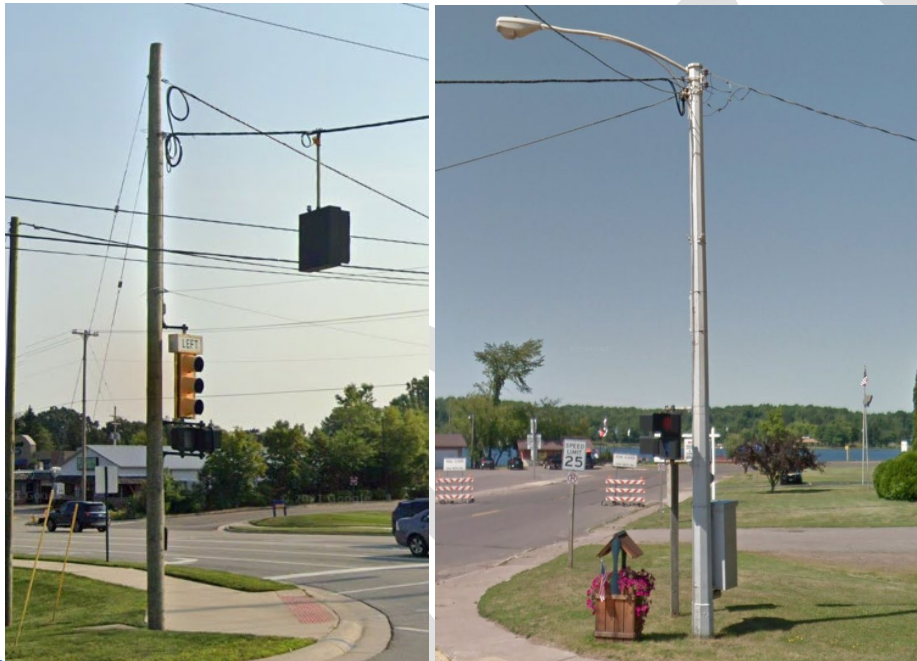
Figure 8.5.1: Embedded wood pole (left) and embedded steel pole (right)

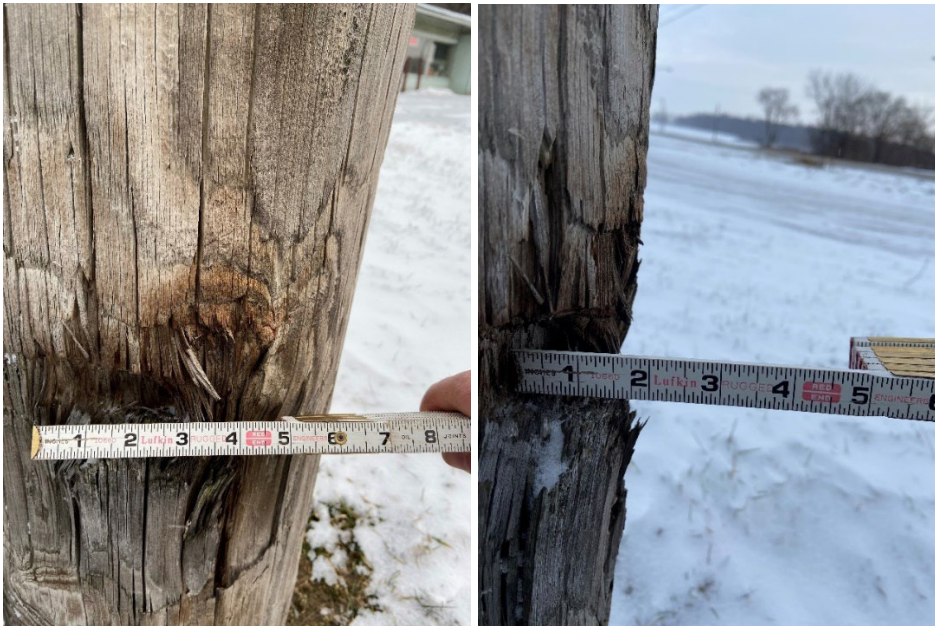
Figure 8.5.11: Measuring impact damage

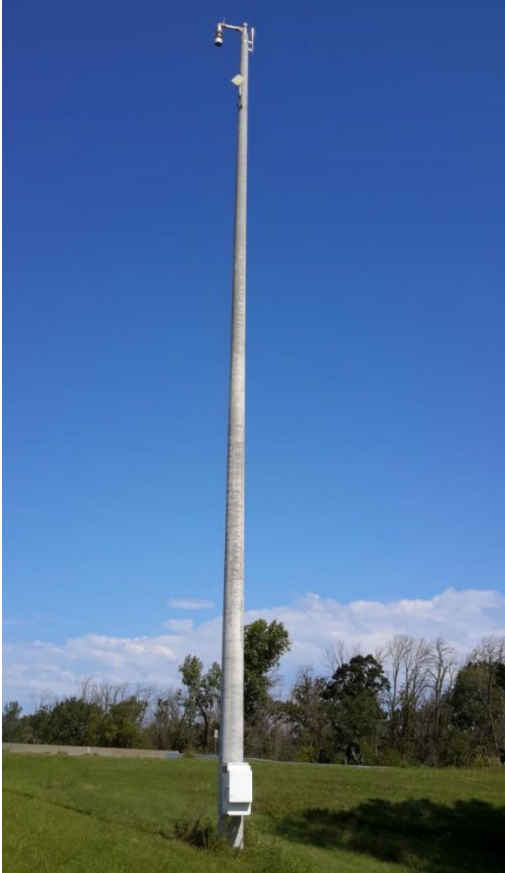
Figure 8.6.1: Spun Concrete Pole

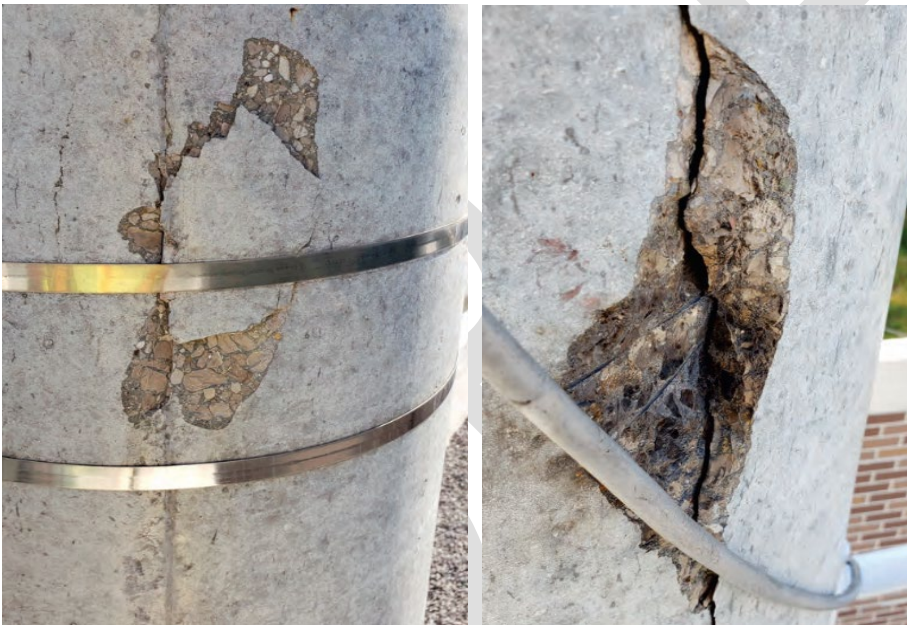
Figure 8.6.6: Spalls (left), major cracking and spalls (right)

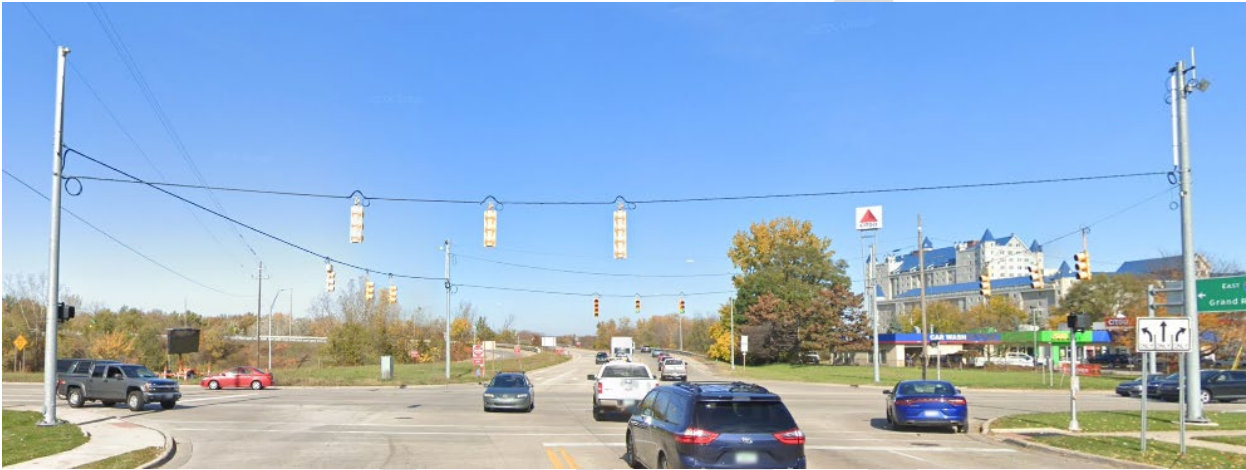
Figure 8.7.1: Steel strain poles with box span configuration

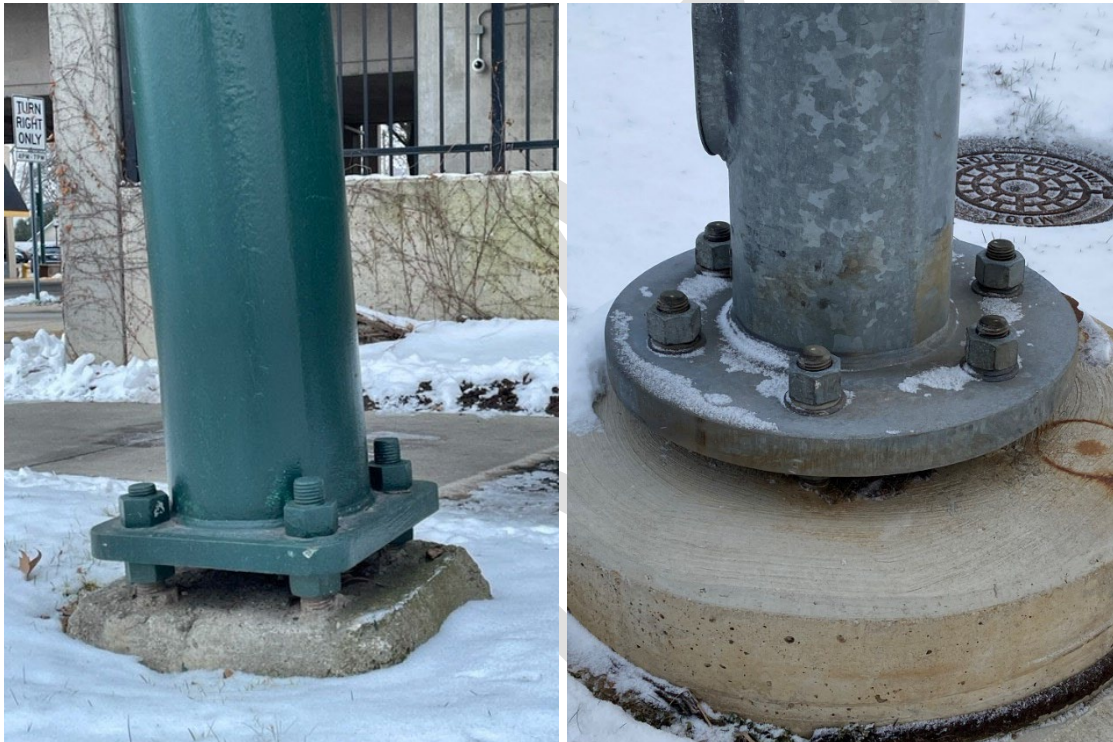
Figure 8.7.7: Steel strain pole square foundation with four anchor bolts (left, note misalignment), newer style drilled shaft foundation with six anchor bolts (right)

Start by inspecting the condition of the soil around the foundation noting any erosion or settlement that could impact the foundation. A gap between the foundation and adjacent soil may indicate foundation movement. Inspect the concrete for cracking, spalling, and delamination noting the quantities and locations. Check for exposed or corroded reinforcing steel. Pay special attention to the concrete immediately surrounding the anchor bolts. Older foundations may be square in shape while current standards specify a circular drilled shaft. Look for signs of impact damage.

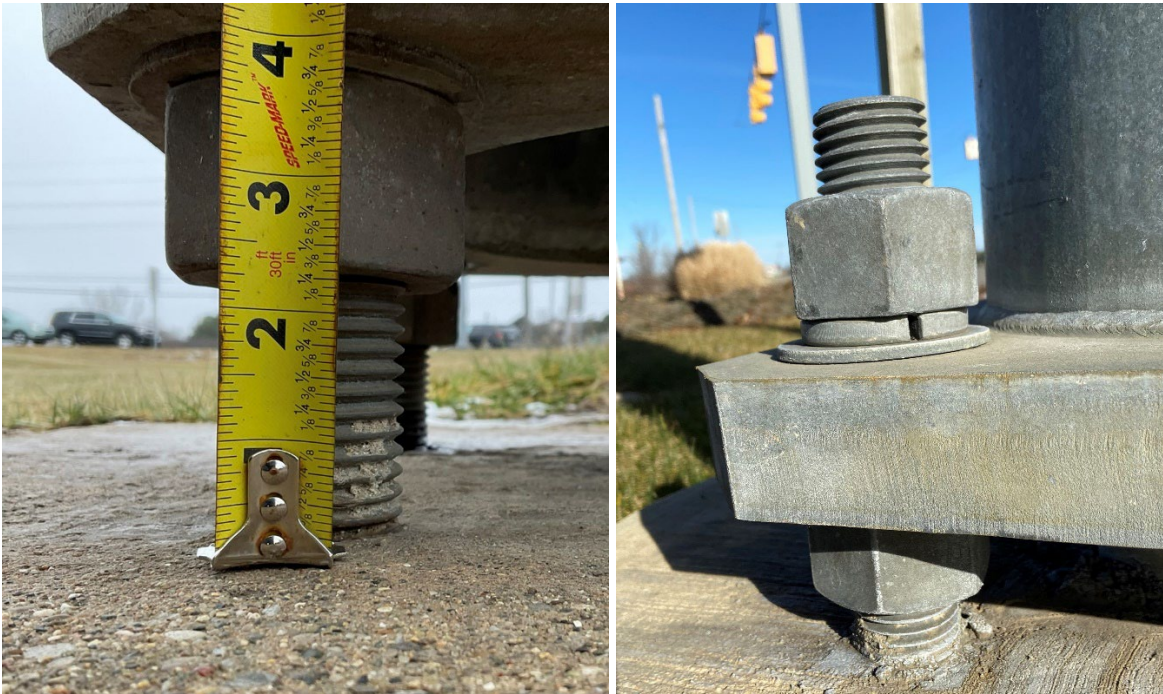
Figure 8.7.8: Excess anchor bolt standoff distance (left), fully compressed lock washer (right)

The top nuts shall be fully engaged on the anchor rod, which means the top of the anchor rod is flush or higher than the top of the nut. Inspect the connection for any signs of impact damage, including bent anchor bolts or damaged threads. Inspect the galvanizing of all components and note corrosion. Nut covers may be present covering the top nuts of the connection. These were used to protect the connection but are a detriment as they retain moisture and debris and can accelerate corrosion; they are no longer permitted.

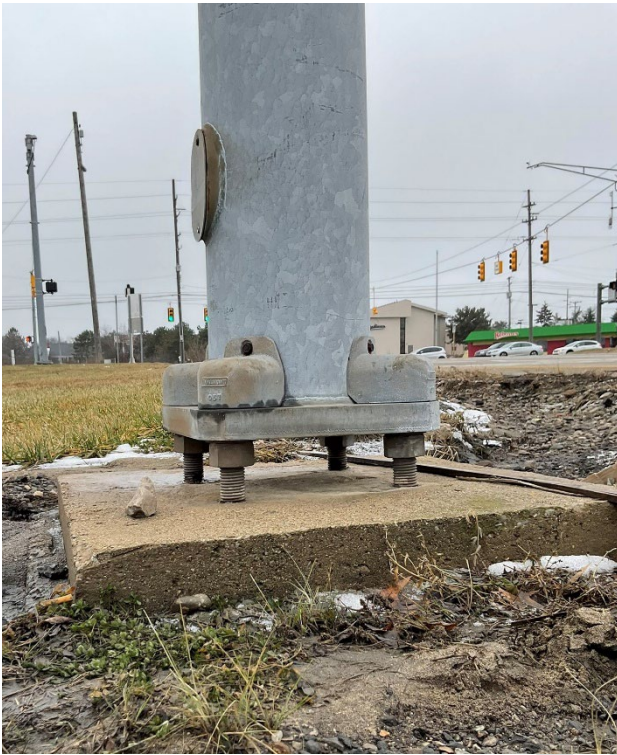
Figure 8.7.10: Steel strain pole foundation with excess standoff distance and nut covers

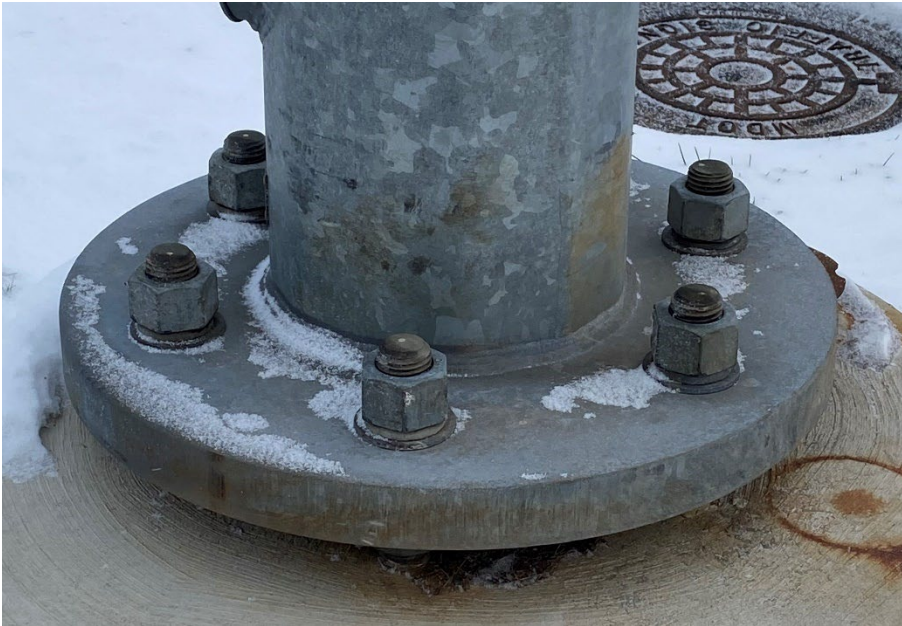
Figure 8.7.11: Steel strain pole base plate with six anchor bolts

The base plate is part of the anchor bolt connection but is connected to the pole with a full penetration weld and considered part of the vertical structure along with the pole and its vertical structure connections. The base plate should be checked for warping that may have occurred during fabrication or construction, and corrosion. Pay particular attention to the weld between the base plate and pole and look for any cracks or weld deficiencies. A crack will typically appear in the galvanizing and may or may not extend into the weld metal. Additional non-destructive testing may be required to determine the extent of any cracks.

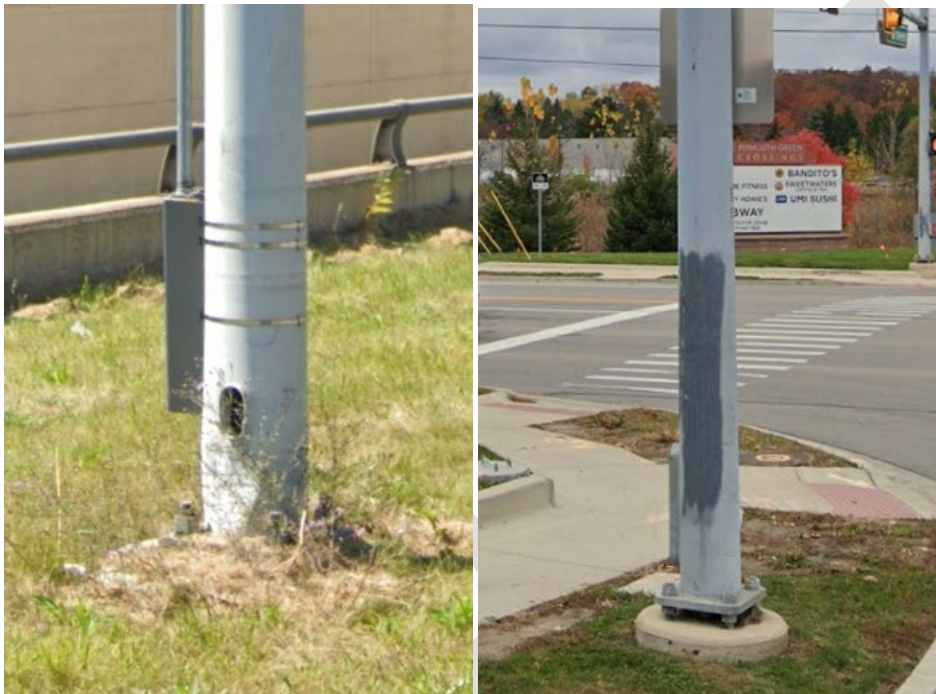
Figure 8.7.12: Impact damage and missing hand hole cover (left) and graffiti/coatings repair (right)

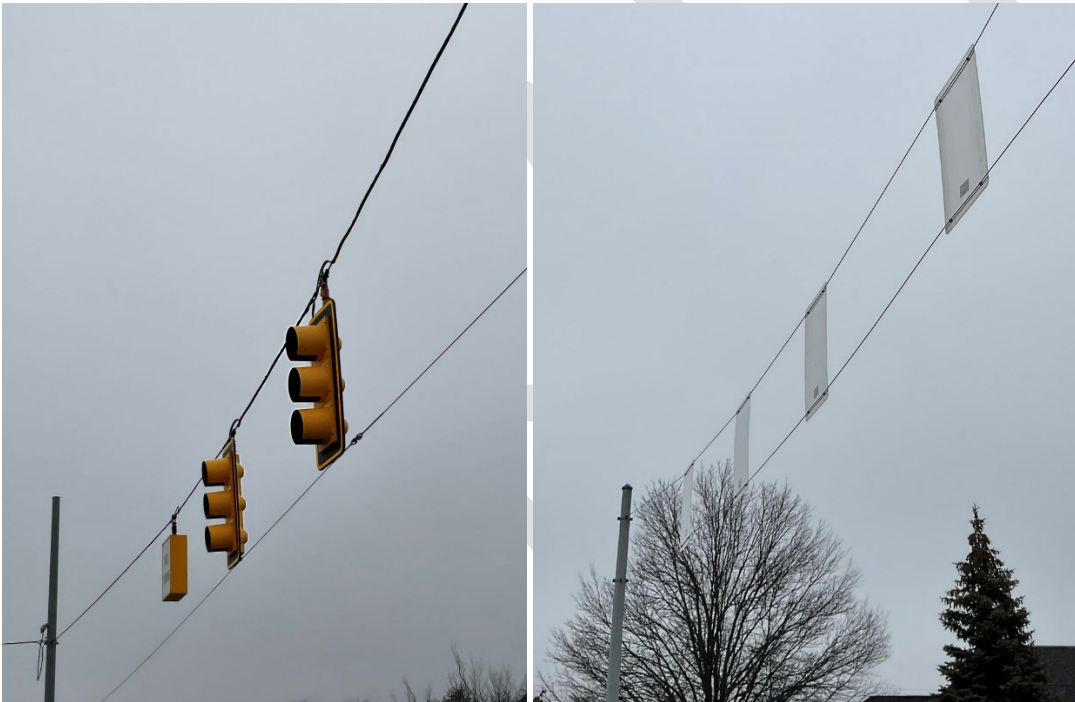
Figure 8.7.17: Span wire supporting signals and sign (left), span wires supporting signs (right)

Attachments connected to the span wire include signals and case signs. Typically, the signals and signs are connected using span wire hangers and suspension clamps. Consider the typical steel and fastener deterioration modes for these connections: loose connections, wear, corrosion, cracking, and deformation. The signals and signs themselves are not rated but if there is noticeable deterioration that could impact safety it should be reported.

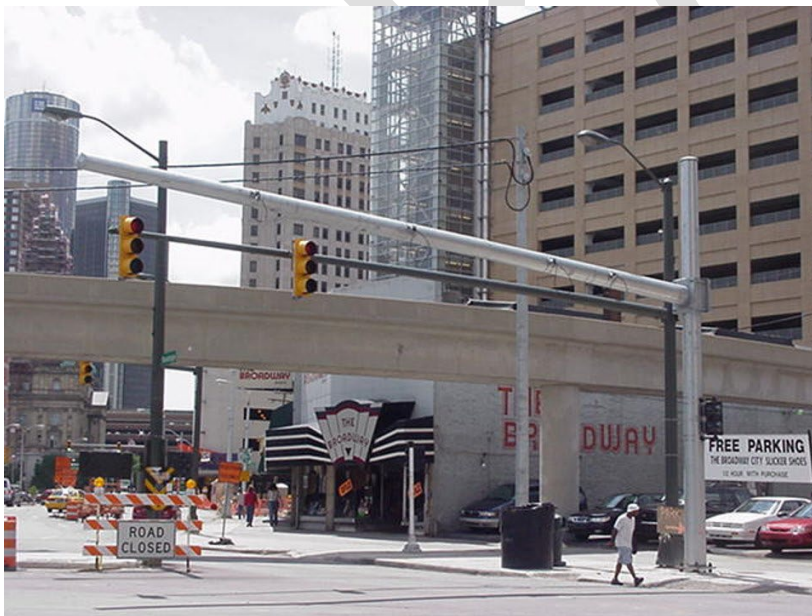
Figure 8.9.1: MDOT Category I Mast Arm, note previous design in background before removal

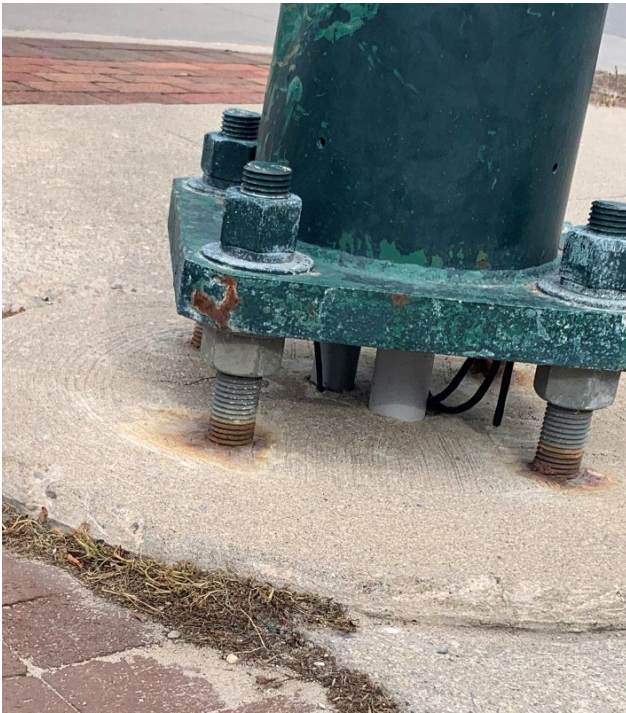
Figure 8.9.7: Four anchor bolt foundation with excessive standoff distance and corrosion

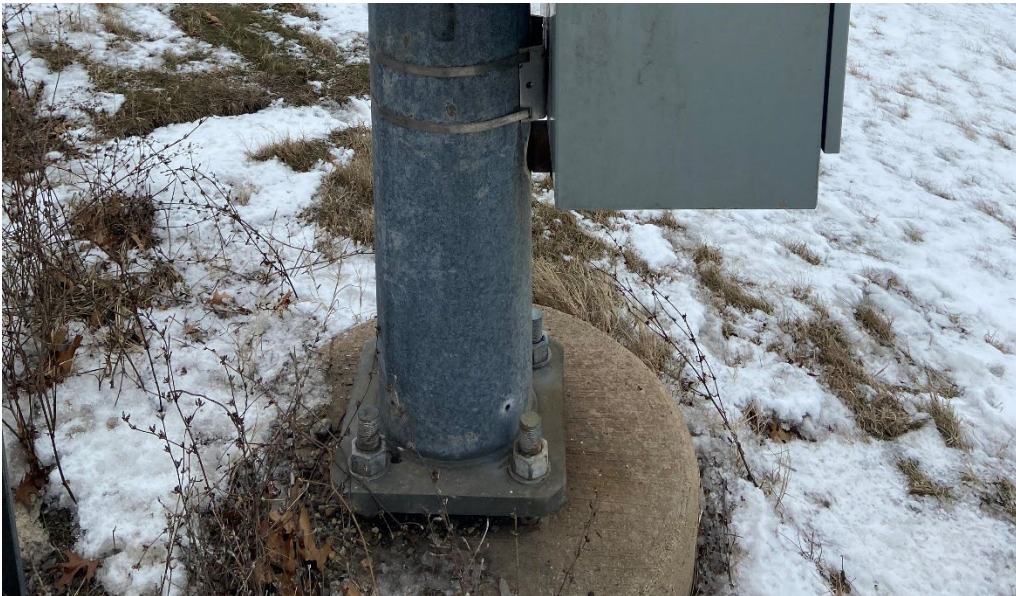
Figure 8.9.8: Mast arm base plate with four anchor bolts

The base plate is part of the anchor bolt connection but is connected to the pole with a full penetration weld and considered part of the vertical structure along with the pole and its vertical structure connections. The base plate should be checked for warping, and corrosion. Pay particular attention to the weld between the base plate and pole and look for any cracks or weld deficiencies. A crack will typically appear in the galvanizing and may or may not extend into the weld metal. Additional non-destructive testing may be required to determine the extent of any cracks.

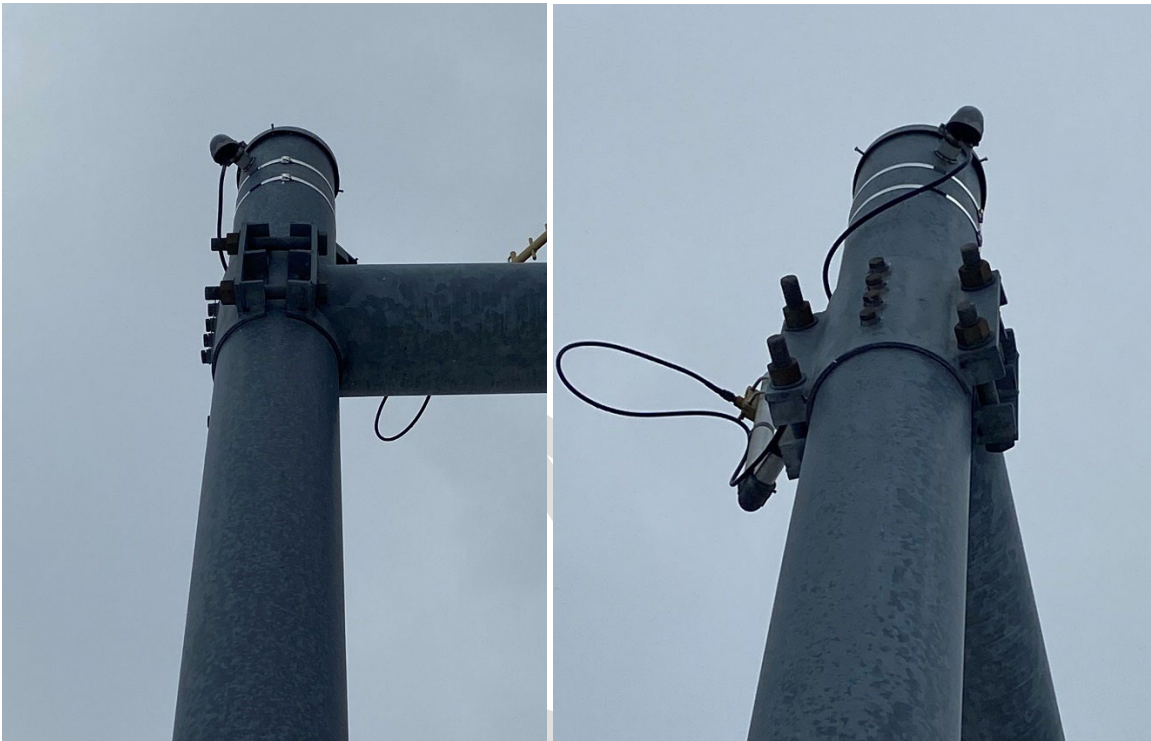
Figure 8.9.10: Mast arm to pole vertical structure connection, saddle clamp type

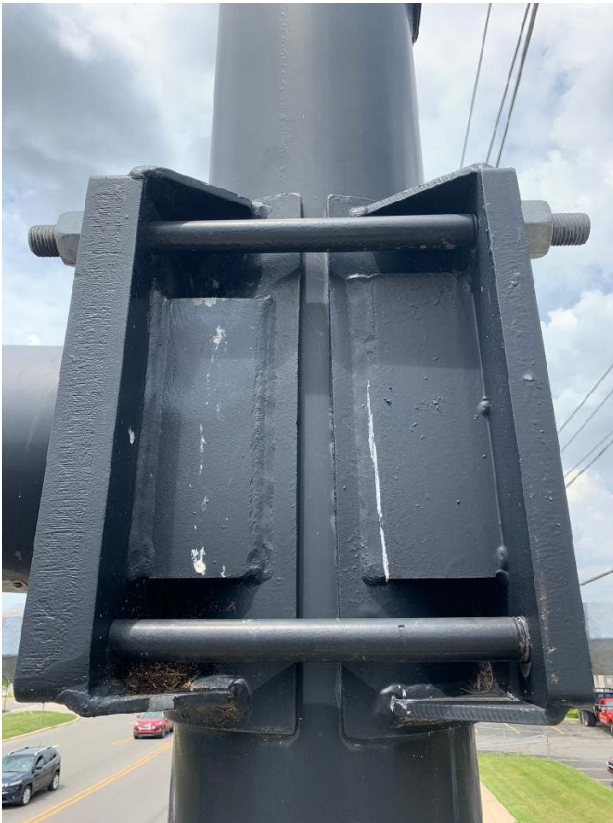
Figure 8.9.12: Mast arm vertical structure connection, note missing vertical weld on gusset plate

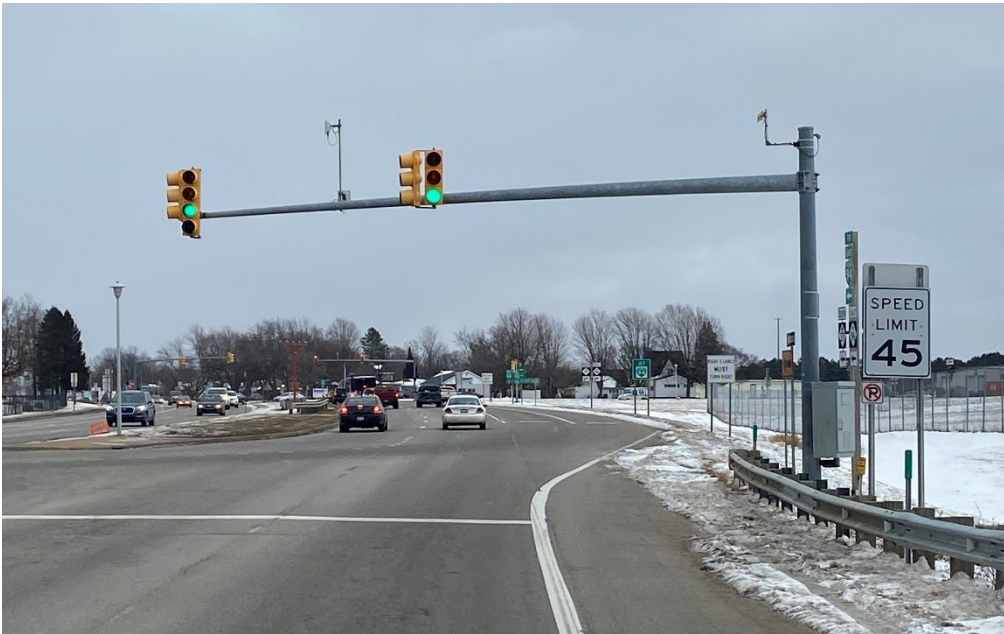
Figure 8.9.13: Mast arm structure with single arm

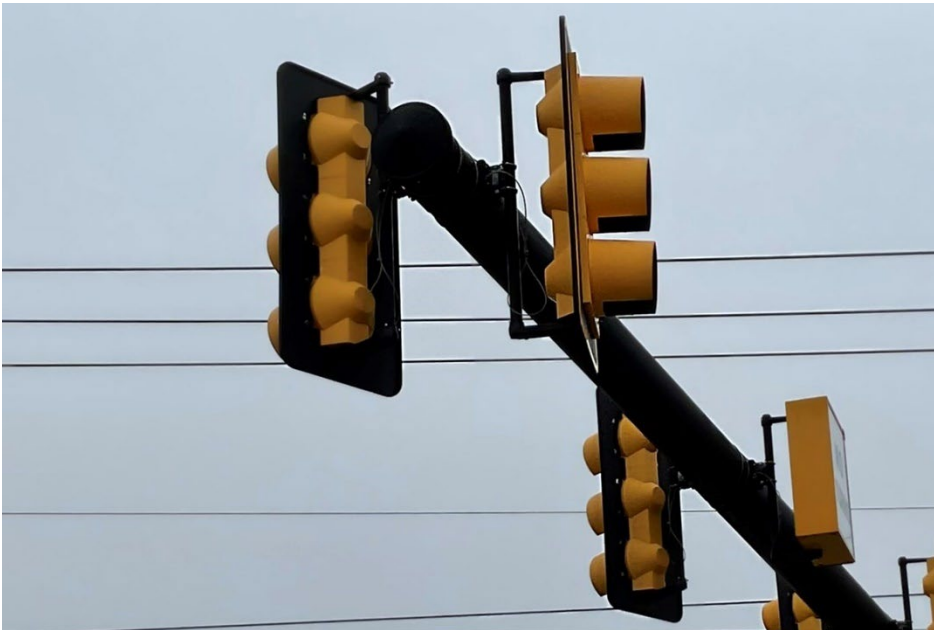
Figure 8.9.15: Mast arm signal and sign attachment connections

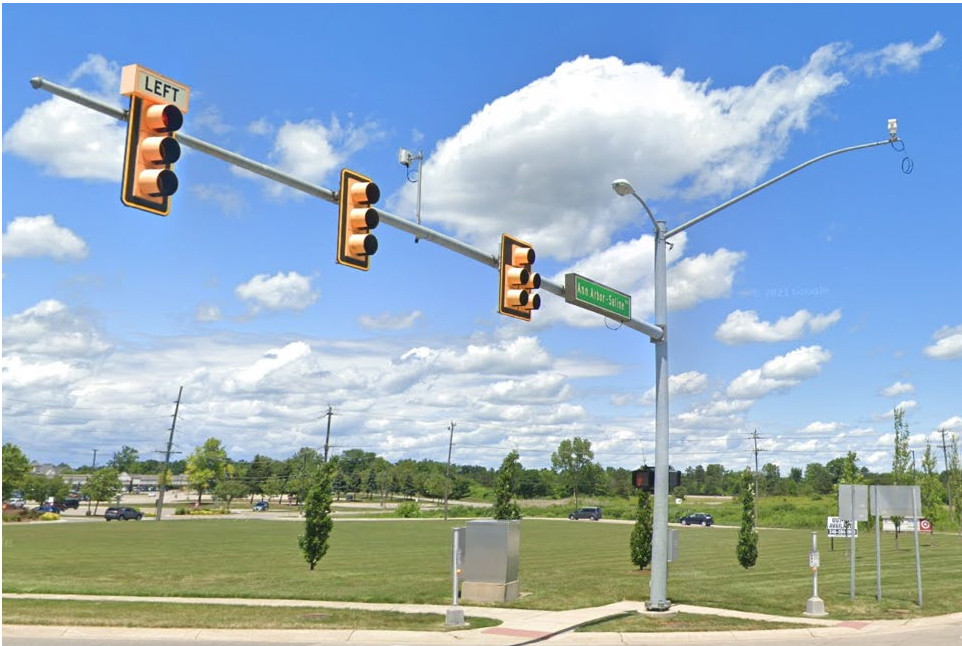
Figure 8.9.16: Mast arm structure supporting signals, sign, luminaire, camera, and sensor

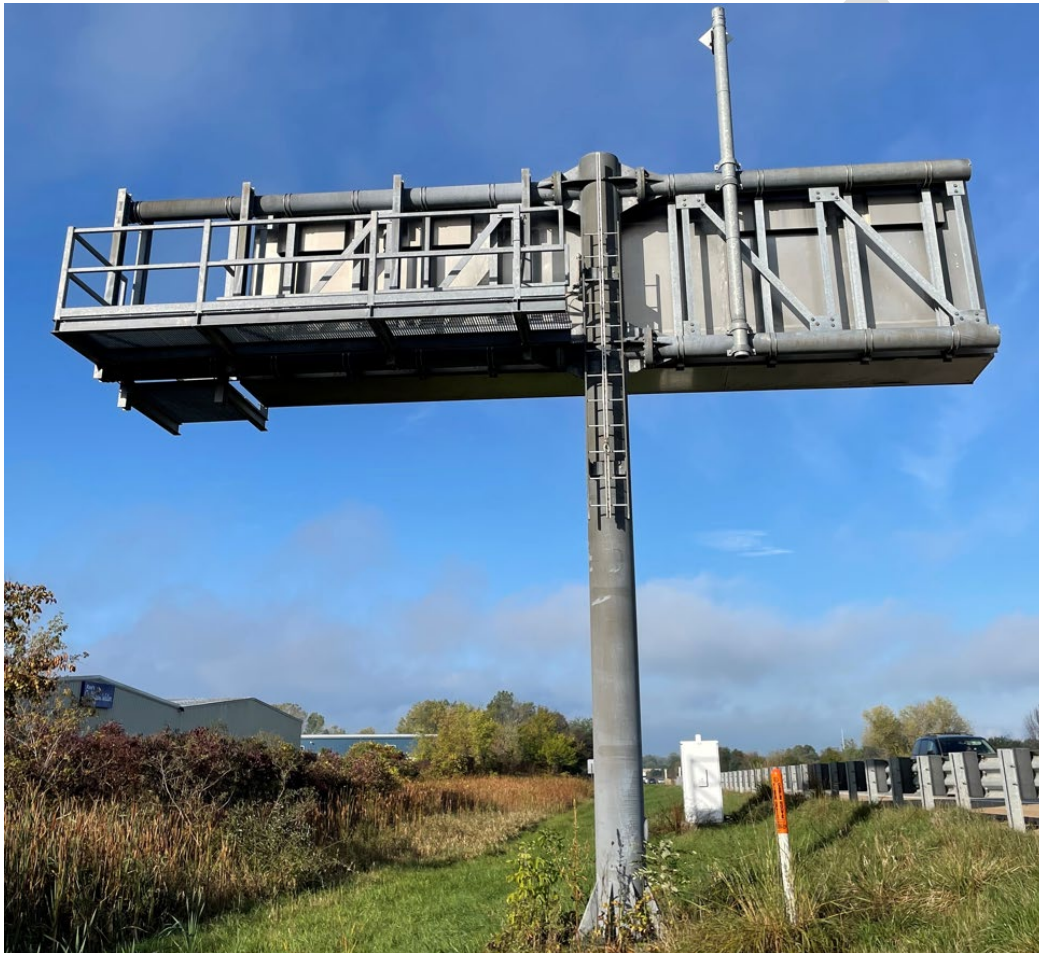
Figure 8.10.1: Dynamic Message Sign Support Structure

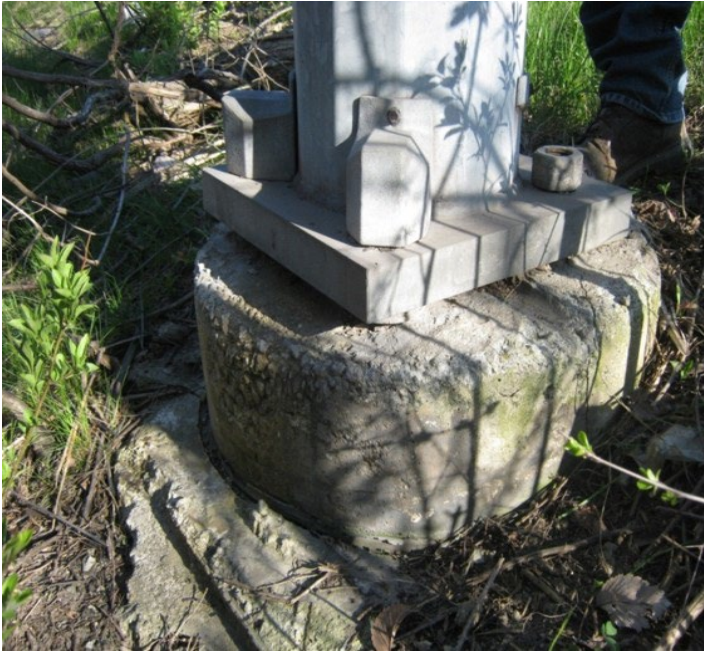
Figure 8.11.5: Non-frangible concrete foundation deterioration

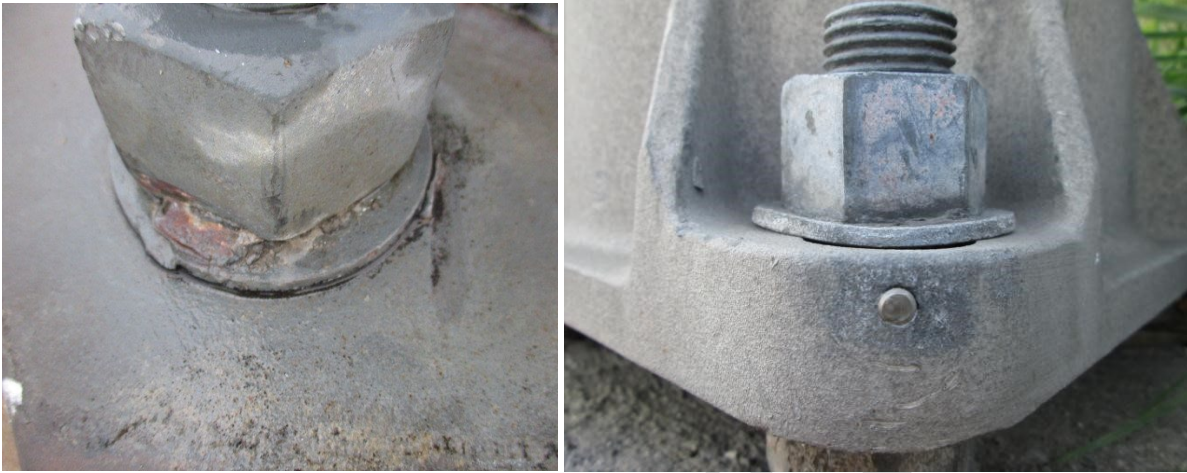
Figure 8.11.11: Anchor bolt and leveling nuts foundation, nut tack welded to washer (left), incorrect washer type – plate washers intended to cover slotted holes (right)

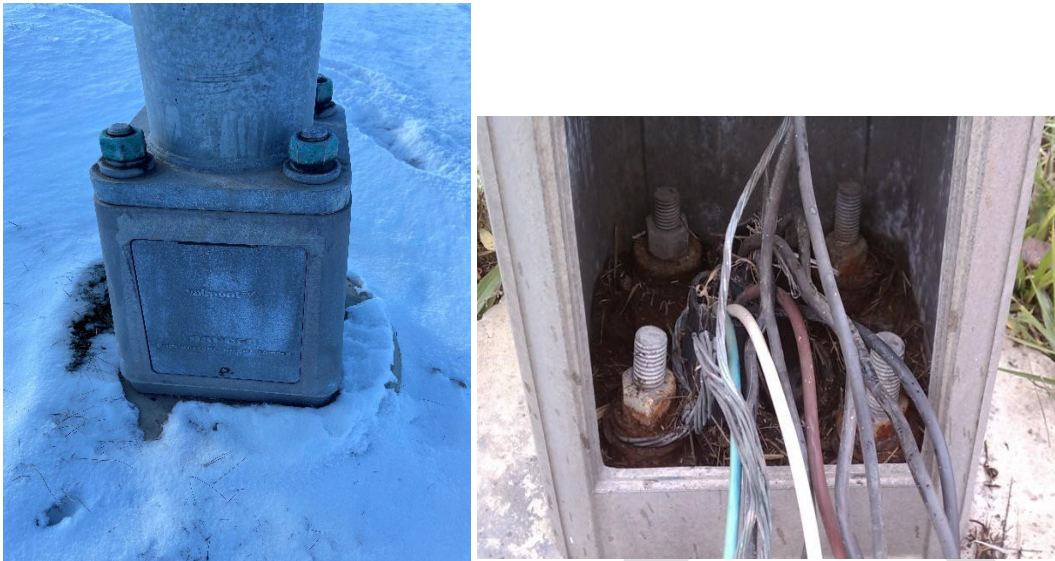
Figure 8.11.12: Frangible transformer base, panel door present (left), corrosion and debris in transformer base interior with missing panel door, and exposed wires (right)

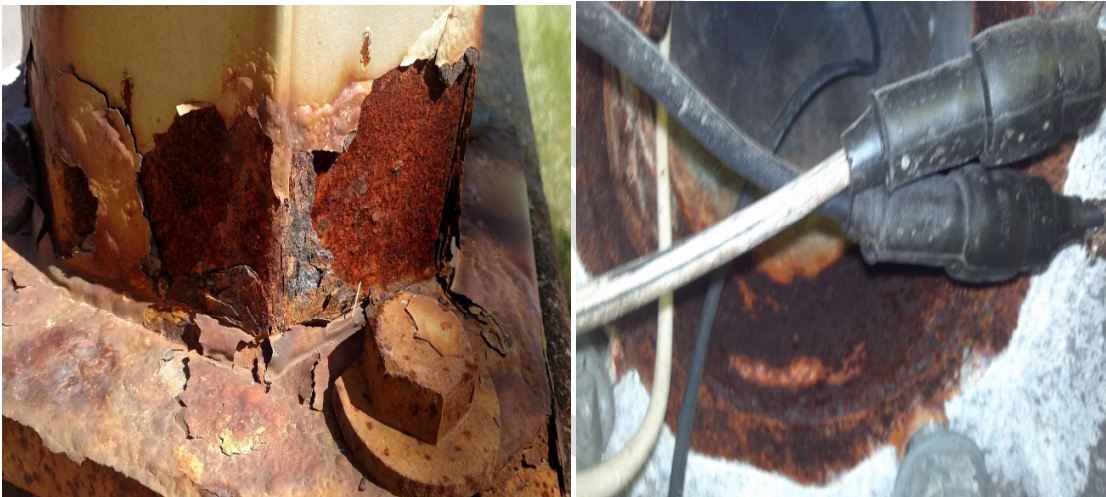
Figure 8.11.17: Non-frangible pole structure vertical support column (upright), coating system failure and corrosion in upright at base weld (left), corrosion inside column (right)
