MIASM UPDATE – SEPTEMBER 2023

MICHIGAN ANCILLARY STRUCTURE INSPECTION MANUAL (MiASIM)

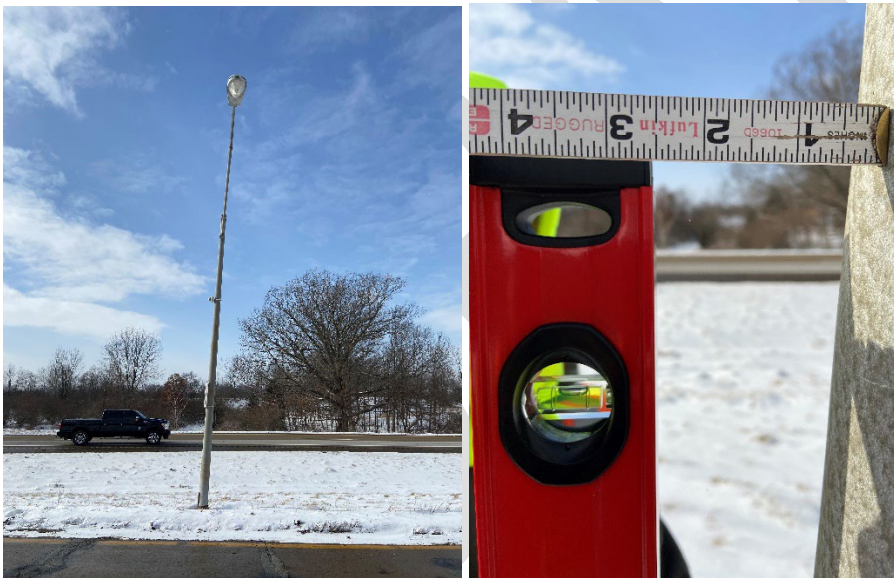
Figure 8.11.20: Non-frangible pole structure vertical support column (upright), visual identification of out of plumb pole (left), measurement of pole plumbness (right)

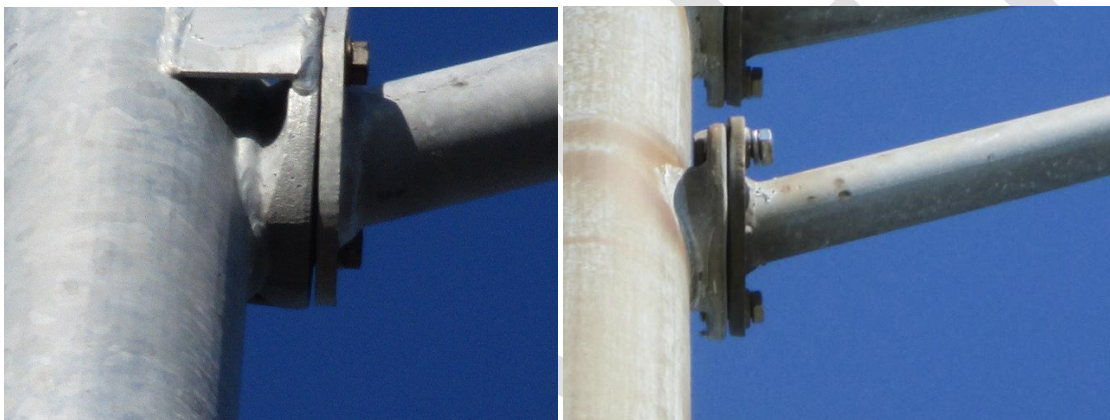
Figure 8.11.21: Frangible and non-frangible pole structure vertical structure connections, gap at arm flange (left), loose arm connection bolt (right)

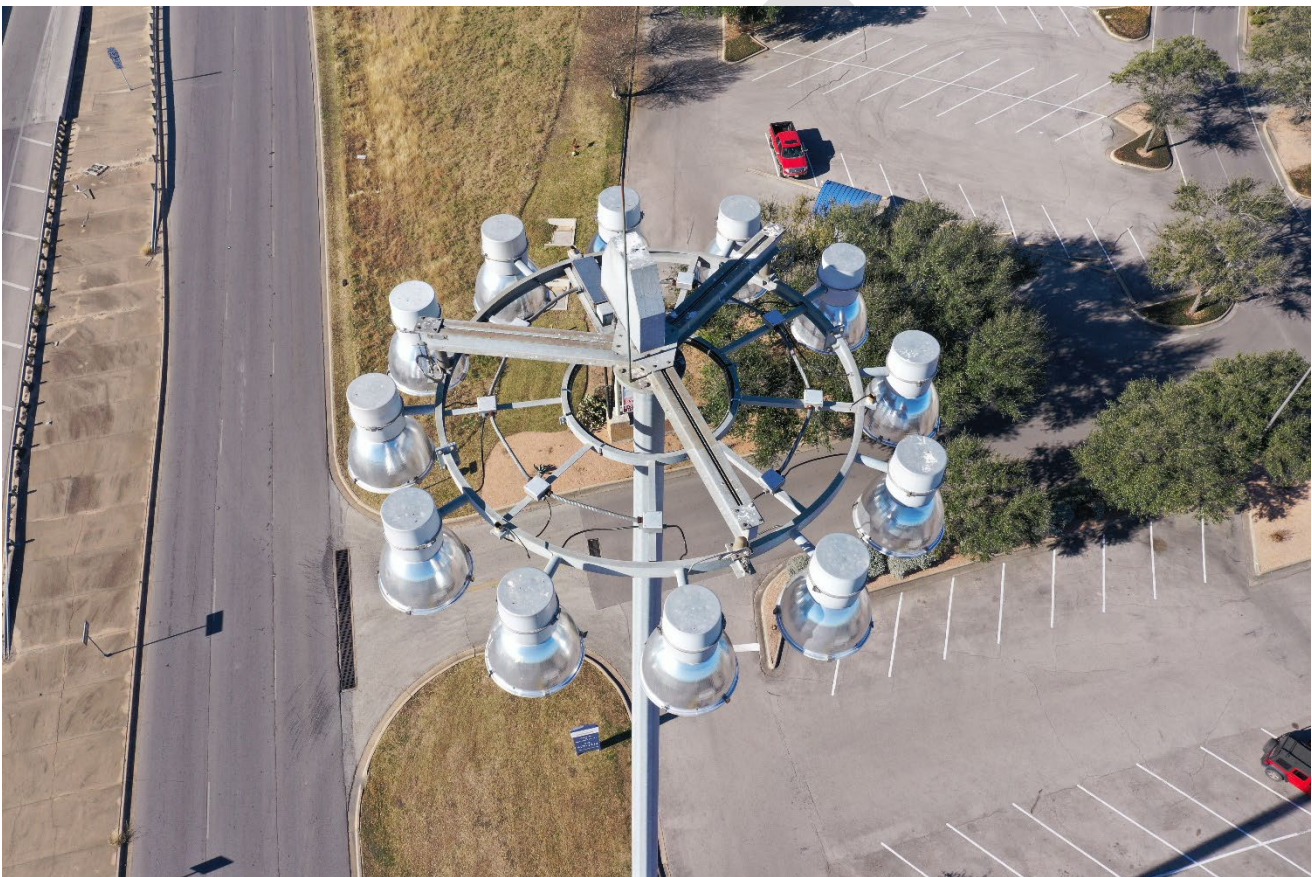
Figure 8.12.1: High-Mast Lighting Tower, aerial view of tower and lighting array from UAS

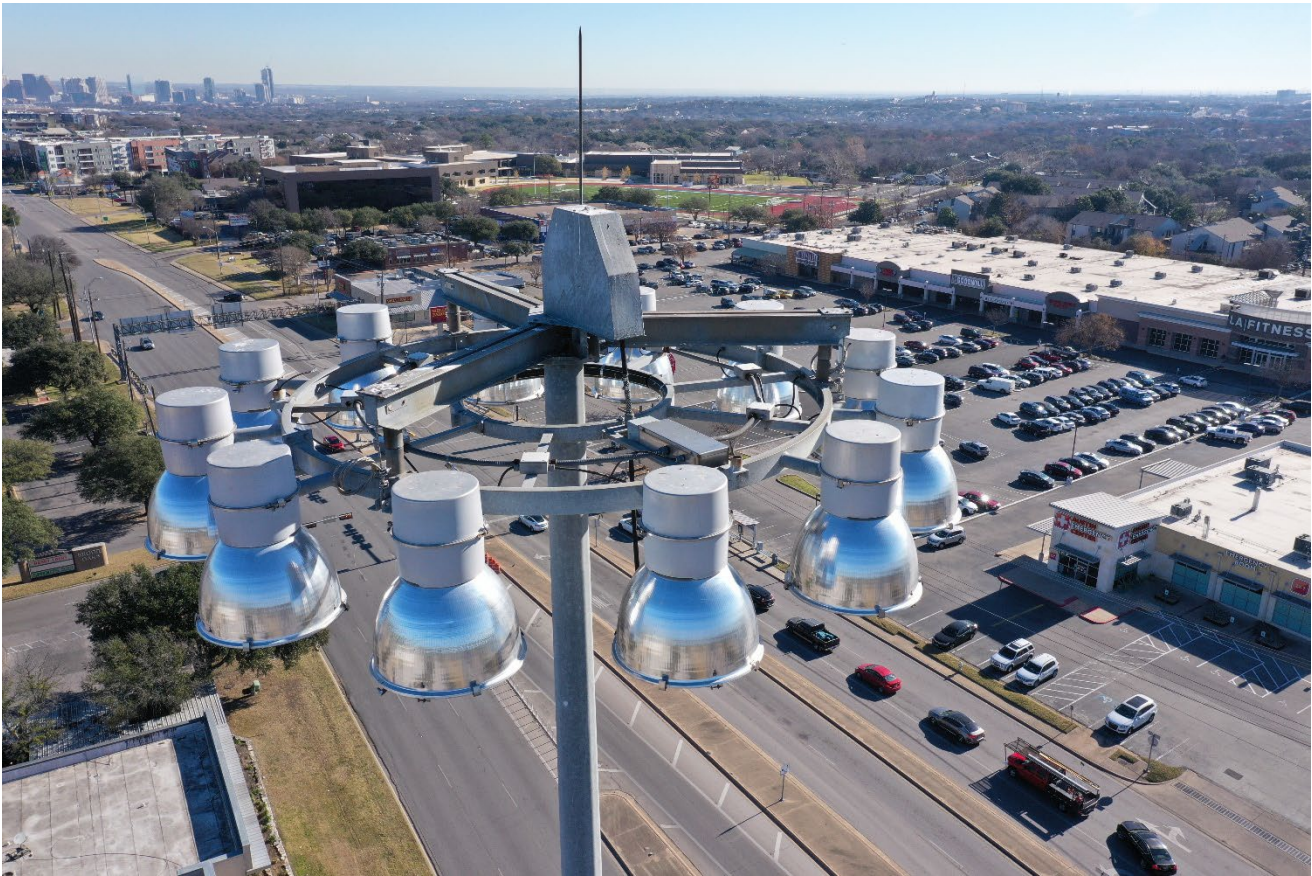
Figure 8.12.7: HMLT lighting array, as seen from a UAS

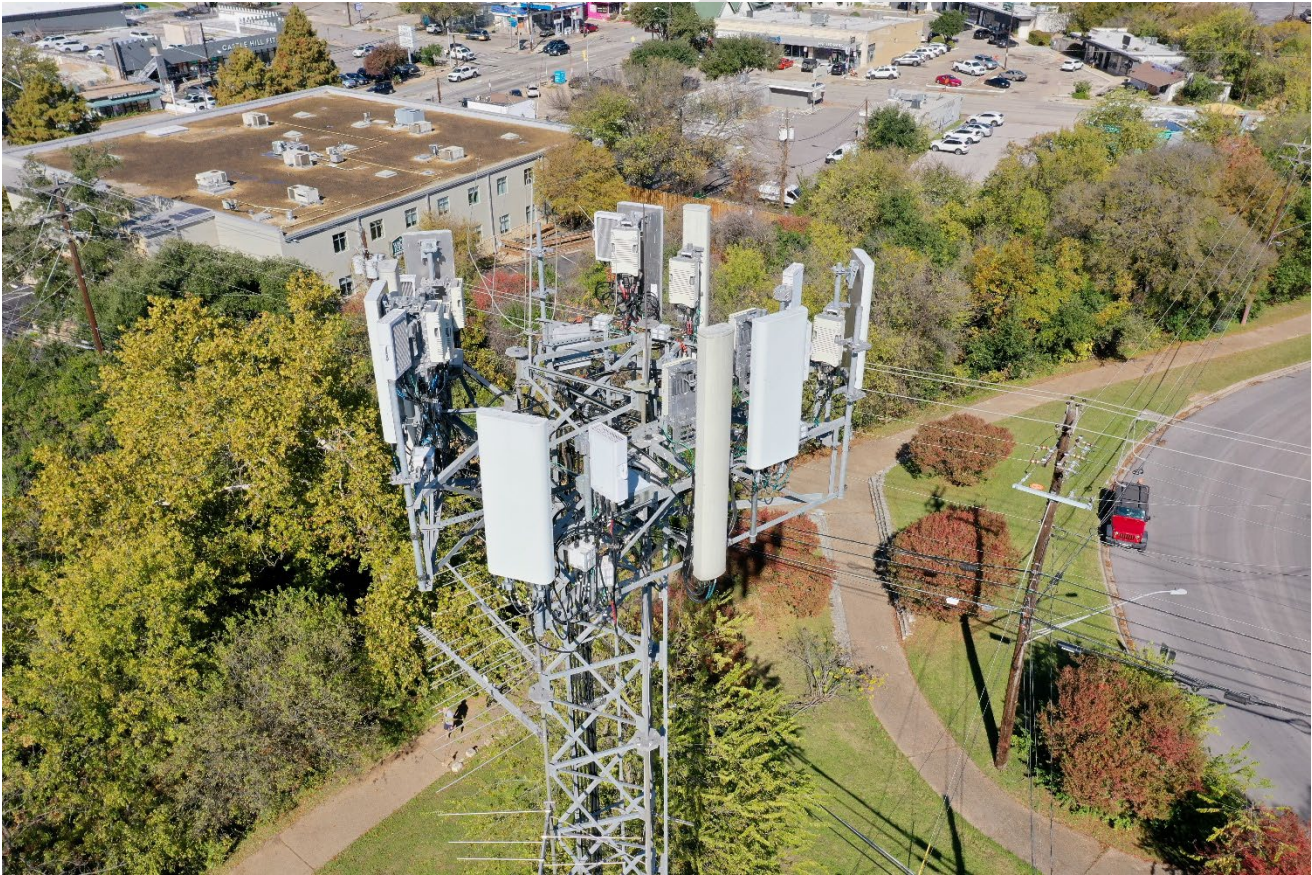
Figure 8.13.1: Communication Tower, aerial view from UAS

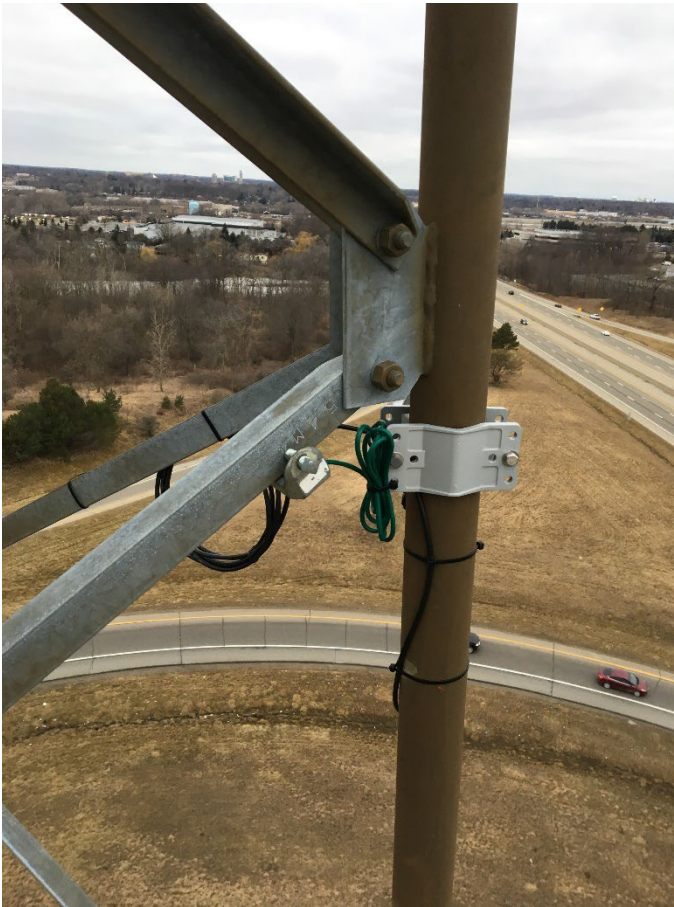
Figure 8.13.5: Bracing showing vertical structure bolted connection to vertical support

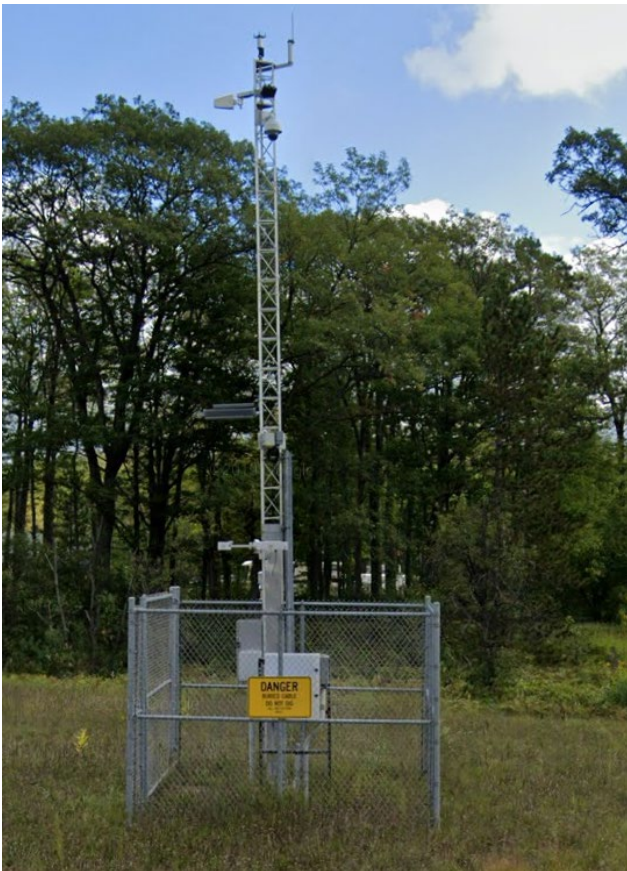
Figure 8.14.1: ESS Tower

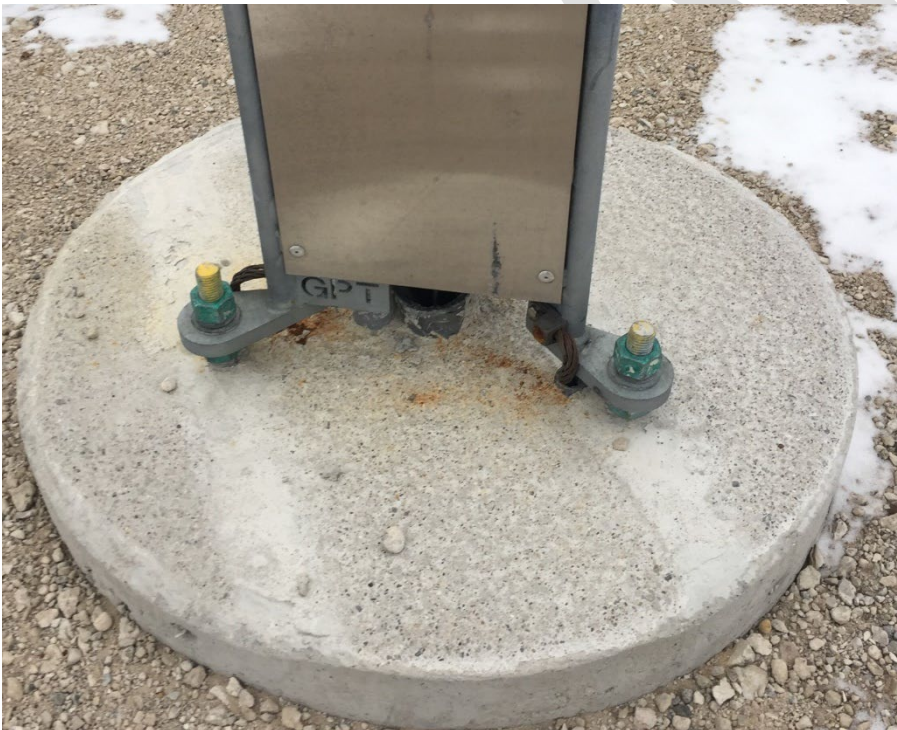
Figure 8.14.4: ESS tower foundation with triangular anchor bolt pattern

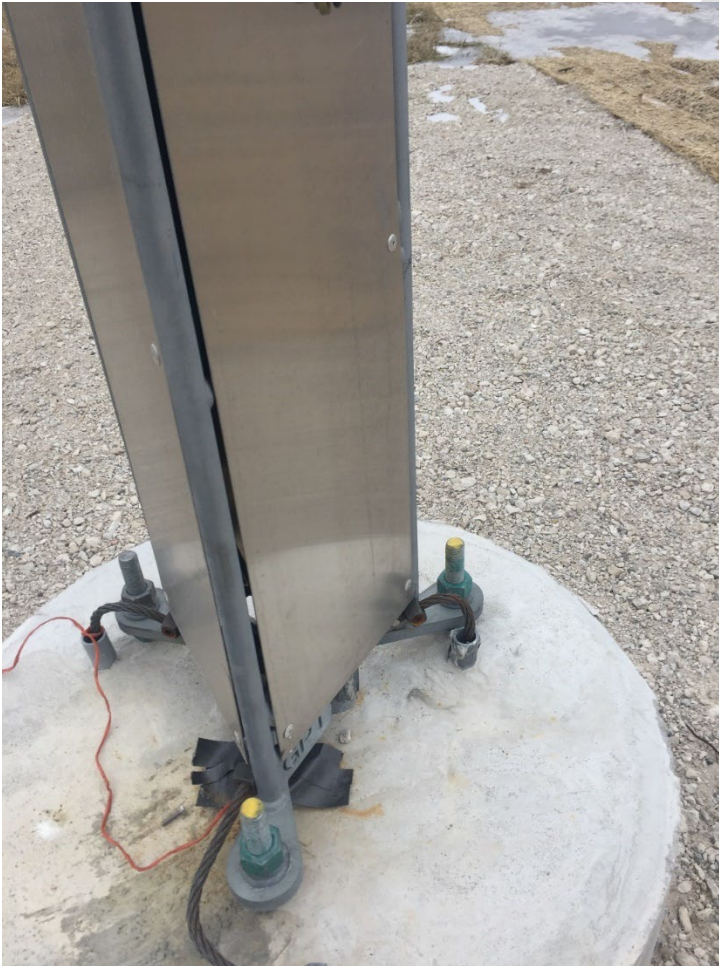
Figure 8.14.5: ESS tower base plate

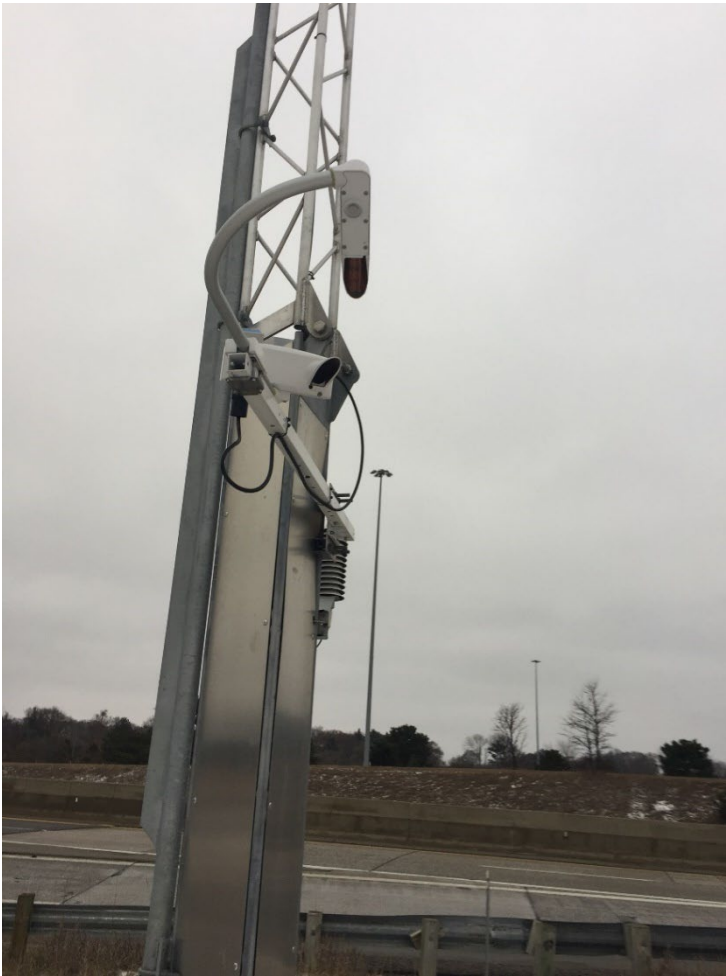
Figure 8.14.6: ESS tower vertical support column with ITS attachments

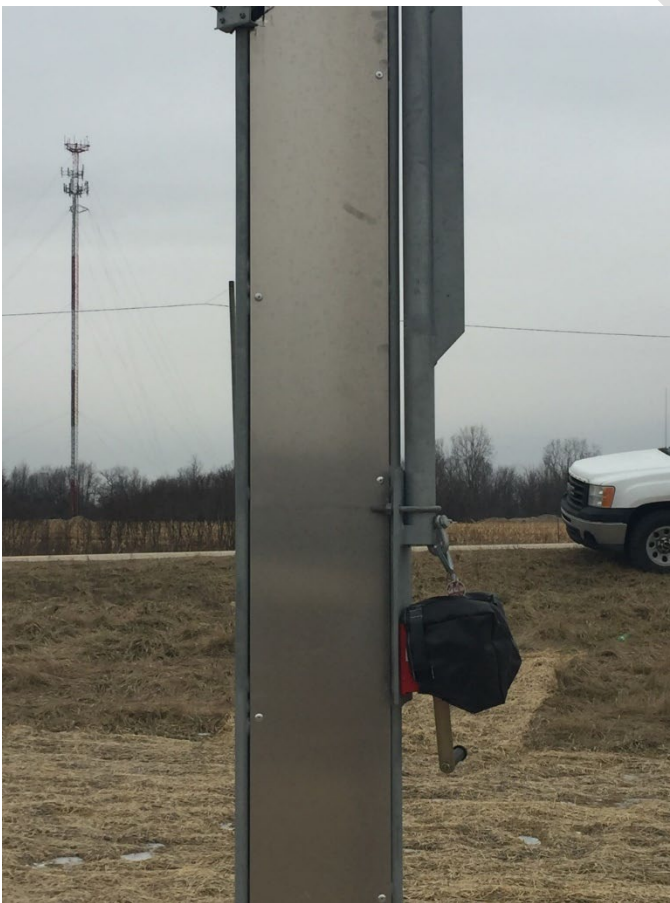
Figure 8.14.7: ESS tower lowering boom element

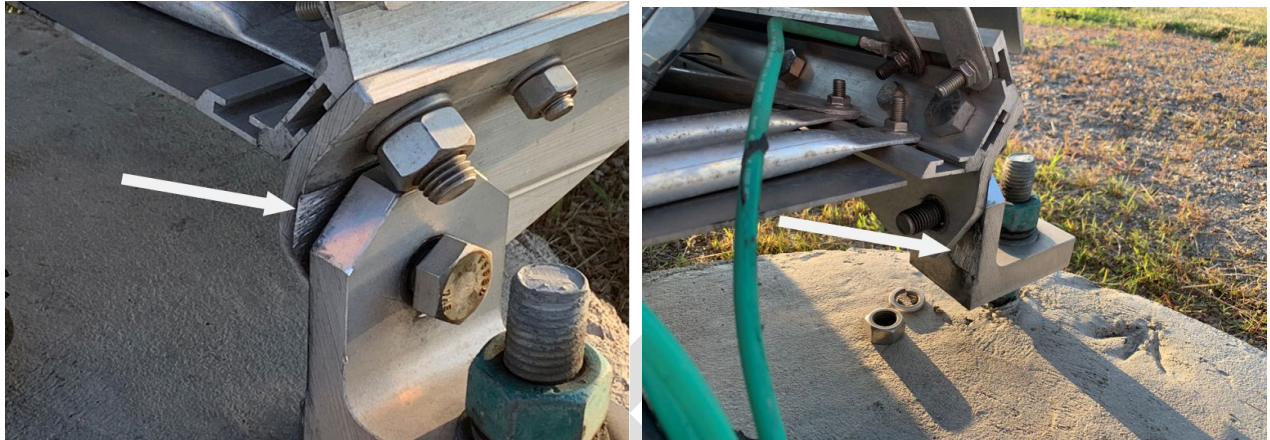
Figure 8.14.8: Evidence of wear on metal due to oscillation along with loose connection
