Vehicle Collision
Avoidance System Pilot

Using Technology to Improve Vehicle Safety

Bay Area Transportation Authority

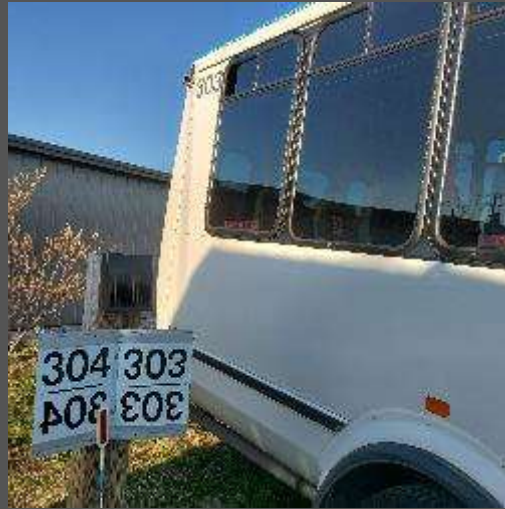
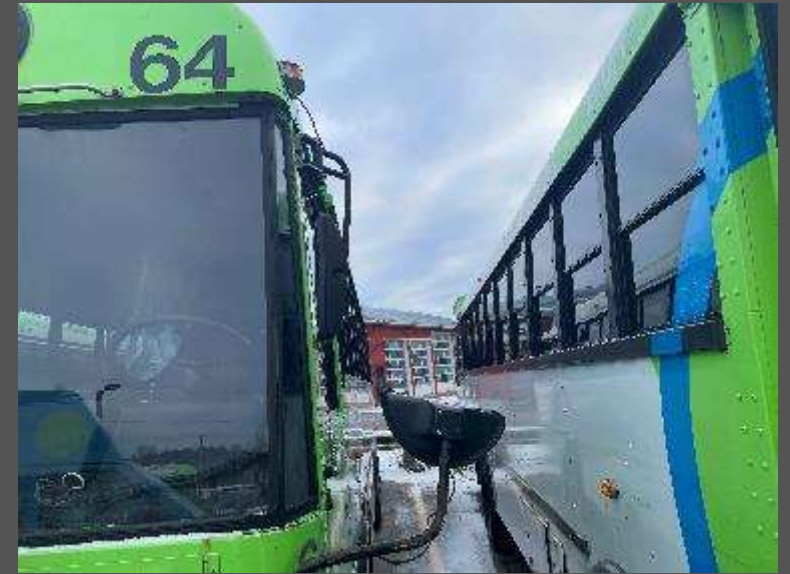
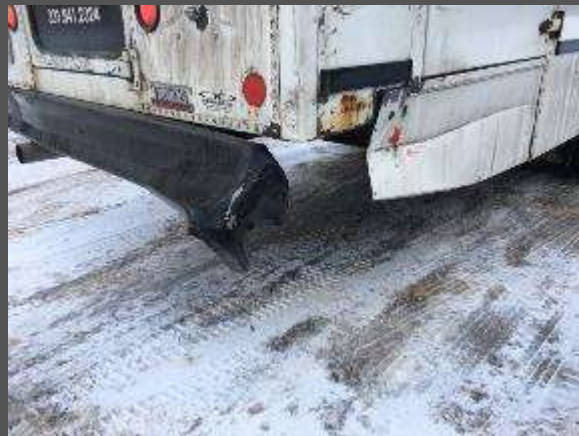
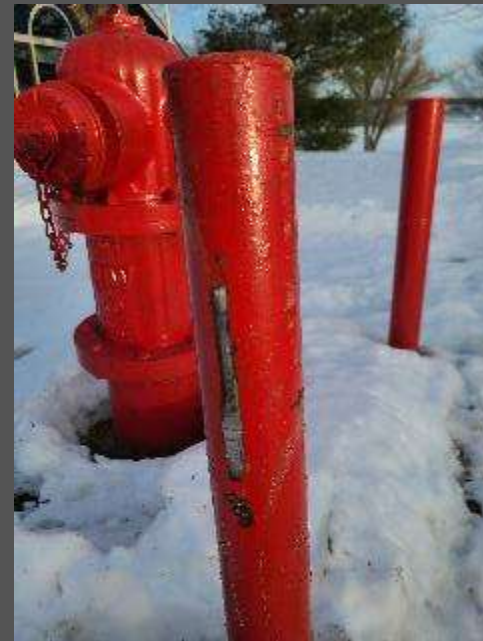
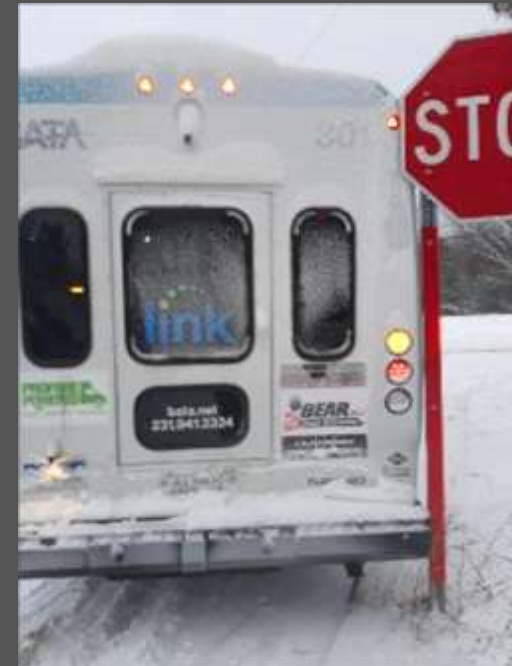
Challenge : Reduce Vehicle Impacts

Tail swipes

Backings

Bike racks

Property damage (bollards, trees, signs)

Mirrors

- ▶ The reason this type of technology was pursued is that a disproportionate amount of BATA's safety incidents were occurring at low speeds, on agency properties, and were often tied back to driver distraction and spatial awareness. Rear-ending and side swipe collisions were also common. Collisions were predominately with fixed objects, such as low overhangs and branches, parked cars, bike racks, bollards, signs, and mailboxes.

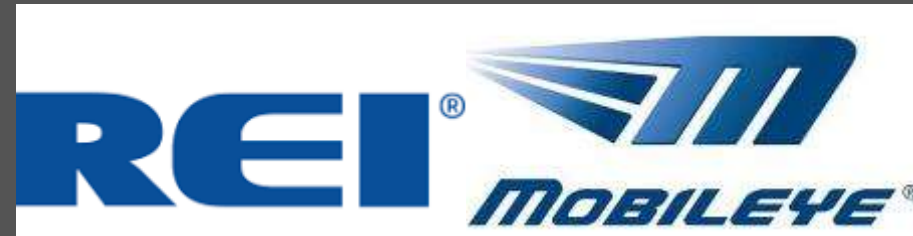
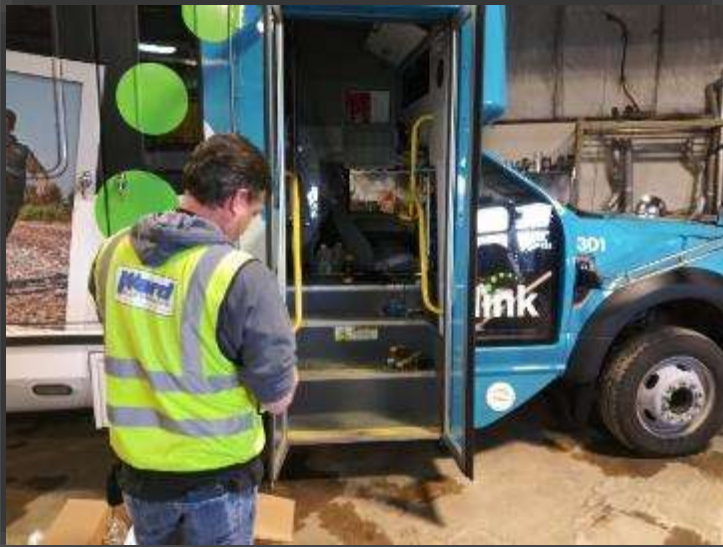
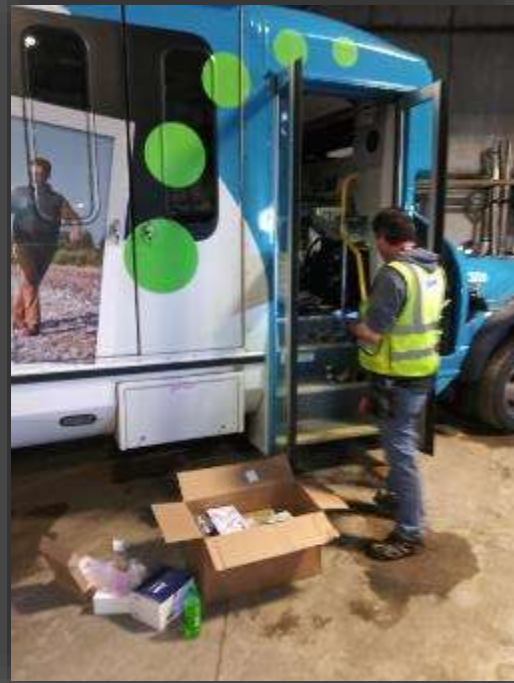
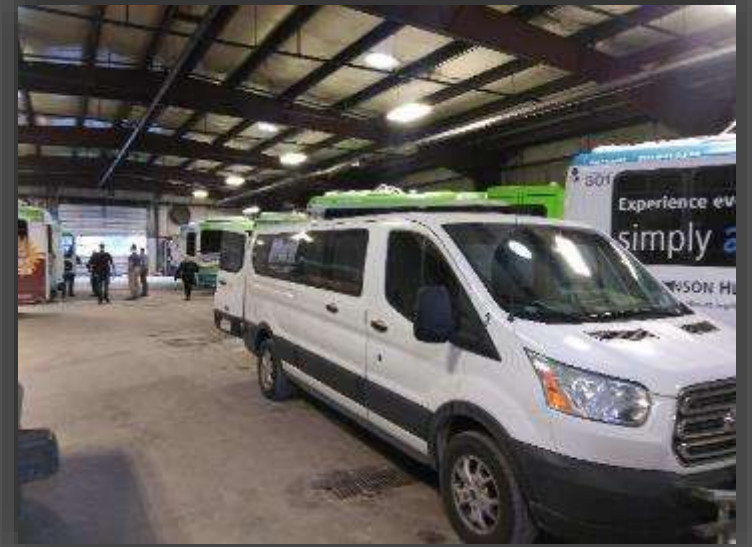
- ▶ Selected REI / Mobileye - Technology integration, additional features beyond collision avoidance, 360-degree camera, rearview camera, good training program and installation plan, flexibility to work around vehicle specification (aka bike rack), Armor capabilities
- ▶ Sensors and devices were installed on 25 vehicles (Ford E-450s and F-550s) in BATA's fleet to enable:
 - ▶ Forward Collision Warnings
 - ▶ Headway Monitoring and Warnings
 - ▶ Pedestrian and Cyclist Warnings
 - ▶ Lane Departure Warnings
 - ▶ Speed Limit Indicator
 - ▶ Audible alerts were made available for the front of the vehicle and a 360-degree camera system can provide visual feedback of objects around the vehicle.

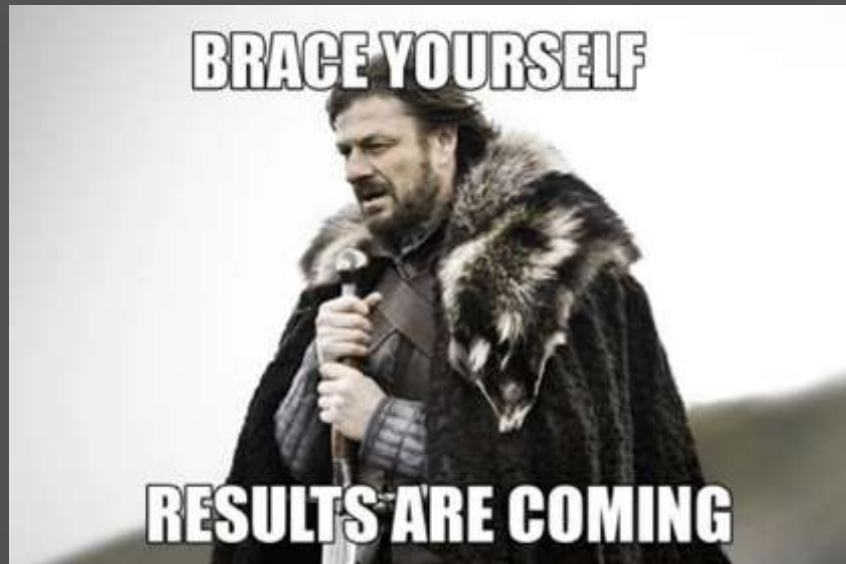
Findings / Results

2018	2019	2020	2021	2021 (equipped vehicles)	Total
Preventable						
Parking (IV)	6	21	3	5	2	35
Sideswipe (IV)	6	12	12	1	1	31
Backing (IV)	6	9	6	5	2	26
Intersection (IV)	3	3	1	4	2	11
Fixed Object (IV)		5	1			6
Tailswing (IV)	3	3				6
Rear end (IV)	4		1			5
Overhead Obstruction (IV)	1	3				4
Curb jump (IV)			2			2
Sideswipe (IV)	2					2
Non-Preventable						
Intersection (OV)	4	5	3	3	2	15
Rear end (OV)	4	4	3			11
Deerstrike	3	2	3			8
Sideswipe (OV)	1	4	3			8
Backing (OV)	1	1	5			7
Backing (IV)		1	1			2
Parking (IV)		2				2
Sideswipe (IV)	1	1				2

- ▶ The most common types of preventable crashes continue to be parking, sideswipe, and backing, and the most common types of non-preventable crashes tend to be intersection and rear-end.

- ▶ Sideswipes have also become less common.
- ▶ Drivers don't always choose to use the system, and often to their detriment – two of the backing collisions that have occurred in 2021 had the system installed, and if they had been using the video monitor they may have seen the object they were about to back into.

- ▶ Two of the parking collisions that also had the system installed occurred when a vehicle was traveling backwards into a tight space, which could've also been prevented if they had been using the system.
