## **Appendix A**

# **Preliminary Assessment Documentation**

## APPENDIX C – Photographic Log

Army National Guard, Preliminary Assessment for PFAS	Camp Grayling	Grayling, Michigan
--	---------------	--------------------

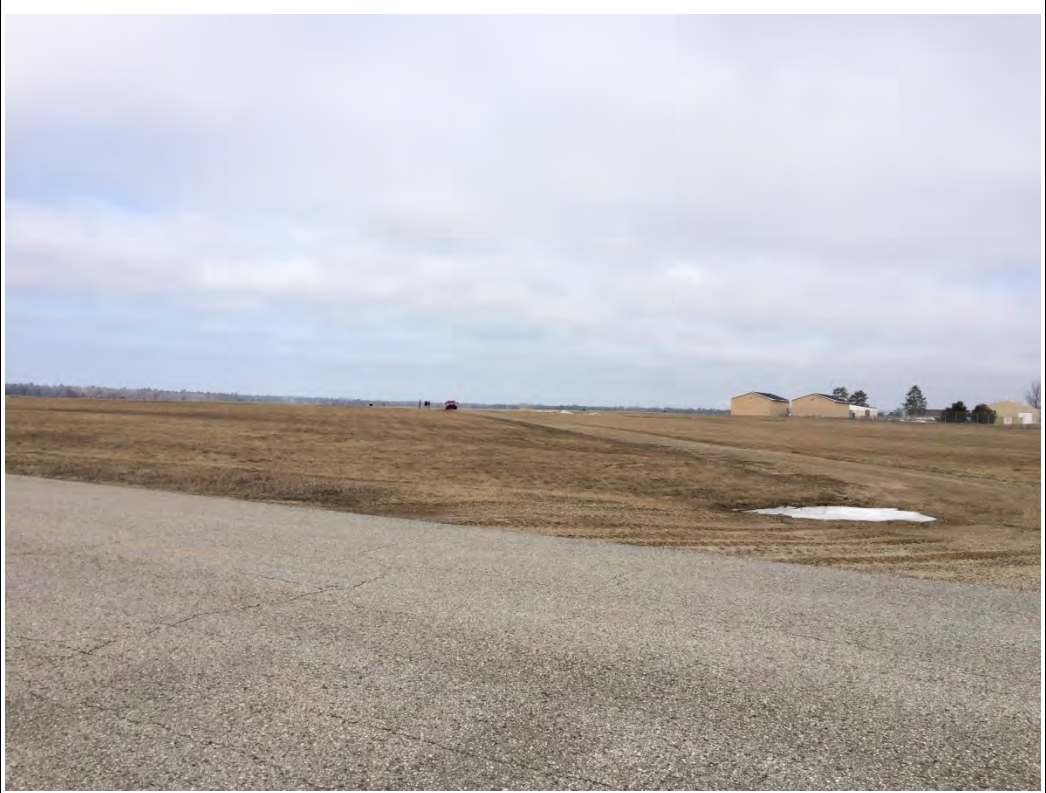
Area of interest (AOI) 1:  
Grayling Army Airfield  
(GAAF); Standing on  
southern access road facing  
north towards the firefighting  
training area and Runway 32.  
Snow in foreground.

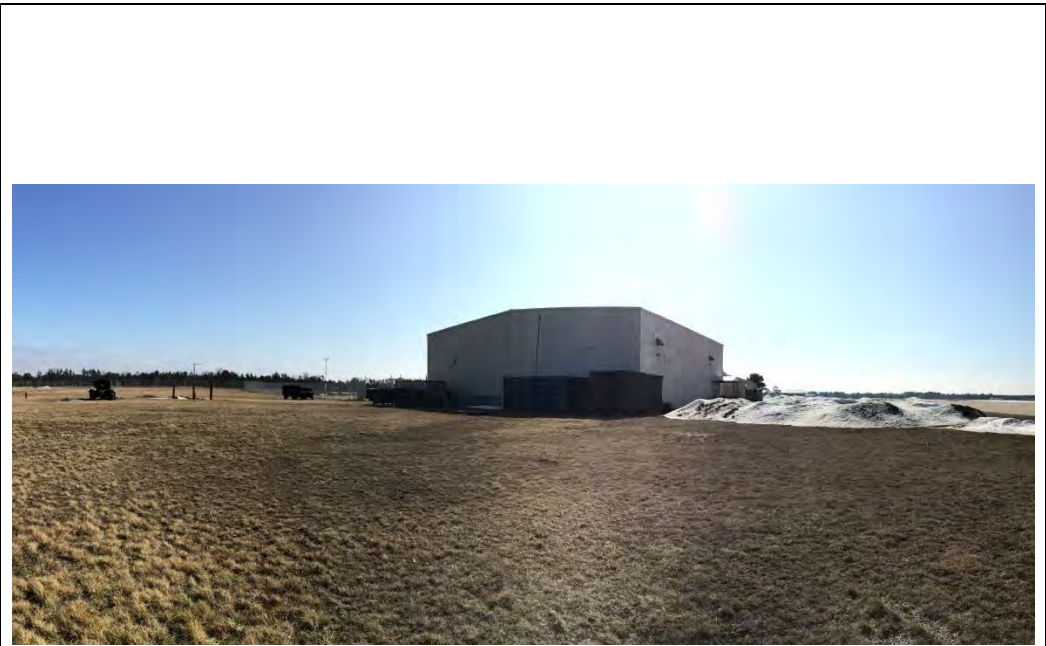
### Photograph No. 2

AOI1: GAAF; Standing on  
northern side of Building 1194  
facing southeast towards  
AOI1. Snow piles on right  
side of photograph. Leaking  
fire trucks were routinely  
parked near Building 1194.

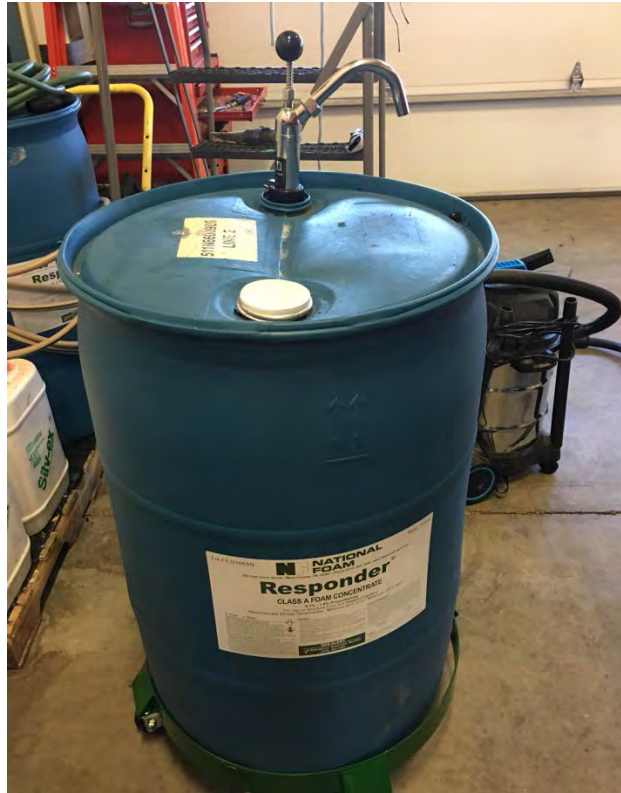
Camp Grayling Fire Department (at GAAF): Class A firefighting foam concentrate stored in the Camp Grayling Fire Department building.

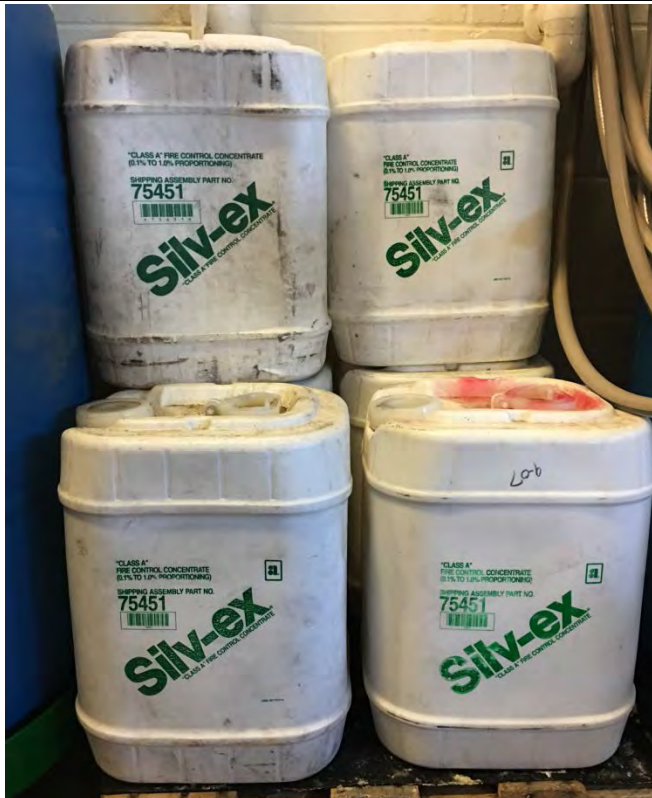
### Photograph No. 4

Camp Grayling Fire Department (at GAAF): Class A firefighting foam concentrate stored in the Camp Grayling Fire Department building.

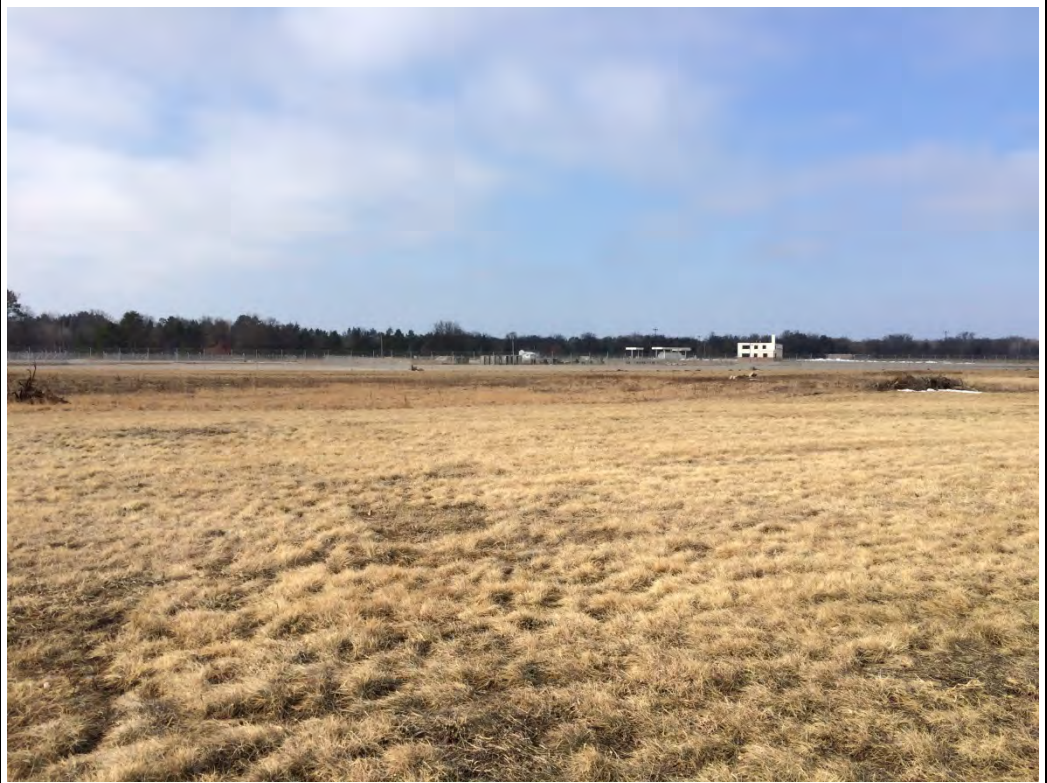
AOI2: GAAF; standing within AOI2 on west side of the southern portion of Runway 32, facing vehicle maintenance Building 1100 (former MATES; AOI3).

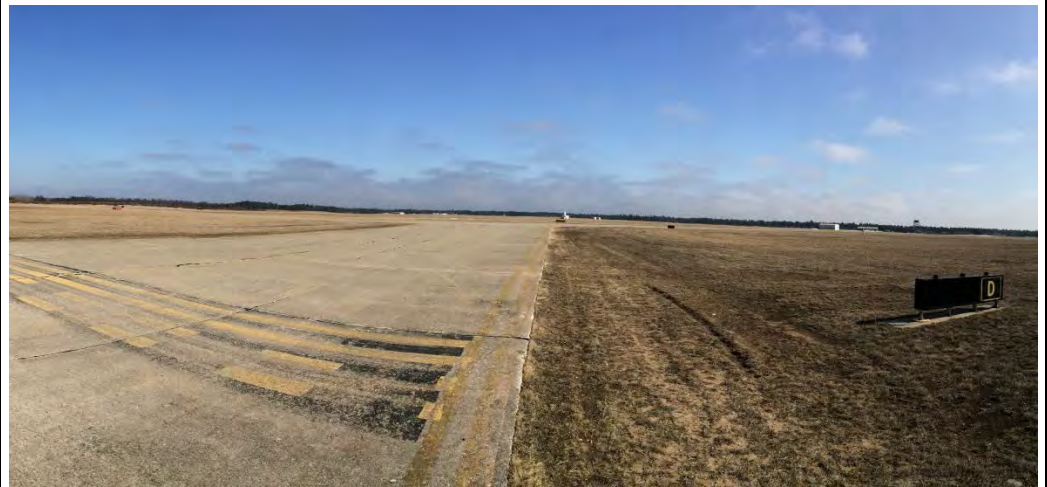
### Photograph No. 6

AOI4: GAAF; Standing at intersection of Runway 32 and 23, looking northeast. Former fire training area

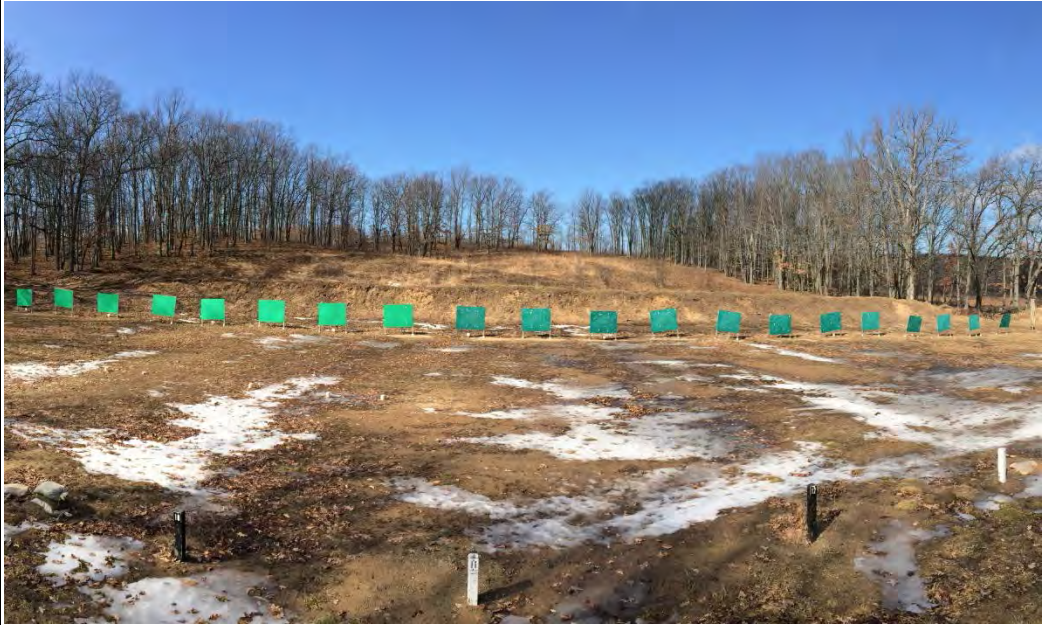
### Photograph No. 7

**Description:**  
AOI1: South Post, Small Arms Range 3A Complex. Standing on southern end of range facing northwest. Snow seen on range floor.

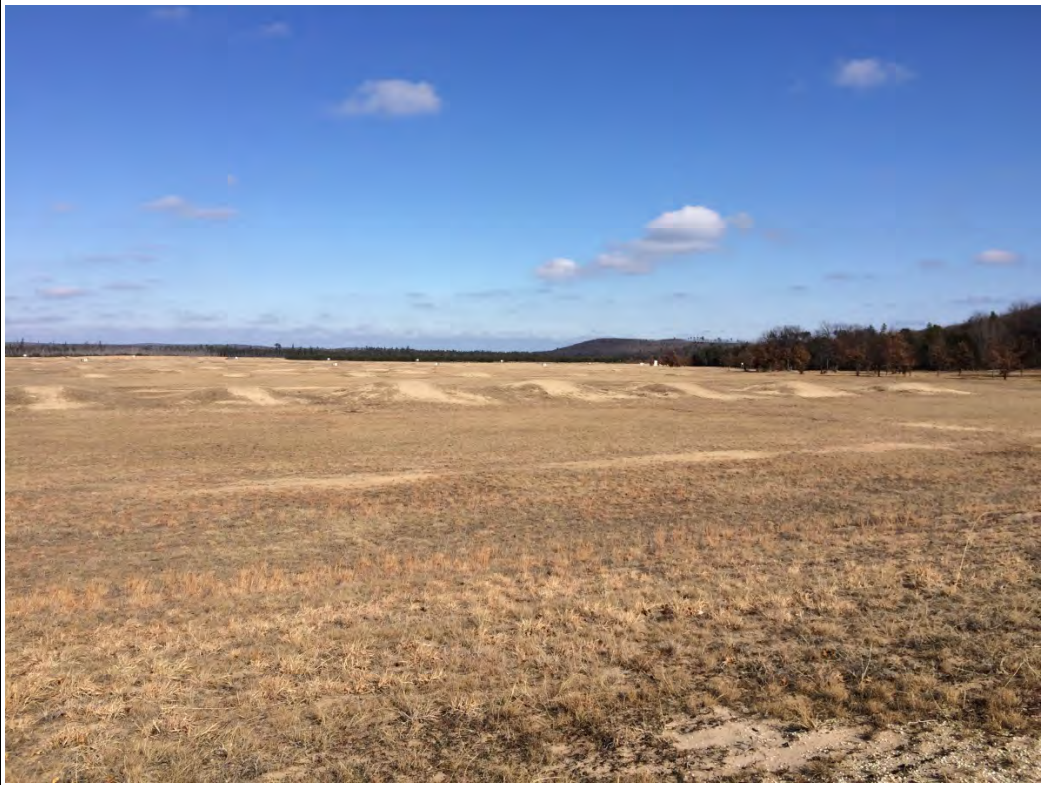
### Photograph No. 8

**Description:**  
AOI10: Range 8 – Multipurpose Machine Gun Range. Standing at firing line looking north-northeast.

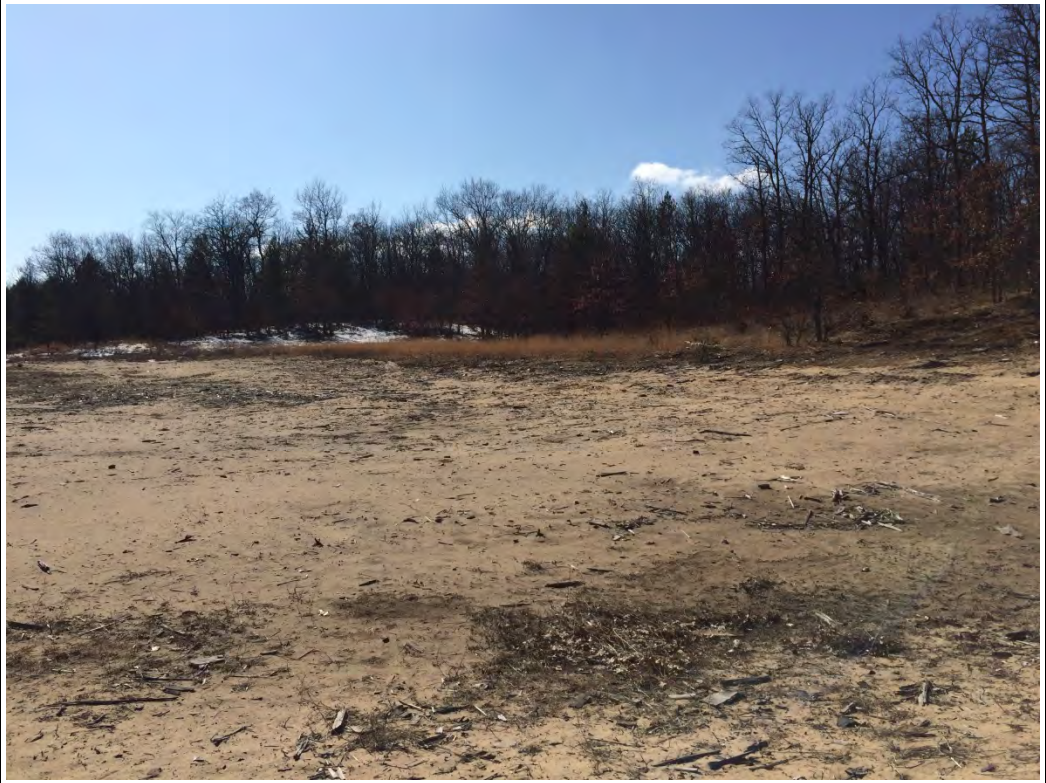
### Photograph No. 9

AOI12: Range 20 – light demolitions range. Range 21 not accessible due to icy roads. Standing on northeast end facing southwest towards range floor.

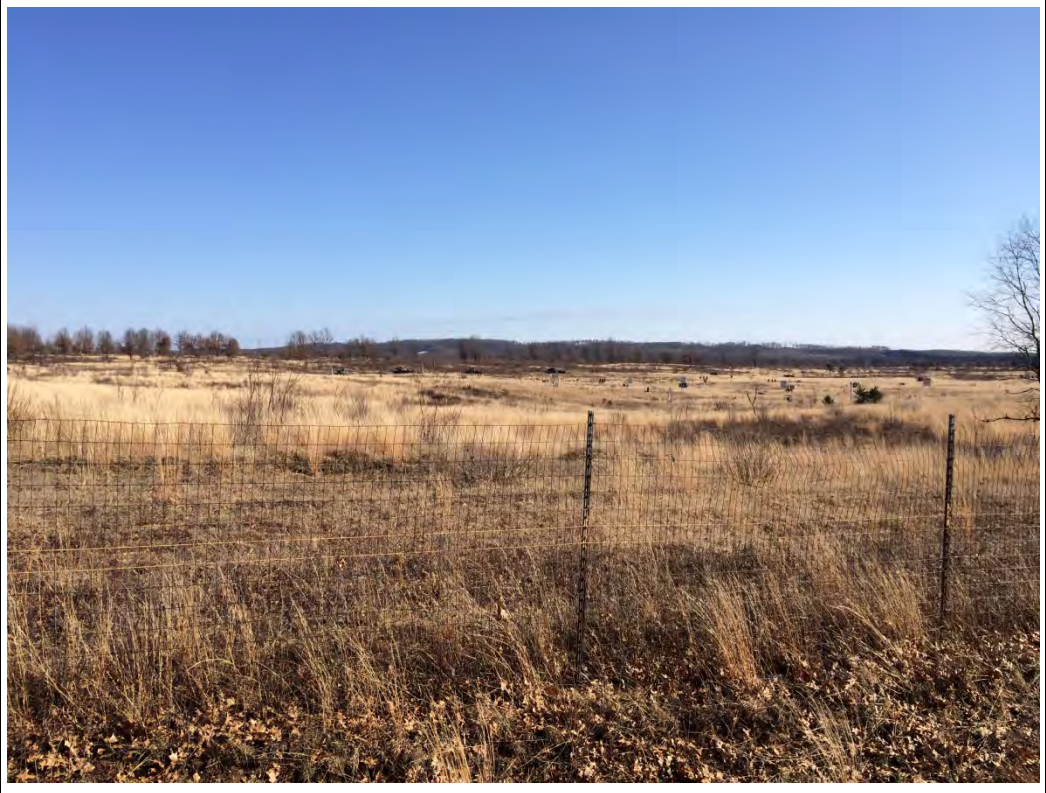
### Photograph No. 10

AOI13: Range 15. Standing on northwest end facing southeast towards range. Fence seen in foreground.

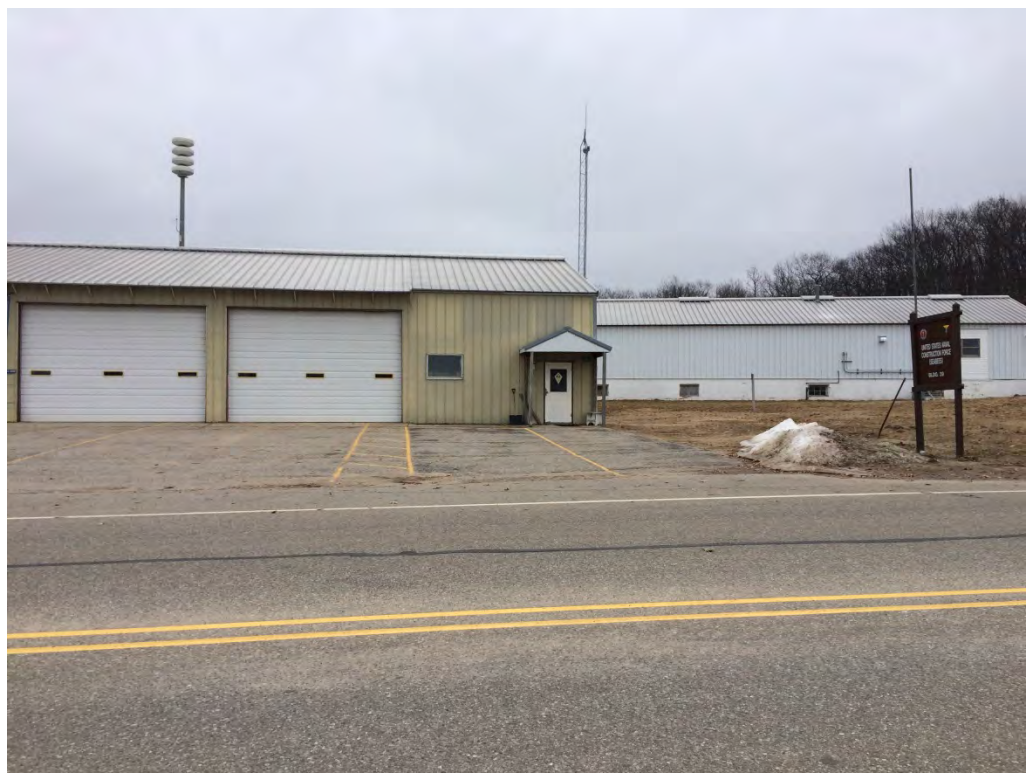
AOI14: Building 39 – Former Fire Barn. Standing on Howe Road facing east.

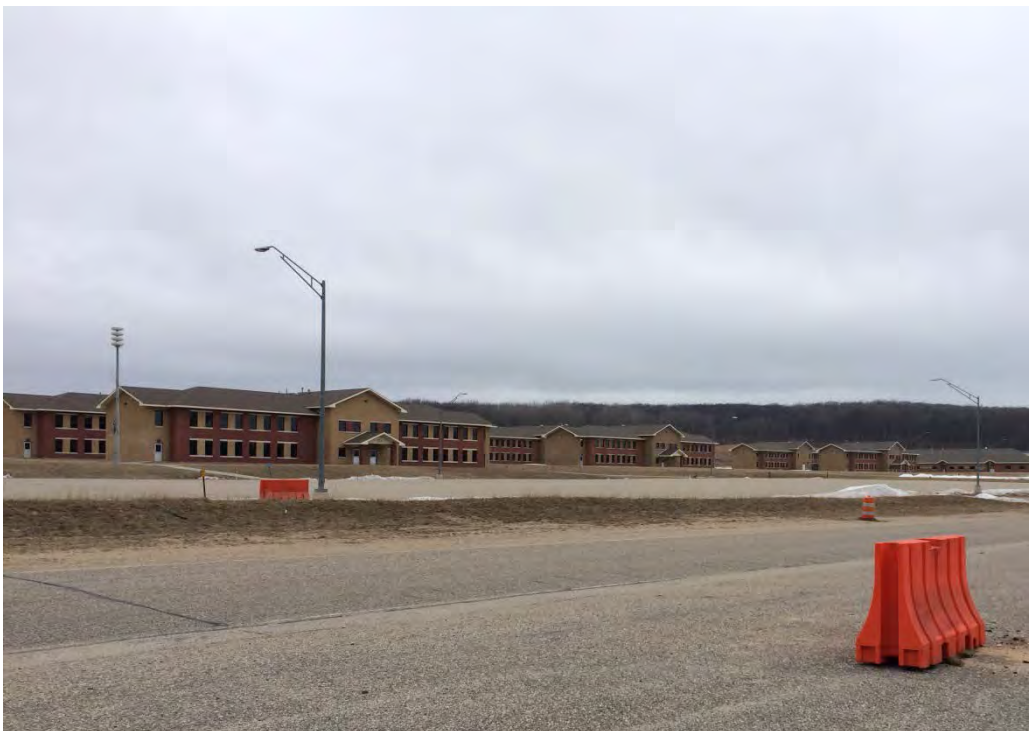
### Photograph No. 12

AOI15: Building 600 area. Standing on east side of 8<sup>th</sup> Street facing northwest towards Building 600 area.

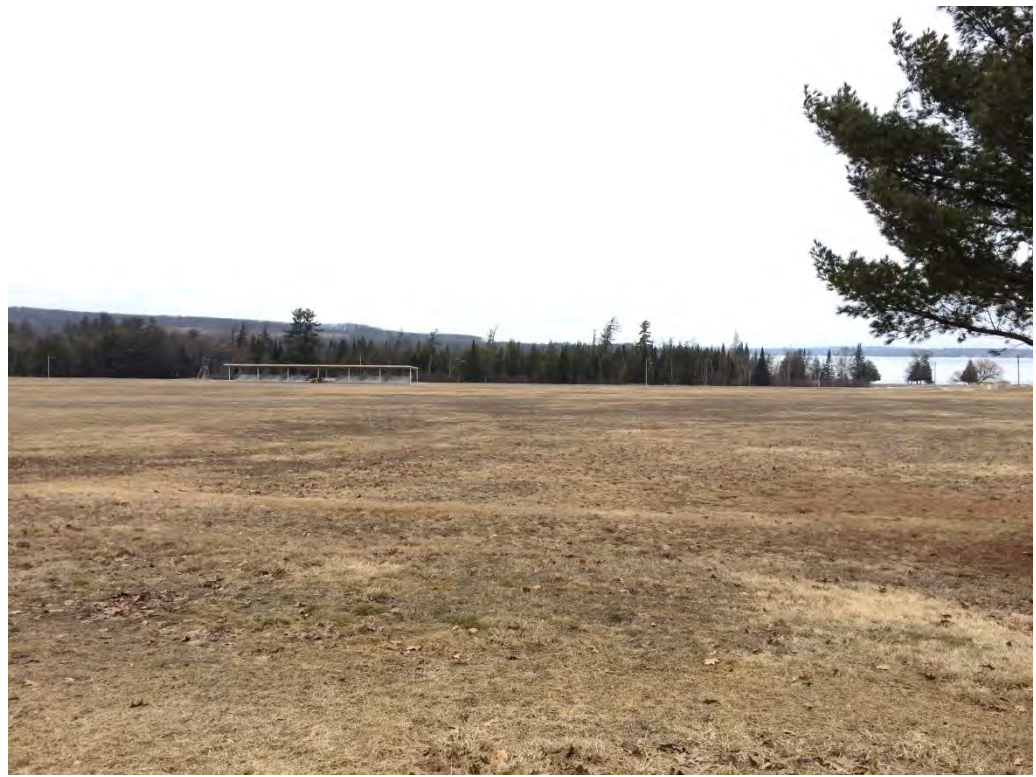
AOI15: Parade Grounds circa 2018. Standing on Howe Road facing north towards Lake Margrethe (seen in background).

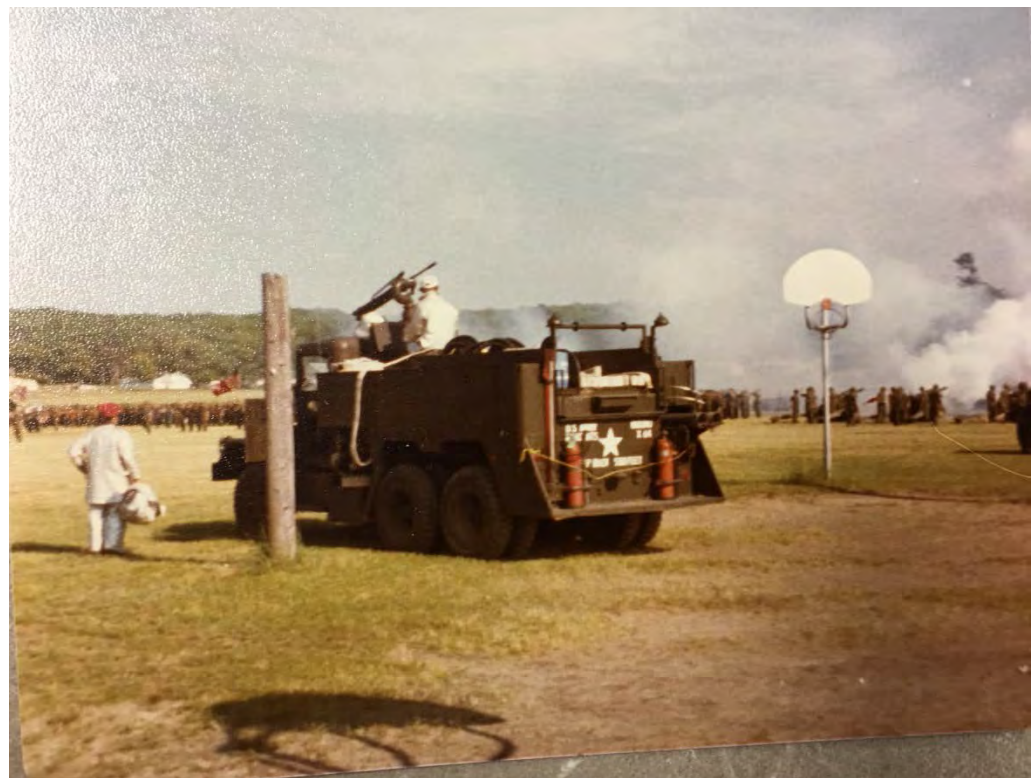
### Photograph No. 14

AOI15: Parade Grounds circa 1970s – 1980s. Photograph provided by Kim Halstead. Camp Grayling fire truck parked on Parade Grounds. Blue AFFF bucket seen in back of truck.

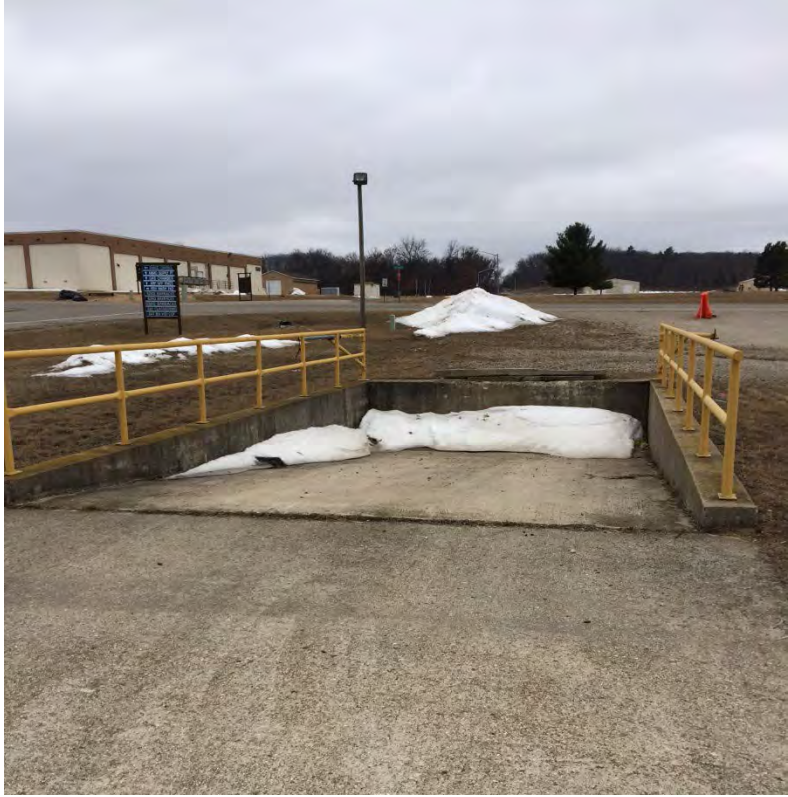
Army National Guard, Preliminary Assessment for PFAS	Camp Grayling	Grayling, Michigan
<p><b>Photograph No. 15</b></p> <p><b>Description:</b></p> <p>AOI15: Wash Rack on corner of Howe Road and 8<sup>th</sup> Street. Standing on east side facing west. Snow present in wash rack and background.</p>

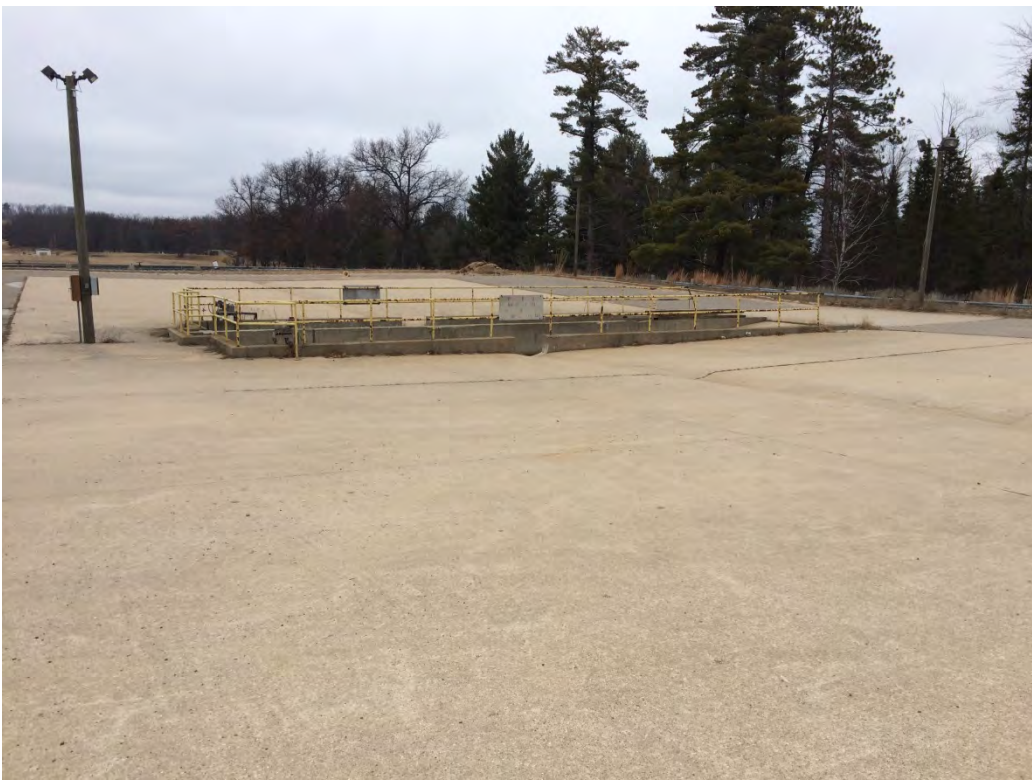
<p><b>Photograph No. 16</b></p> <p><b>Description:</b></p> <p>AOI15: Larger Wash Rack on corner of Parade Road and 8<sup>th</sup> Street. Standing on southern side of Wash Rack facing north. Wash Rack surrounded by large concrete pad.</p>

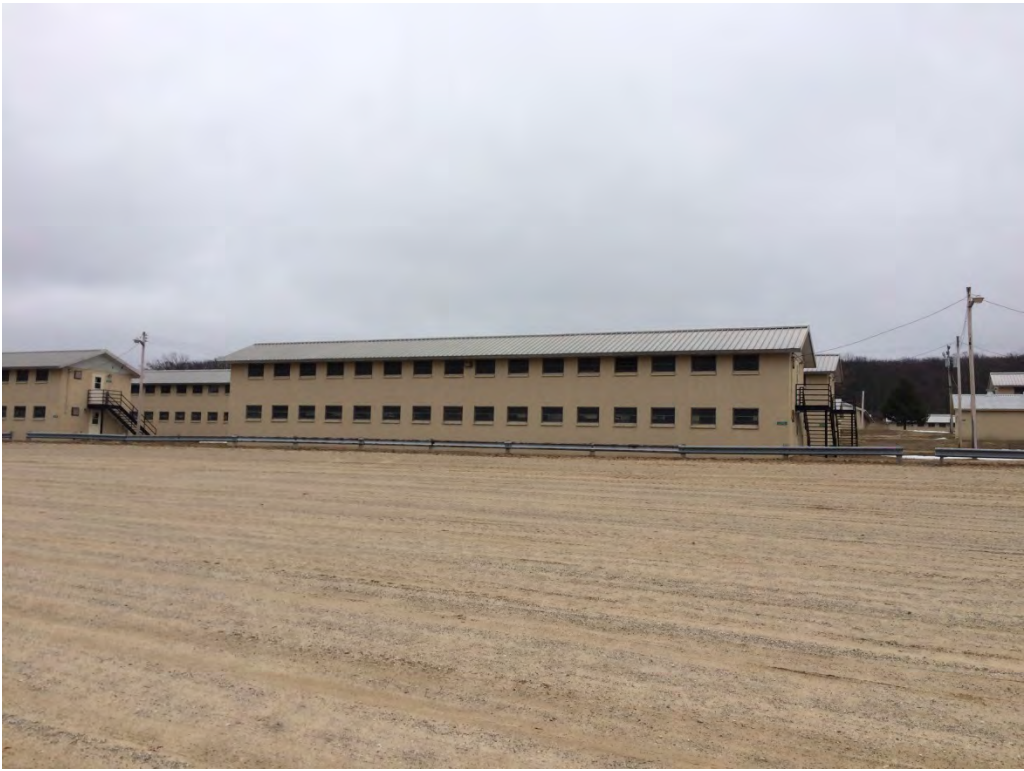
Army National Guard, Preliminary Assessment for PFAS	Camp Grayling	Grayling, Michigan
<p><b>Photograph No. 17</b></p> <p><b>Description:</b></p> <p>AOI14: Building 228Q (circa 2018), standing on west side of buildings facing east. Unpaved parking area in foreground.</p>

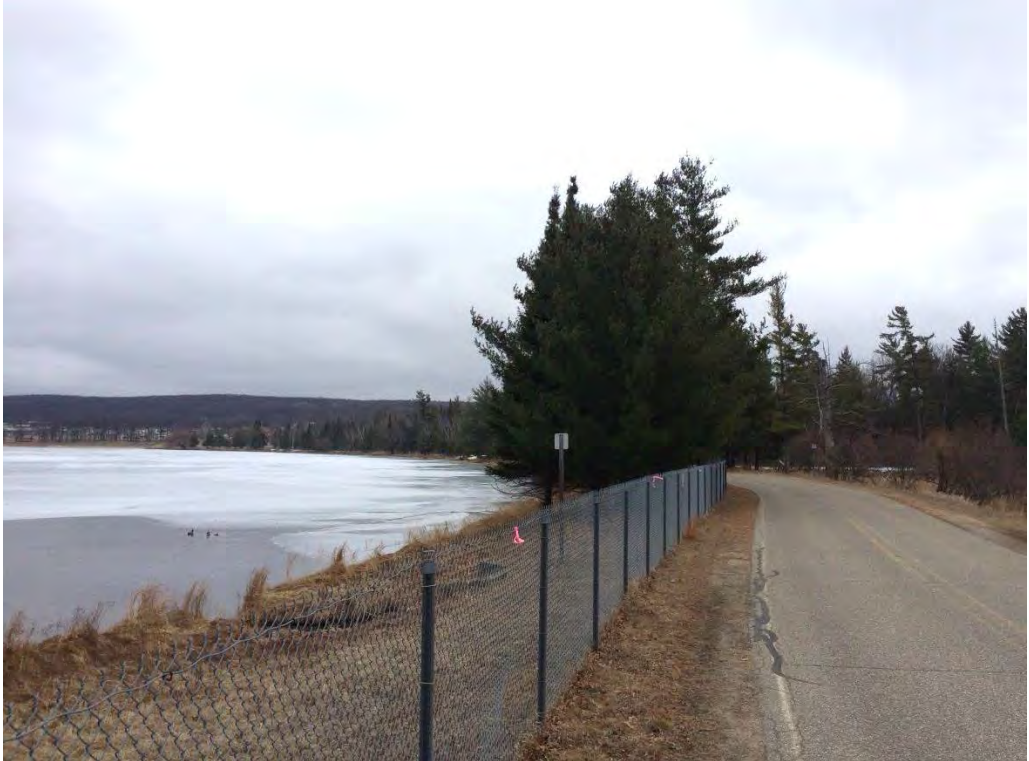
Army National Guard, Preliminary Assessment for PFAS	Camp Grayling	Grayling, Michigan
<p><b>Photograph No. 19</b></p> <p><b>Description:</b></p> <p>AOI15: Check nozzle area (2018). Standing on Soldier Drive facing southeast toward a frozen, snow covered Lake Margrethe.</p>

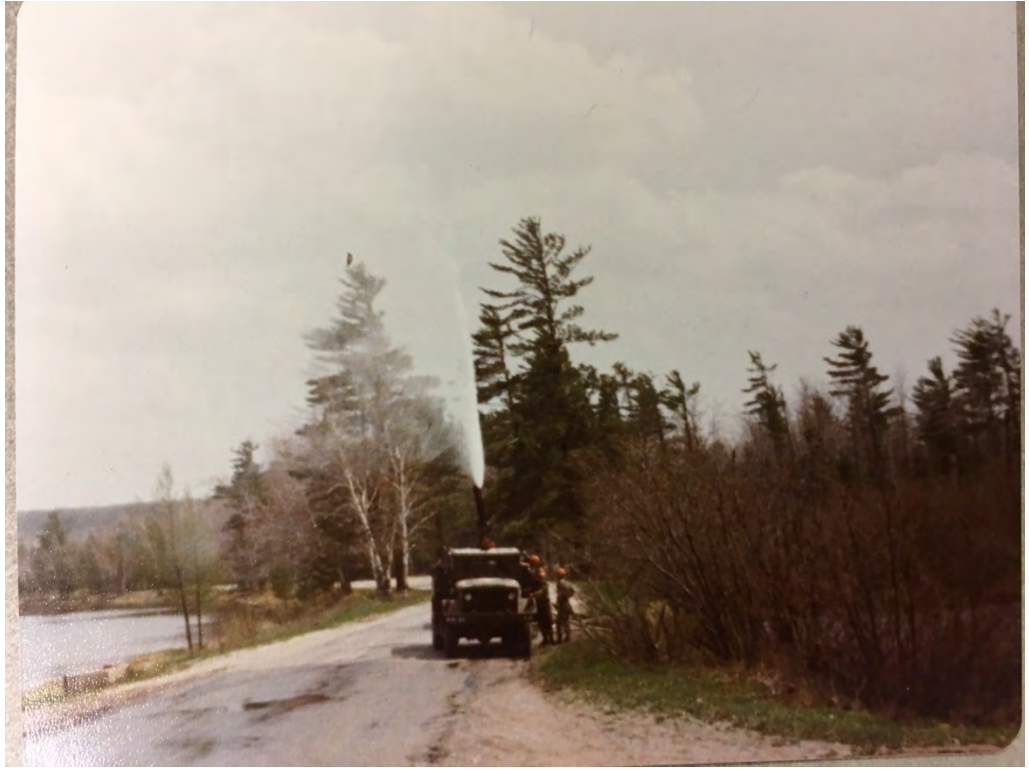
<p><b>Photograph No. 20</b></p> <p><b>Description:</b></p> <p>AOI15: Check nozzle area (1970s - 1980s). Photograph provided by Kim Halstead. Camp Grayling Firefighters performing check nozzle maintenance on fire truck next to Lake Margrethe.</p>

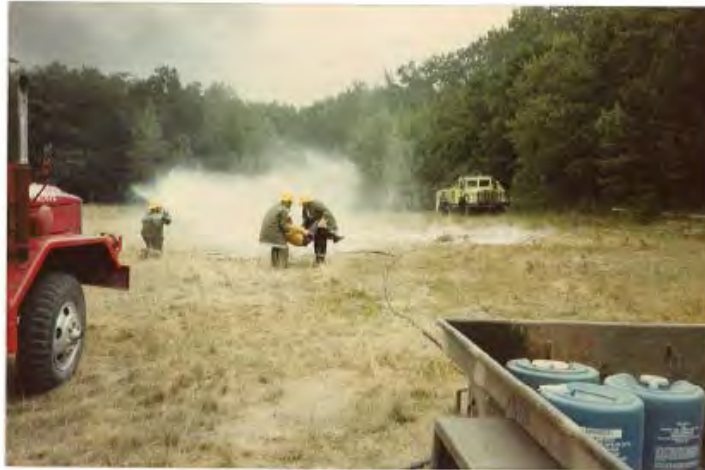
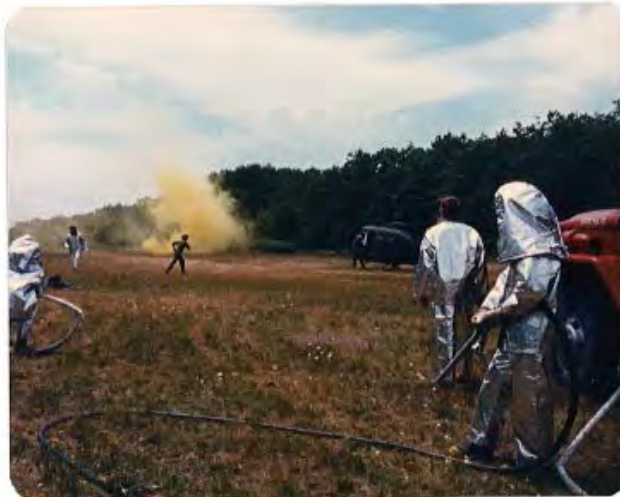
AOI16

Early 1980-1981  
Wilson Hill - By the track

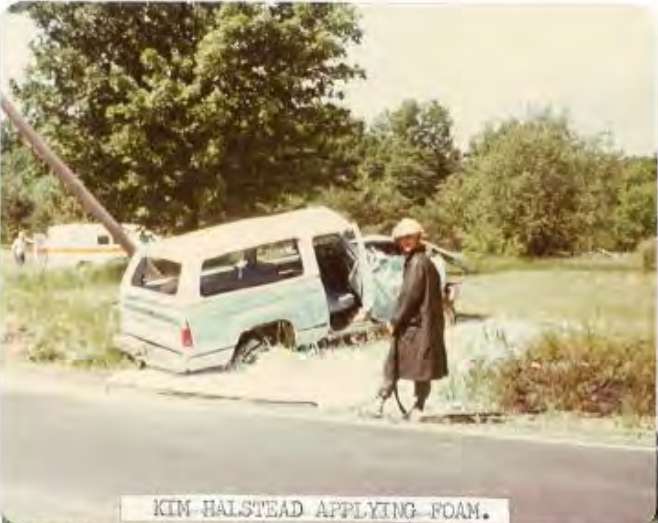
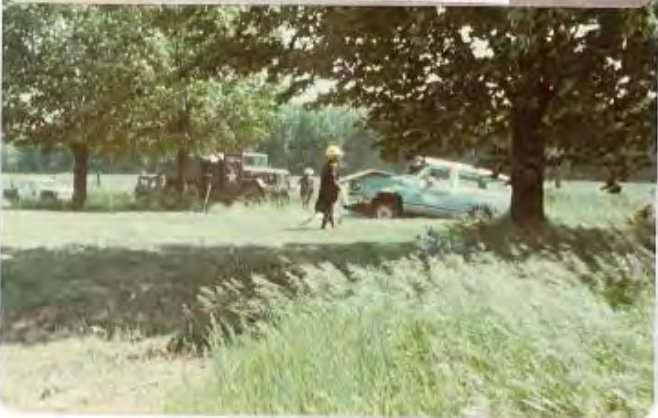
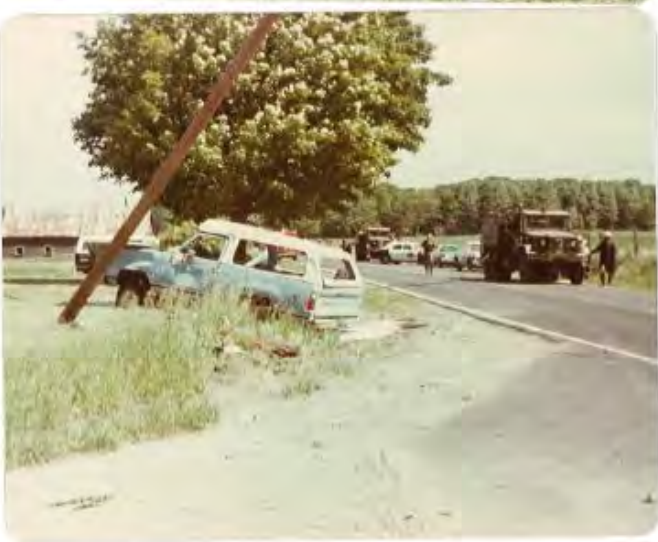
Army National Guard, Preliminary Assessment for PFAS	Camp Grayling	Grayling, Michigan
<p><b>Photograph No. 23</b></p> <p><b>Description:</b></p> <p>Single time emergency response to car accident.</p>	<p data-bbox="617 289 1339 388"><i>Military at Beaver Road Accident 1979</i></p>

<p data-bbox="727 888 1112 919">KIM-HALSTEAD APPLYING FOAM.</p>

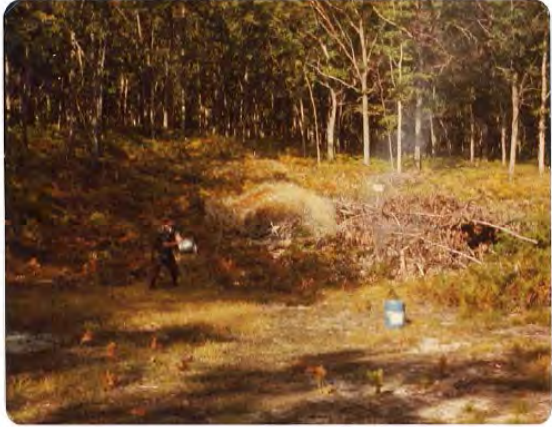
Army National Guard, Preliminary Assessment for PFAS	Camp Grayling	Grayling, Michigan
<p><b>Photograph No. 24</b></p> <p><b>Description:</b> AOI17</p>	<p>1981 or 1982 after Buildings were Demolished at the Old ASP on south access <sup>RD</sup> By the Old Quonset Hut at the Range Gate. Burning Brush Piles. Used AFFF to Put out Brush fires.</p>

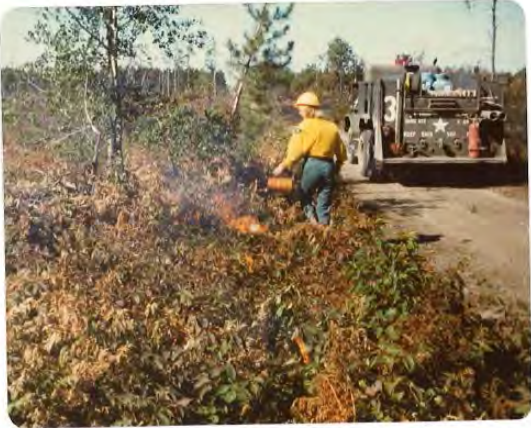
<p><b>Photograph No. 25</b></p> <p><b>Description:</b> AOI18</p>	<p>Pre-Burn on Range 30 Complex in the Early 1980s. AFFF was Put into the water tank on the Fire truck and mixed with water to form wet water to Fight wild Land Fires</p>

<p>← AFFF = Blue Containers on Back of fire truck.</p>	
--	--	--

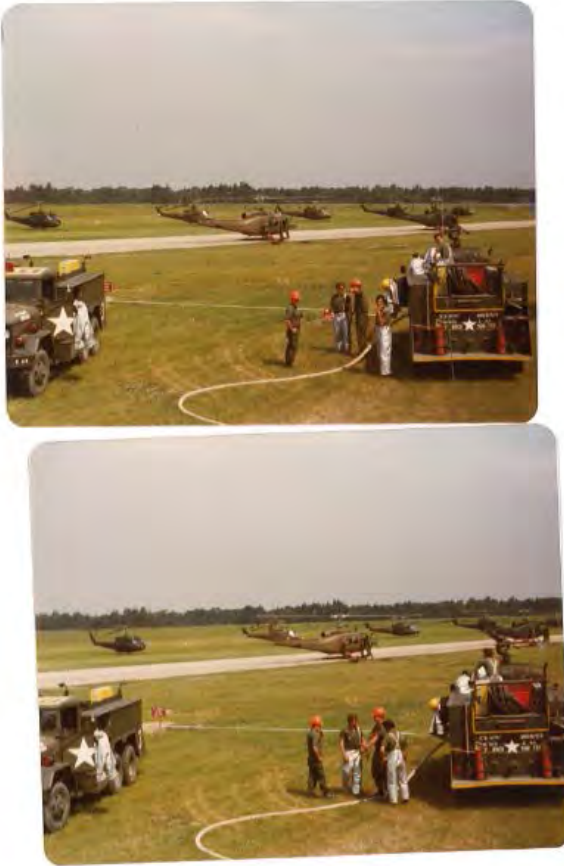
Army National Guard, Preliminary Assessment for PFAS	Camp Grayling	Grayling, Michigan
<p><b>Photograph No. 26</b></p> <p><b>Description:</b></p> <p>AOII</p>	<p>Fire trucks staged at CGAAF Near Ops Building Early 1980's</p>

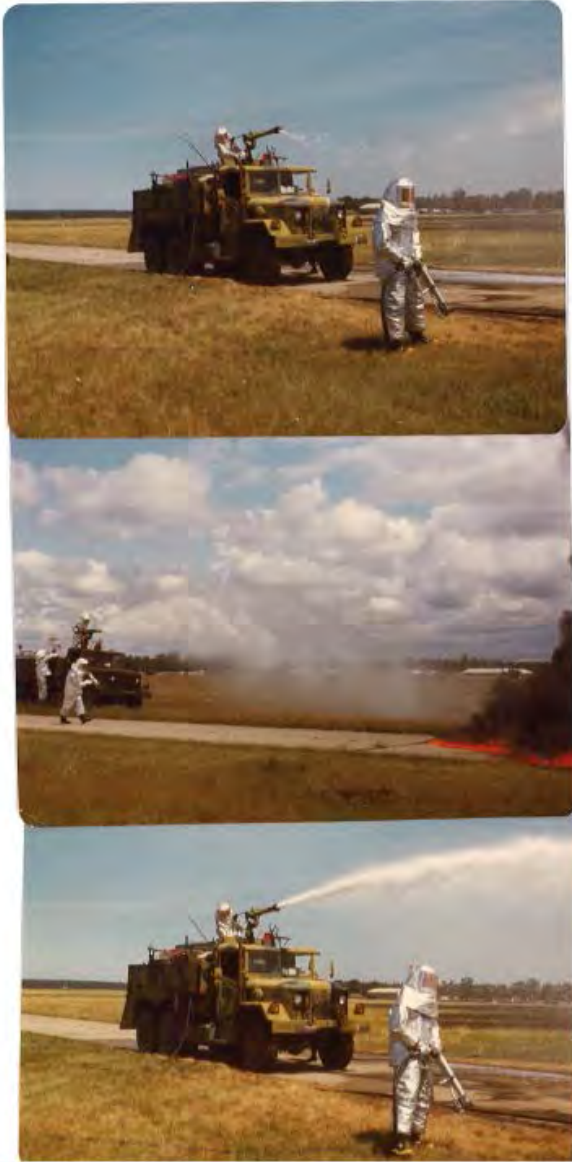
Army National Guard, Preliminary Assessment for PFAS	Camp Grayling	Grayling, Michigan
<p><b>Photograph No. 27</b></p> <p><b>Description:</b> AOI4</p>	<p>Indiana National Guard troops training at the Airfield (CGAAF) Early 1980's with Foam Cannon &amp; Ground Hoses (Page 1)</p>

<p>The photograph log contains three vertically stacked images. The top image shows a green military truck with a foam cannon mounted on its back, parked on a grassy airfield. A person in a white hazmat suit stands next to the truck. The middle image shows the same truck and person, with a large plume of white foam being discharged from the cannon. The bottom image shows the truck and person again, with a high-pressure water hose being used to spray the ground.</p>

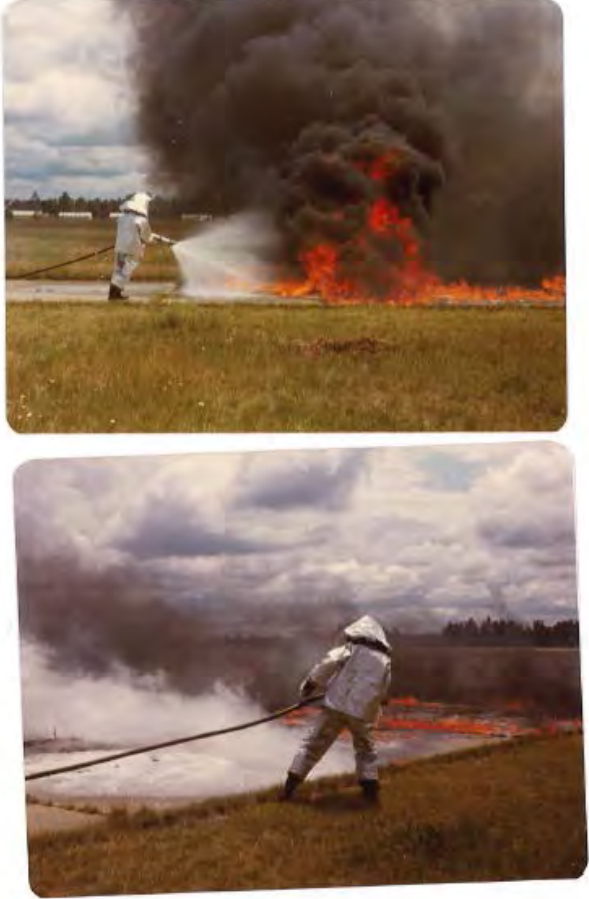
Army National Guard, Preliminary Assessment for PFAS	Camp Grayling	Grayling, Michigan
<p><b>Photograph No. 28</b></p> <p><b>Description:</b> AOI4</p>	<p>Indiana National Guard Training Early 1980's (Page 2)</p>

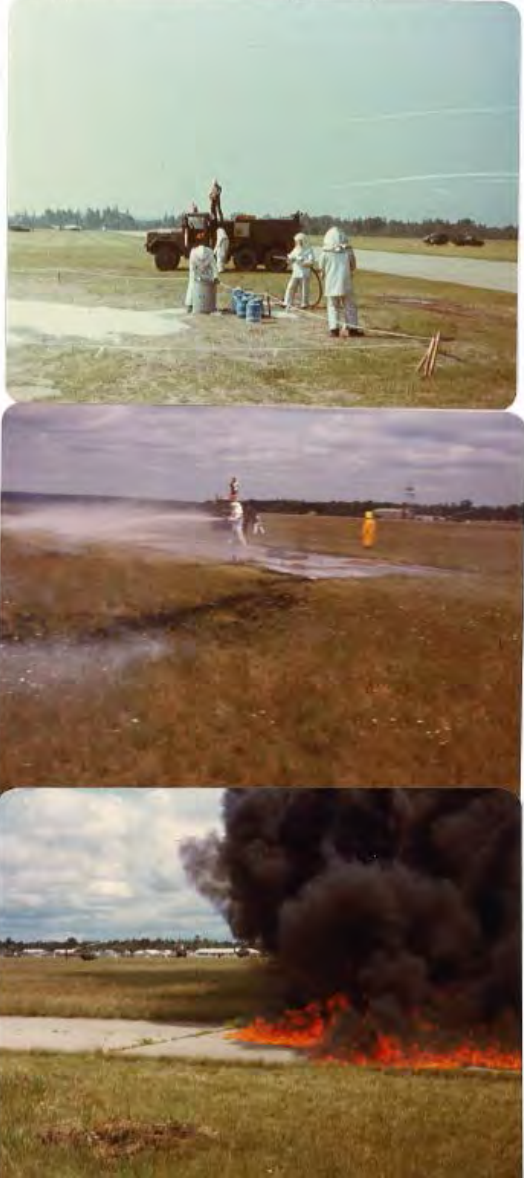
Army National Guard, Preliminary Assessment for PFAS	Camp Grayling	Grayling, Michigan
<p><b>Photograph No. 29</b></p> <p><b>Description:</b></p> <p>AOI4</p>	<p>Michigan National Guard CGATS (Fire Detachment) TRAINING mid 1980's (Page 1) AIRFIELD</p>
