**Grand Rapids Water Resource Recovery Facility
Former Incinerator Ash Lagoon
November 28, 2022
Regulated PFAS Sampling Results**

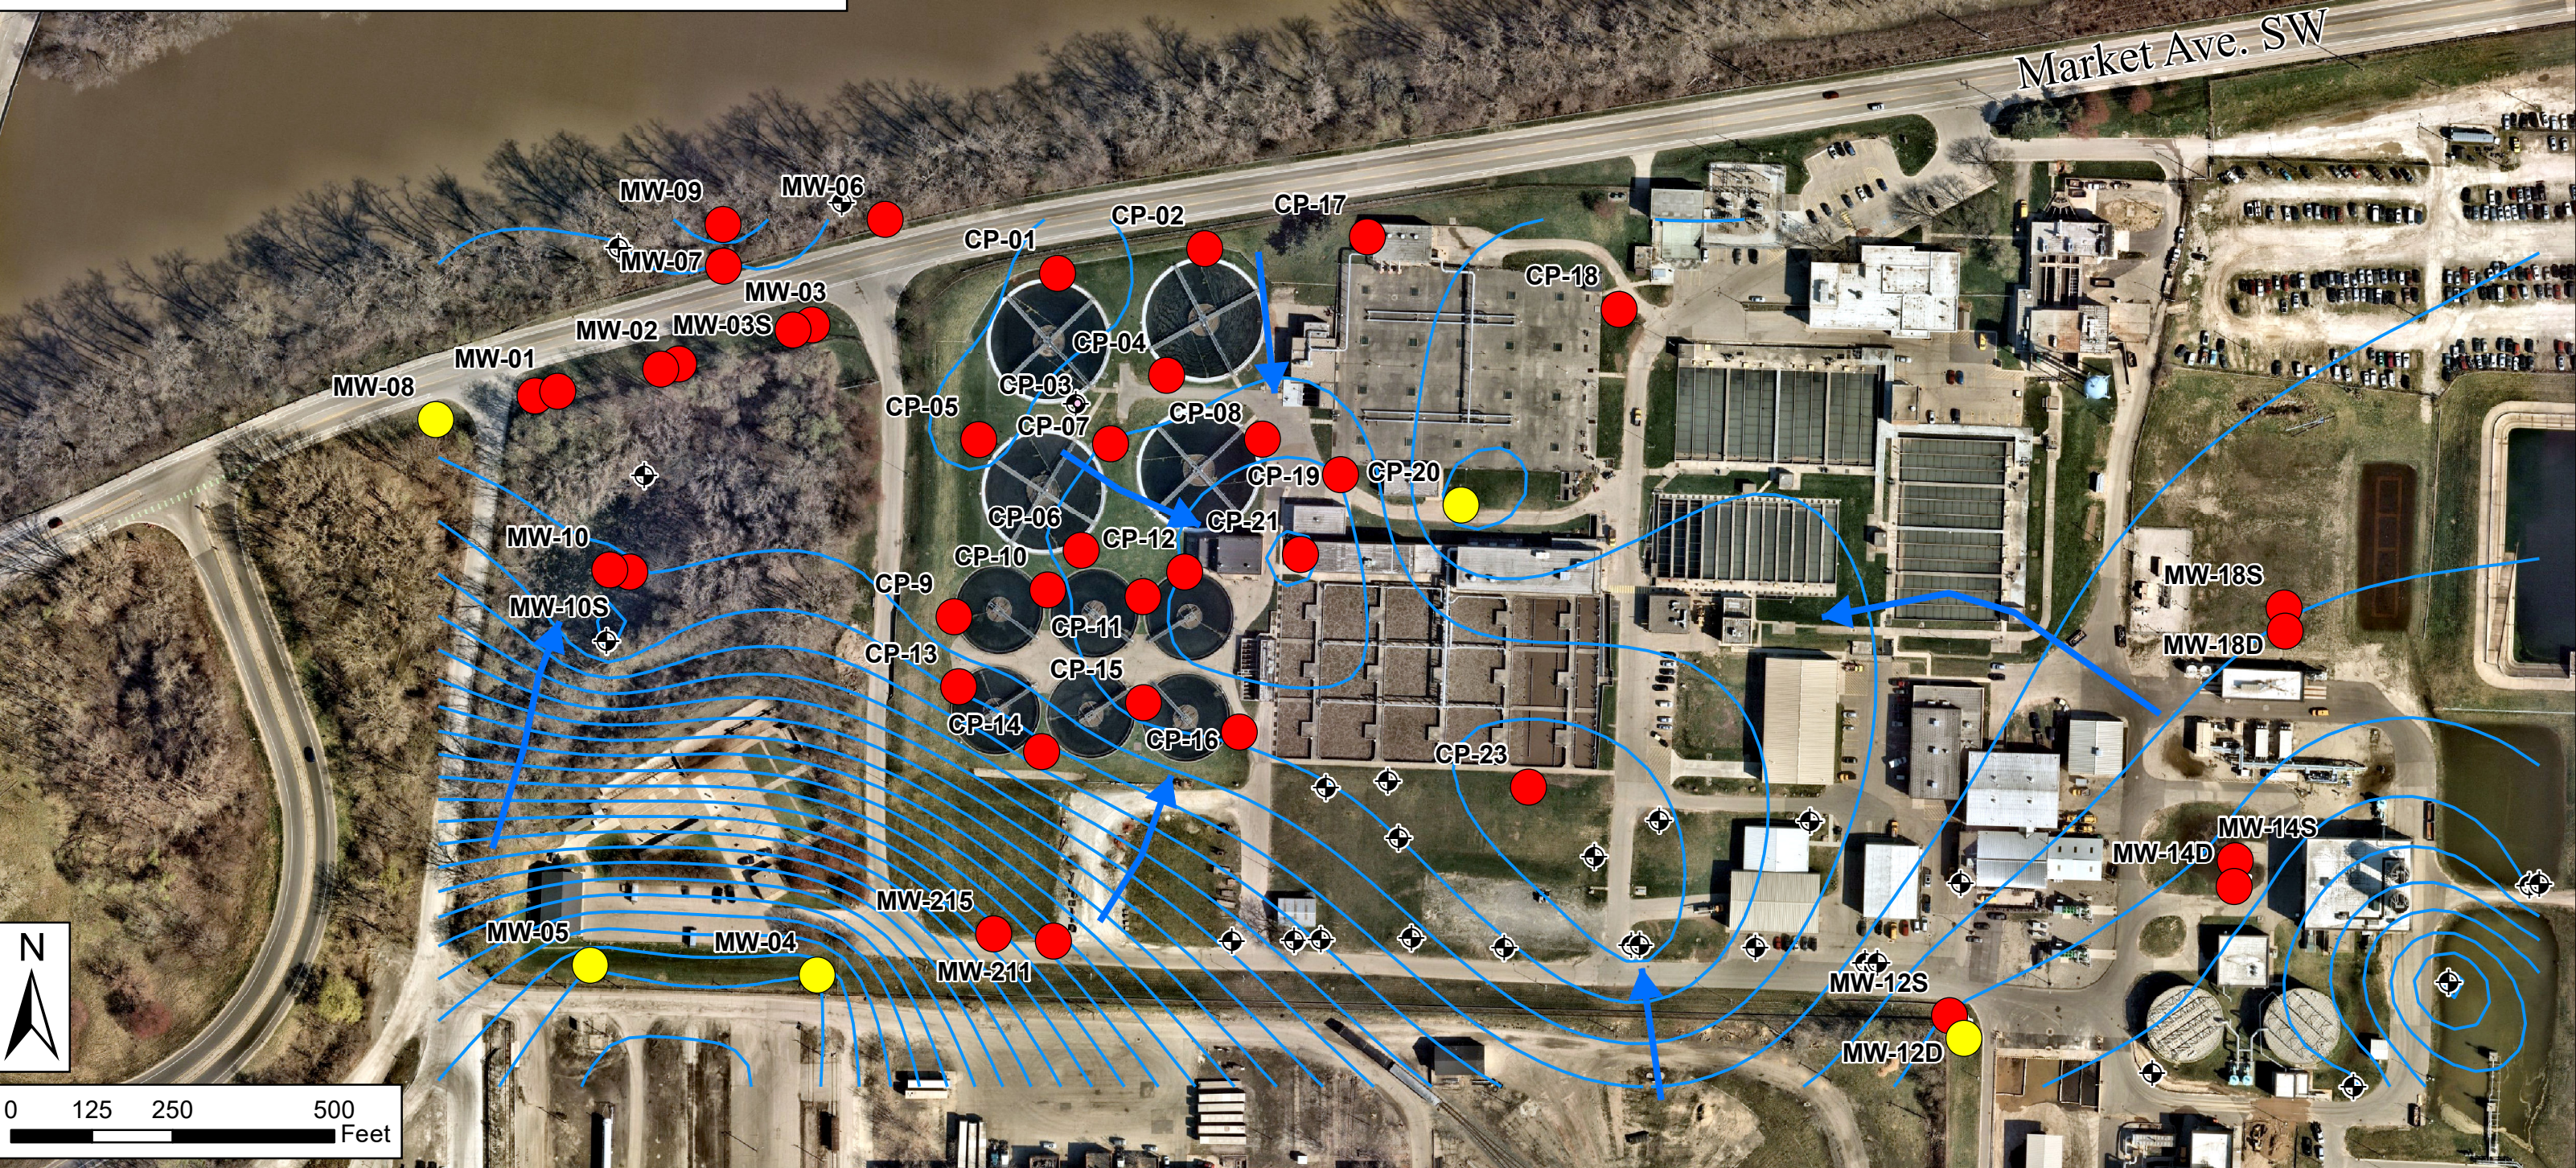
- Non-Detect
- Detection
- Exceedance
- ⊕ Groundwater Monitoring Points
- ➔ Approximate Groundwater Flow Direction
- 2023-02-21 Groundwater Contours
