Investigations Underway at Wolverine World Wide

Wolverine World Wide Sites

Rockford and Belmont, Michigan

November 2018

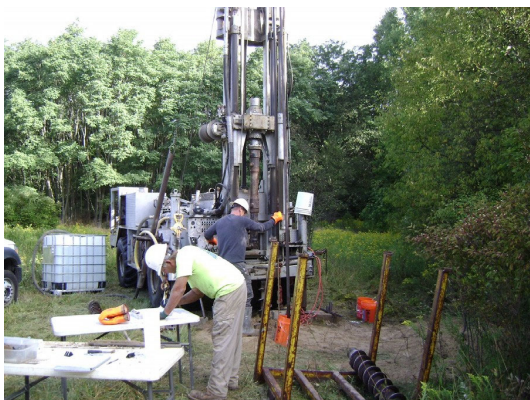
Contractors use a Geoprobe to collect soil samples on the Wolverine site.

Sample locations were chosen both through a grid pattern over the investigation site and in areas where previous on-site production or waste storage took place. For soil and soil gas sampling, geologists logged and classified soil from the sample core, typically in 5-foot lengths taken from the surface down 15 to 20 feet (*see Figure 4 on Page 4*). Field screening instruments and visual clues were used to identify areas where potential waste may be present. Sediment samples were also collected and then screened in a similar manner to the soil.

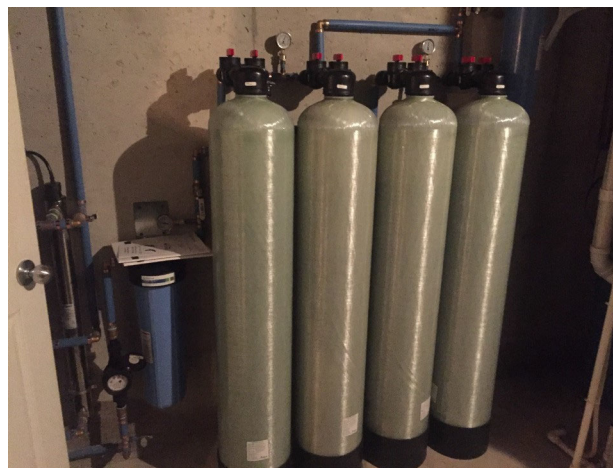
Whole-house filters like the one above have been installed in affected homes.

Wolverine has managed the immediate risks in the short term by installing whole-house filters in affected houses and by offering bottled water to all residents located in a sampling area regardless of the groundwater concentrations. This is a temporary measure to lessen the drinking water risks until a long-term reliable solution is implemented, such as connection to municipal water. Further work to identify and define impacted areas continues (*see Figure 2 on Page 3*).

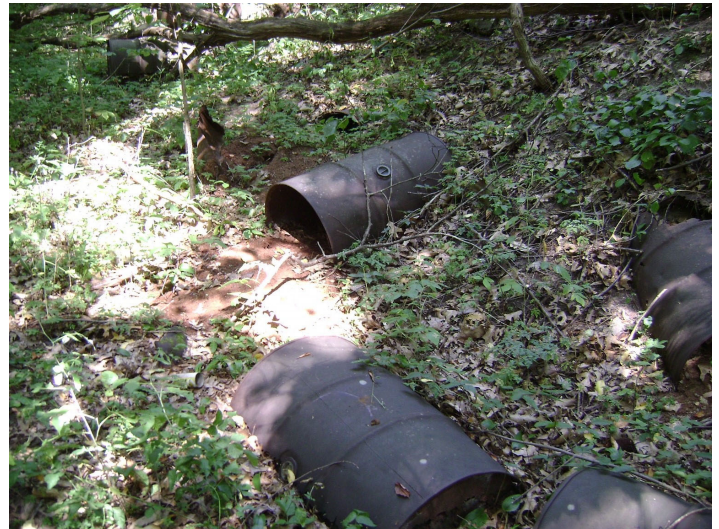
Drums removed from a property across the street from the House Street Disposal Area.
