Former Four Star Property  
1391 Kalamazoo Street  
South Haven, MI

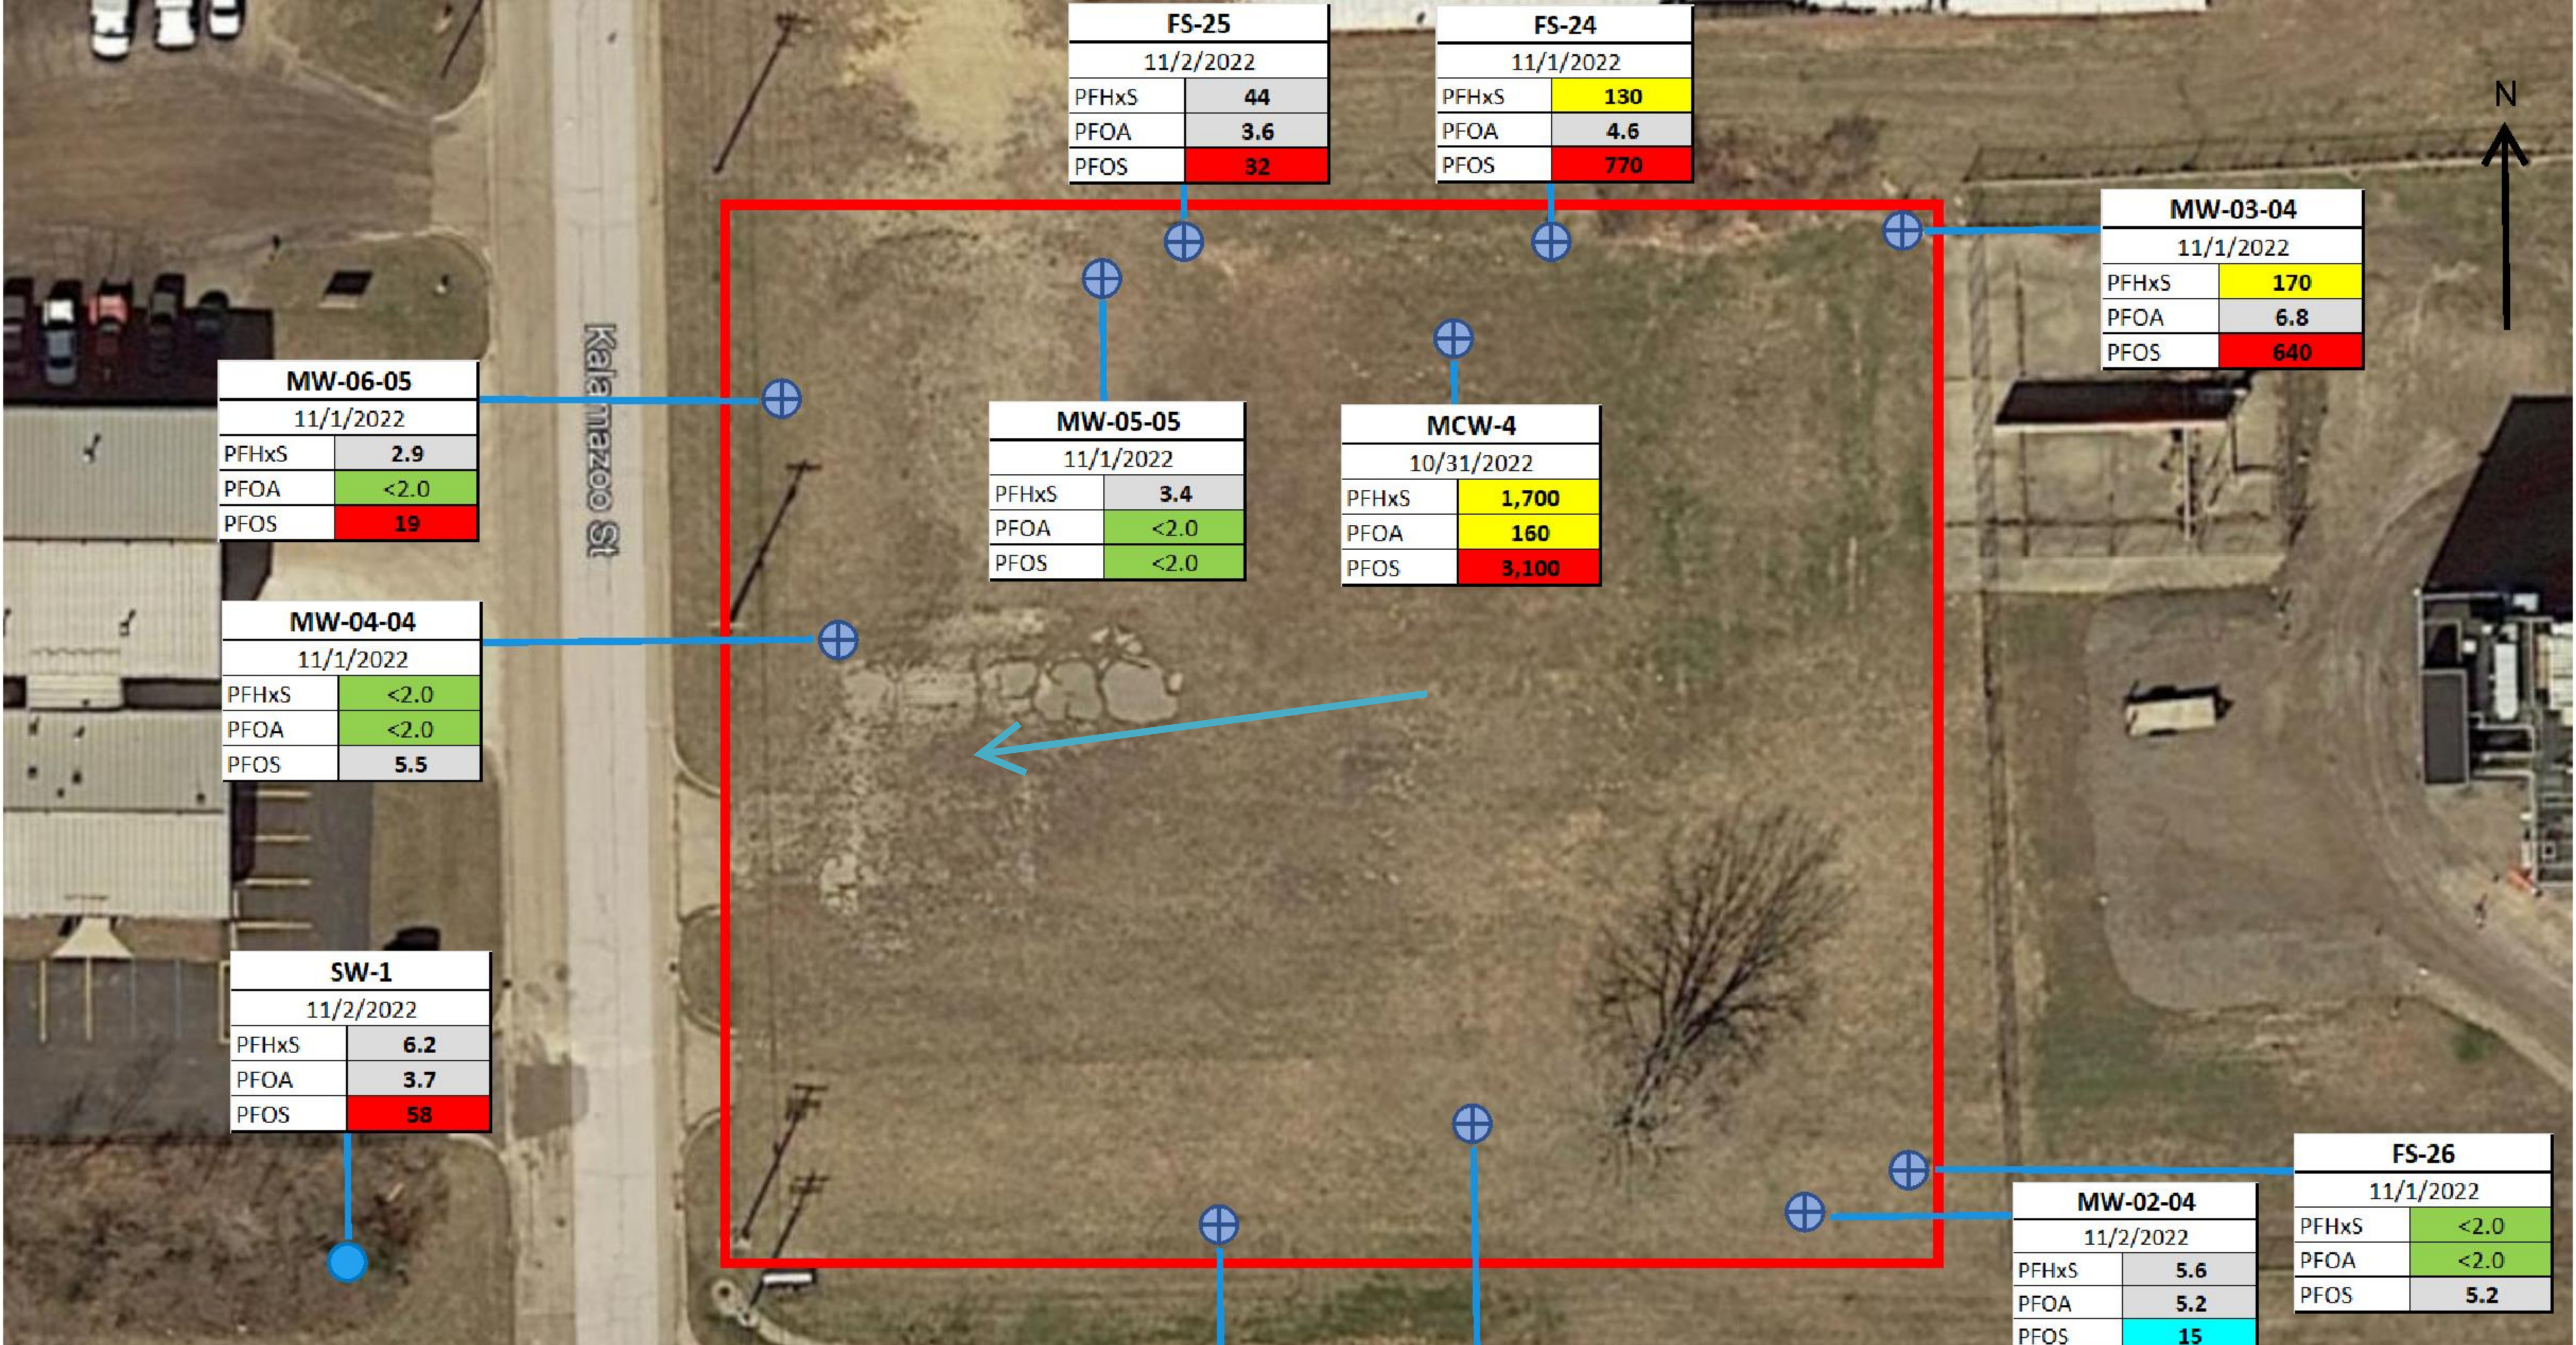
FS-25	
11/2/2022	
PFHxS	44
PFOA	3.6
PFOS	32

FS-24	
11/1/2022	
PFHxS	130
PFOA	4.6
PFOS	770

MW-03-04	
11/1/2022	
PFHxS	170
PFOA	6.8
PFOS	640

MW-06-05	
11/1/2022	
PFHxS	2.9
PFOA	<2.0
PFOS	19

MW-05-05	
11/1/2022	
PFHxS	3.4
PFOA	<2.0
PFOS	<2.0

MCW-4	
10/31/2022	
PFHxS	1,700
PFOA	160
PFOS	3,100

MW-04-04	
11/1/2022	
PFHxS	<2.0
PFOA	<2.0
PFOS	5.5

SW-1	
11/2/2022	
PFHxS	6.2
PFOA	3.7
PFOS	58

FS-26	
11/1/2022	
PFHxS	<2.0
PFOA	<2.0
PFOS	5.2

MW-02-04	
11/2/2022	
PFHxS	5.6
PFOA	5.2
PFOS	15

MW-01-04	
11/2/2022	
PFHxS	9.9
PFOA	<2.0
PFOS	150

FS-27	
11/2/2022	
PFHxS	80
PFOA	12
PFOS	410

Direction of groundwater flow ←
