# I-94 PILEUP

KALAMAZOO COUNTY

January 9<sup>th</sup>, 2015

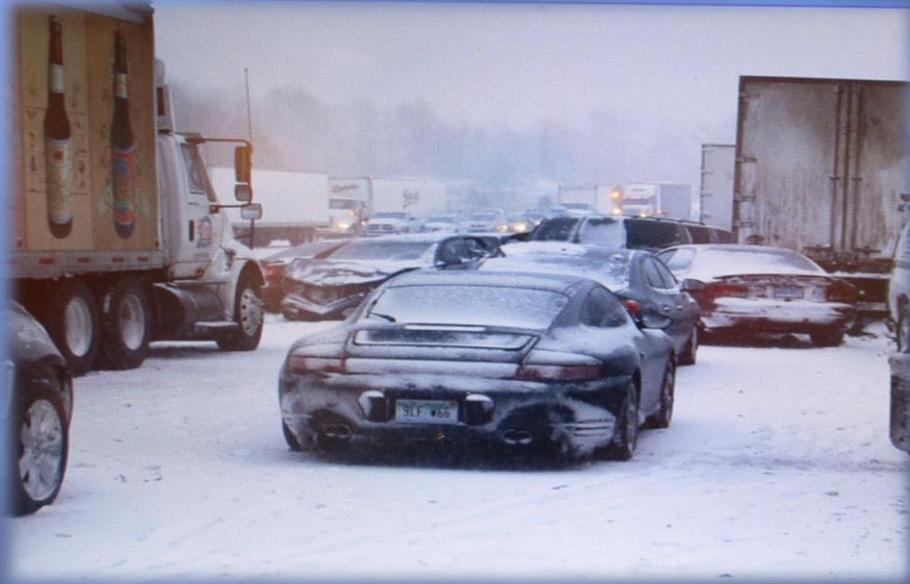
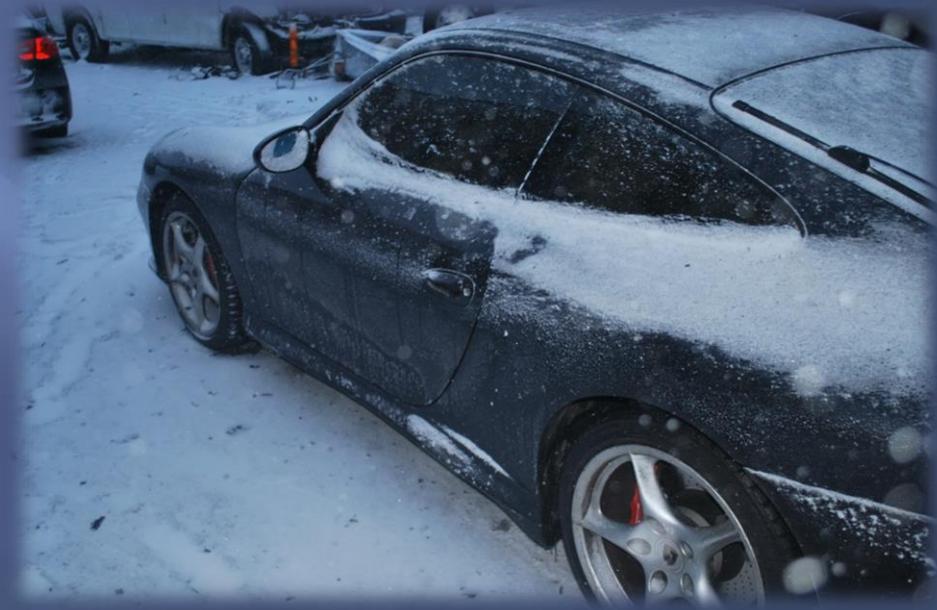
# Avoiding the Hazard Porsche Snow Tires?
