Belle Isle Boathouse**Renovations**

Detroit, Michigan

Belle Isle Boathouse Building and Site Assessment

December 2019

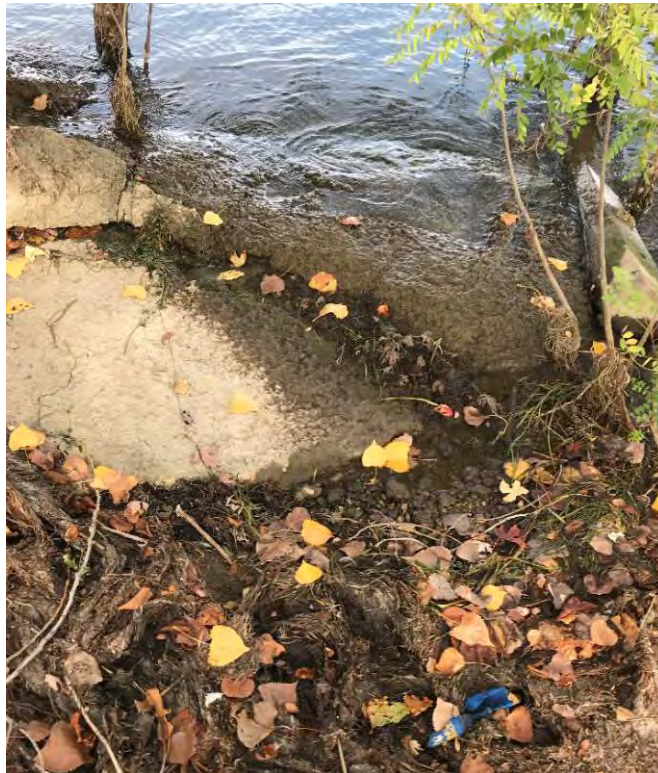
Photo 5

- Typical condition behind sheet pile wall **[Photo #1, #2, #3]**.
- Non-structured shoreline, rubble present **[Photo #4, #5]**.

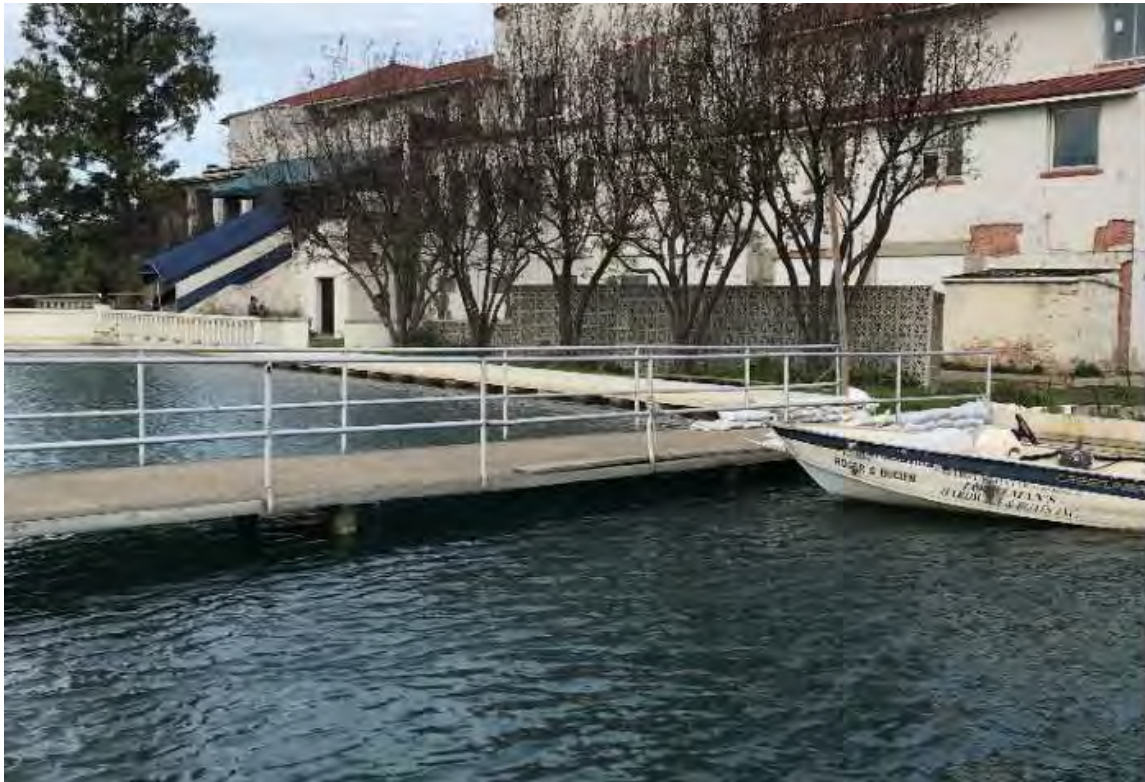
Photo 14

- Dock system on east side, some decking recently replaced **[Photo #14]**.
- Representative condition of docks on north side of island. These docks are not safe for use **[Photo #15]**.
- West side docks are a combination of formats. Newer metal portions may be salvageable **[Photo #16]**.

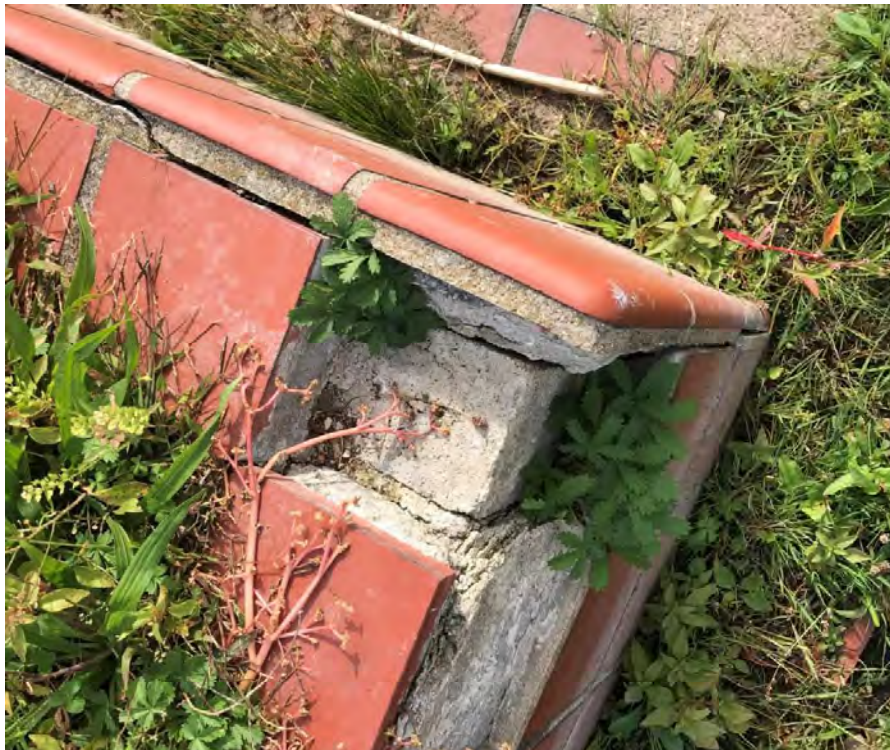
Photo 21

- Concrete spalling, cracking and damage is evident throughout the site [Photo #21].
- Heaving concrete walk at connection to north docks [Photo #22].

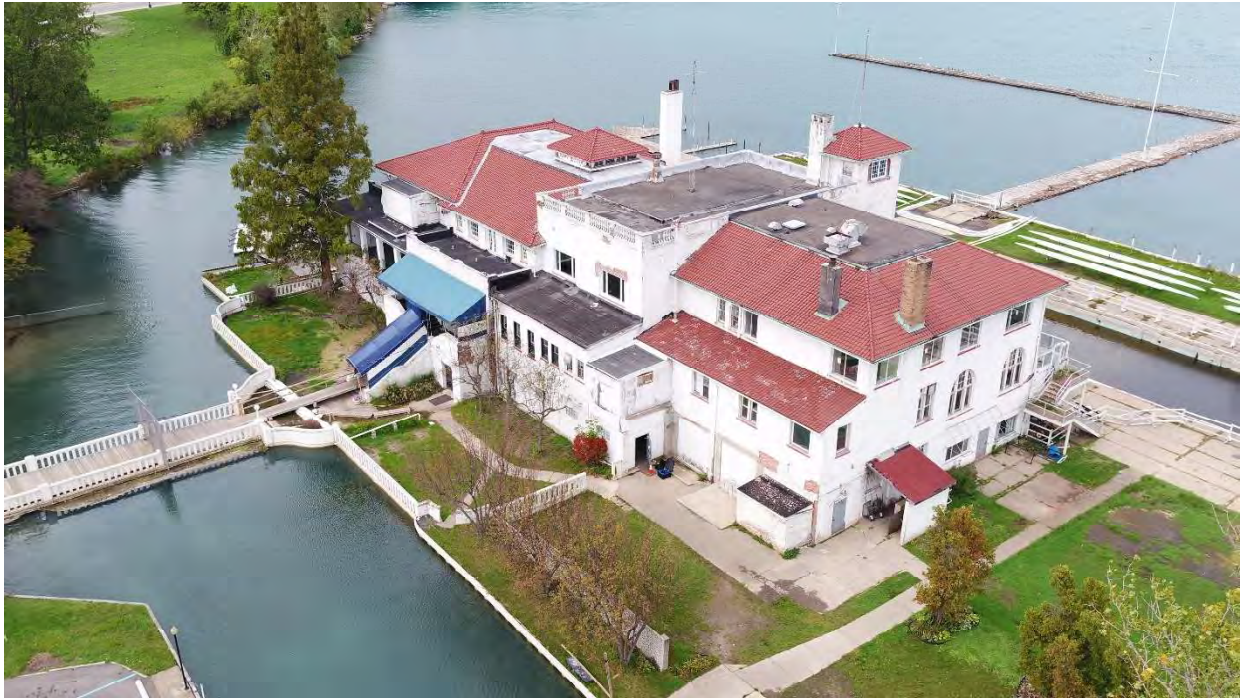
Photo 1

The Boat House [Photo 1-2], constructed in 1902, is a stucco finished brick mass masonry building over a concrete and steel frame. The building is constructed on a concrete supported slab with grade beams supported on wood piles driven into the riverbed, **[Photo 3-4]**. The Boat House had a significant addition to the east side of the structure. This addition may have occurred in 1922, but actual documentation of this has not yet been verified. The original Boat House sat in the water with a single bridge access. Subsequent improvements constructed an island around the Boat House featuring swimming pools, a pavilion and a series of docks. A second bridge was also added.

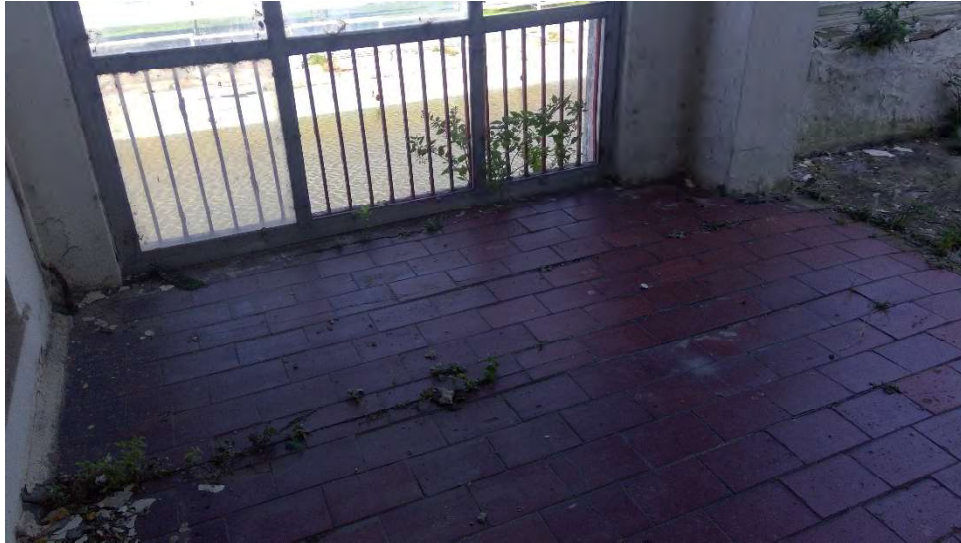
Photo 13 Exposed Terrace Tile

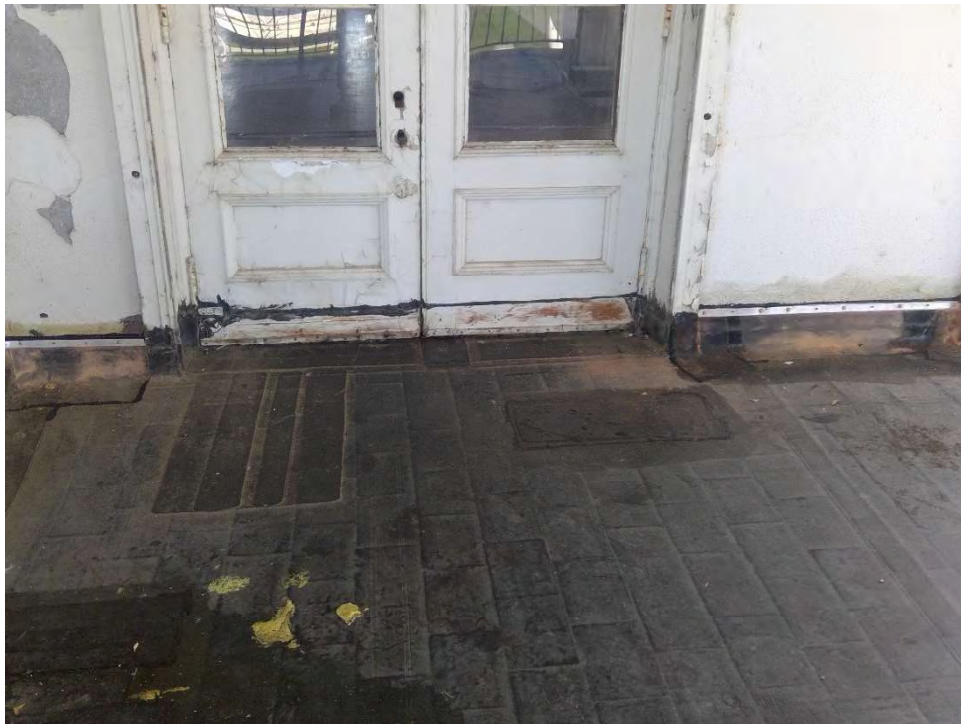
Photo 14 EPDM covered tile terraces

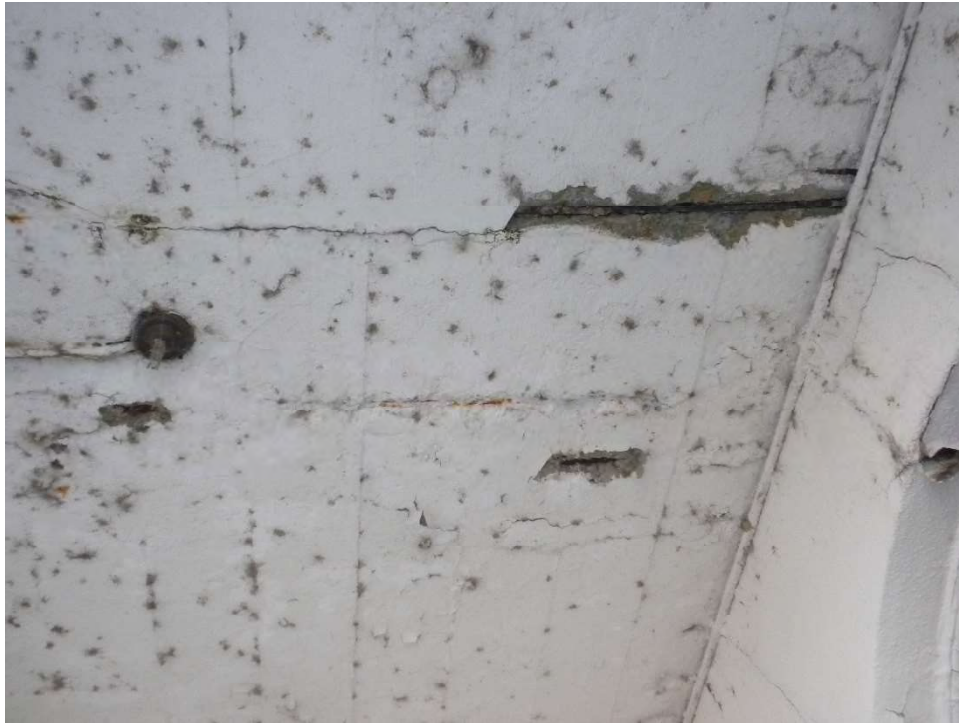
Photo 15 Damaged Stucco – Surface Scaled Finish

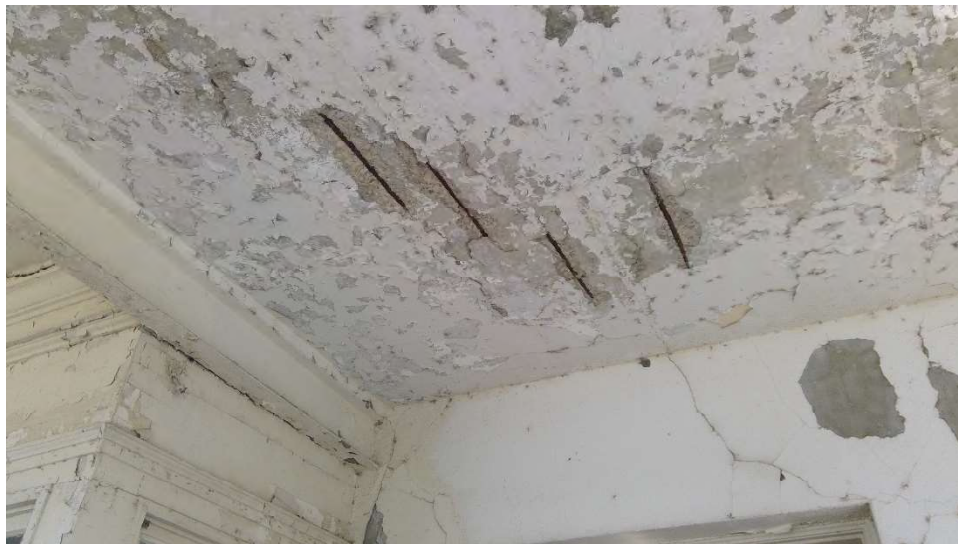
Photo 16 Damaged Stucco – Surface Scaled Finish

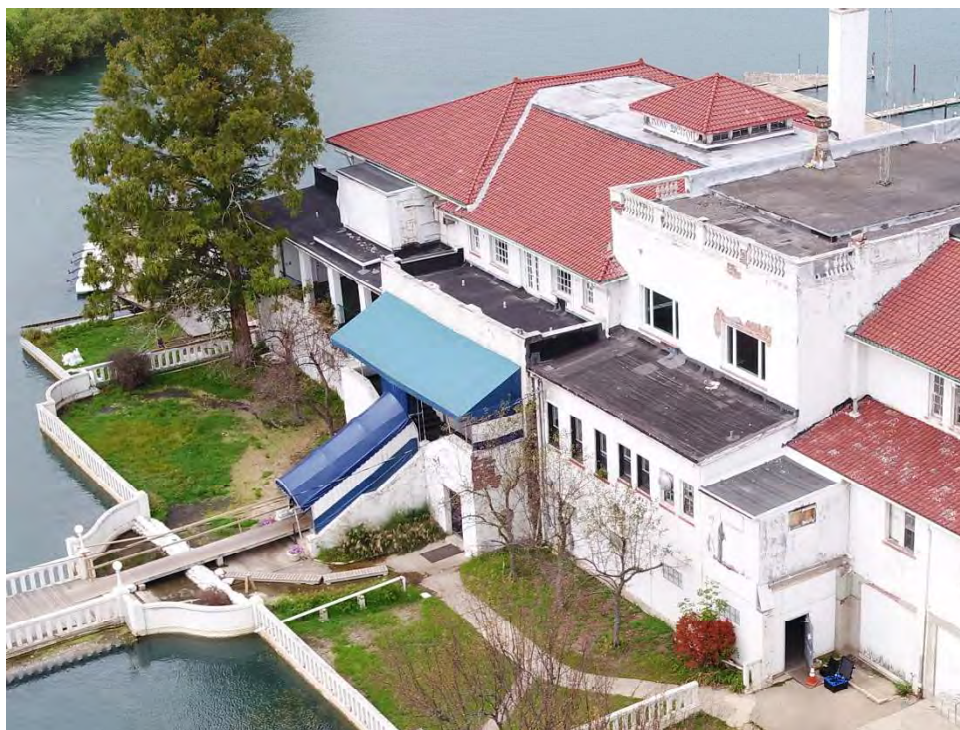
- The main or south entrance stair [Photo 17-18]
- The north entrance stair [Photo 19]
- The northeast secondary egress stair [Photo 20]

Photo 17 South Staircase

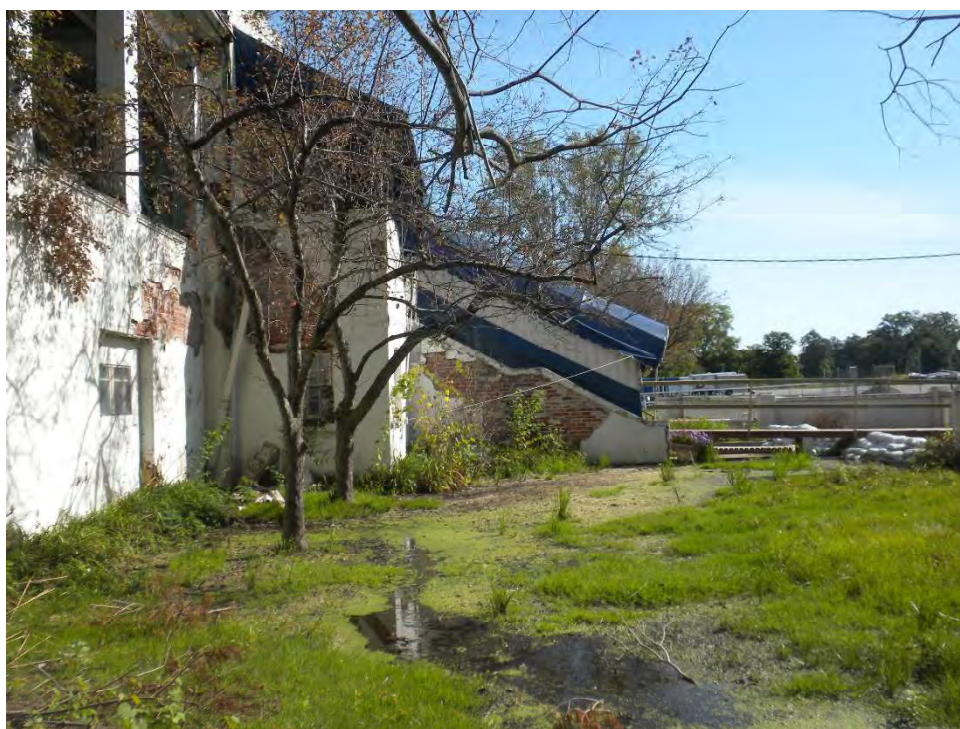
Photo 18 South Staircase

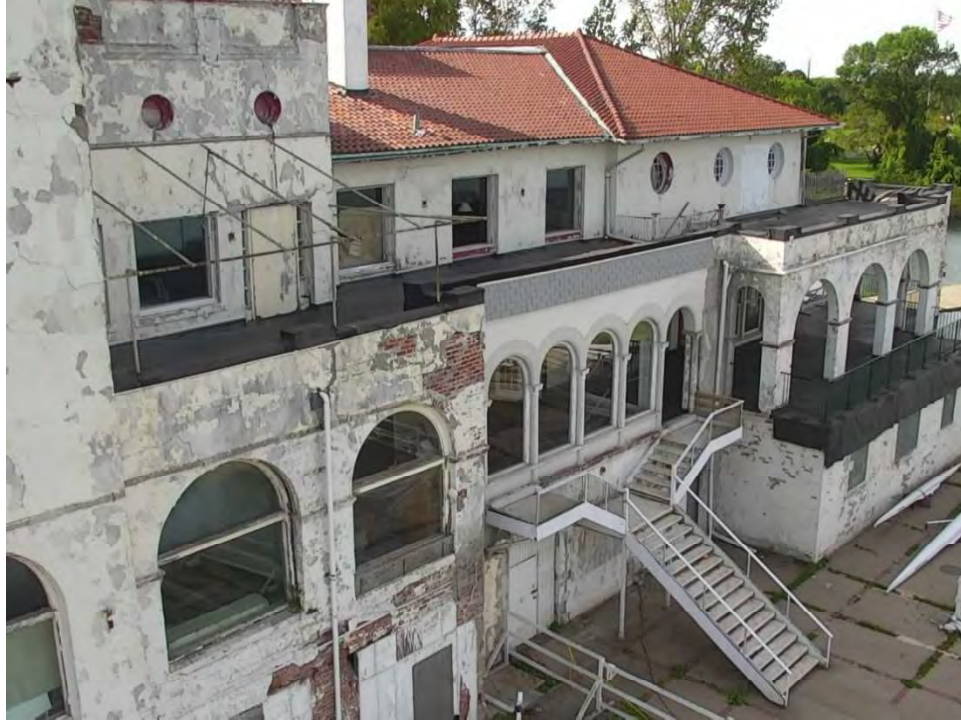
Photo 19 North Staircase

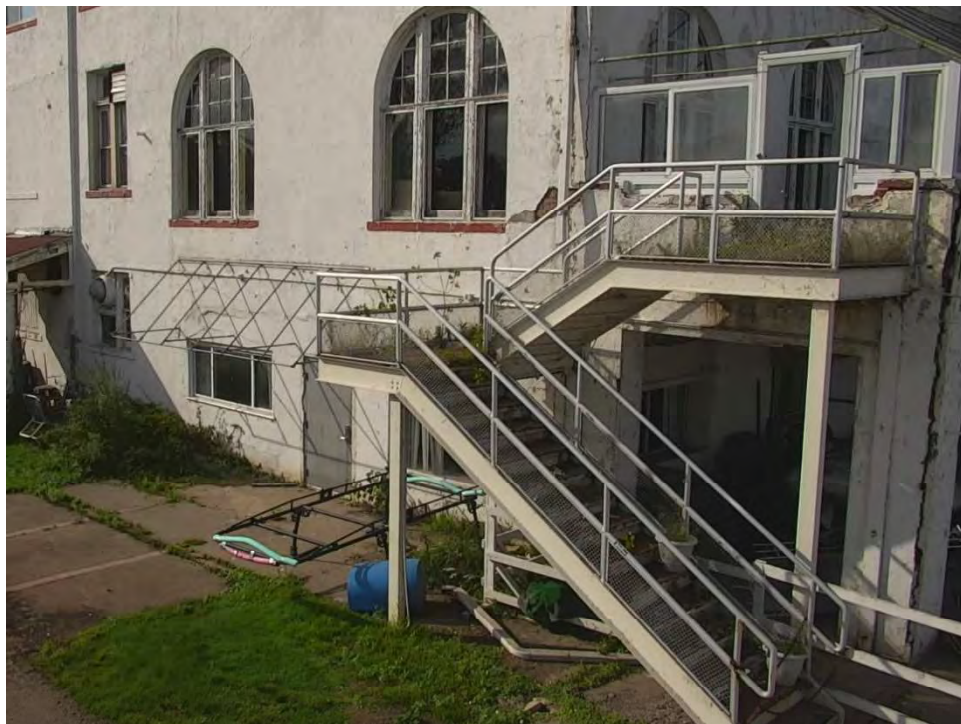
Photo 20 Northeast Secondary Staircase

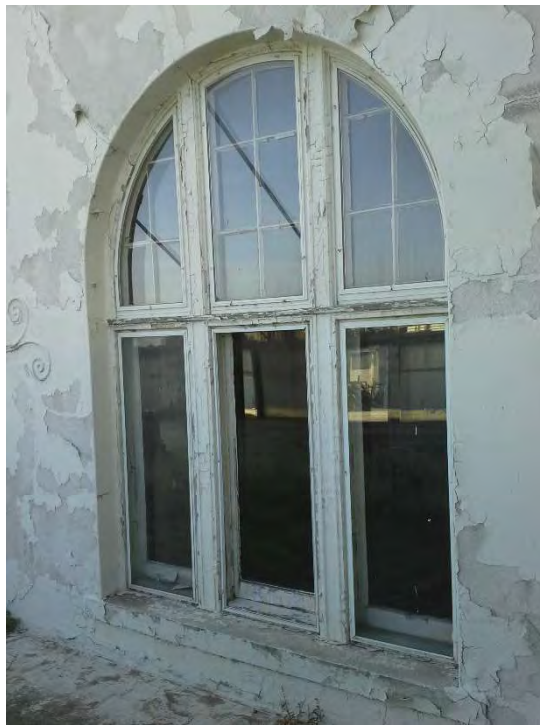
Photo 34 Historic Dining Room Windows

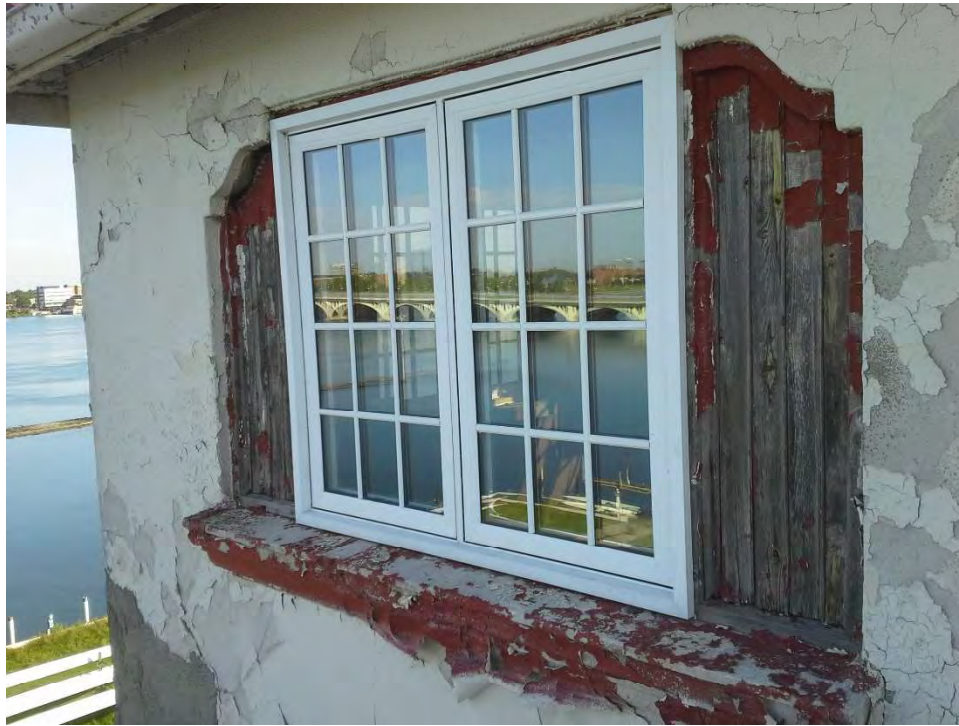
Photo 35 Modern Replacement Window

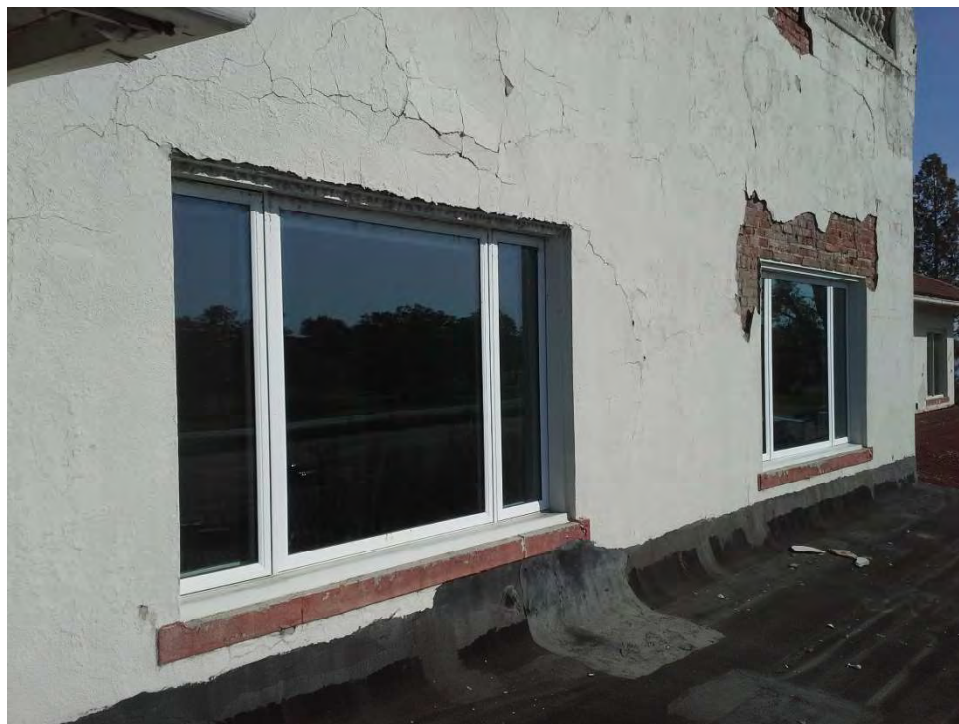
Photo 36 Modern Replacement Windows

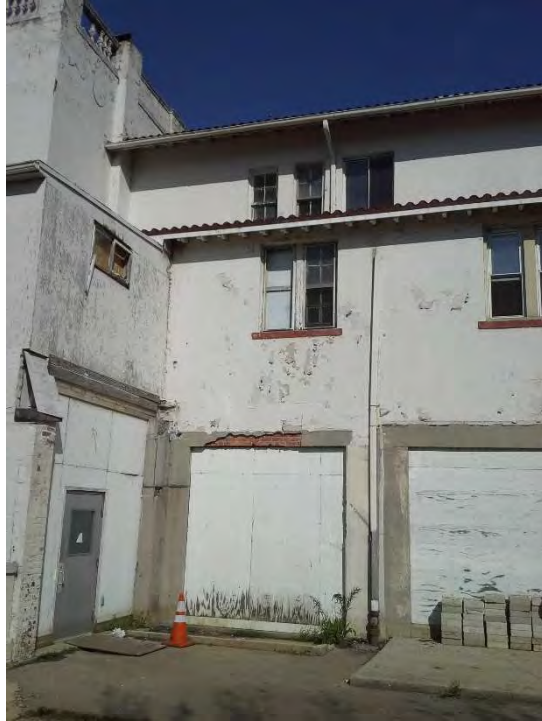
Photo 37 Various Infill Strategies

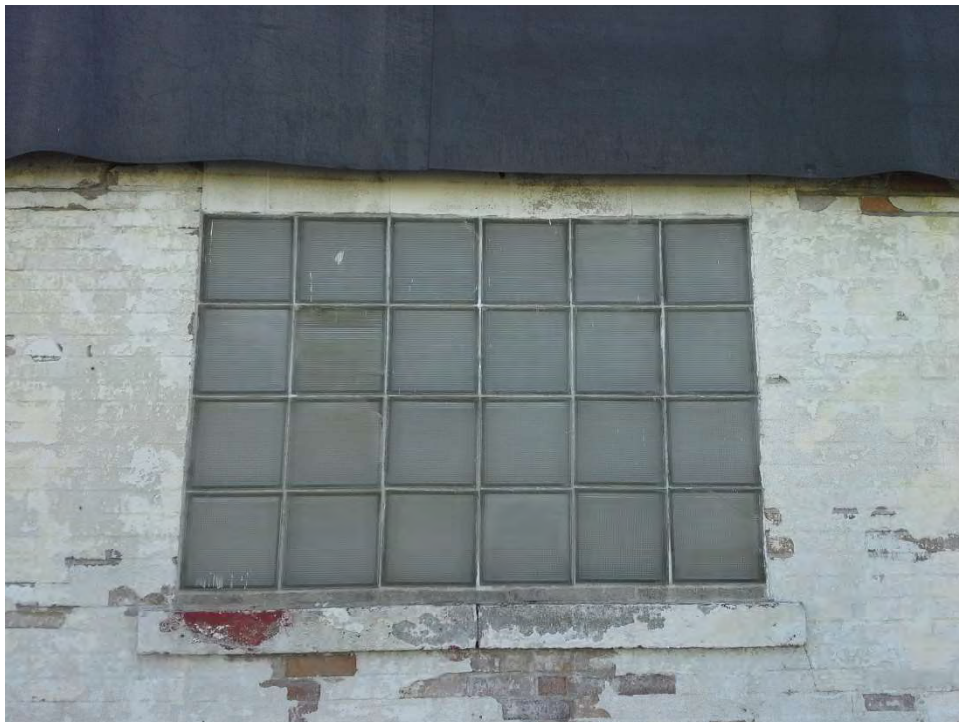
Photo 38 Glass Block Infill

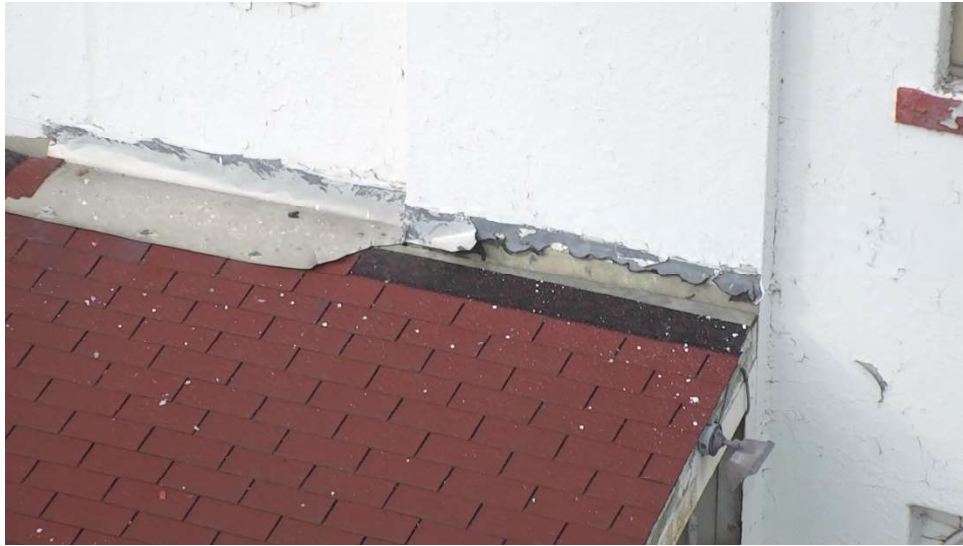
Photo 49 Shingle Roof

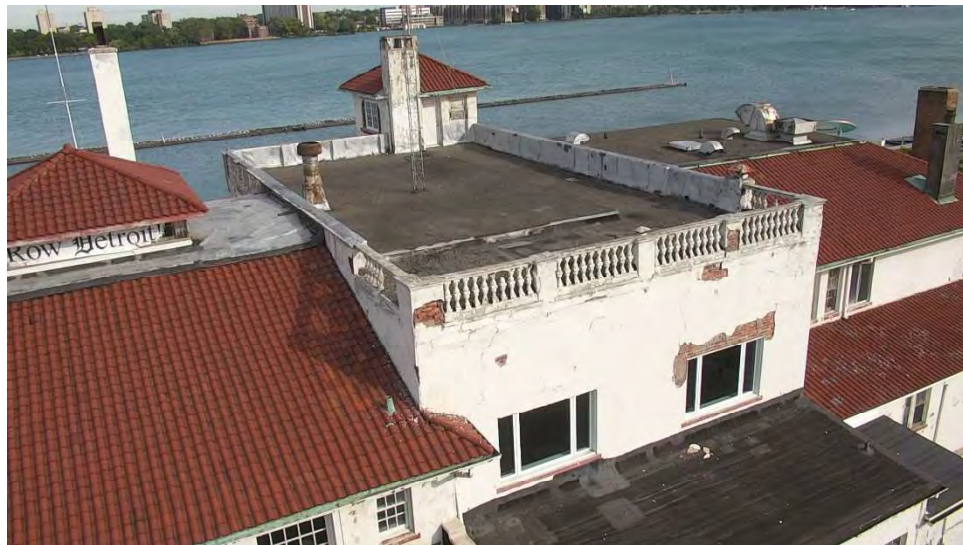
Photo 50 Upper Low Slope Roofs

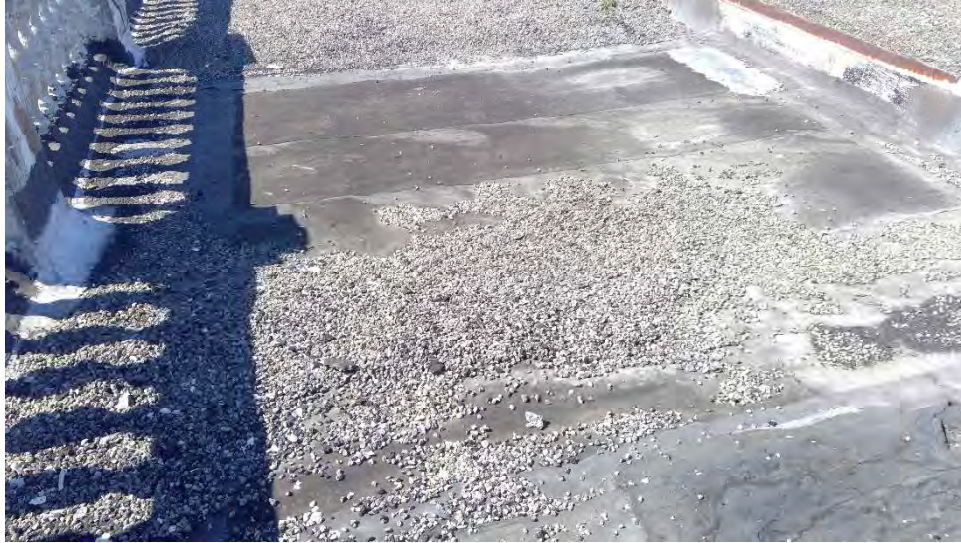
Photo 51 Multiple Roof Patches

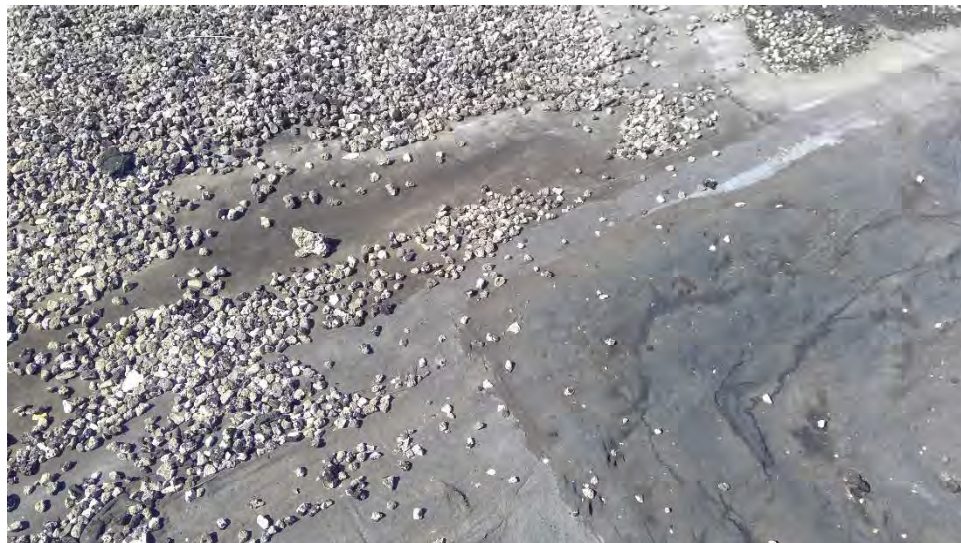
Photo 52 Scoured Roof Surface

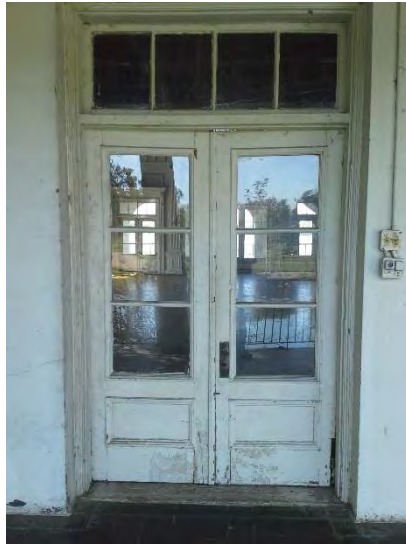
Photo 75 Wood Doors at Ballroom (South)

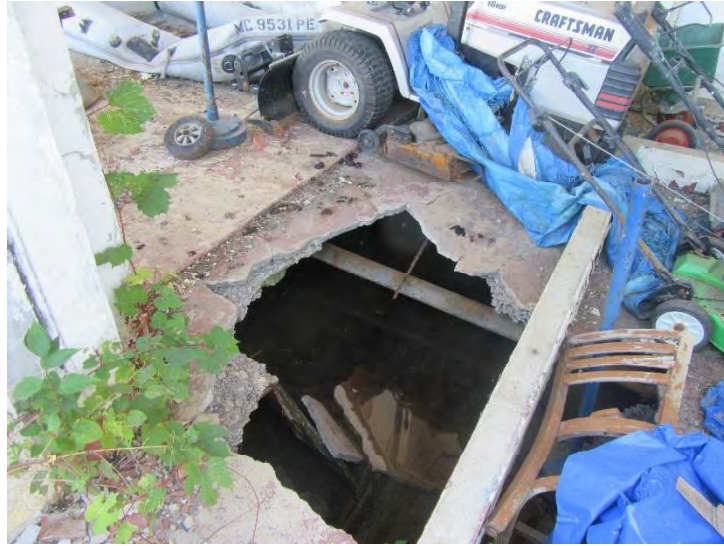
Photo 79 Hole in Pool Deck Below Northeast Terrace 2019

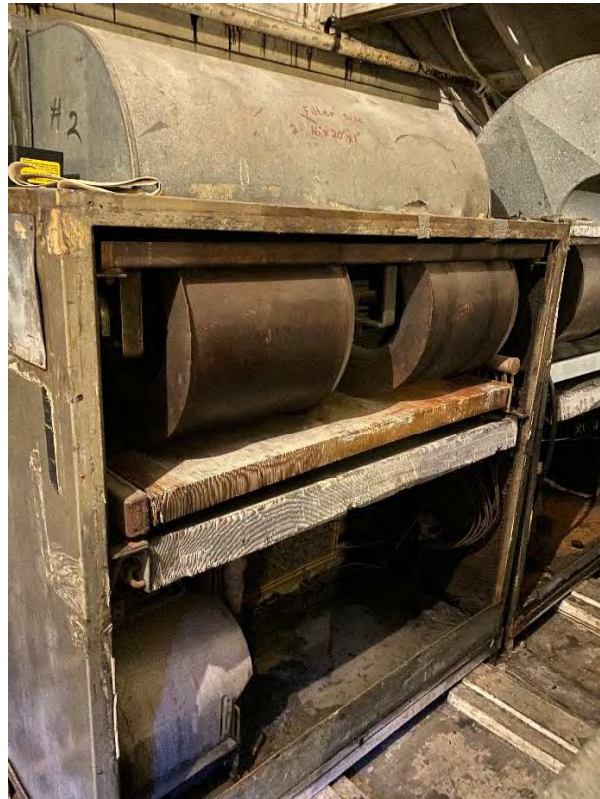
Photo 4

- Air Handling Unit serving second floor [Photo 1].
- Air Handling Units in attic space [Photos 2,3].
- Exhaust Fans in Ballroom [Photo 4]

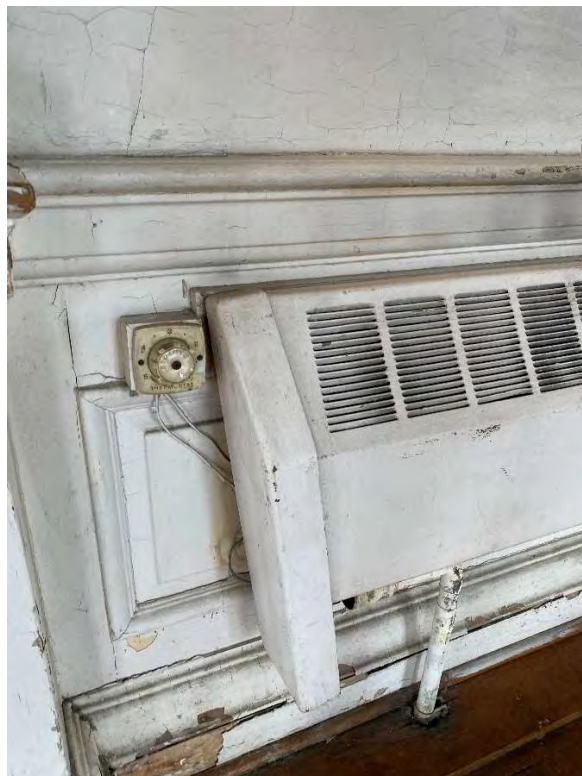
Photo 6

- Perimeter heat in ball room [Photos 6]

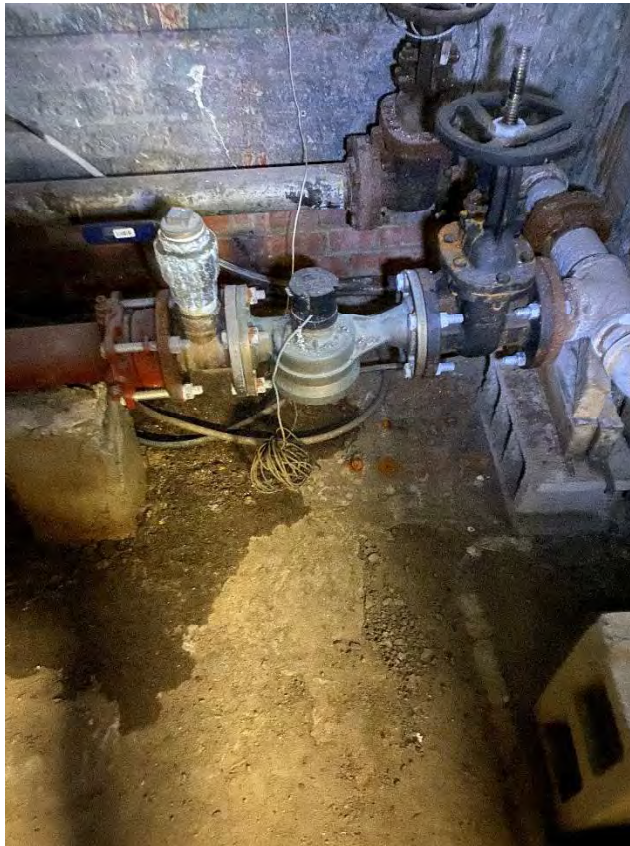
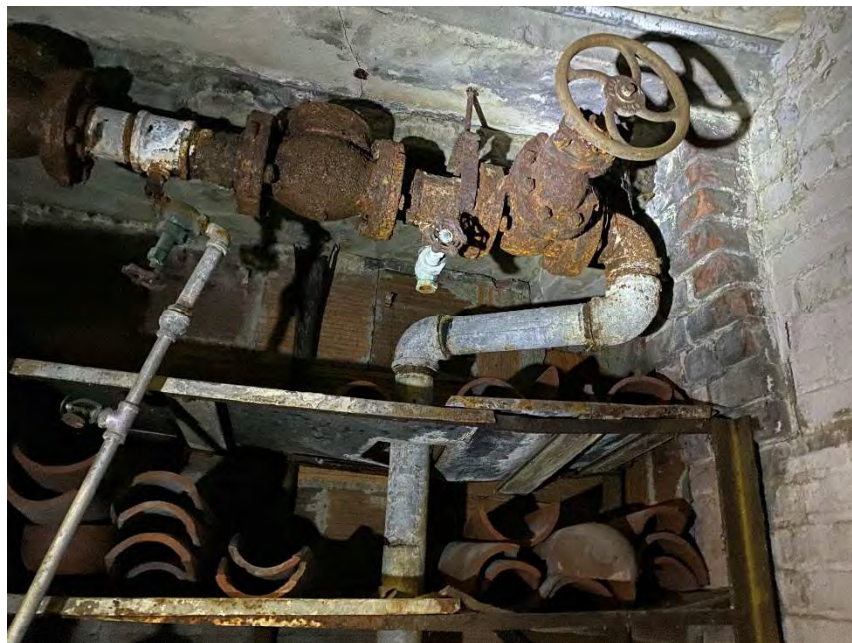
- Water main into the building [Photos 7,8]

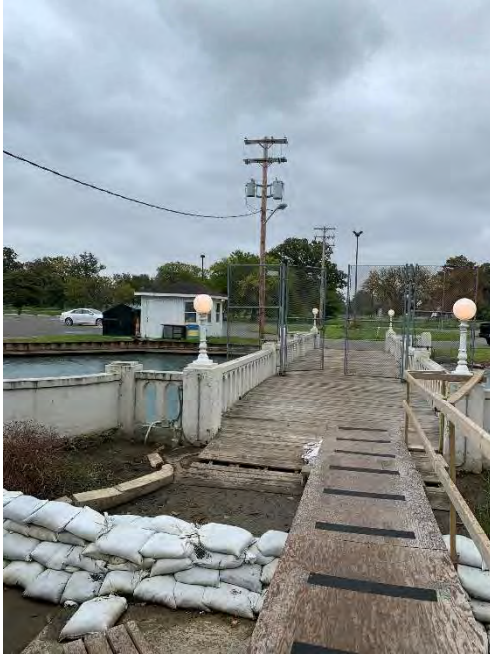
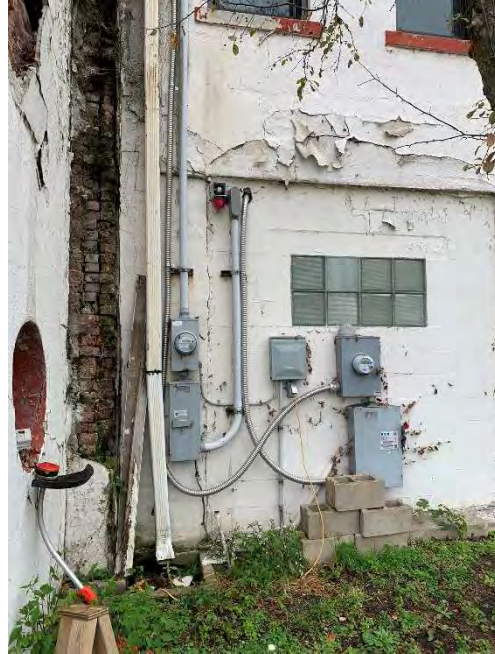
- Incoming overhead service and outdoor meters [Photos 1, 2].
- Sections of abandoned service equipment [Photos 3, 4].

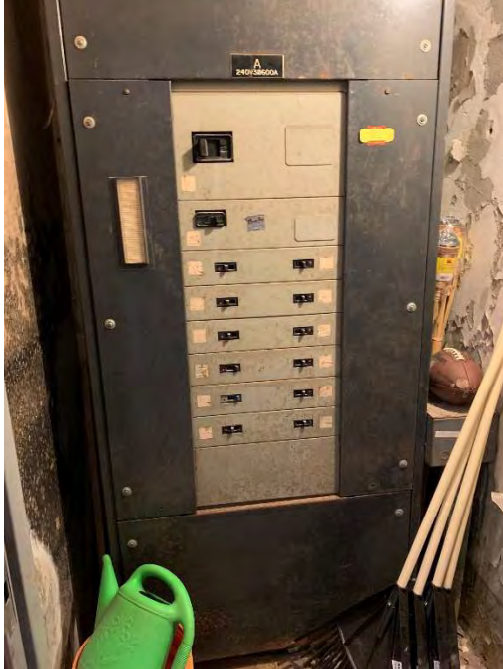
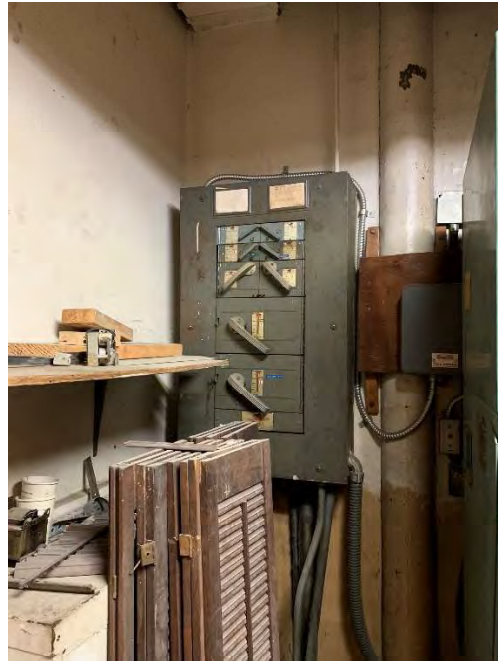
- Distribution Panelboards [Photos 5, 6].
- Branch Circuit Panelboards [Photos 7, 8].

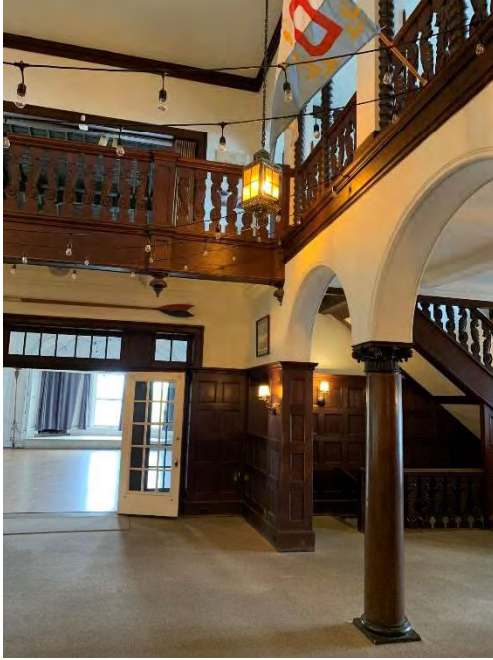
Photo 9

- Historic/Original hanging light fixture **[Photo 9]**.
- Historic/Original wall sconce light fixture **[Photo 10]**.

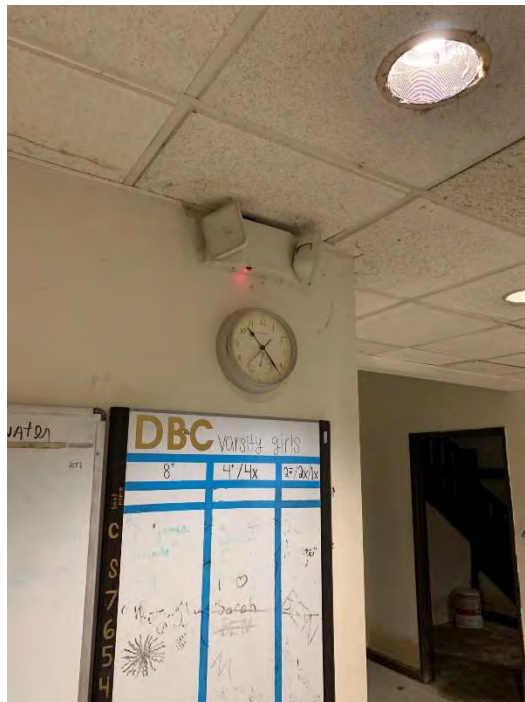
Photo 11

- Wall-mounted emergency lighting battery pack **[Photo 11]**.
