Edenville Dam Inspection Report

Dam Identification No.: 549
Hazard Potential: High
SE ¼ Section : T.17N. – R.01W.
Tobacco Township, Gladwin County, Michigan
Located on Tobacco & Tittabawassee Rivers
Per Part 315, Act 451 of 1994

Date of Inspection: June 2019 to March 2020

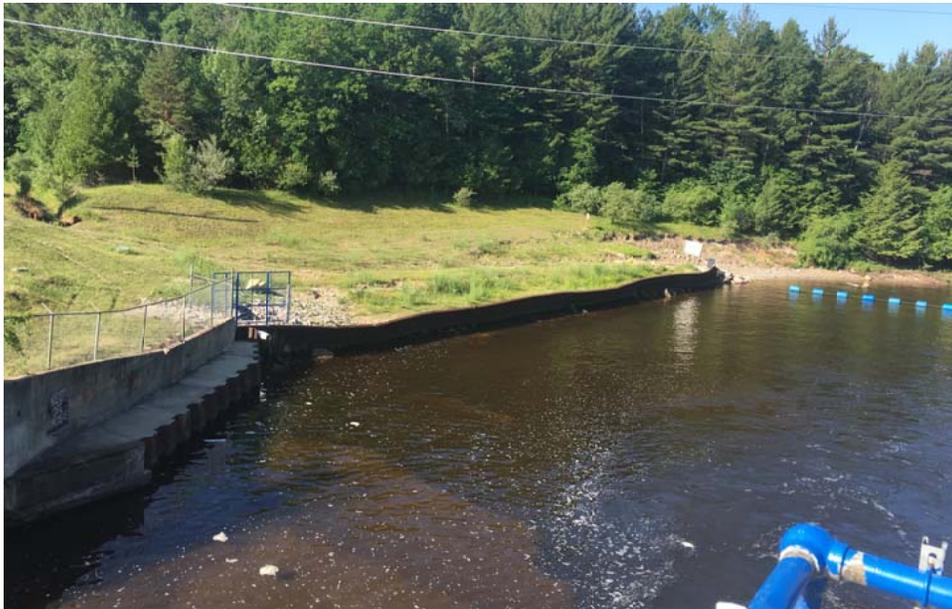
15 - Lower End of Left Training Wall & Sheetpile Retaining Wall in Tailrace - Sheetpile has Failed

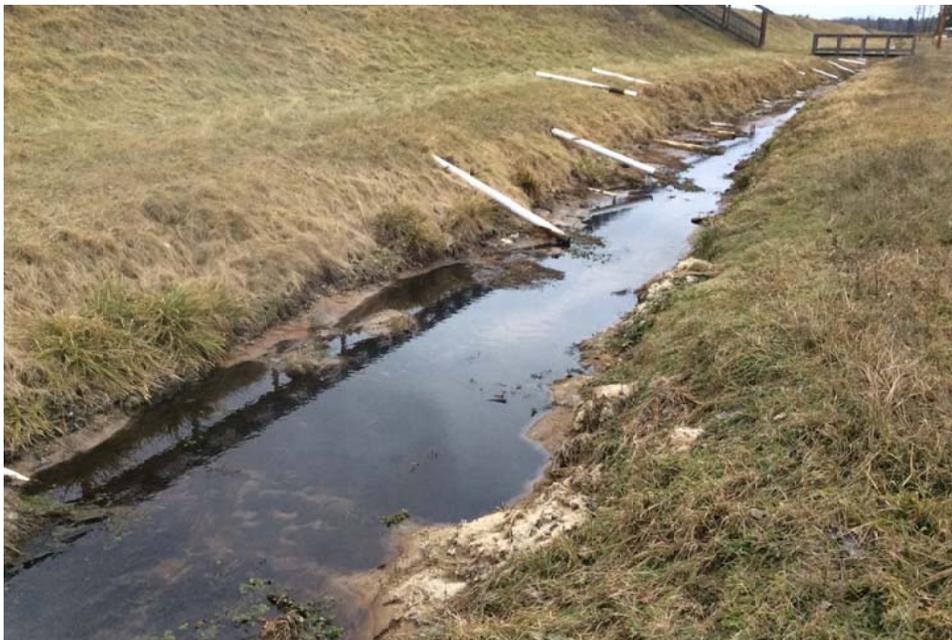
27 - Right Embankment - Broken/Submerged Seepage Tiles, Looking Northeast

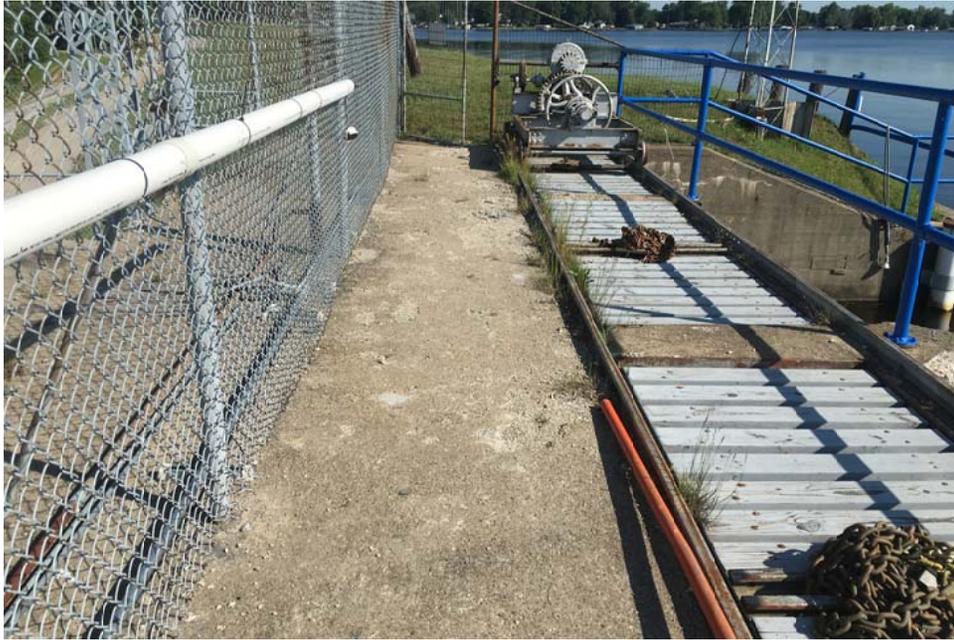
41 - Head Gate Hoist System

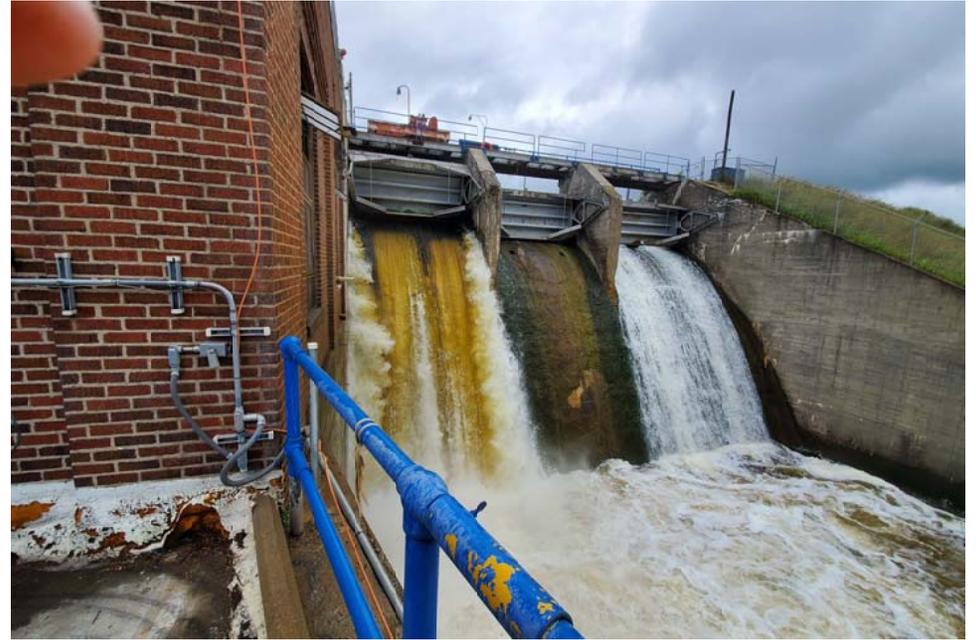
42 - Downstream Face of the Rollway

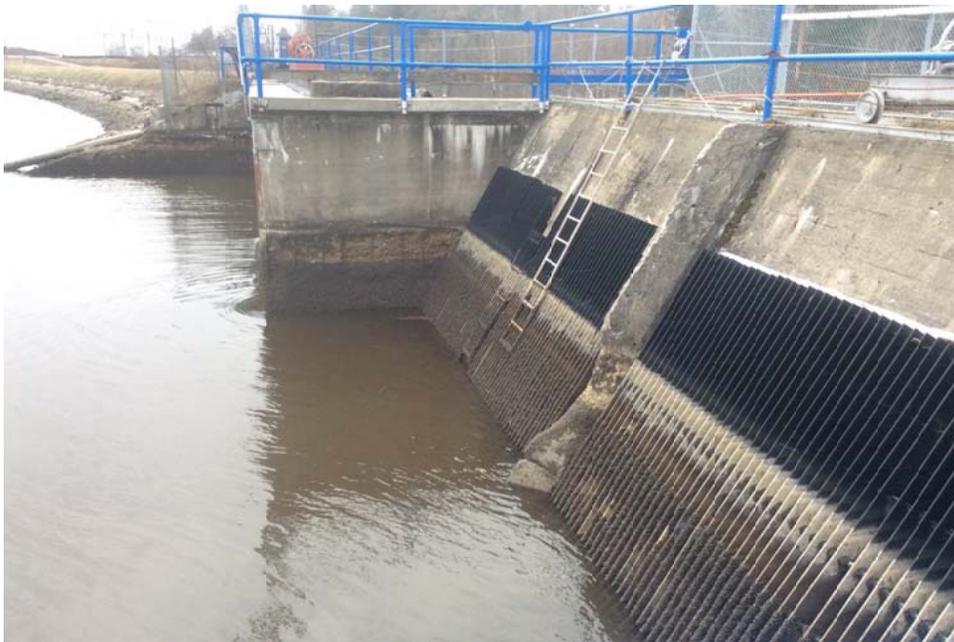
43 - Powerhouse Trash Rack

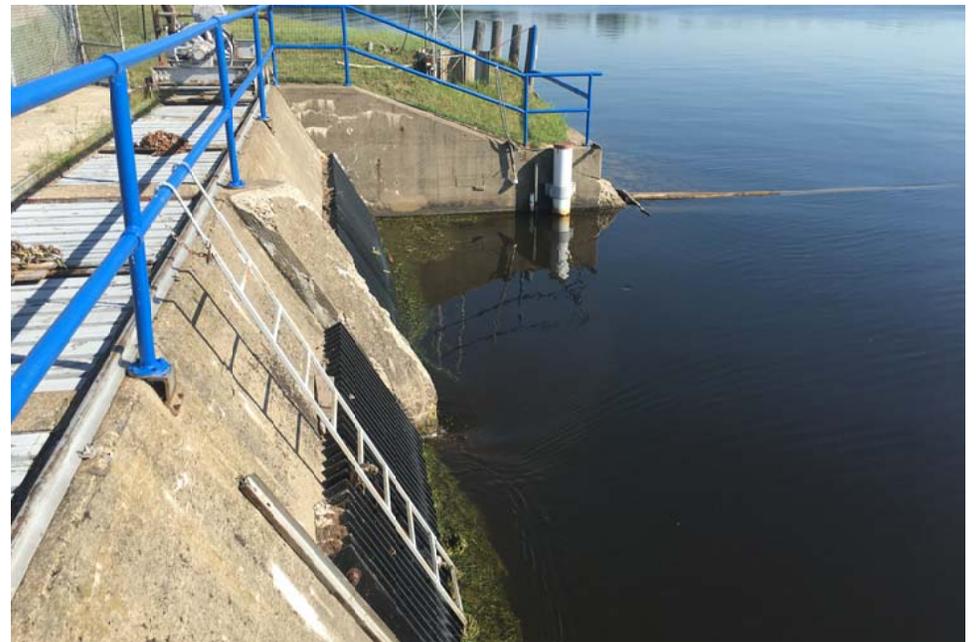
44 - Powerhouse Trash Rack

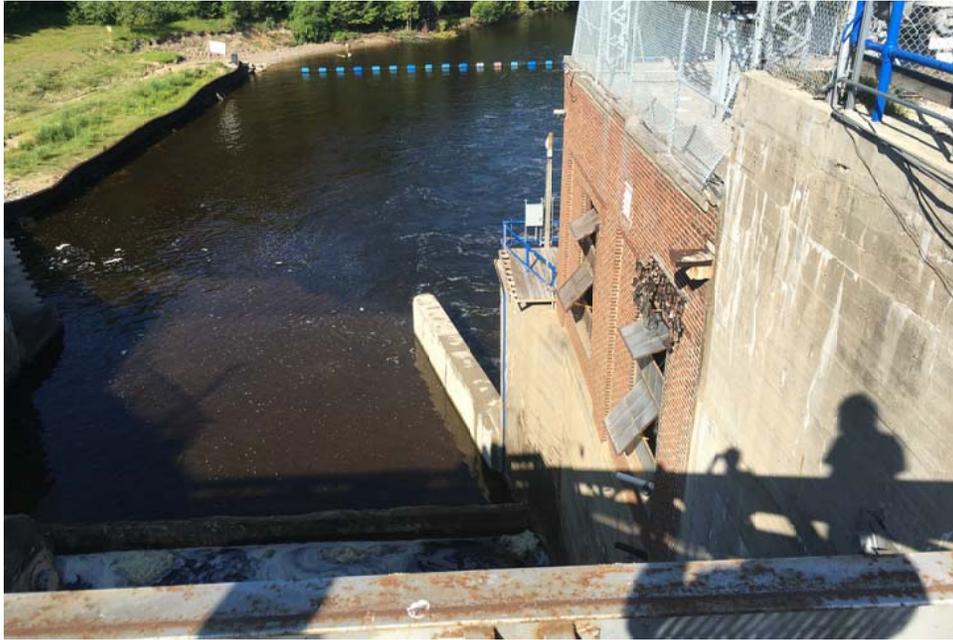
45 - Top Overview of Powerhouse Wall & Divider Wall

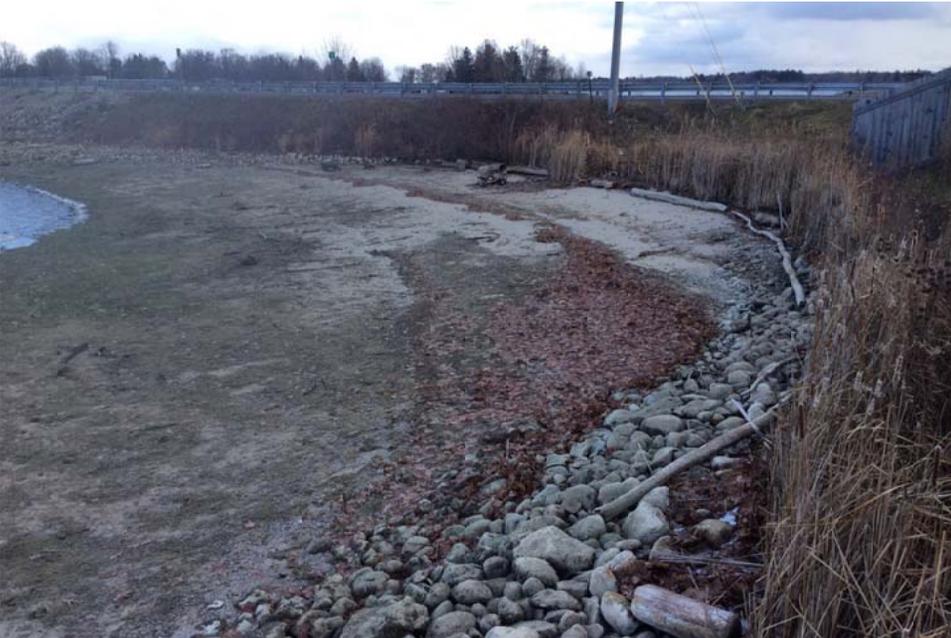
1 - Left Embankment near M-30

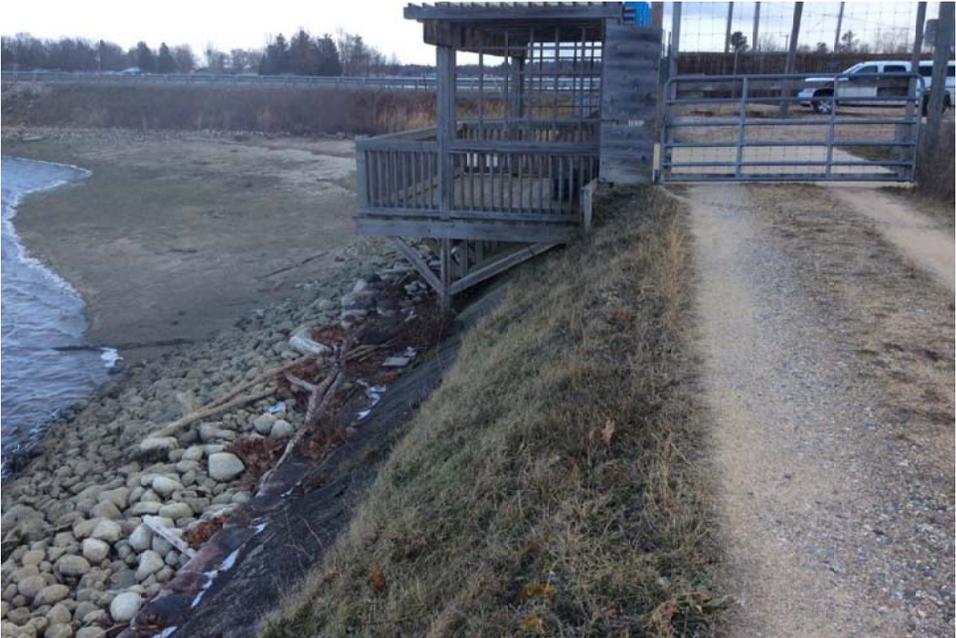
2 - Left Embankment at Gate

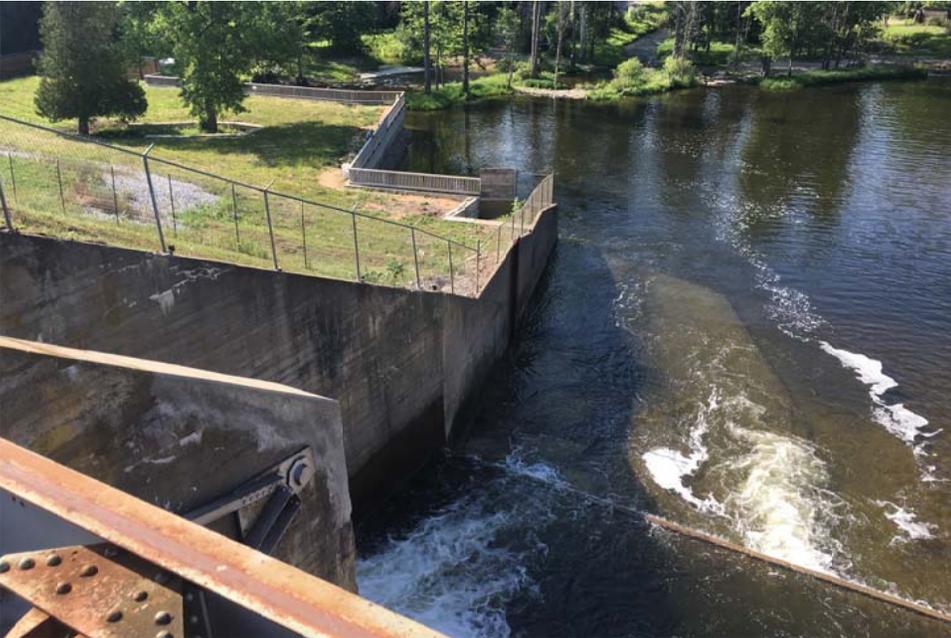
3 - Left Training Wall

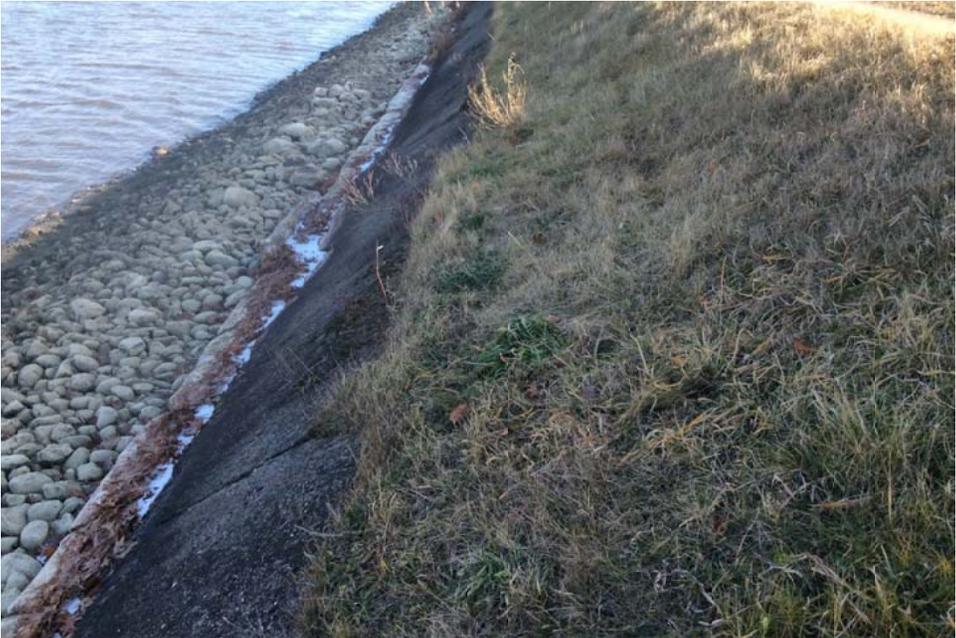
4 - Left Embankment - Upstream Slope, Looking East

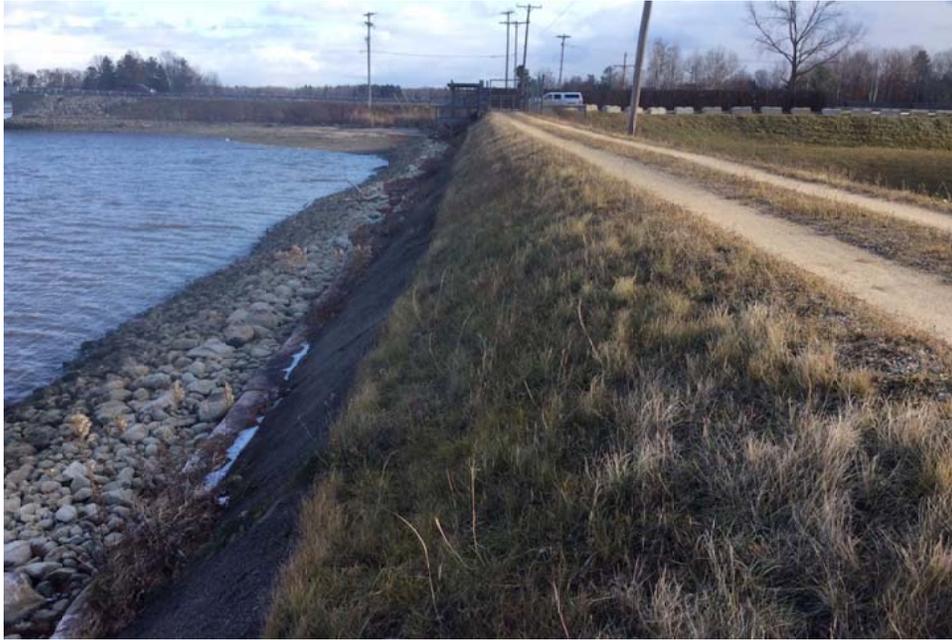
5 - Left Embankment - Upstream Slope Armored with Concrete, Looking East

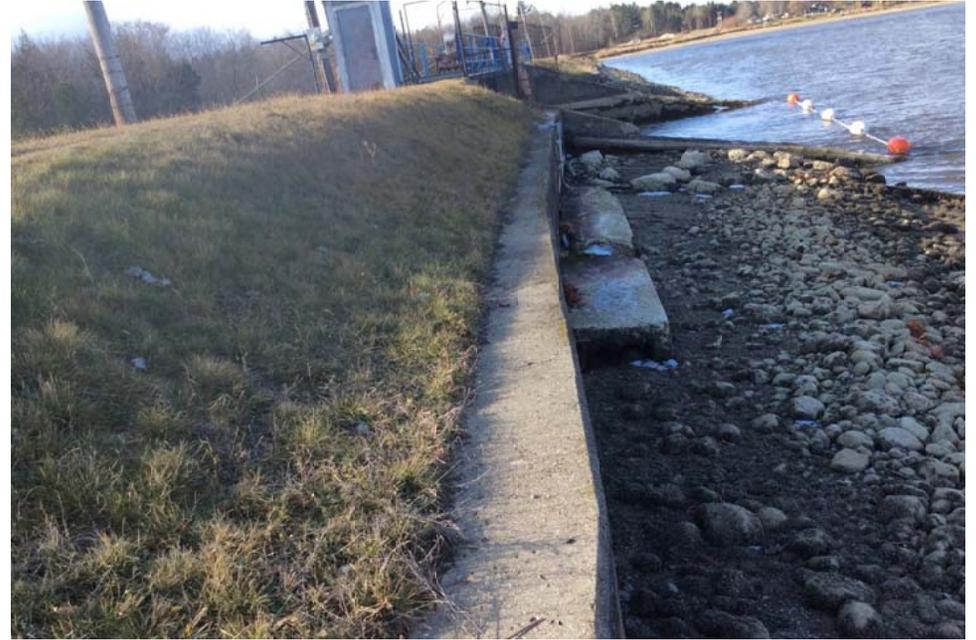
6 - Left Embankment - Upstream Concrete Wall, Looking West

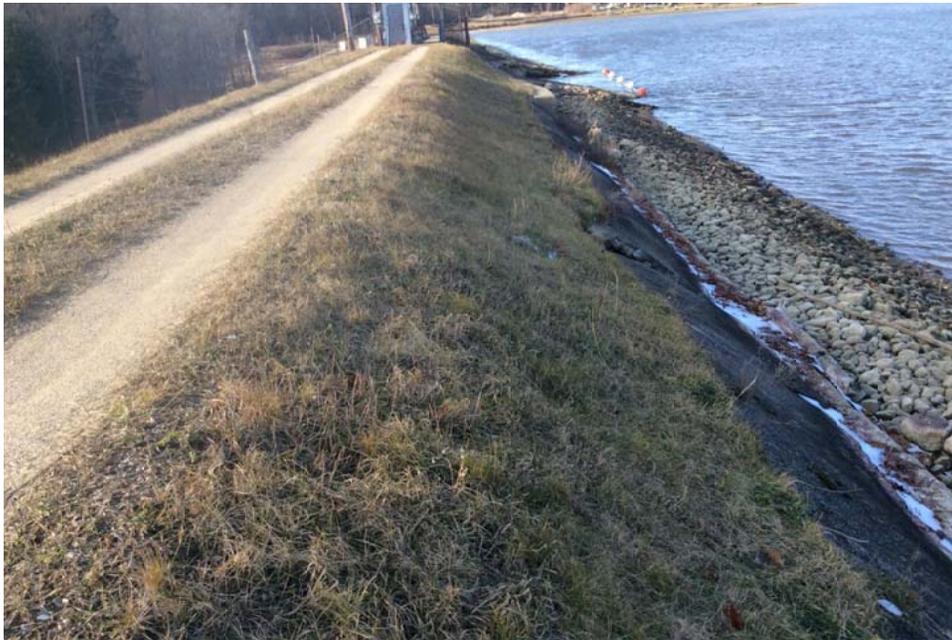
7 - Left Embankment - Upstream Slope near Spillway, Looking West

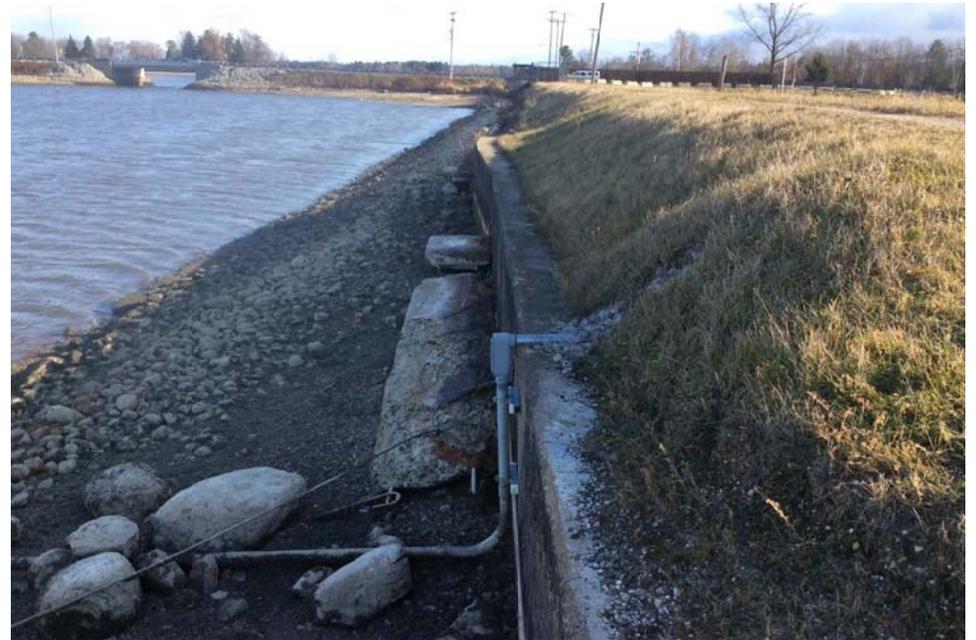
8 - Left Embankment, Looking East

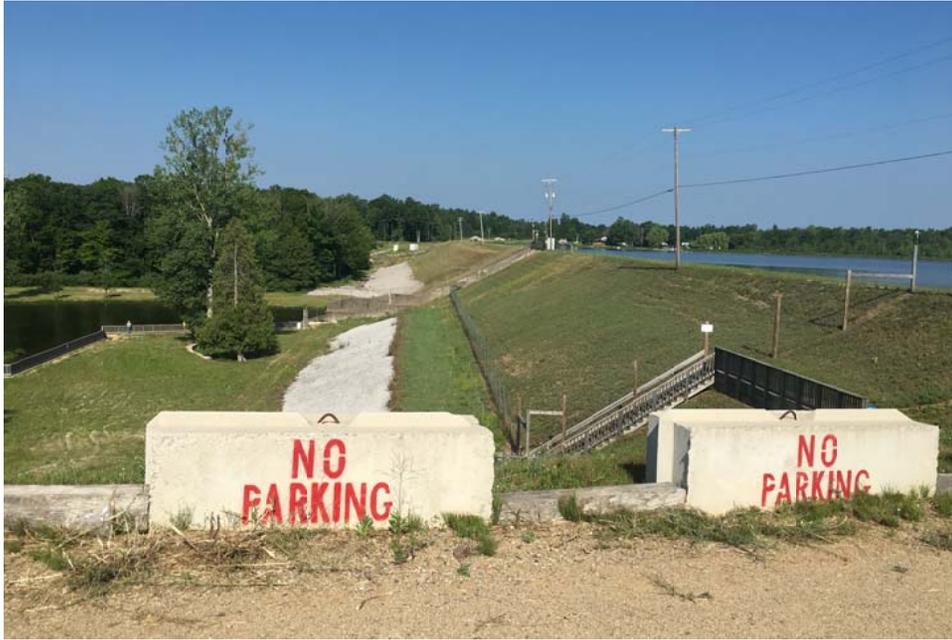
9 - M-30 Parking Lot looking at the Downstream Side of Left Embankment

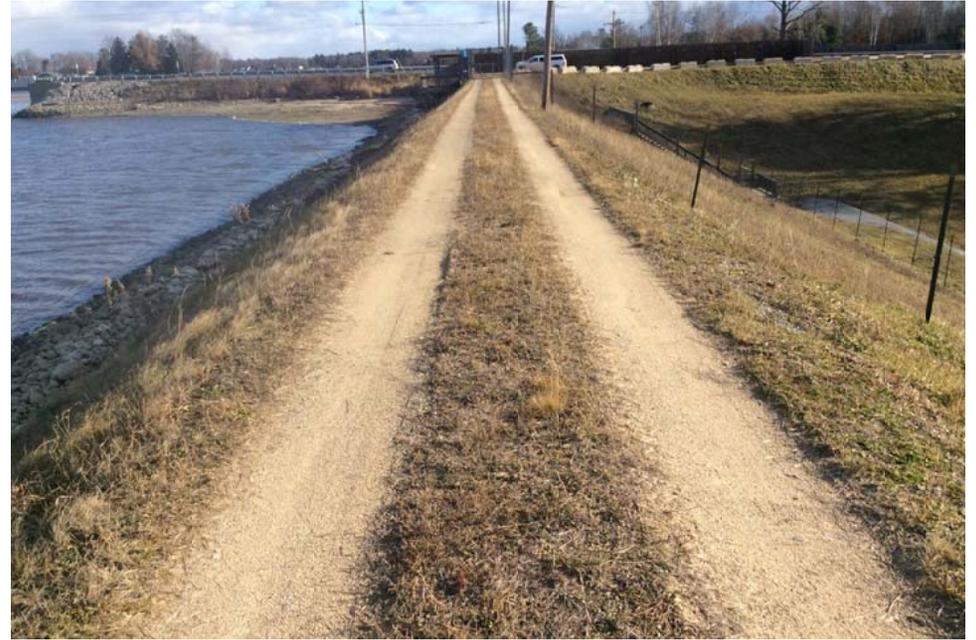
10 - Left Embankment - Access Drive, Looking East towards M-30

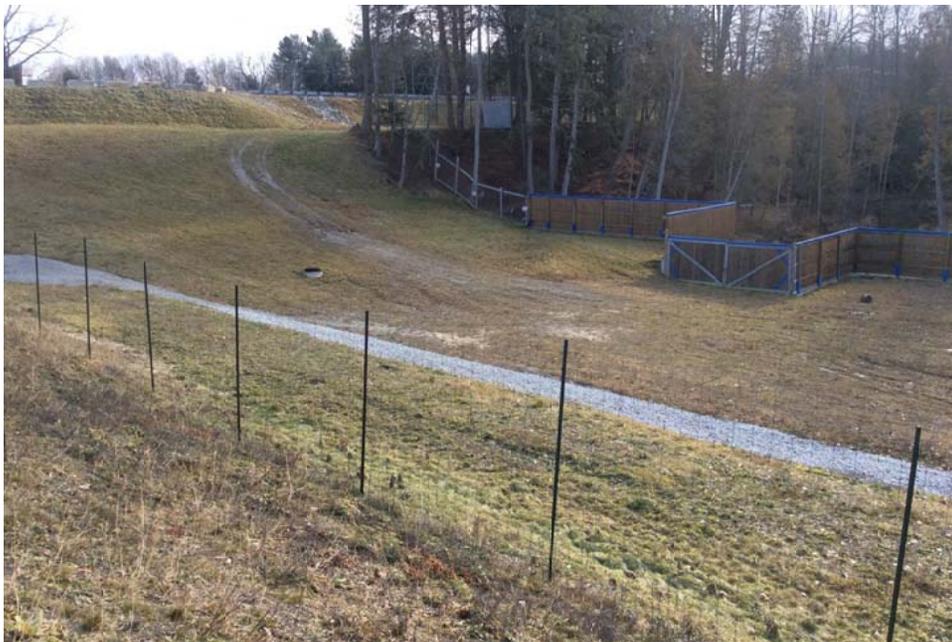
11 - Left Embankment - Downstream Slope, Looking Southeast

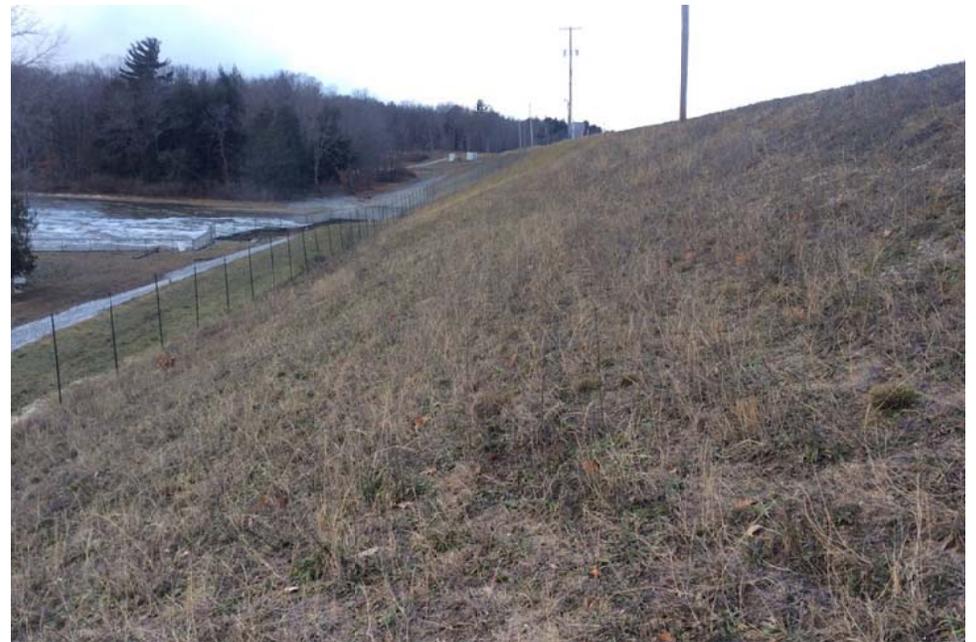
12 - Left Embankment - Downstream Slope, Looking towards Spillway

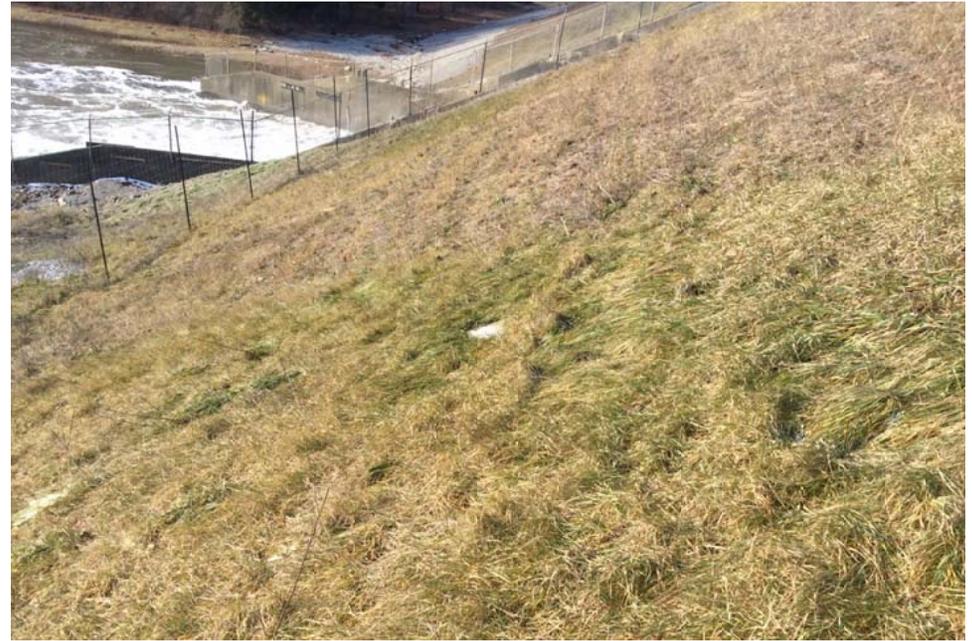
14 - Left Embankment - Downstream Slope, near Spillway

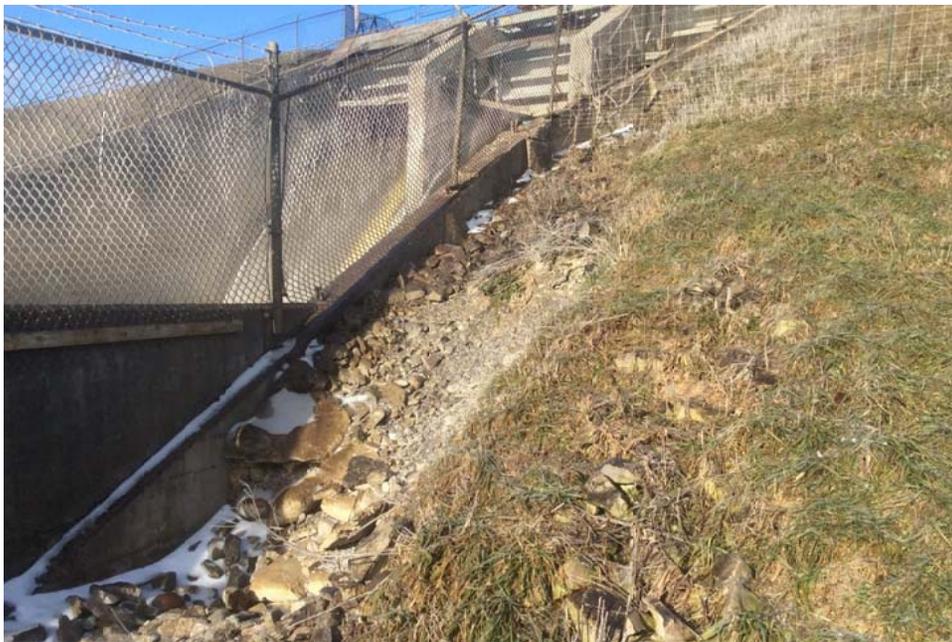
15 - Left Embankment - Erosion at Left Training Wall

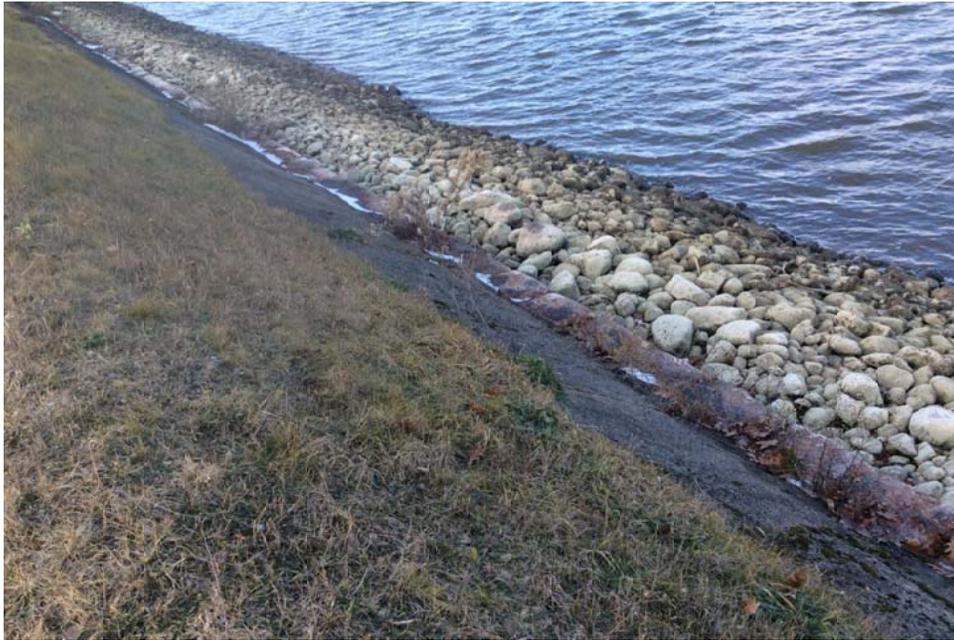
17 - Left Embankment - Upstream Slope, Looking Northwest

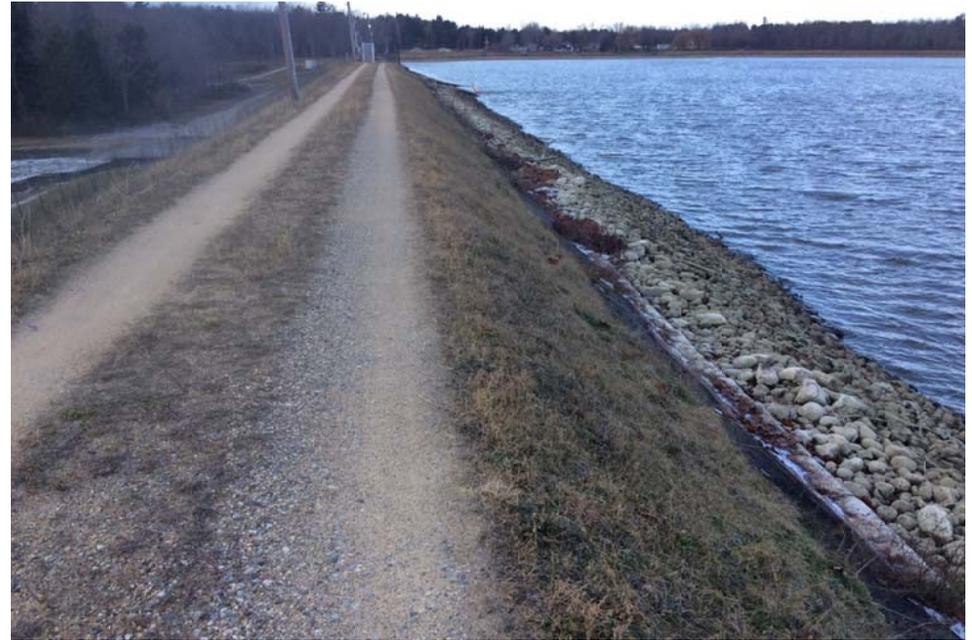
18 - Left Embankment - Upstream Slope, Looking West towards Spillway

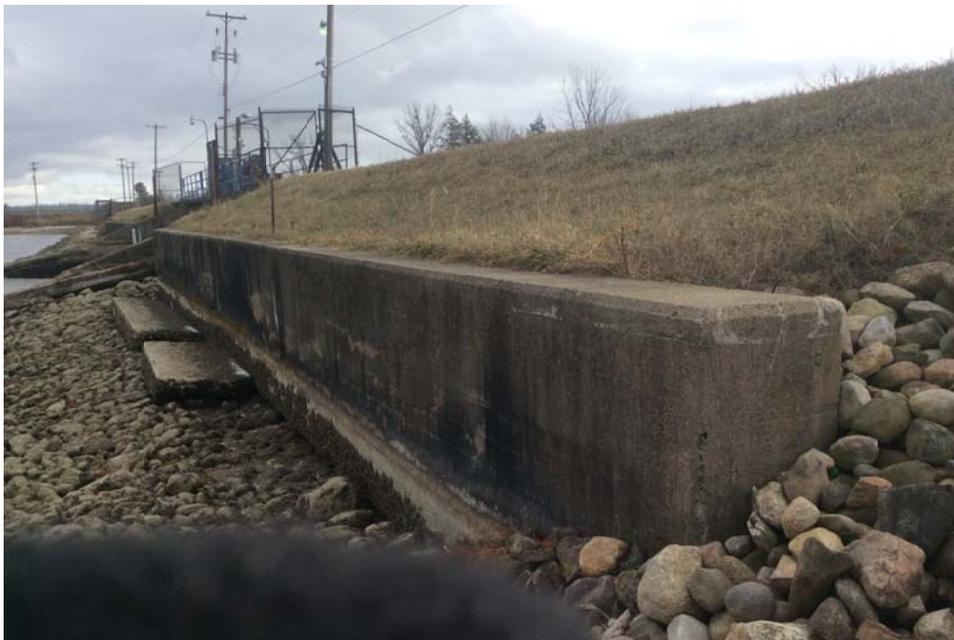
Retaining walls exist primarily at the spillway structures and serve to support the upstream face of the embankment. These concrete retaining walls also serve as the cap to the sheet pile cutoff wall beneath. In addition, a retaining wall exists in the tailrace area on the Edenville spillway side. This wall also acts as an erosion control measure, however as shown in the photos of Appendix C, this wall is in poor condition.

19 - Right Embankment - Upstream Concrete Wall

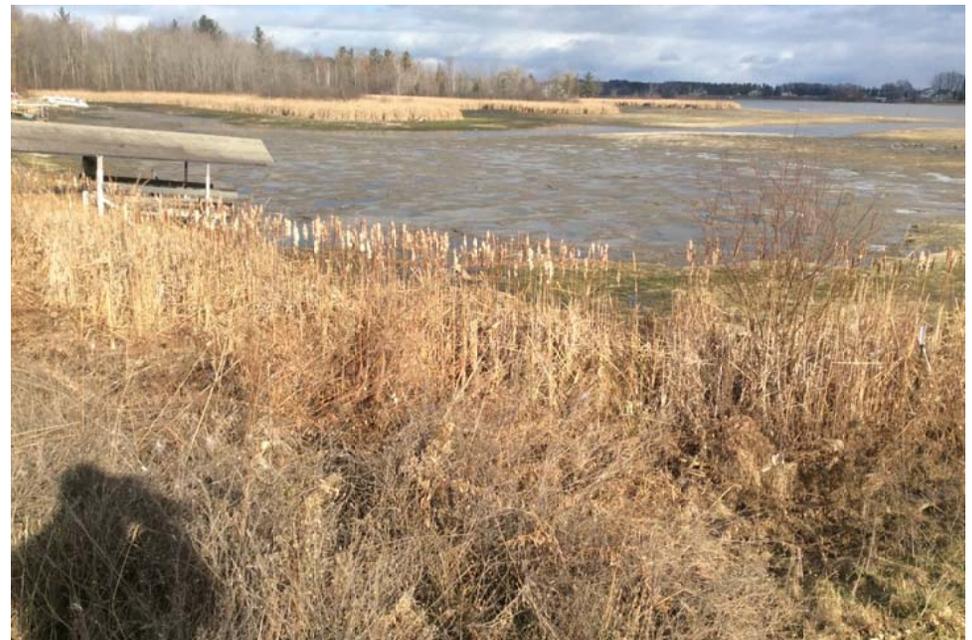
20 - Right Embankment, Westerly Side of Dam

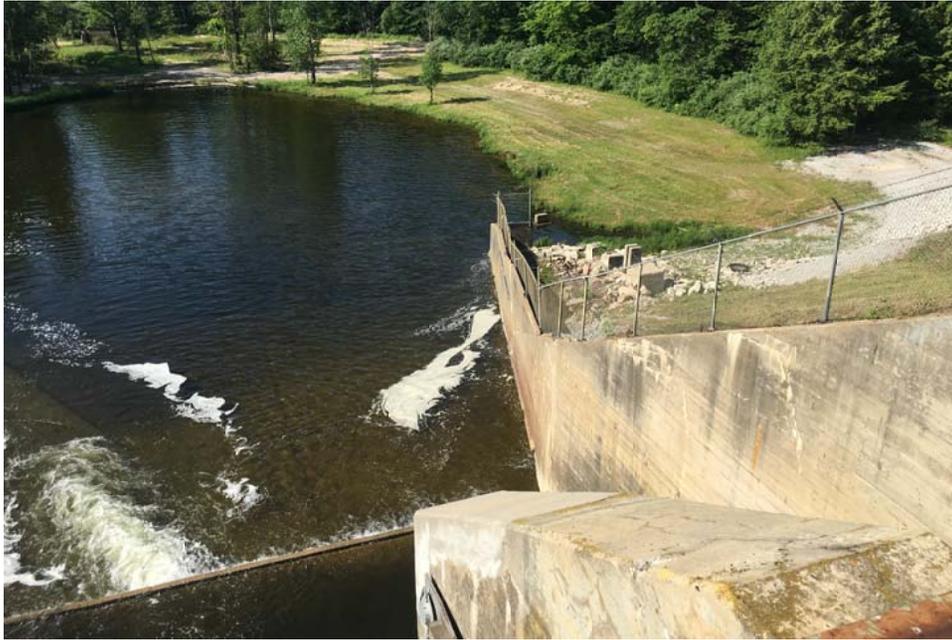
21 - Right Retaining Wall

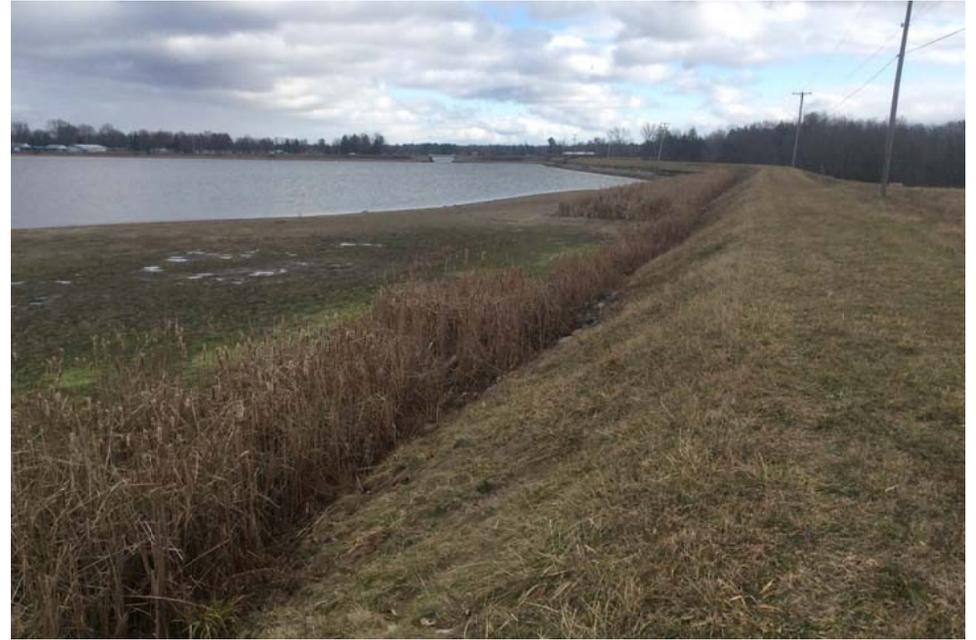
22 - West Embankment - Upstream Face, Looking Southeast

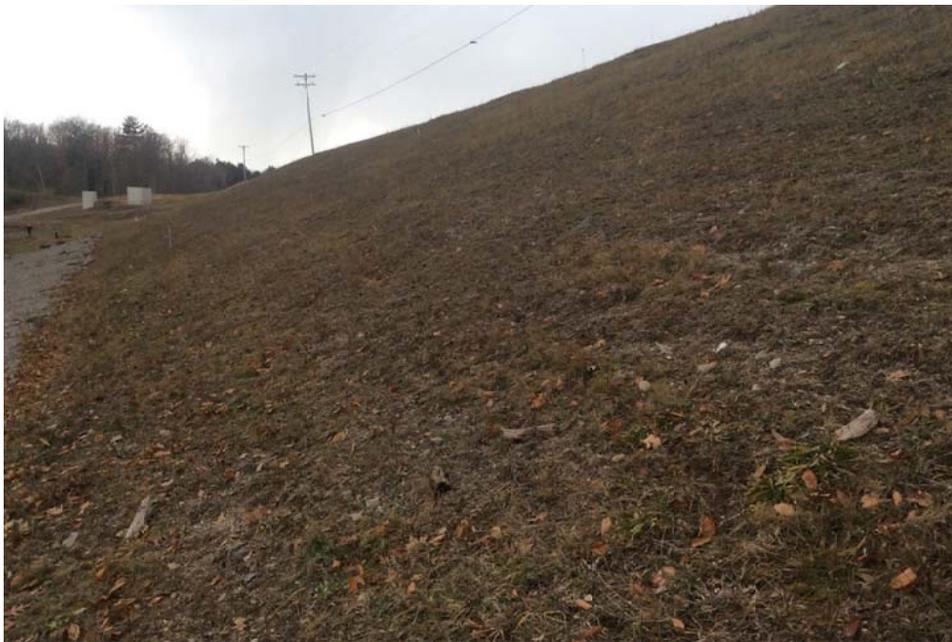
23 - Right Embankment - Downstream Slope, Looking West

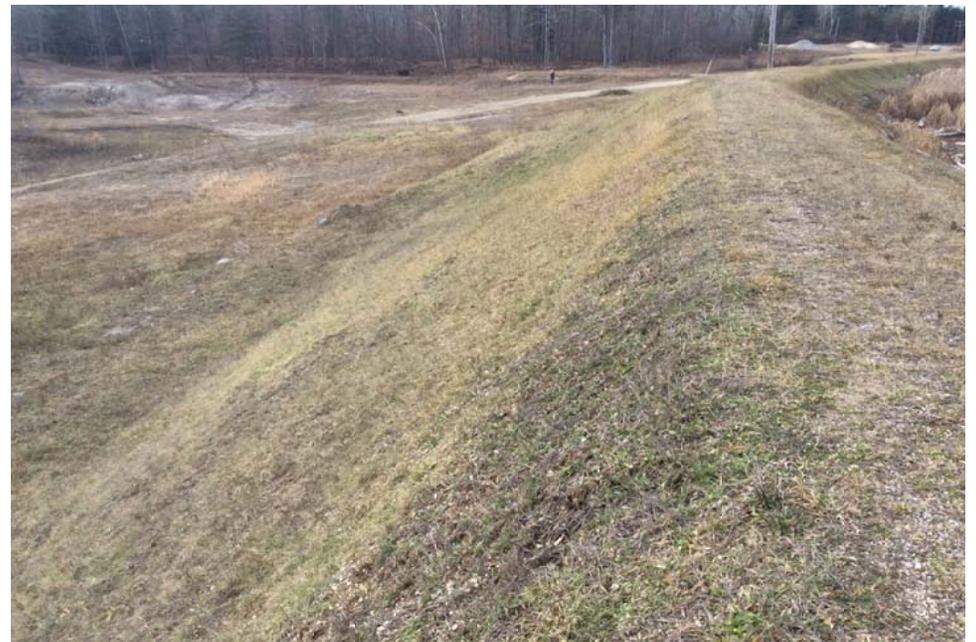
24 - Right Embankment - Downstream Slope at Bend

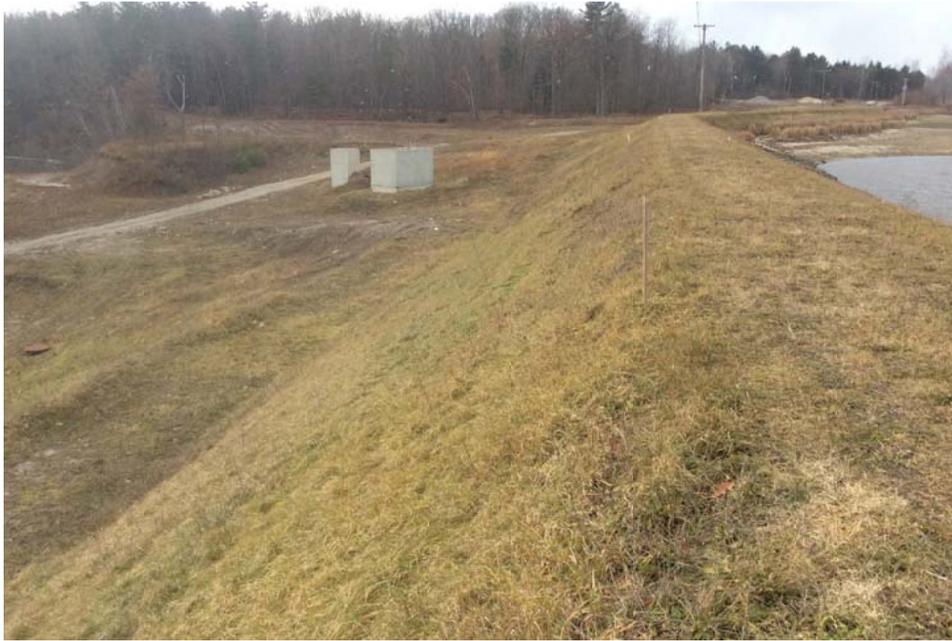
25 - Right Embankment - Downstream Slope near Bend

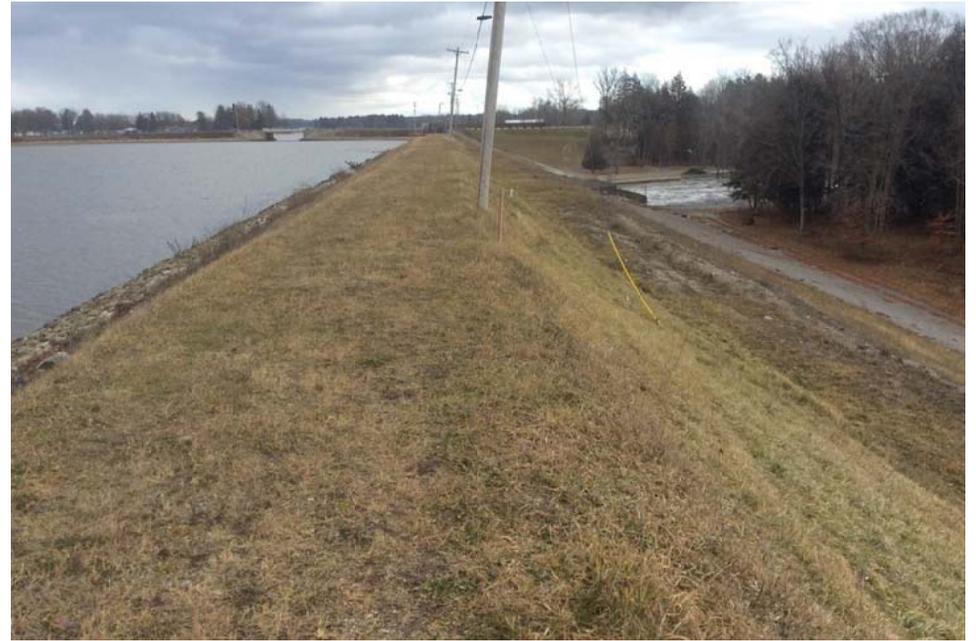
26 - Right Embankment, Looking towards M-30

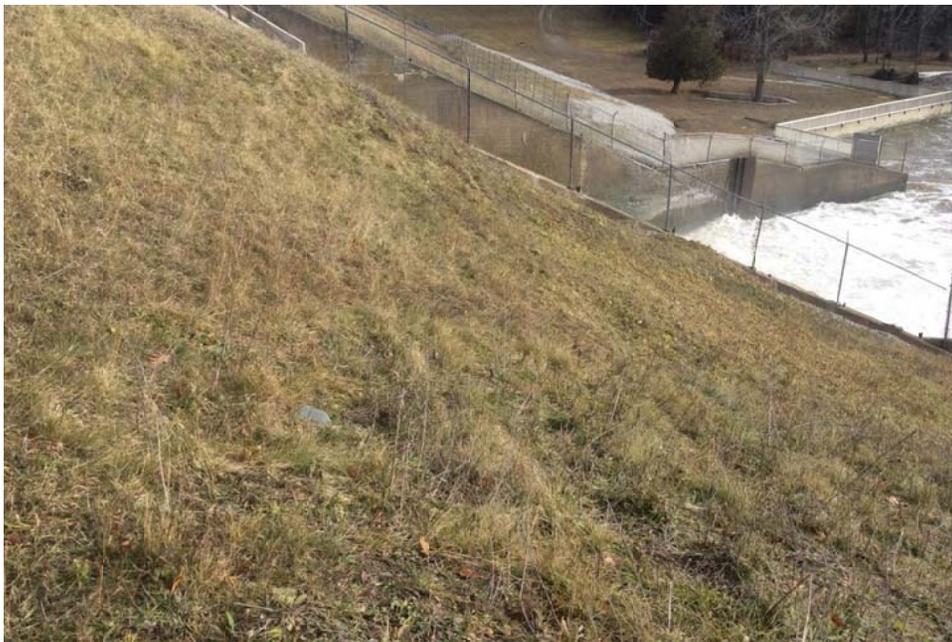
27 - Right Embankment near Spillway

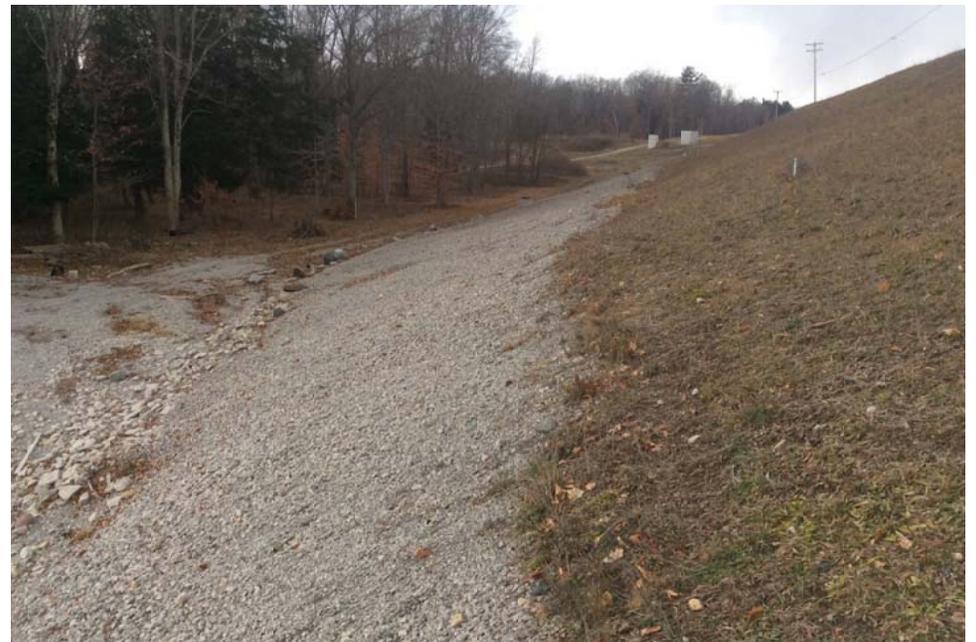
28 - Right Embankment - Downstream Toe of Slope, Looking West

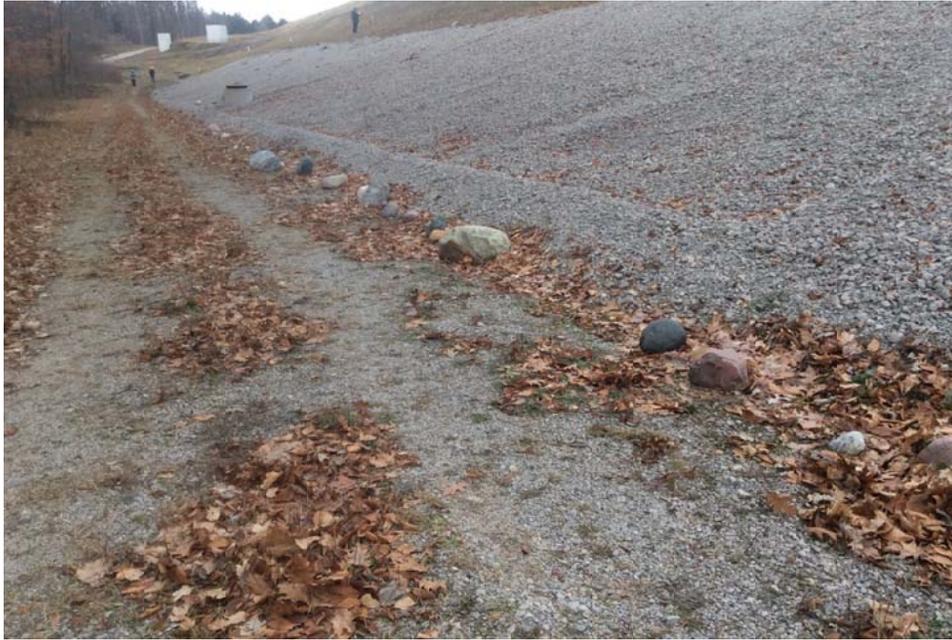
29 - Right Embankment - Downstream Slope, Looking West

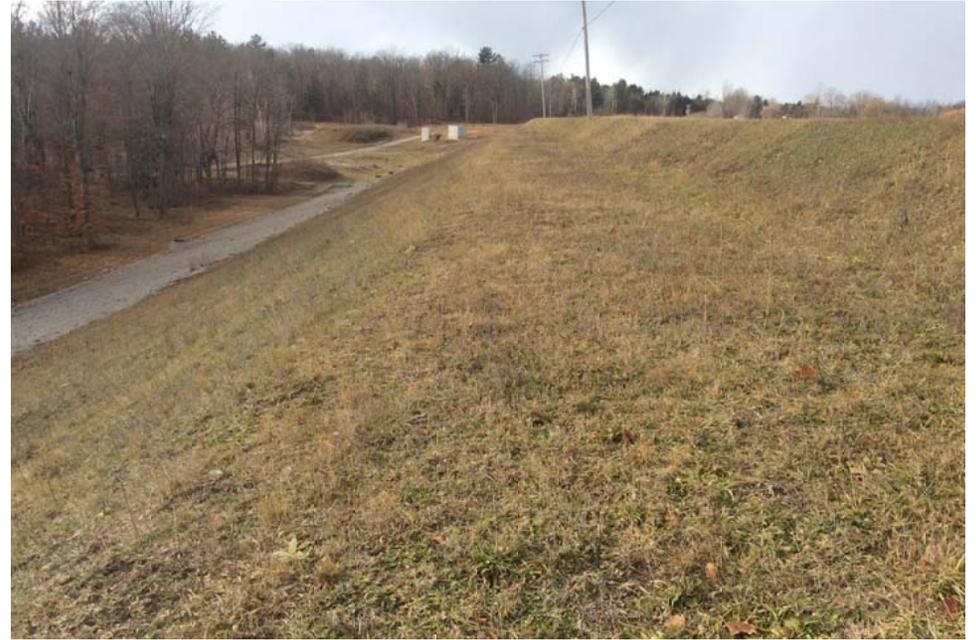
30 - Right Embankment - Downstream Slope

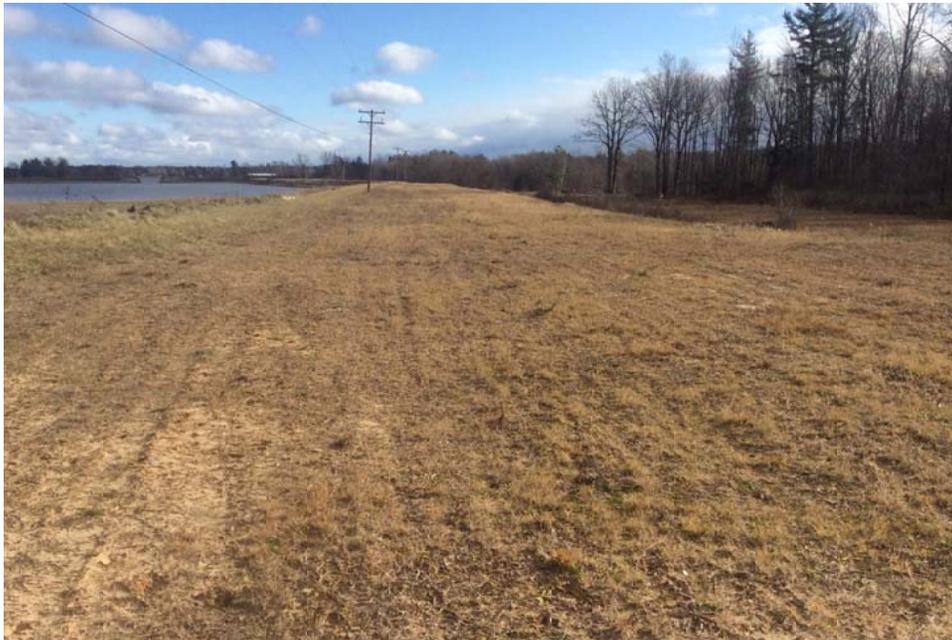
31 - Right Embankment - Far West Side of Project, Looking East
