Edenville Dam Inspection Report

Dam Identification No.: 549
Hazard Potential: High
SE ¼ Section : T.17N. – R.01W.
Tobacco Township, Gladwin County, Michigan
Located on Tobacco & Tittabawassee Rivers
Per Part 315, Act 451 of 1994

Date of Inspection: June 2019 to March 2020

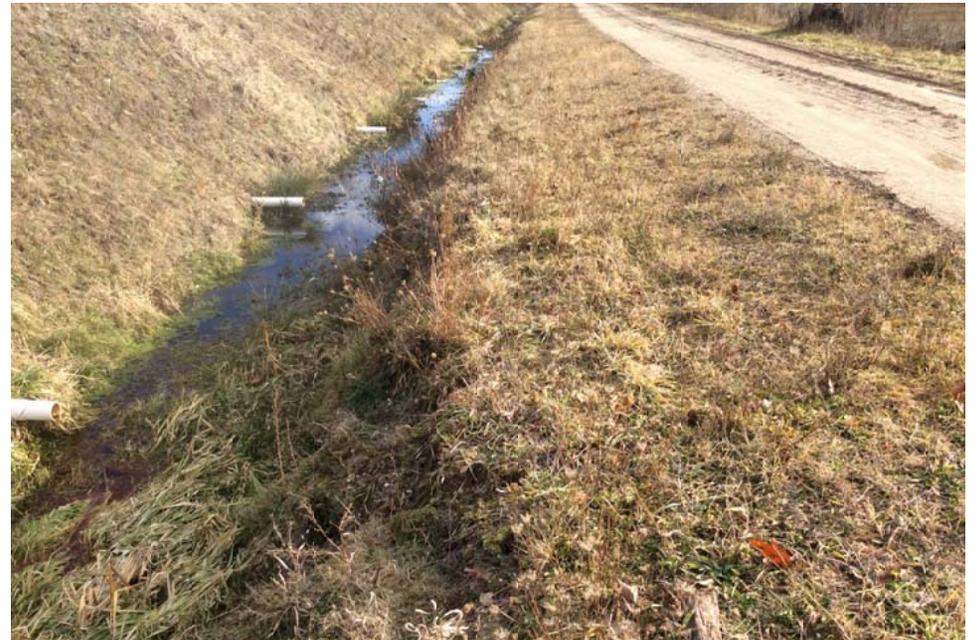
32 - Right Embankment - Seepage Tiles, Looking East

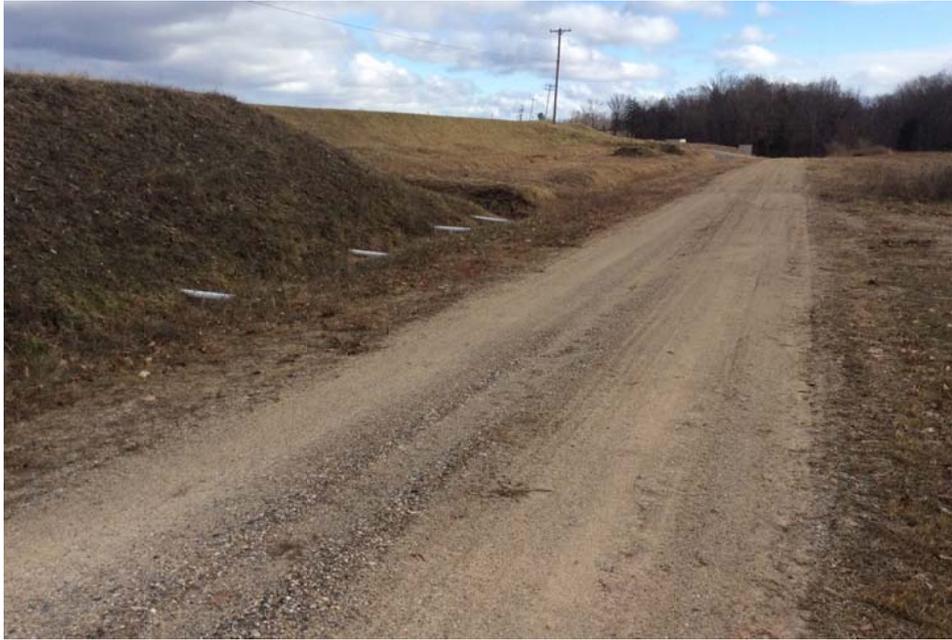
33 - Right Embankment - Seepage Tiles, Looking Southeast

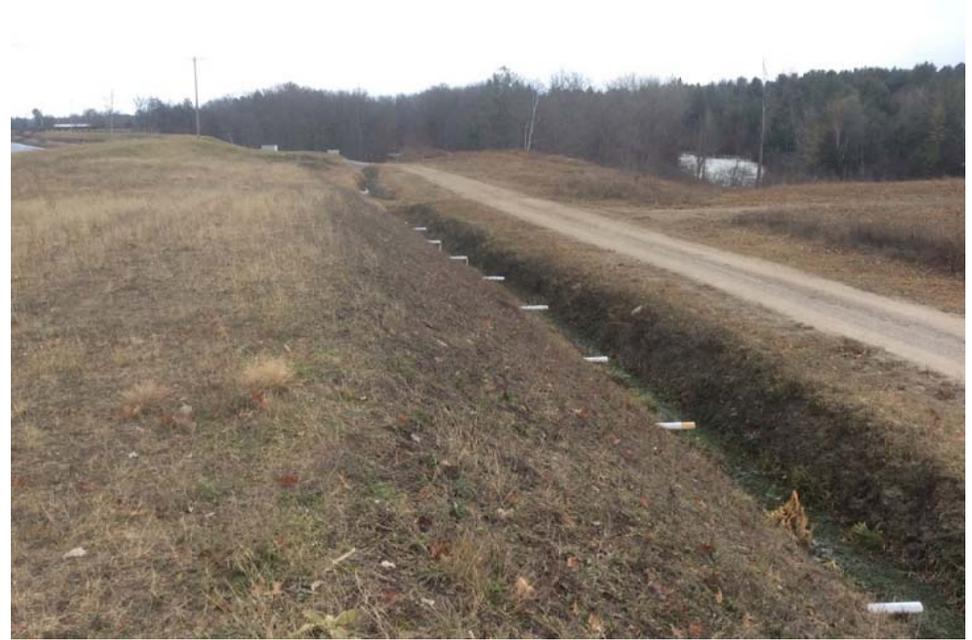
34 - Right Embankment - Seepage Tiles, Looking Southeast

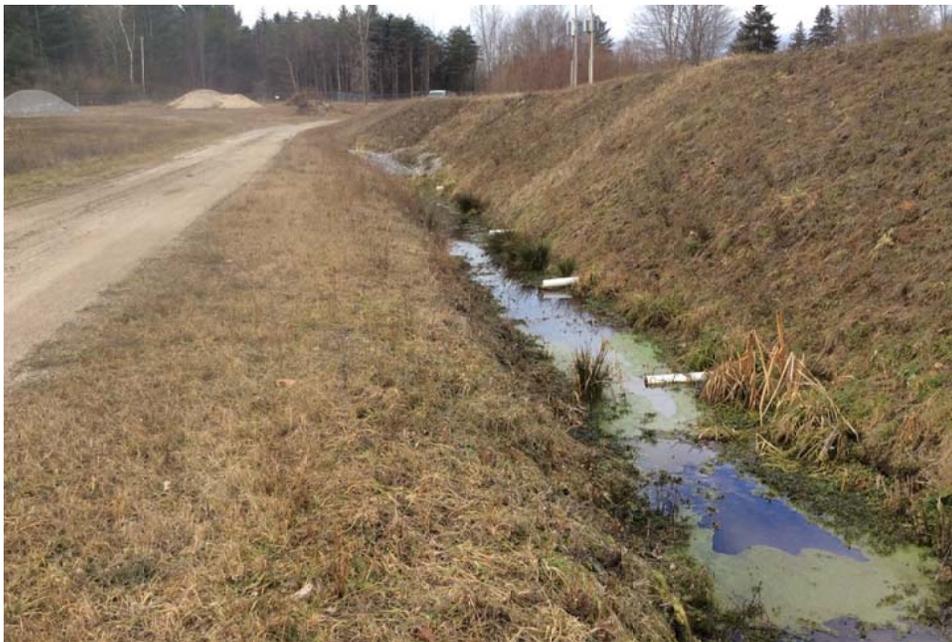
35 - Right Embankment - Seepage Tiles & Drainage Ditch, Looking West

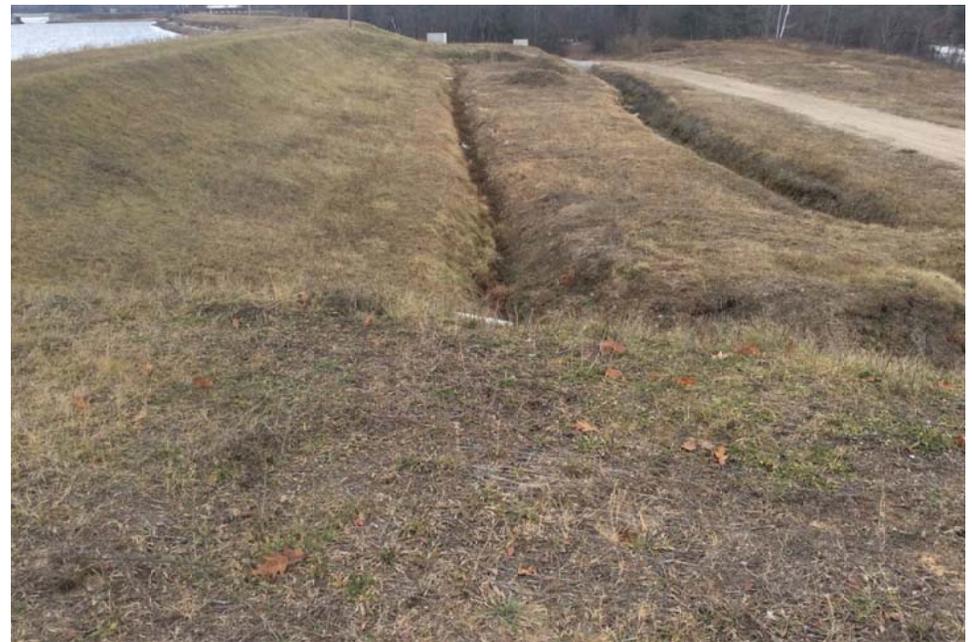
36 - Right Embankment - Seepage Tiles & Drainage Ditches, Looking Southeast

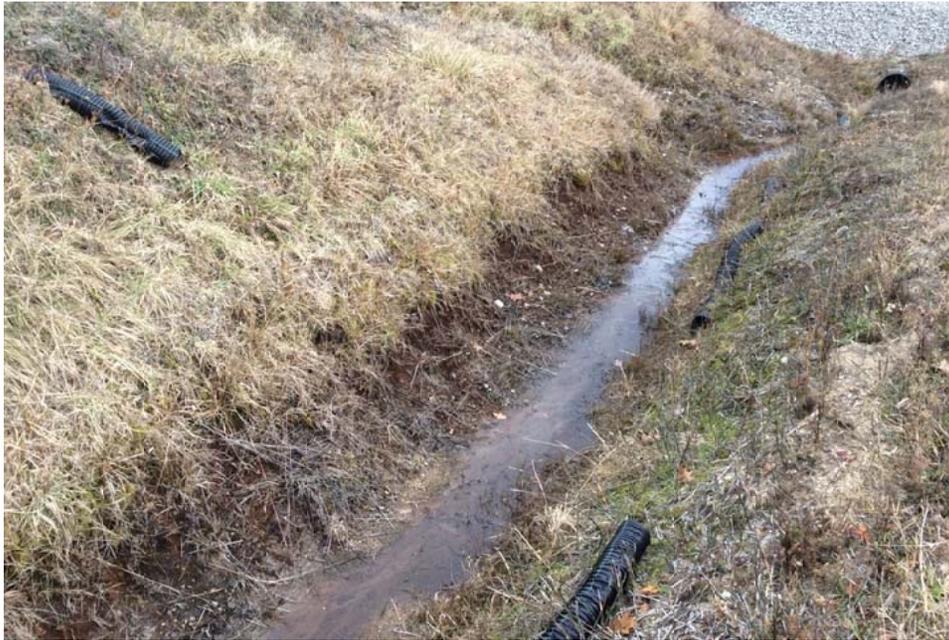
37 - Right Embankment - Seepage Tiles in Ditch

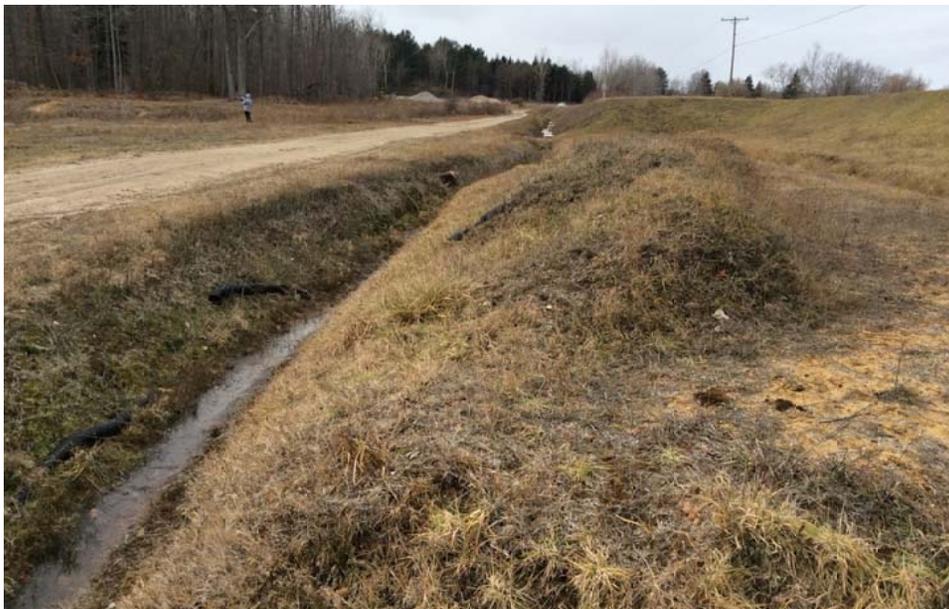
38 - Right Embankment - Seepage Tiles, Drainage Ditch & Access Rd., Looking West
