Benton Harbor Area Schools

Facilities Assessment November 4, 2016

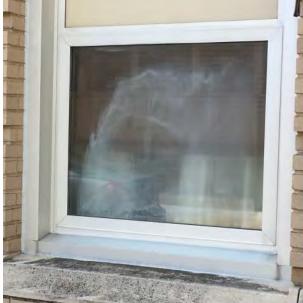
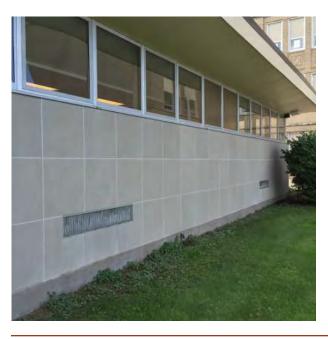
- Single pane glazing should be replaced with insulated units
- Limestone panels need to be cleaned and sealed
- Entrance steel framing showing signs of rust, prep and repaint
- Entrance soffit/ceiling grid is rusting. Replace system

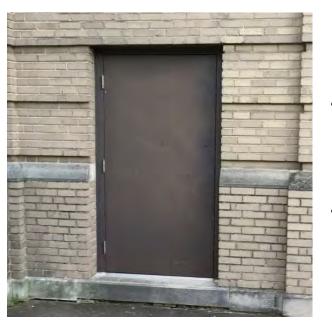
- East and west library stoops and emergency exit door walkway do not meet ADA egress requirements. Bring elevation up to floor level.
- Repaint exit door and frame

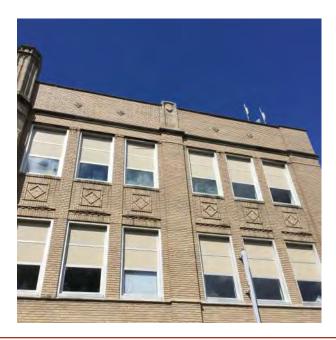
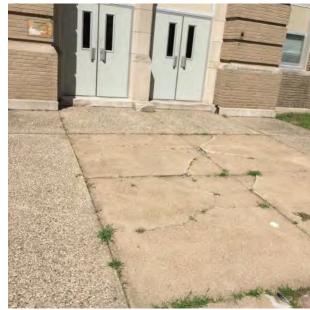
- Tuck and spot pointing needed at original masonry
- South side entry concrete does not meet ADA requirements. Remove and bring elevation of landing up to floor level then ramp down to grade

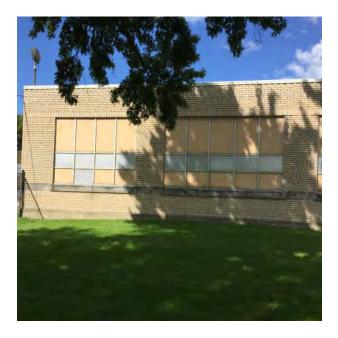
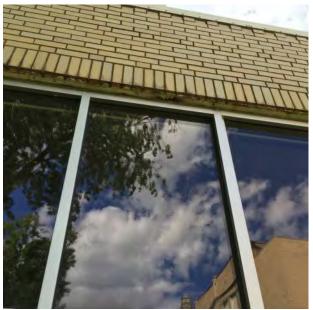
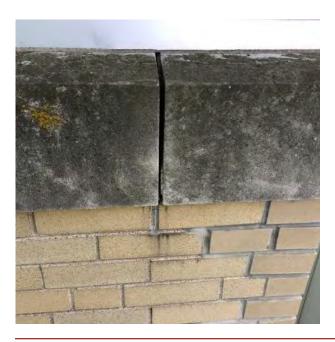
- Exit door has no landing install per code.
- Replace all frames and glazing at south 1950's addition.
- Prep & repaint all lintels; caulk joints.

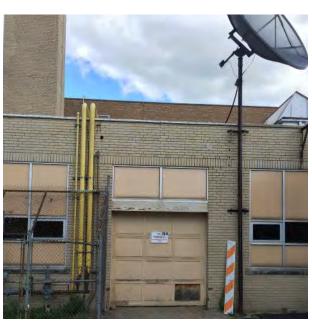
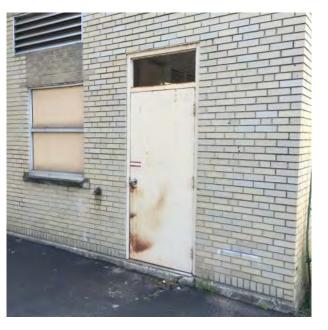
- Limestone sills missing joint caulk and need cleaning.
- Tuck point masonry and repaint.
- Remove miscellaneous steel and patch.

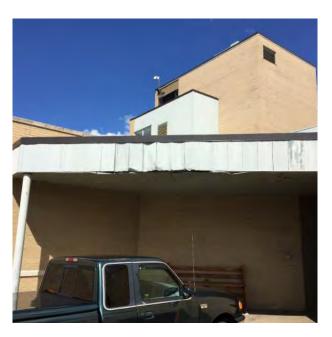
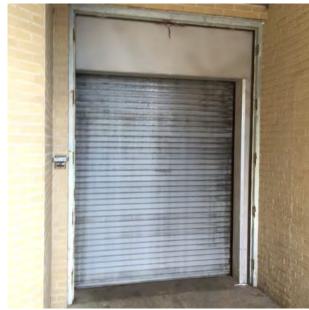
Loading Dock:

- Replace siding at soffit.
- Replace coiling overhead door; remove extra frame.
- Limb up or remove trees.

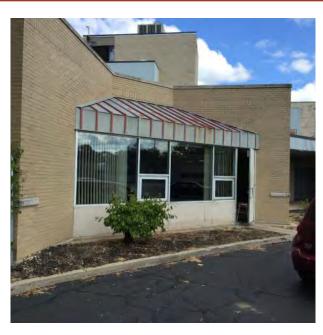
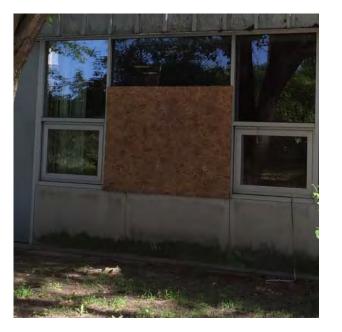
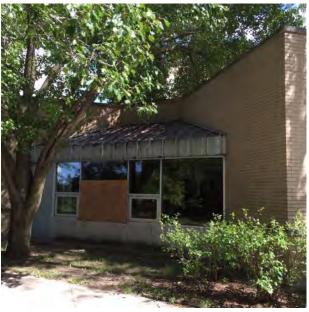
Cafeteria wing:

- Repaint standing seam metal roofs.
- Replace damaged glazing
- Limb up trees or remove

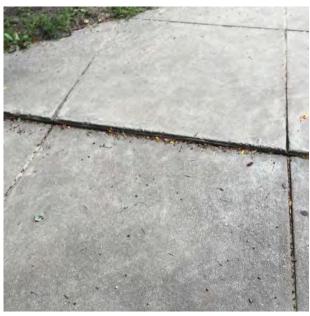
- Level concrete pads at courtyard to eliminate trip hazards
- West elevation windows need replacement in 2-5 years

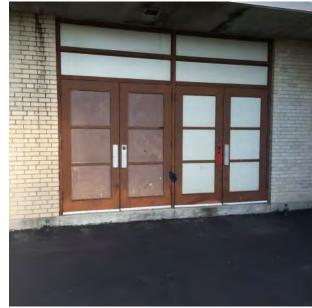
- Clean and tuck point brick as needed
- Repair canopy and add sloped roofing & gutter for handling runoff
- Replace panels and patch stone at stairwell by Gym

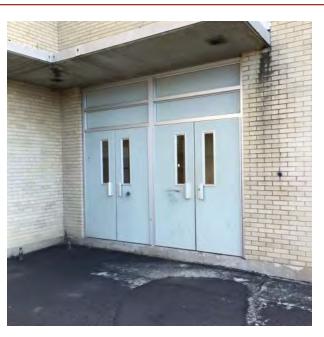
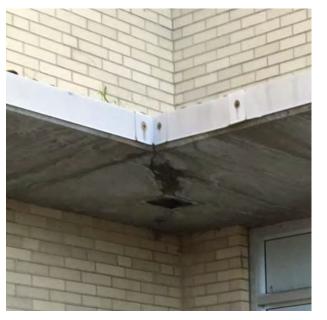
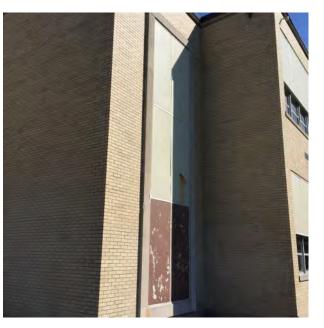
- Repair damaged concrete below brick
- Replace scupper and downspout at North Gym wall

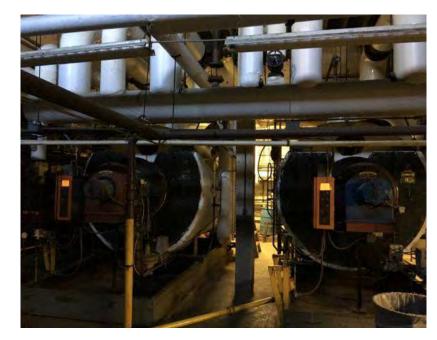
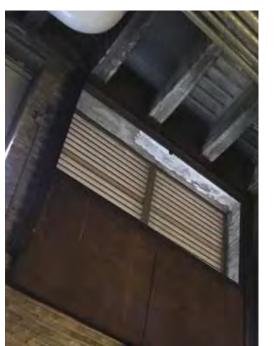
- (2) 1955 10,350 lb/hr Johnson Steam Boilers
- (1) 1955 3,450 lb/hr Johnson Steam Boiler

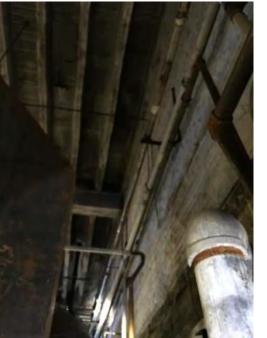
- Radiator at corridor
- City water line with many patches

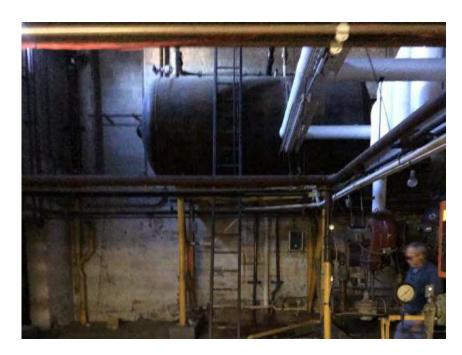
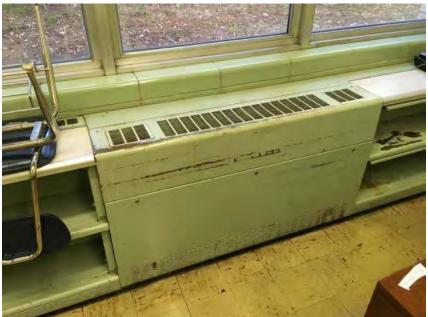
- 1955 Steam heated hot water storage tank
- Rusty, leaky piping, bottom of hot water storage tank

- 1955 Nesbitt steam classroom unit vent
- Clasroom seam fin tube heat, under windows

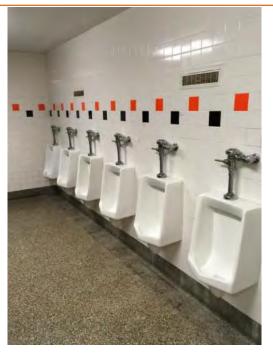
- Boys restroom urinals with manual flush
- Typical water closet with manual flush

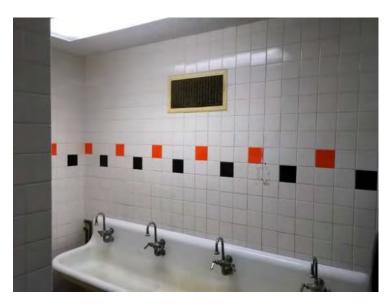
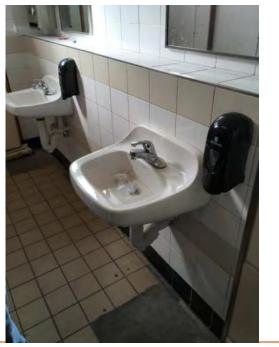
- Boys restroom lavatory with manual faucets
- Girls restroom water closet & lavatories with manual faucets

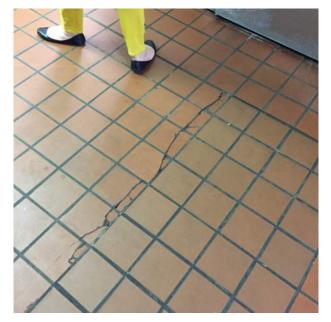
27 Cooking Kitchen - ceiling & flooring repairs needed

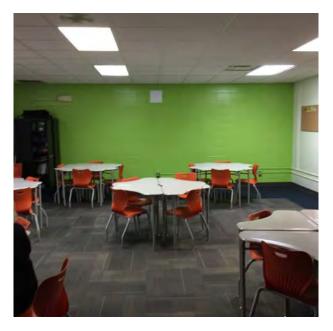
210 Classroom - replace sidelight

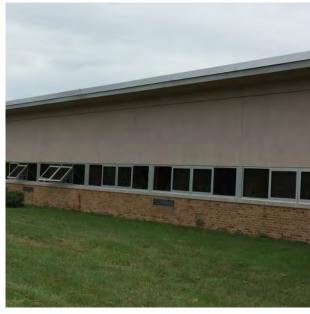
- Typical stone sill condition at North Elevation - seal joints
- EIFS finish to be recoated in 3-5 years

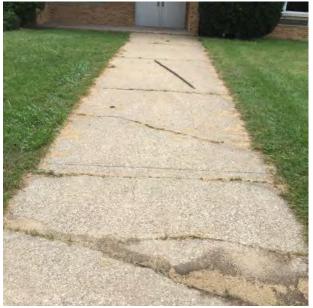
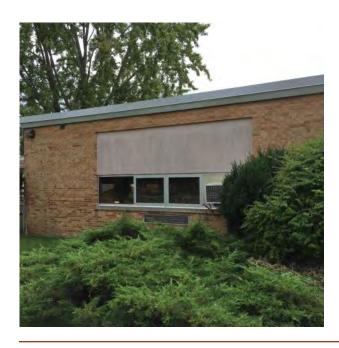
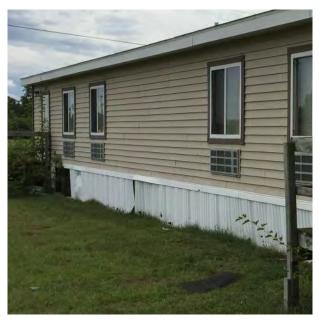
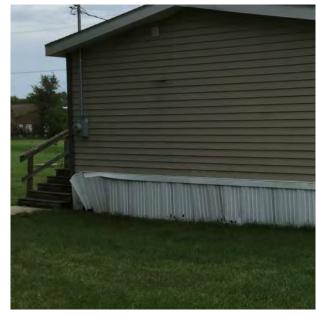
- Re-coat EIFS at Northeast classroom
- Replace or repair skirting at portables

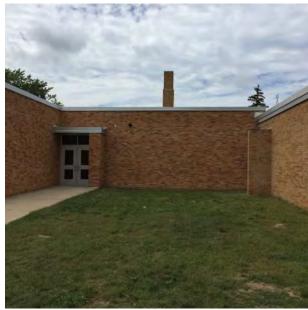
- Good brick condition at addition area
- Replace service doors.

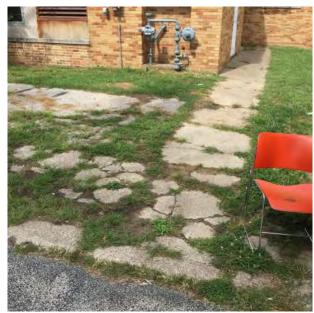
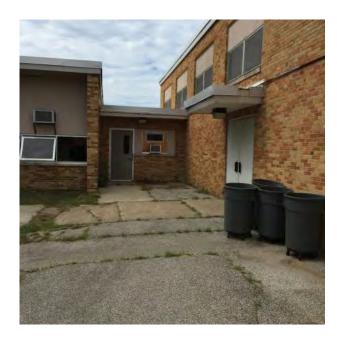
Replace concrete and reconfigure walks at entry

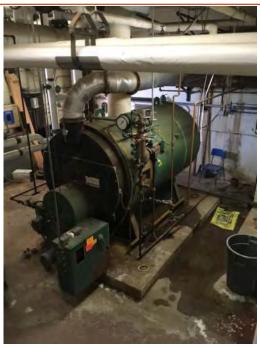
- 1955 Steam Boiler
- 2011 Gas Water Heater and Water Softener
- Combustion Air Louver no damper

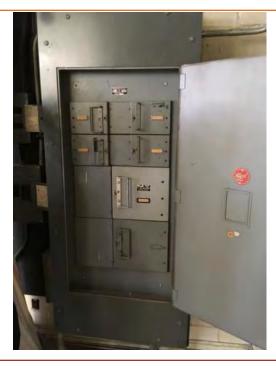
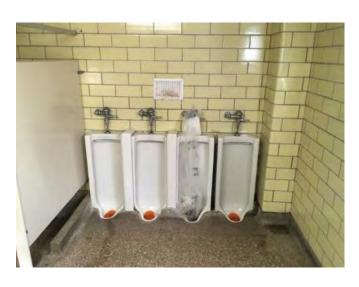
- 1955 Main Electrical Distribution Panel
- Typical cabinet unit ventilator
- Typical in-classroom water closet

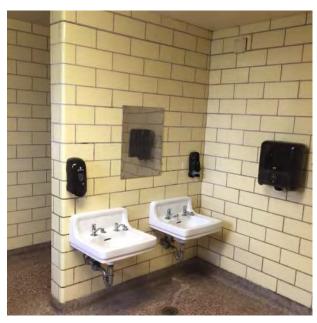
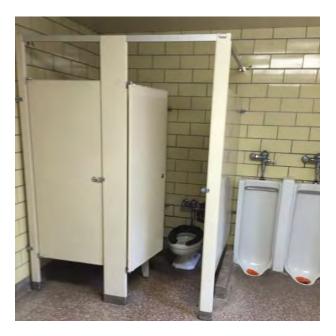
7 Boys Restroom - fixtures too low to meet ADA requirements

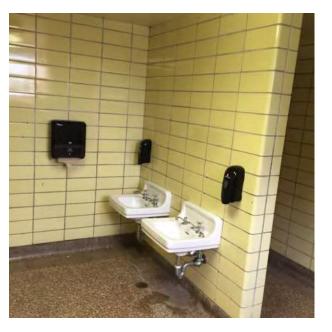
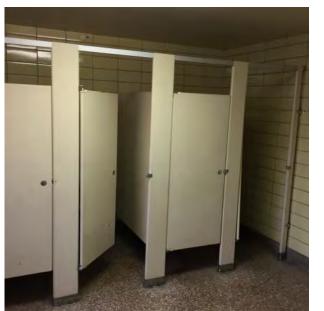
8 Girls Restroom - fixtures too low to meet ADA requirements

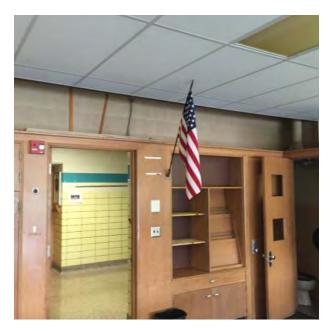
117 Classroom

Typical cabinetry at South Wing classrooms

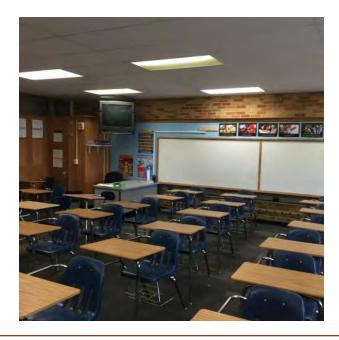
118	Classroom	789	Classroom	A/B	2008 carpet, ceiling & paint	20	Desks, Teacher shelving, sink	two water closets		Recessed 2x4 fluorescent troffer lensed	Unit Ventilator	Close in above cabinets \$1000, paint cement block walls and above windows \$500, refinish cabinets & casework \$1,500, new sink & countertop \$1,500, replace restroom doors \$1500, TOTAL = \$6,000	1	1
119	Classroom	786	Classroom	A/B	2008 carpet, ceiling & paint	31	Desks, Teacher shelving, sink	two water closets		Recessed 2x4 fluorescent troffer lensed	Unit Ventilator	Close in above cabinets \$1000, paint cement block walls and above windows \$500, refinish cabinets & casework \$1,500, new sink & countertop \$1,500, replace restroom doors \$1500, TOTAL = \$6,000	1	1
120	Classroom	789	Classroom	A/B	2008 carpet, ceiling & paint	Not in use	Desks, Teacher shelving, sink	two water closets		Recessed 2x4 fluorescent troffer lensed	Wall Air Conditioning Unit & Unit Ventilator	Close in above cabinets \$1000, paint cement block walls and above windows \$500, refinish cabinets & casework \$1,500, new sink & countertop \$1,500, replace restroom doors \$1500, TOTAL = \$6,000	1	I

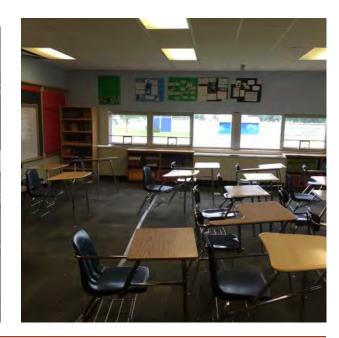
120 Classroom - not in use
