Repair of Bridge Deck Fascias OR22-002

Final Report

09/30/2023

> **Prepared By:** Furkan Cakmak Fatmir Menkulasi Christopher Eamon Hwai-Chung Wu

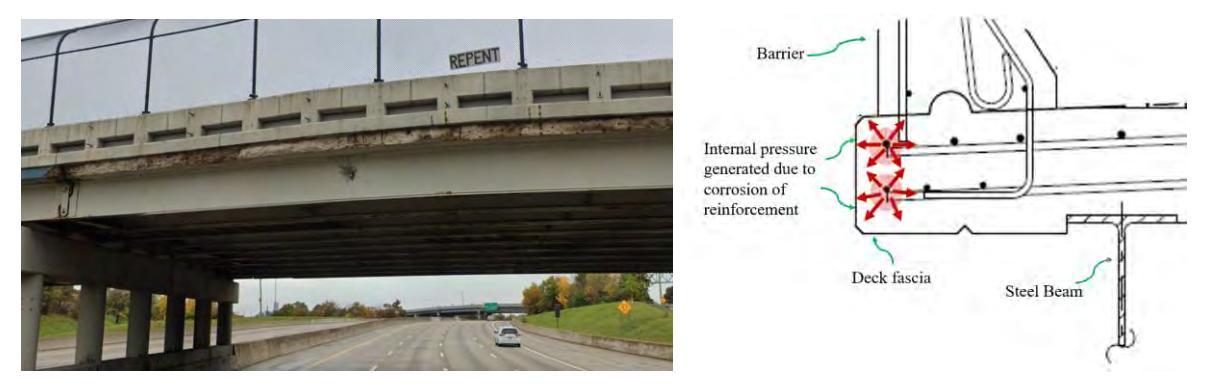
The relatively high supply of moisture in bridge deck fascias often causes them to deteriorate more quickly than other portions of the bridge. This causes the fascia concrete to become debonded from the reinforcement and fall, posing a safety hazard to traffic or pedestrians beneath the bridge. An example of a deteriorated bridge deck fascia is shown in Fig. 1.1 which shows signs of corrosion in deck reinforcement. The current Michigan Department of Transportation (MDOT) maintenance strategy is to avoid patching these areas, since overhead patches can later spall off, posing the same safety risk as the original fascia failure. Rather, delaminated concrete is removed to minimize the potential of falling debris. However, this practice leaves the fascia reinforcement exposed, resulting in corrosion and further degradation.

Fig. 1.1 Example of deck fascia deterioration on McGraw Avenue Bridge over I-96 eastbound (detected by PI) and illustration of built-in pressures due to reinforcement corrosion

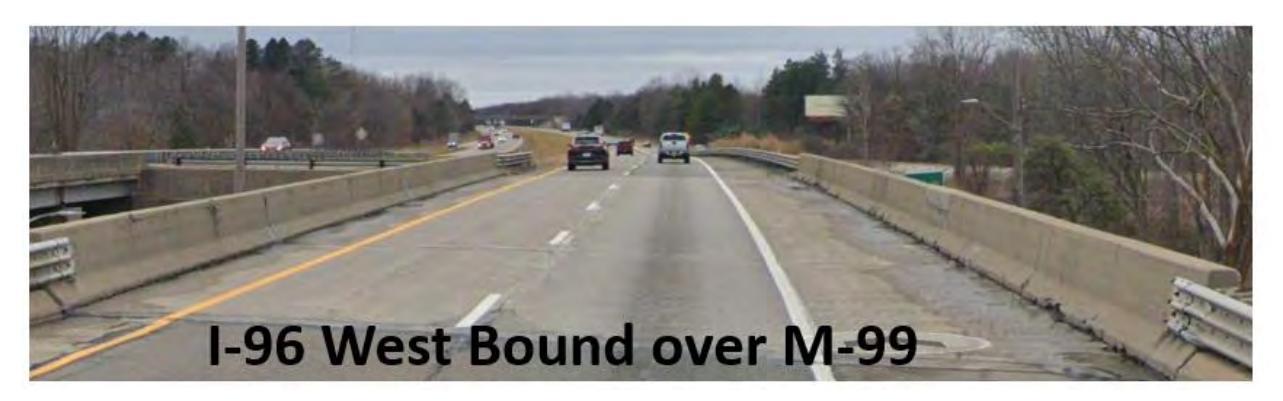
Fig. 3.3 Illustration of the higher moisture near the barrier and deck fascia (image obtained from Google Maps)

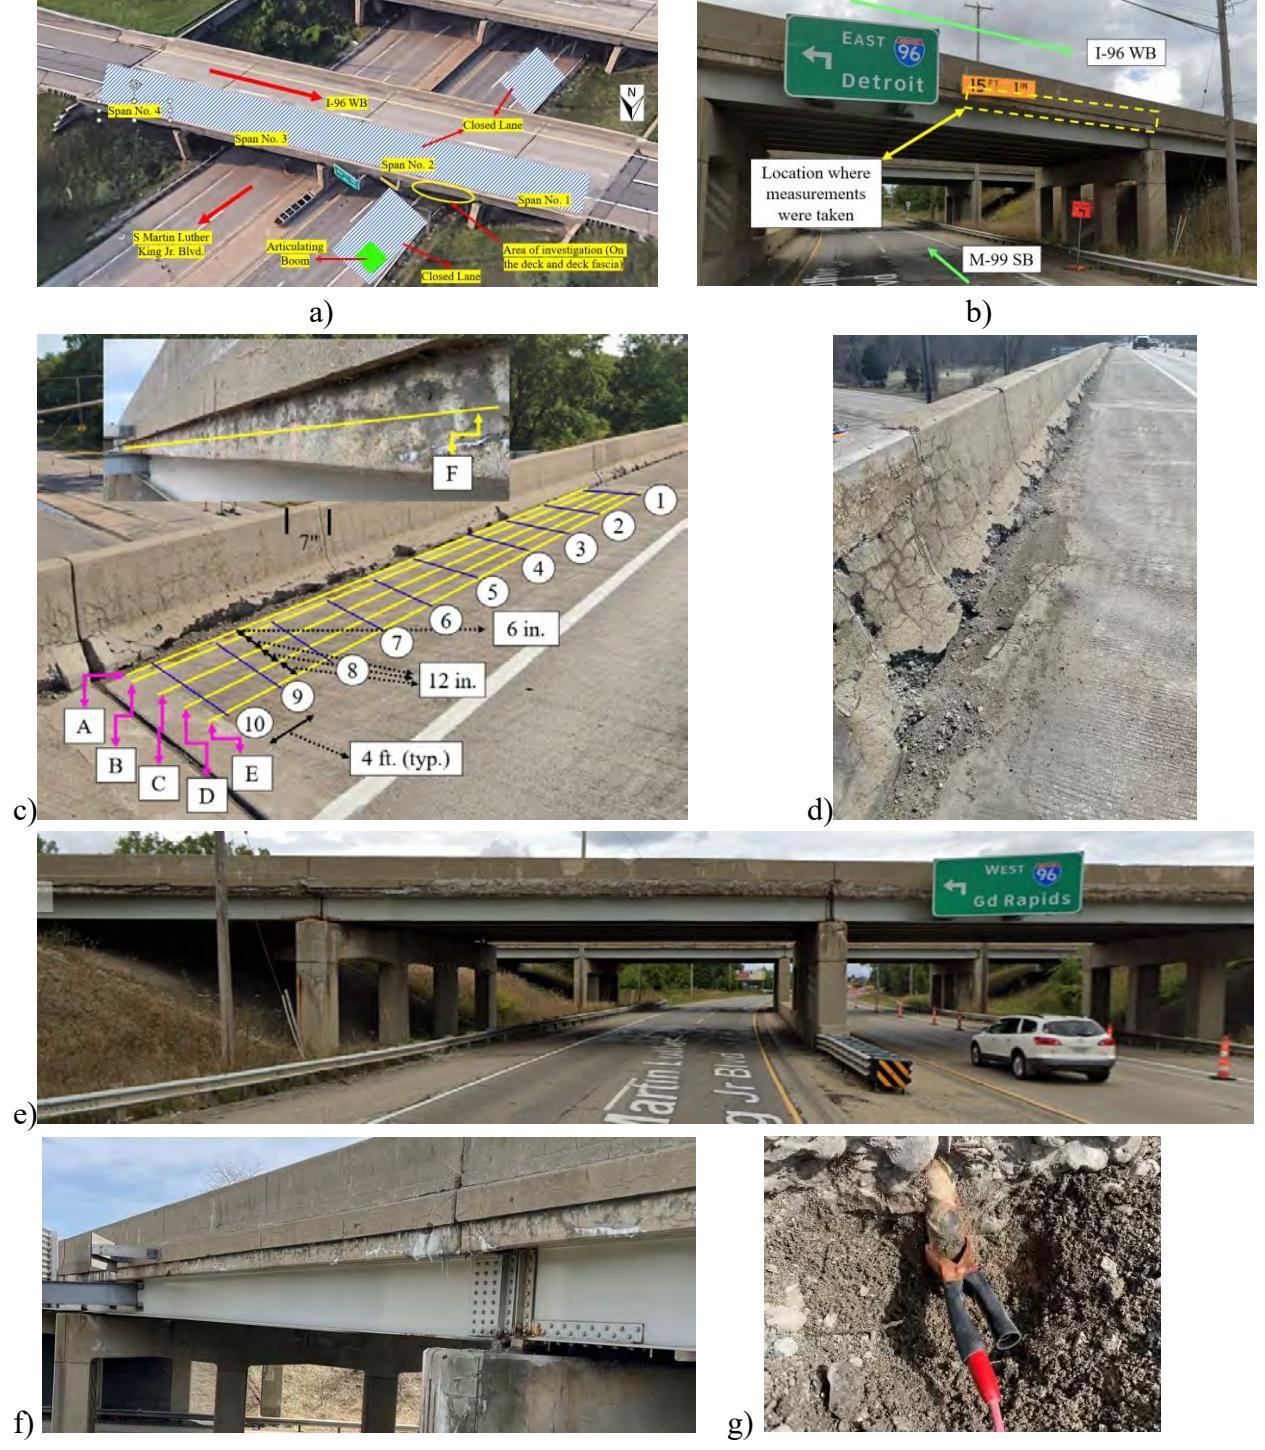
Fig. 3.5 a) Closed lanes on I-96 WB and M-99 to facilitate nondestructive testing on the deck surface and deck fascia, b-c) region where measurements were taken on the deck fascia and deck surface, respectively, d) severe barrier deterioration, e) deck fascia deterioration on I-96 EB, f) deck fascia deterioration on I-96 WB, g) connection of electrode to exposed steel in the barrier

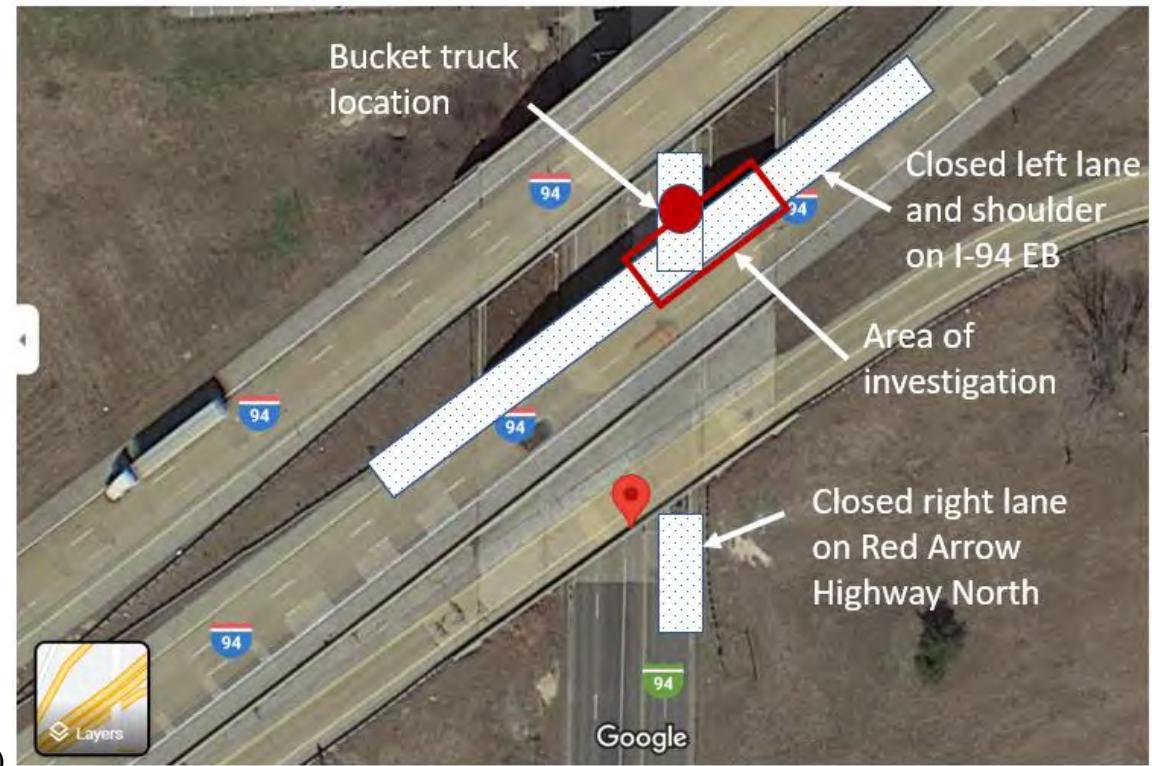
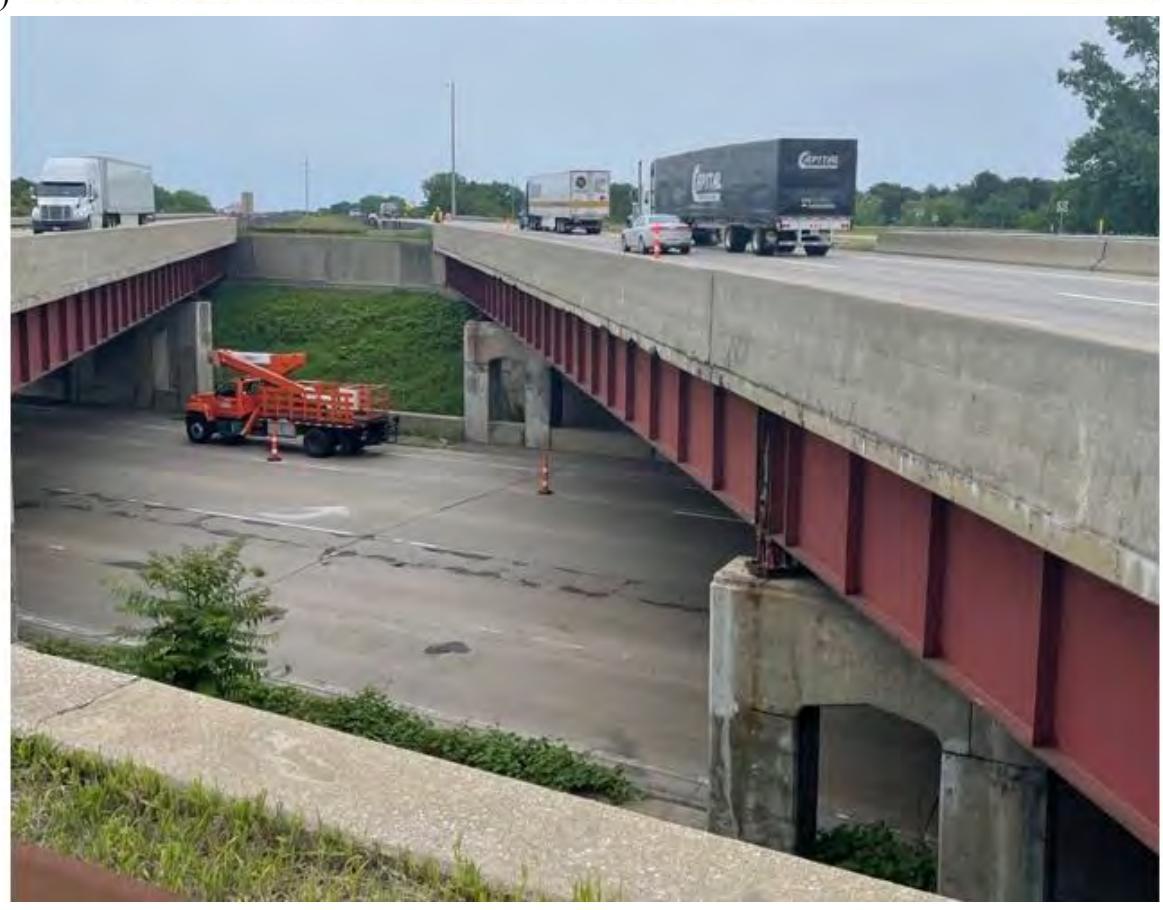
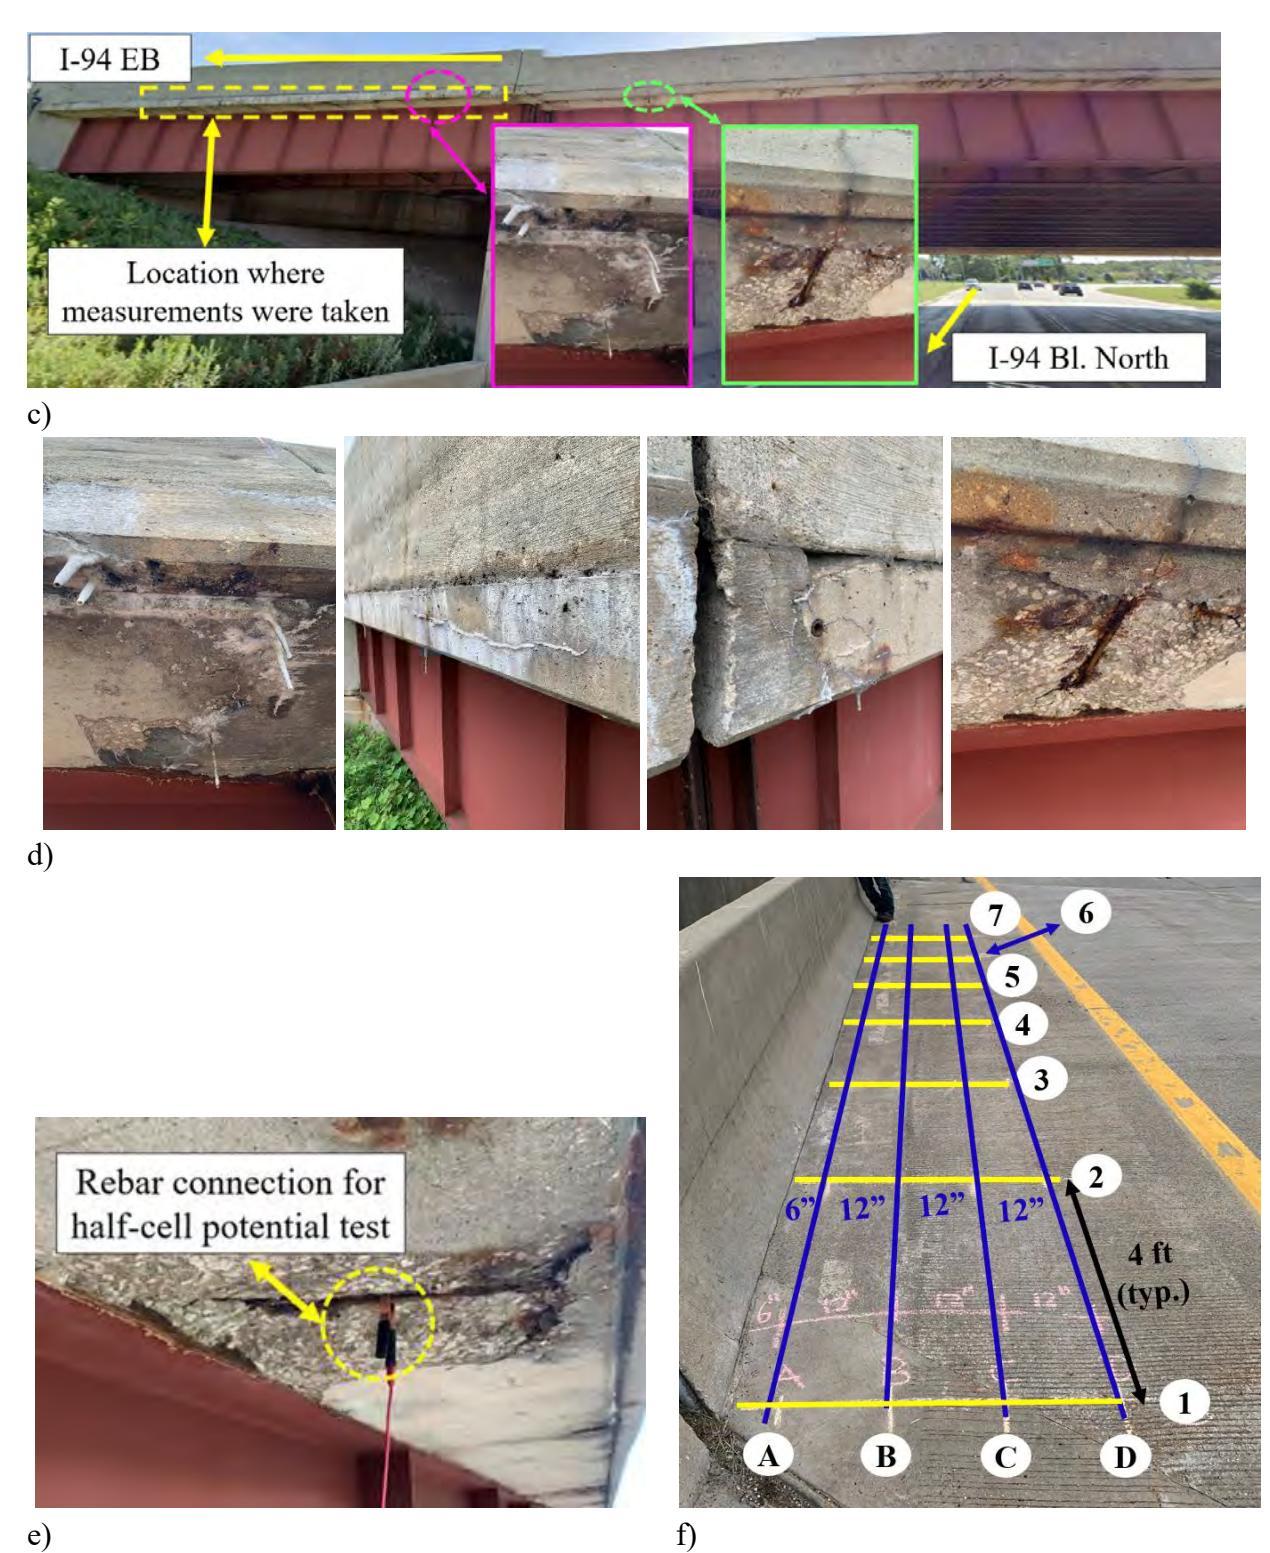
6) Southwest Region: I-94 EB over Red Arrow Highway North. The bridge featured a deteriorated deck fascia. Fig. 3.9a shows the location of the bridge, the area where the investigation was conducted, the location of the bucket truck, which was used to take measurements along the deck fascia, and the lanes that were closed to conduct the investigation. Fig. 3.9b shows the deteriorated deck fascia. Fig. 3.9c shows the location where the measurements were taken along the deck fascia, as well as two close-up photographs illustrating deterioration and corrosion of reinforcement. Fig. 3.9d shows additional close-up photographs illustrating deterioration, the presence of efflorescence, and reinforcement corrosion. Fig. 3.9e shows the location where the electrode was connected to the reinforcement to conduct half-cell potential measurements. Finally, Fig. 3.9f shows the location of the grid that was used to take measurements on the deck surface.

Fig. 3.9 Bridge on I-94 EB over Red Arrow Highway North: a) location of bridge, b) view of deck fascia, c) location where measurements were taken along the fascia, d) photographs of various deck fascia regions, e) connection of electrode to exposed reinforcement at the bottom of deck fascia, f) grid where measurements were taken on the deck surface

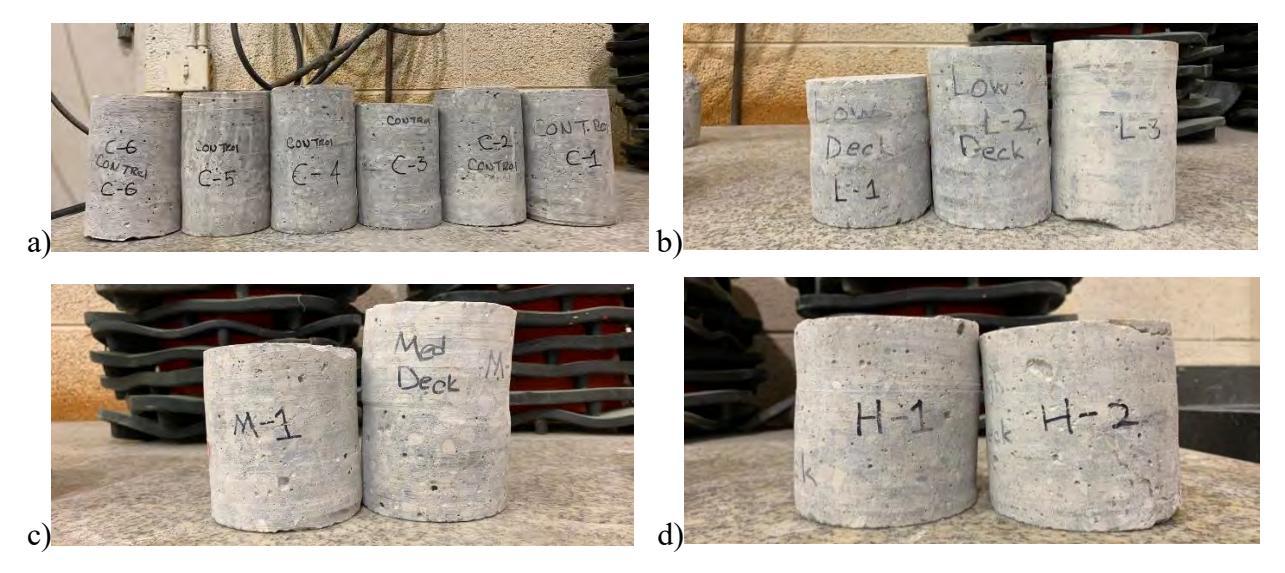
Fig. 3.10 Illustration of usable cores obtained from I-69 EB over Fenton Road for each deterioration level: a) control, b) low, c) medium, and d) high

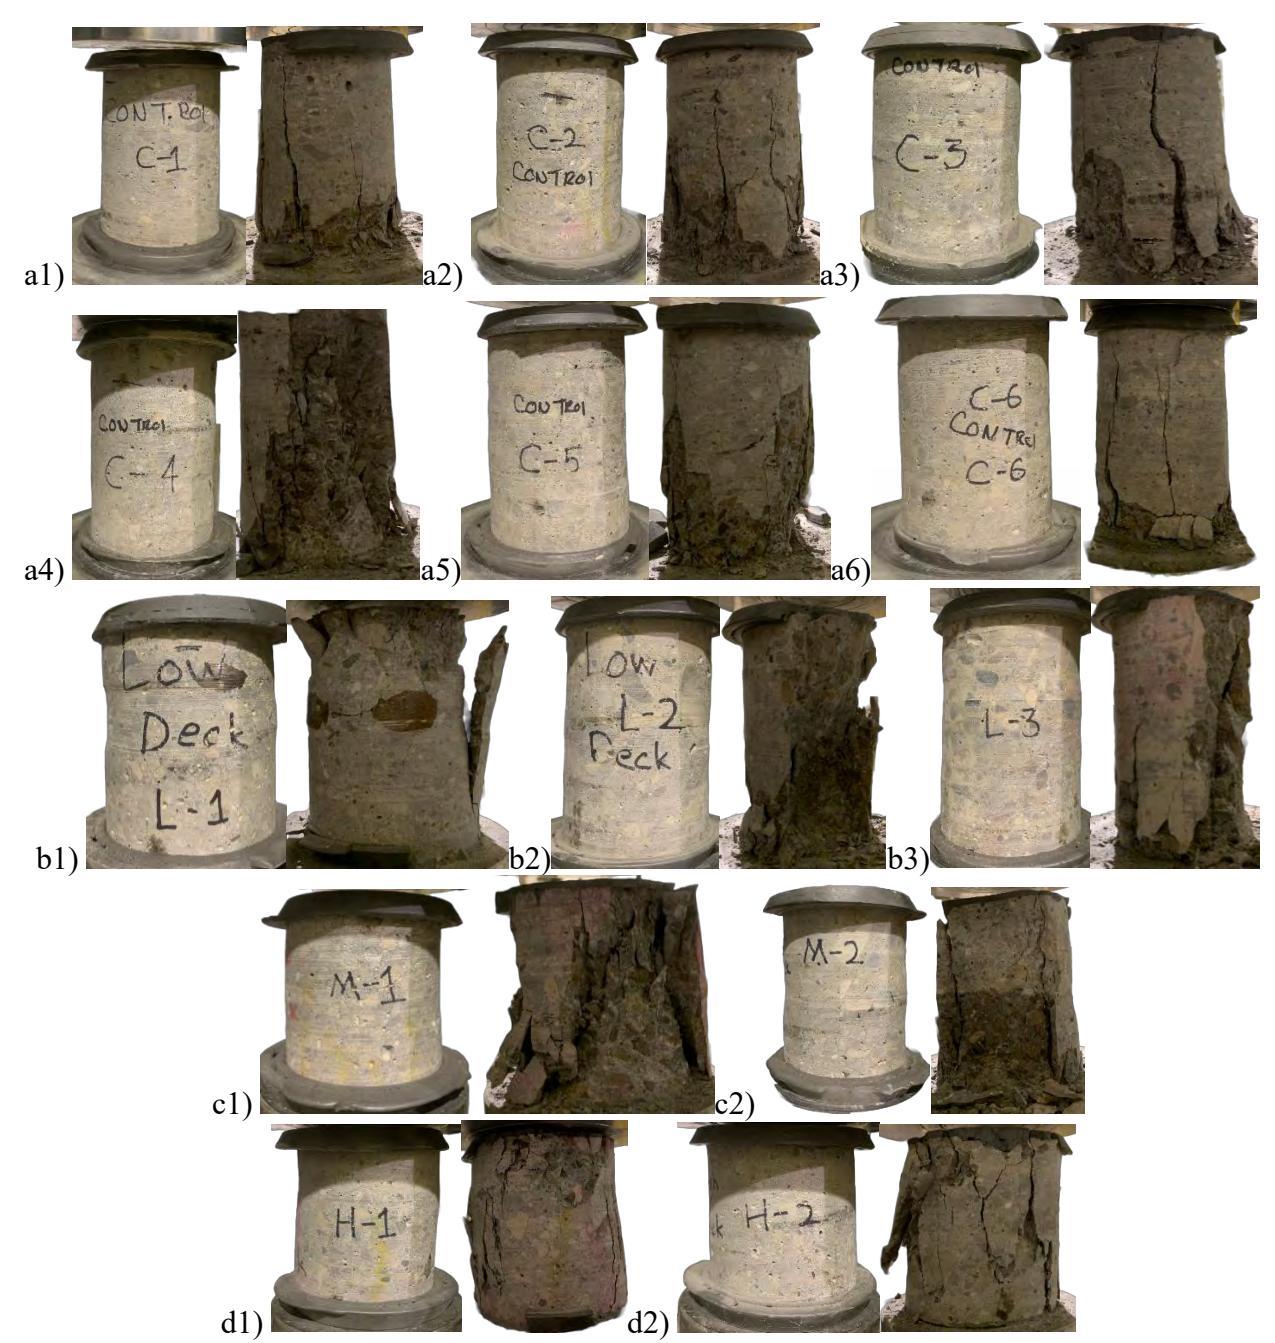
In some specimens, such as M-2, it appears that there are two layers of concrete because the colors at the top and bottom regions of the specimen appear to be different. Based on the information provided in the MiBridge database it appears that an overlay was installed in the bridge deck in 2003 thus explaining the presence of two layers. Since the two layers are connected in series the compressive strength test represents the strength of the weaker material.

Fig. 3.17 Core specimens before and after testing: a) Control; b) Low; c) Medium; and d) High

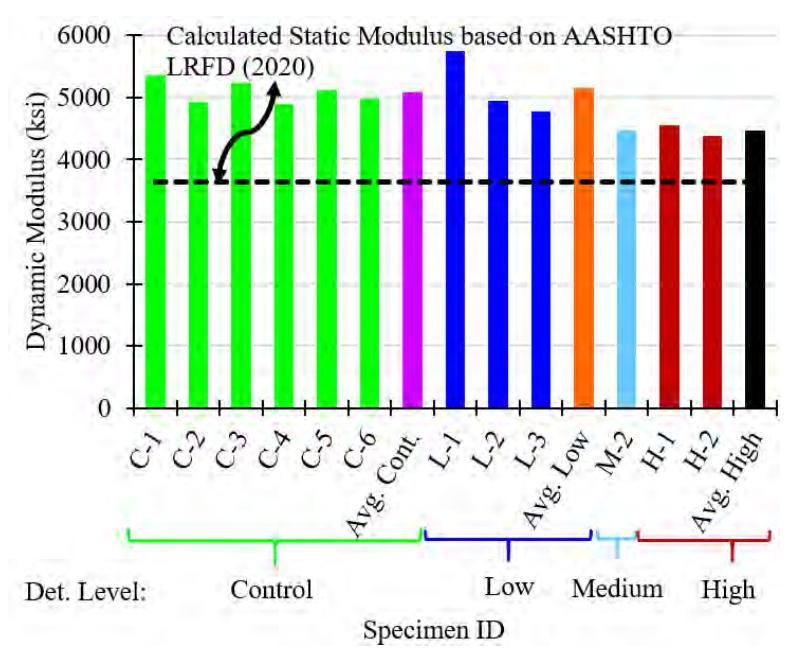
The results of dynamic modulus testing are shown in Table 3.6 and Fig. 3.20. Fig. 3.20 suggests that there is a general trend of lower dynamic moduli for higher levels of deterioration. The dynamic moduli are generally higher than the static modulus. The calculated static modulus based on AASHTO LRFD (2020) is 3639 ksi. Recall that the goal of the dynamic modulus testing was to establish benchmark values for when to terminate accelerated weathering tests.

Fig. 3.20 Dynamic modulus test results based on the cores obtained at different deterioration levels

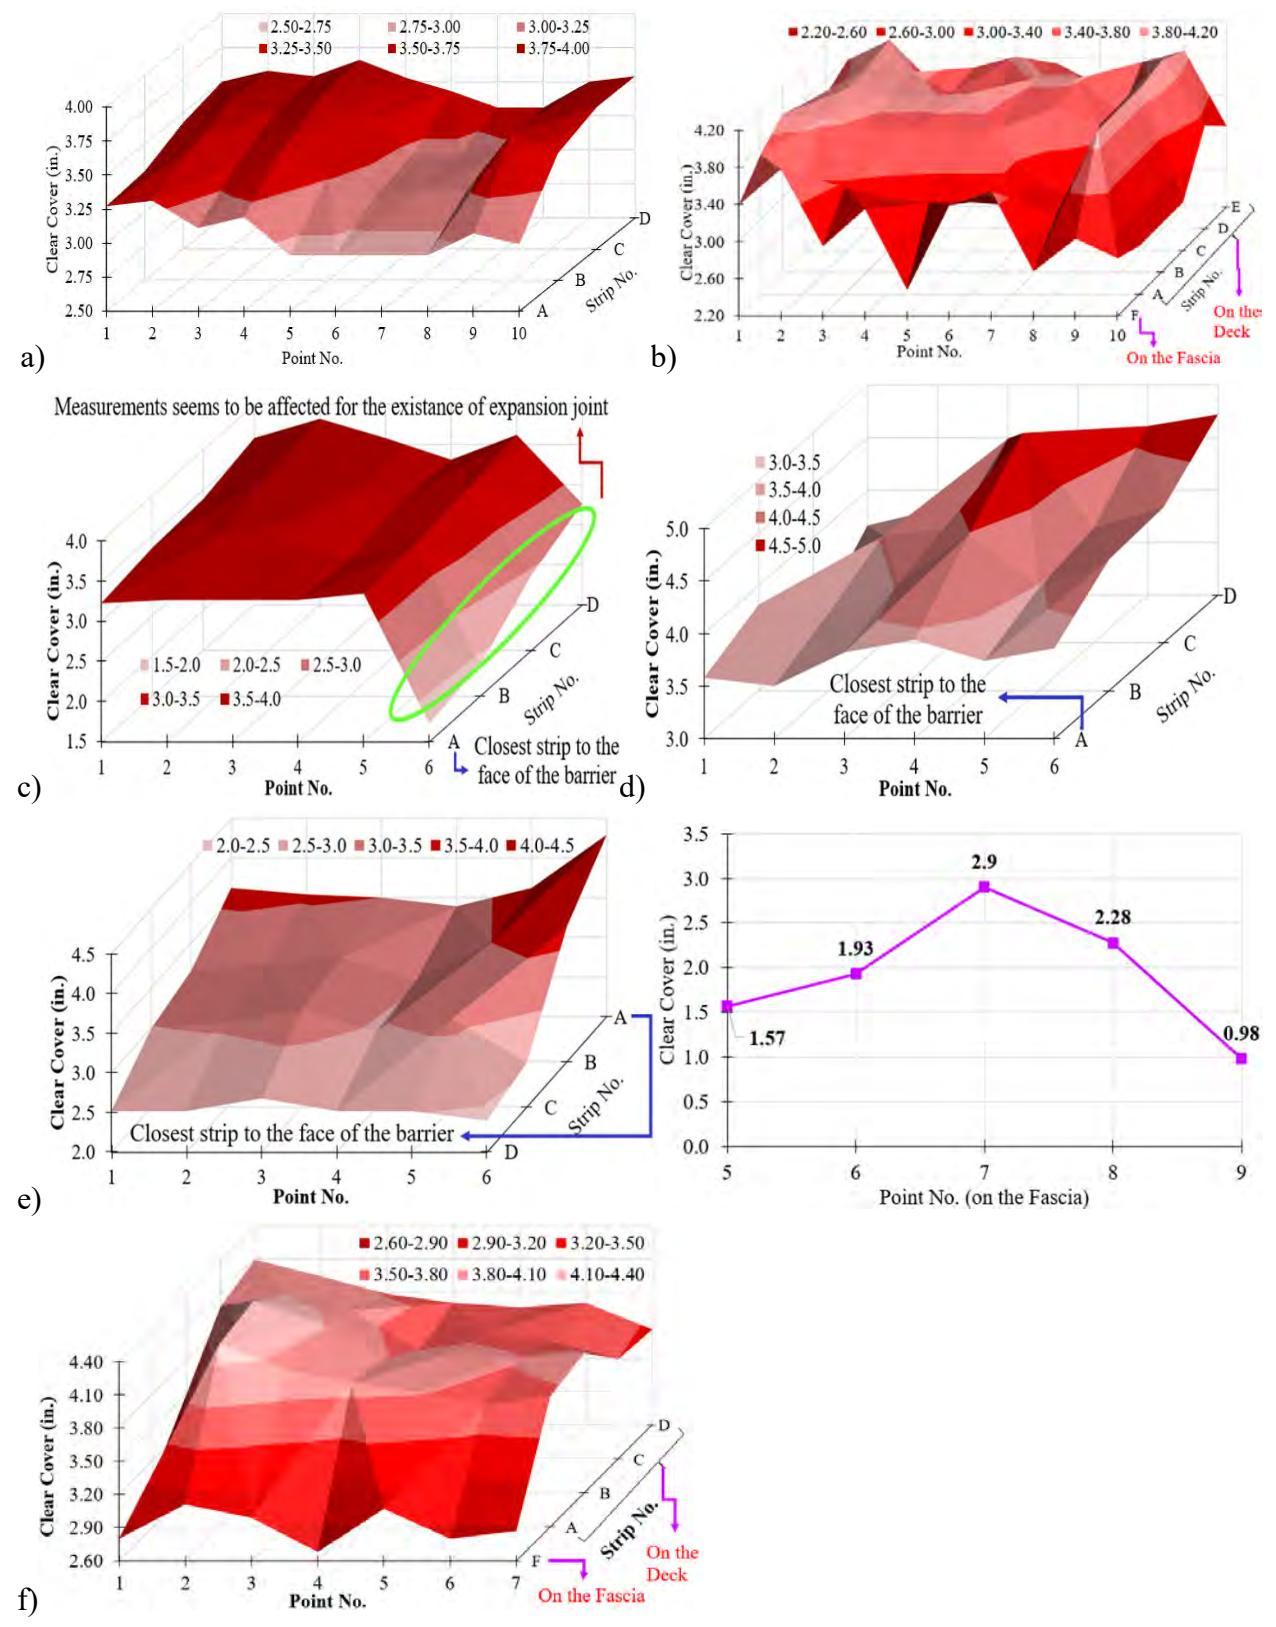
<u>Bridge on I-69 over Fenton Road in Bay Region</u>: For the bridge on I-69 over Fenton Road in Bay Region, the clear cover varied from 2.5 in. to 4.0 in. with the regions near the deck fascia exhibiting lower cover. This indicates a lower level of protection against corrosion at the deck fascia region. The variation in clear cover readings shows a lack of consistency and varying levels of protection in the selected region.

For the bridge in the Metro Region (Waldon Road over I-75) clear cover varied from 3.0 in. to 5.0 in. Clear cover is inconsistent. Minimum requirements specified in AASHTO LRFD (2020) are met. Although, excessive cover, such as 5.0 in. is not necessarily good, because it reduces flexural capacity and creates large crack widths. There appears to be a general trend towards lower cover near the fascia.

For the Bridge on I-94 EB over Red Arrow Highway, the clear cover measurements did not show a clear trend and varied from 2.6-4.4 in. The measurements taken along the deck fascia were lower

than those measured on the deck surface. Generally, clear cover measurements were larger than 3.0 in. The maximum measured clear cover was 4.33 in.

Fig. 3.23 Clear cover for: a) clear cover for the I-69 over Fenton Road bridge in Bay Region, b) clear cover for the I-96 WB over M-99 bridge in Bay Region, c) County road over I-75, d) Waldon road over I-75, e) US 131 Ramp over W River Dr. NW, f) I-94 EB over Red Arrow HW

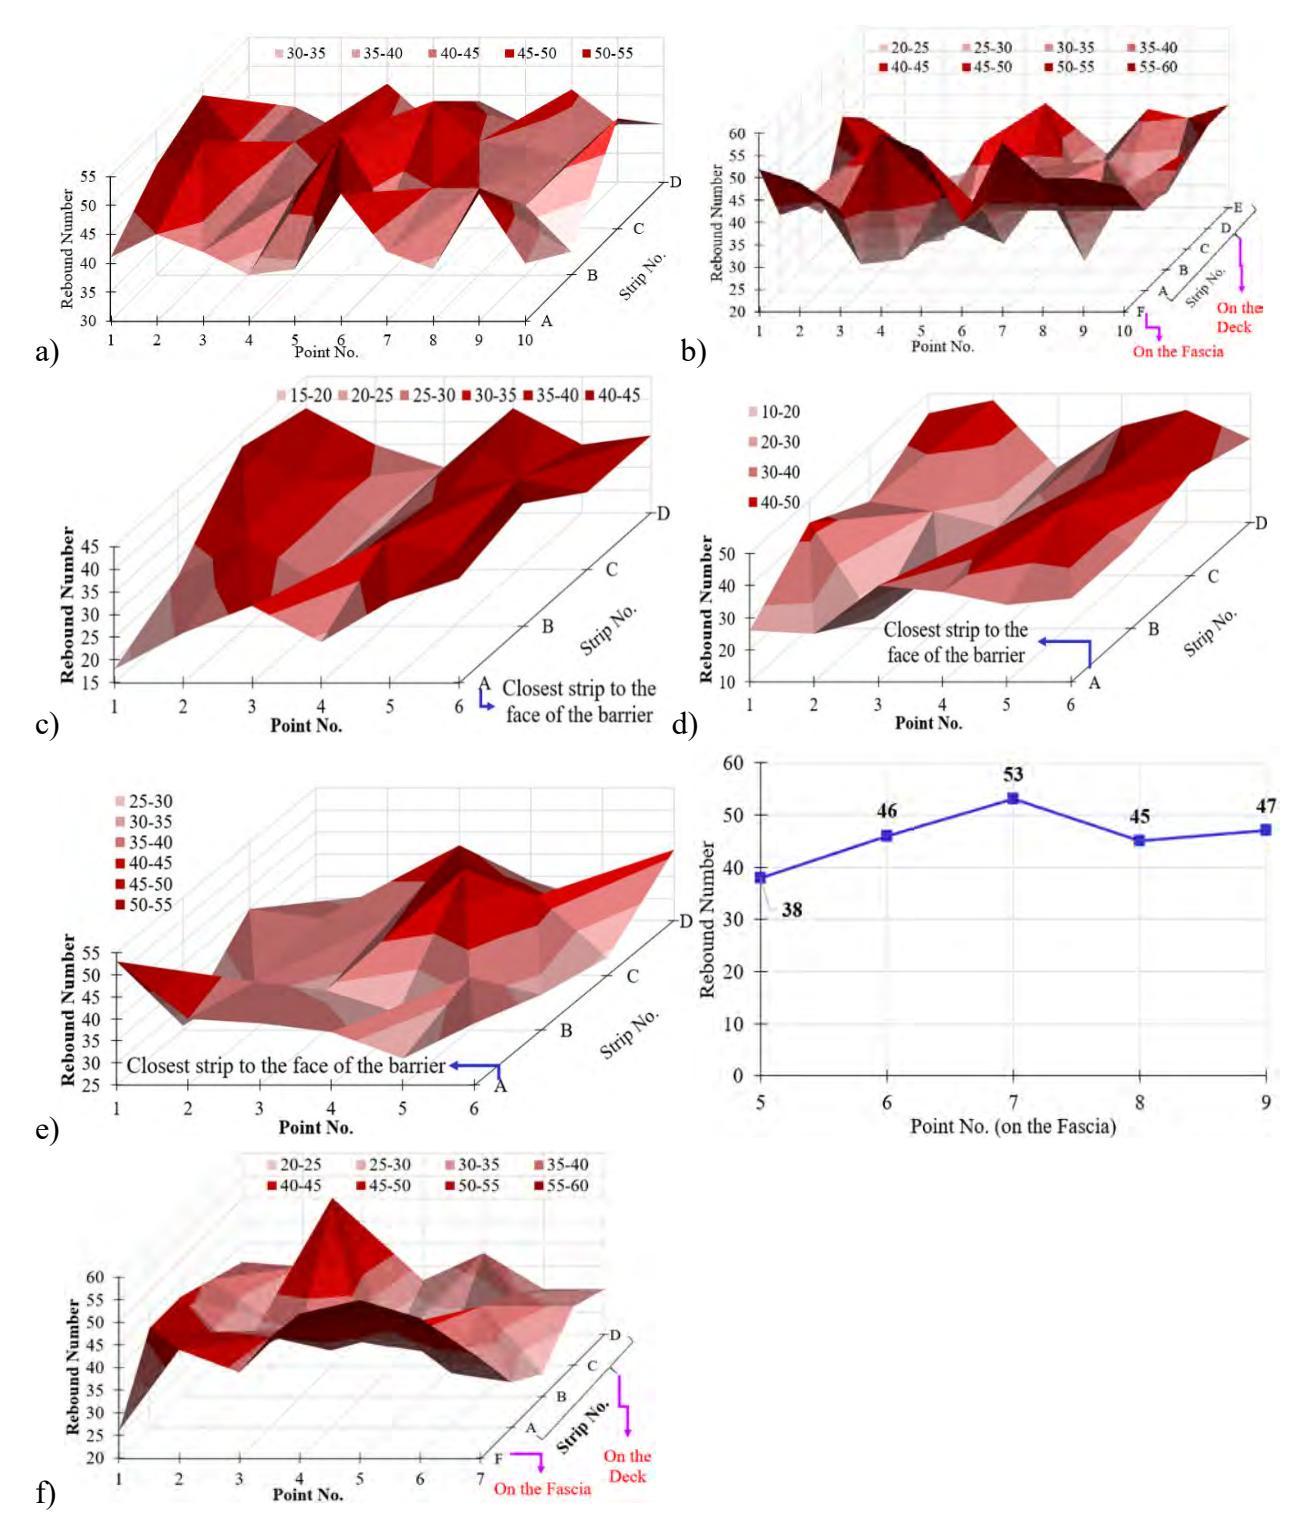
For the bridge located on I-69 over Fenton Road in Bay Region, the rebound hammer readings varied from 30-55 and no specific trend was observed.

For the bridge located on I-94 EB over Red Arrow HW the rebound hammer readings varied from 24 to 57. No trends in surface hardness was observed.

Fig. 3.25 Rebound numbers for: a) the bridge on I-69 over Fenton Road in Bay Region, b) the bridge on I-96 WB over M-99 in University Region, c) County road over I-75, d) Waldon road over I-75, e) US 131 Ramp over W River Dr. NW, f) I-94 EB over Red Arrow HW

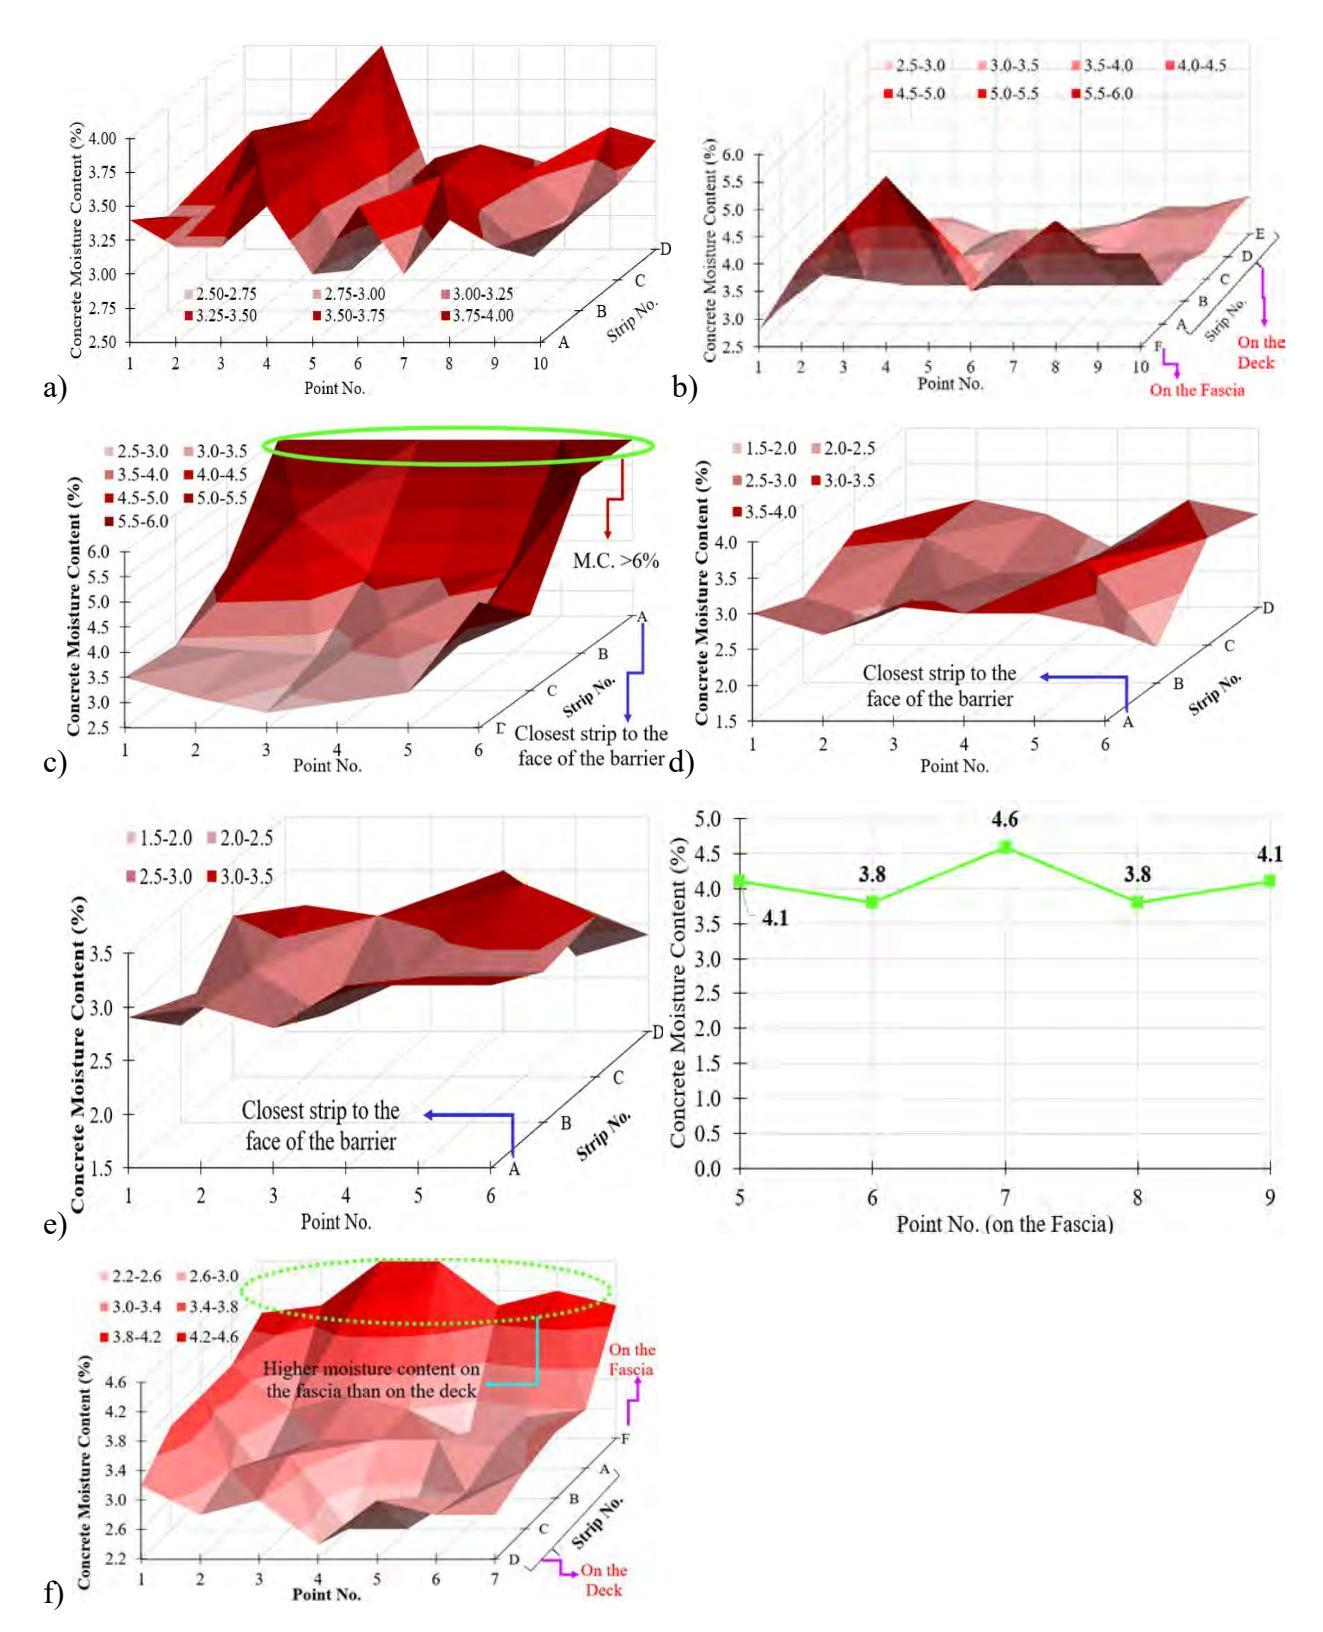
The collected data is shown in Fig. 3.28a. For the bridge on I-69 over Fenton Road in Bay Region, moisture content varies from 2.5 to 4.0 without exhibiting any specific trend at the time of the test.

For the bridge on I-96 over M-99 in University Region, moisture content varied from 2.5-6% with moisture content near and on the deck fascia generally being higher than the test of the locations. As shown earlier in Fig. 3.3, there is clear evidence of higher moisture content in the vicinity of the barrier and deck fascia due to improper or incomplete drainage for the bridge on I-96 over M-99 in University Region.

For the bridge on County road over I-75 in North Region both visual inspections and moisture meter readings demonstrate the higher moisture content near the deck fascia. Moisture meter readings varied from 2.5->6% and were consistently higher near the deck fascia.

For the bridge on Waldon road over I-75, moisture meter readings varied from 1.5-4%. No specific trend was observed.

For the bridge on US 131 Ramp over W River Dr. NW., moisture meter readings varied from 1.5-3.5% on the deck surface. Along the deck fascia they were higher than 3.8%. This is a clear indication of higher surface moisture content along the fascia.

For the bridge located on I-94 EB over Red Arrow HW the moisture content varied from 2.2% to 4.6%. There was a clear trend towards higher moisture content along the deck fascia.

Fig. 3.28 Concrete moisture content for: a) the bridge on I-69 over Fenton Road in Bay Region, b) the bridge on I-96 over M-99 in University Region; c) County road over I-75, d) Waldon road over I-75, e) US 131 Ramp over W River Dr. NW, f) I-94 EB over Red Arrow HW

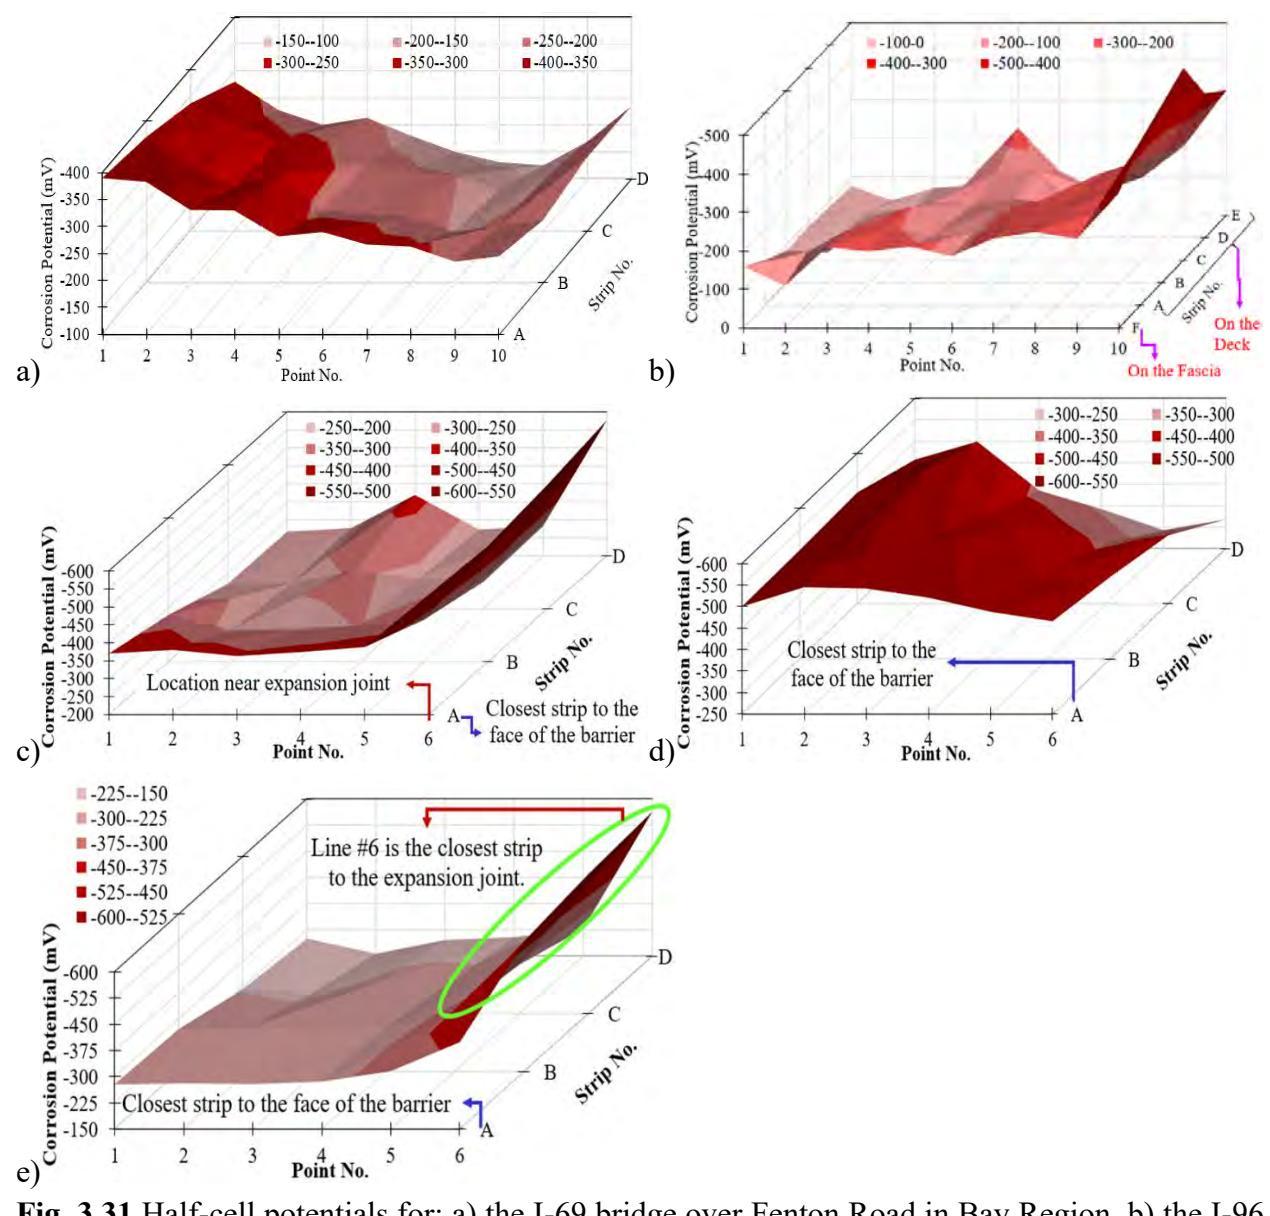
For the bridge on I-96 over Fenton Road, generally, higher high-cell potential measurements were recorded in the vicinity of the deck fascia. The results are shown in Fig. 3.31a. Potentials greater than -200Mv generally indicate 90% or higher probability of no corrosion taking place at the time of measurement. For both bridges there are only a few points that fall in this category. Potentials in the range of -200 to -350mV are inconclusive. Potentials less than -350mV generally indicate

90% or higher probability of active corrosion in the area in question at the time of testing. For the bridge on I-69 over Fenton Road there were several points in which the readings were less than - 350 mV, including areas in the vicinity of the deck fascia confirming active corrosion activity. As can be seen in, Fig. 3.31a there is active corrosion activity in the curb near the barrier. The half-cell potential readings suggest that such corrosion extends into the deck in the vicinity of the deck fascia.

Similar observations were made for the bridge on I-96 over M-99, except that in this case the highest corrosion potentials were recorded near the expansion joint, suggesting a higher probability of active corrosion in this area (Fig. 3.31b). As noted earlier, there is visible corrosion and severe deck fascia deterioration on the deck fascia on I-96 EB. Since the measurements were taken on I-96 WB due to the presence of a steel barrier on I-96 EB, corrosion potentials were not as high as one might have expected for I-96 EB.

For the bridge located on County Road over I-75 half-cell potential readings varied from -200 to -600 mV, with most readings being above -350 mV. This is a clear indication of high corrosion activity not only along the deck fascia as noted by visual inspections, but also in the deck region where the measurements were taken. Highest half-cell potentials were recorded near the expansion joint.

For the bridge located on Waldon road over I-75, readings varied from -250 to -600 mV with most readings being above -350 mV. This is a clear indication of high corrosion activity not only along the deck fascia as noted by visual inspections, but also in the deck region where the measurements were taken.

For the bridge located on US 131 Ramp over W River Dr. NW readings varied from -150 to -600 mV. The reading along the deck fascia were all lower than -350 mV. High half-cell potential readings were noted near the expansion joint. This is a clear indication of high corrosion activity not only along the deck fascia, but also in the deck region.

For the bridge located on I-94 EB over Red Arrow HW half-cell potential measurements varied from 0 to -600 mV. There is a clear trend towards lower readings towards the deck fascia. The average reading along the deck fascia was -560 mV. The average reading on the deck surface was -142 mV. There is a high probability of corrosion along the deck fascia, which was confirmed by visual inspections in certain areas. According to the readings on the deck surface, there is a 90% or higher probability that there is no corrosion on the deck surface, with the exception of the readings that were collected for the gridline closet to the expansion joint. For this gridline, the readings suggested a 90% or higher probability of corrosion. The lower negative values recorded on the rest of the deck surface may have been affected by a latex modified concrete overlay, which was installed in 1993. This overlay may have protected the reinforcement within the deck from reaching notable levels of corrosion activity. In summary, the lower clear cover recorded along the deck fascia, the higher moisture content, and the high level of corrosion activity explain why the fascia in this bridge is deteriorating.

Fig. 3.31 Half-cell potentials for: a) the I-69 bridge over Fenton Road in Bay Region, b) the I-96 bridge over M-99 in University Region, c) County road over I-75, d) Waldon road over I-75, e) US 131 Ramp over W River Dr. HW

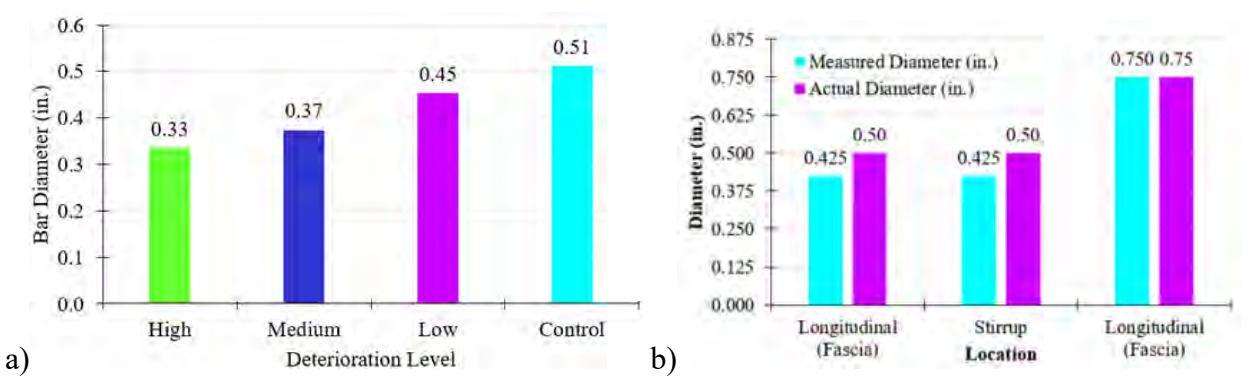
In the bridge located on I-69 over Fenton Road, the diameter of corroded reinforcement in the vicinity of the deck fascia (curb) was measured on a No. 4 bar. Various measurements were taken to document various levels of corrosion. The collected data is illustrated in Fig. 3.32a. The measured diameters varied from 0.33 in. to 0.51 in. Up to a 34% section loss was observed at the highly deteriorated areas of rebar.

Similarly, section loss was measured in exposed corroded bars in the bridge located on Waldon Road over I-75. The collected data is illustrated in Fig. 3.32b. Measurements were taken on longitudinal bars along the fascia as well as U-shaped bars (herein denoted as stirrups) in the transverse direction. The size of the bars used was No. 4 and No. 6 (i.e. the uncorroded diameter is 0.5 in. and 0.75 in., respectively). Up to a 15% section loss was observed at the highly deteriorated areas of rebar.

Fig. 3.32 Section loss in corroded bars: a) bridge on I-69 over Fenton Road, and b) bridge on Waldon Road over I-75

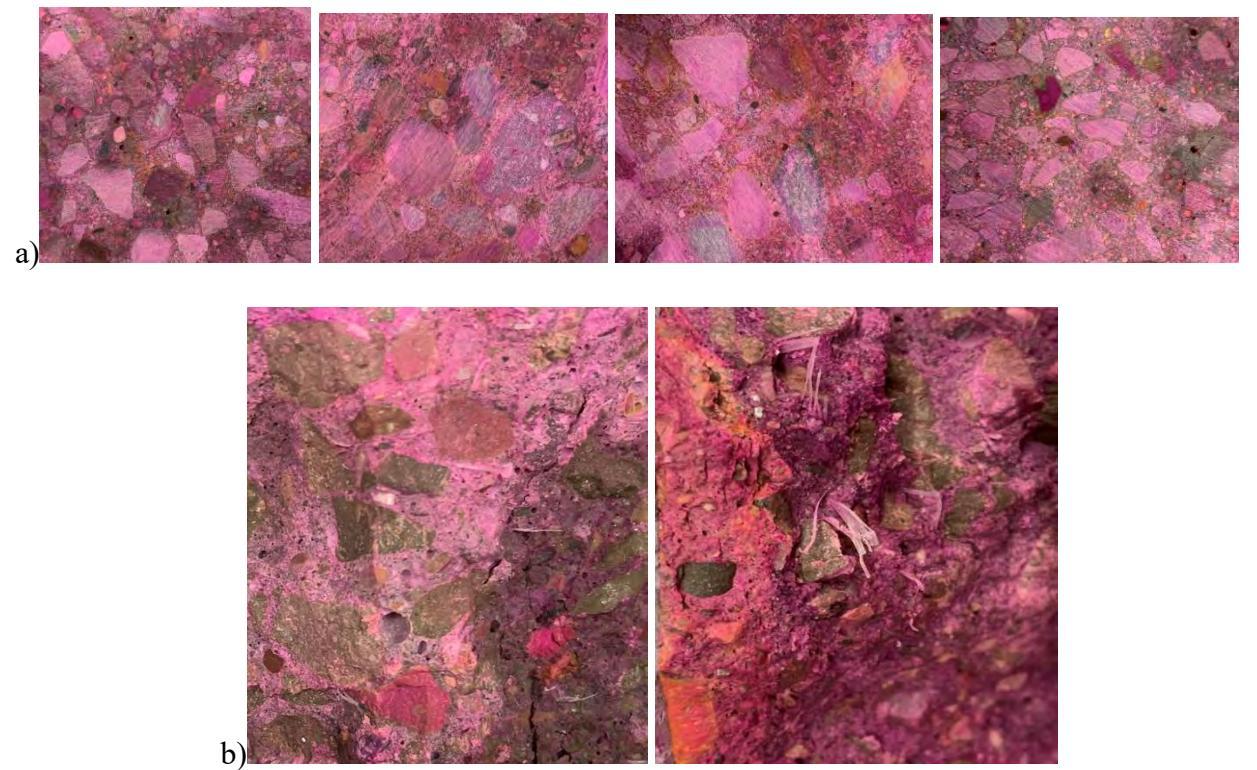
- Some yellow stains were observed indicating presence of ASR.
- Pink stains were observed although not necessarily with yellow stains.
- Presence of ASR is likely.

Fig. 3.33 ASR test results for the cores obtained from the bridge located in Bay Region on I-69 over Fenton Road: a) at the cross-section of the cores; b) along the height of the cores after compressive strength testing
