Repair of Bridge Deck Fascias OR22-002

Final Report

09/30/2023

> **Prepared By:** Furkan Cakmak Fatmir Menkulasi Christopher Eamon Hwai-Chung Wu

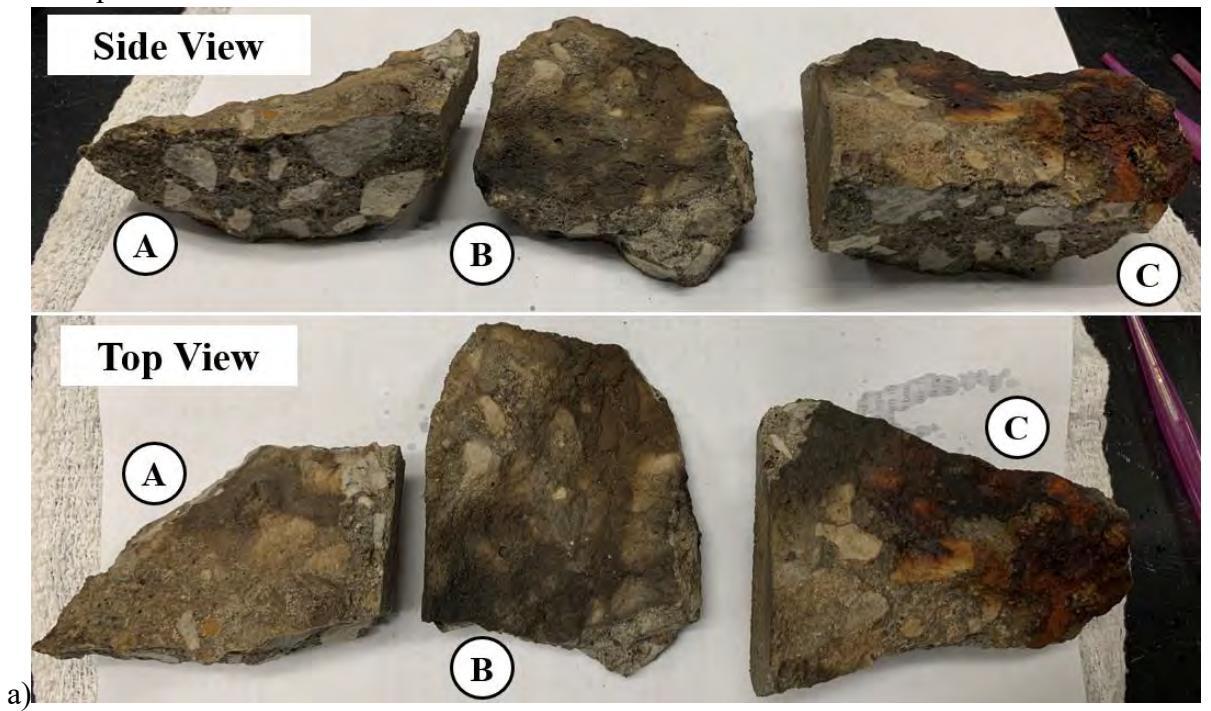
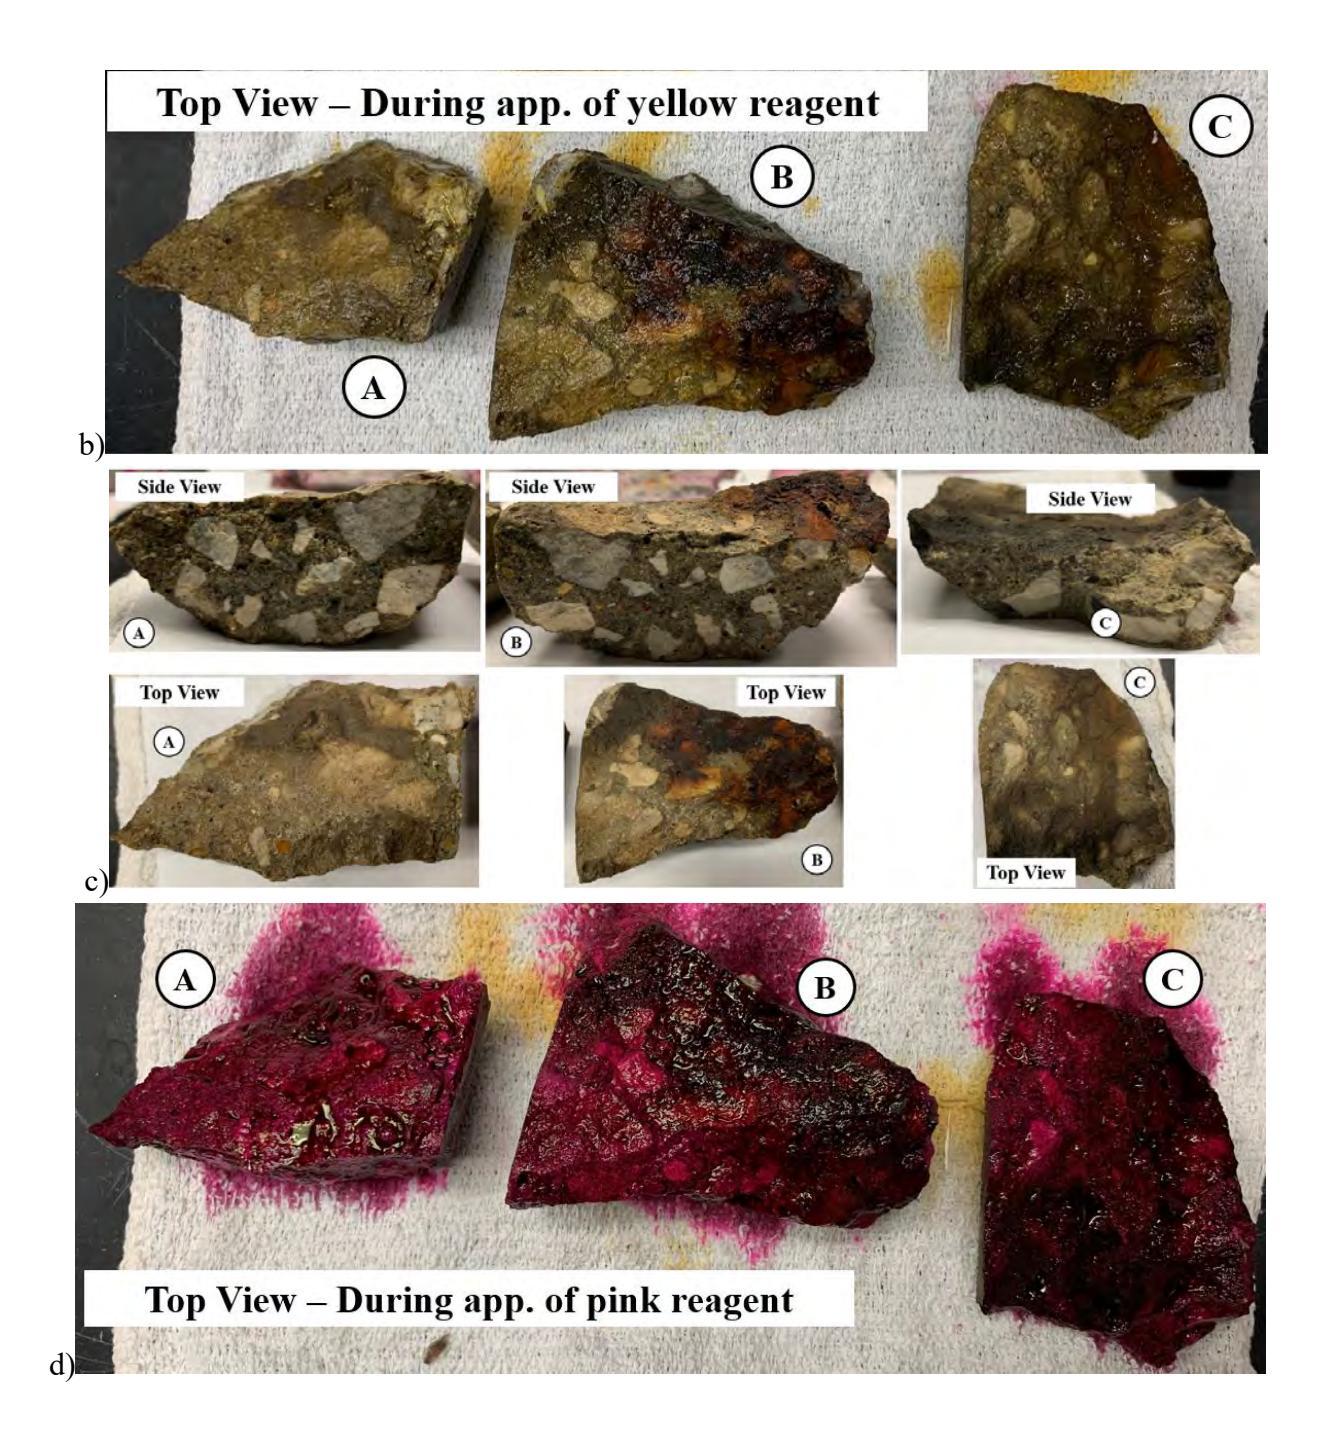
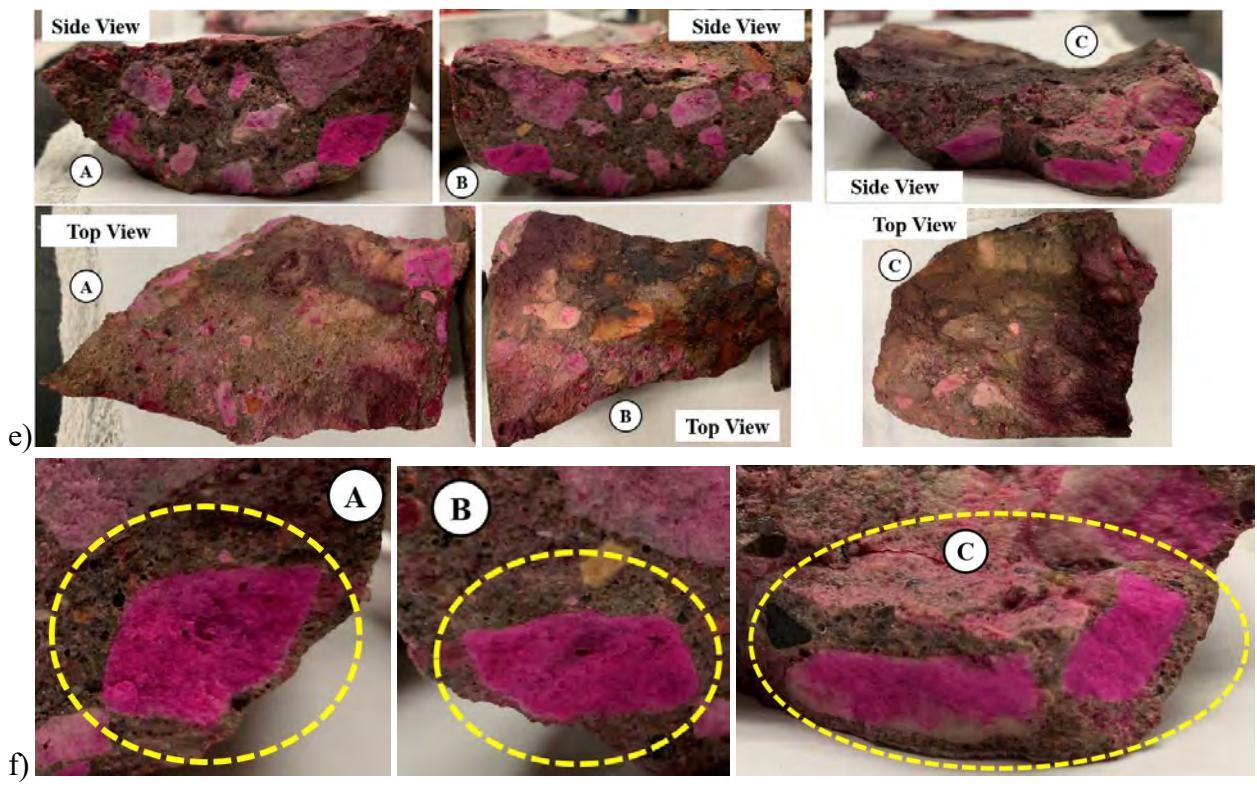
- The ASR testing was conducted on broken concrete fragments obtained from the deck fascia.
- There is no yellow residue after rinse off
- There is some pink residue after rinse off although this residue appears to be concentrated within the surface of the aggregate and not around the boundaries between the aggregates and paste.
- Presence of ASR does not appear likely.

Fig. 3.38 Application of ASR test kit on the concrete fragments obtained from the bridge located in I-94 EB over Red Arrow Highway (S.N. 818 & C.S. S17-11015): a) views before application of reagents; b) views during application of yellow reagent; c) views just after rinsing off the yellow reagent; d) views during application of pink reagent; and e-f) views just after rinsing off the pink reagent

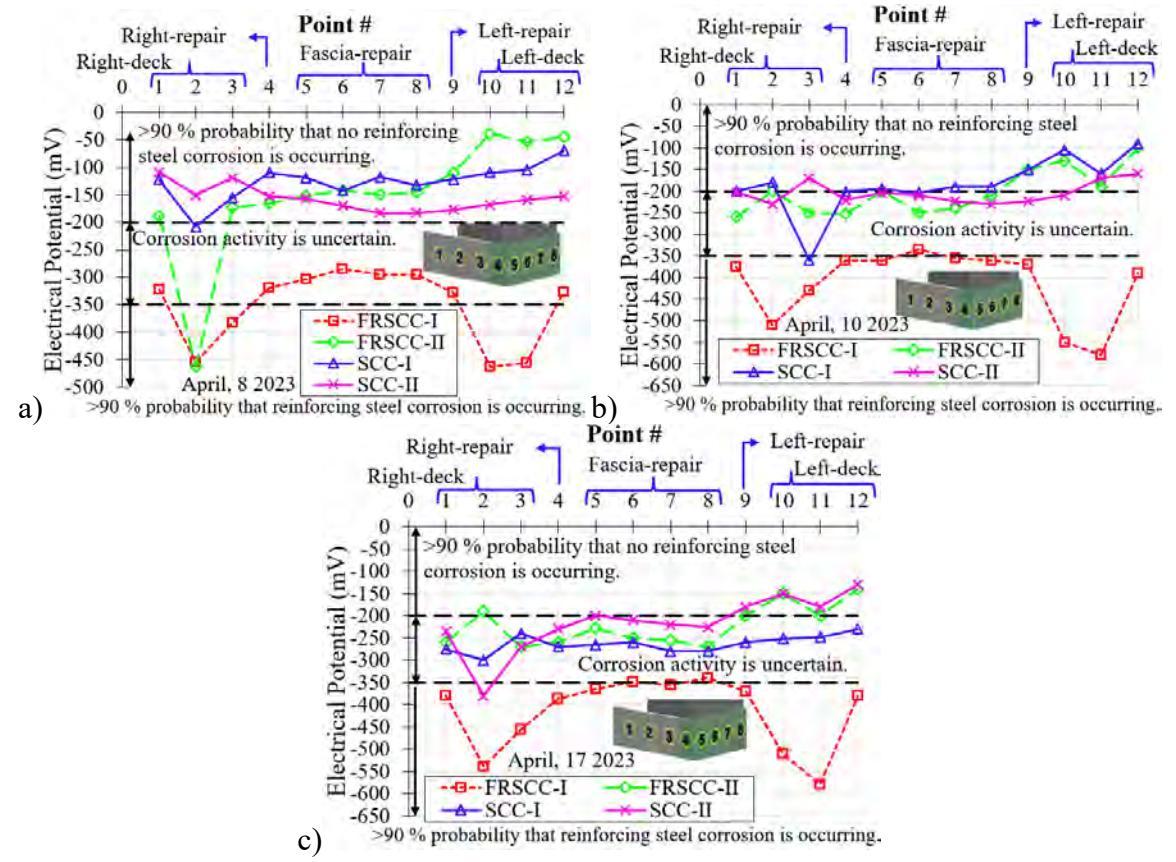
Fig. 6.24 shows half-cell potential measurements at different points around the deck fascia at three different points in time: a) just after the termination of test (18 days), b) 2 days after the termination of test (20 days), and c) 9 days after the termination of test (27 days). Recall that only side I of FRSCC was completely submerged in the sodium chloride solution. The other side of FRSCC and the two sides of SCC were subjected only to 3 in. of standing sodium chloride solution due to leakage problems. Therefore, the half-cell potential measurements suggest that either corrosion activity is uncertain or there is 90% probability or greater that there is no corrosion of reinforcement in the test specimen that was repaired with SCC and one of the sides of the test specimen that was repaired with FRSCC. In FRSCC specimen side I, the half-cell potential readings suggest that there is >90% probability that reinforcing steel corrosion had occurred. There was also one measurement in the test specimen that was repaired with the SCC that suggested a > 90% probability that reinforcement corrosion had occurred. The differences in the likelihood of corrosion within the specimen as well as between the specimens provided an opportunity to determine the impact that any existing corrosion in the deck may have on the crashworthiness of

Fig. 6.24 Half-cell potential measurements around the fascia taken from the repair specimens: a) on April 8, 2023 (just after the termination of the test); b) on April 10, 2023 (2 days after termination of the test); and c) on April 17, 2023 (9 days after the termination of the test)

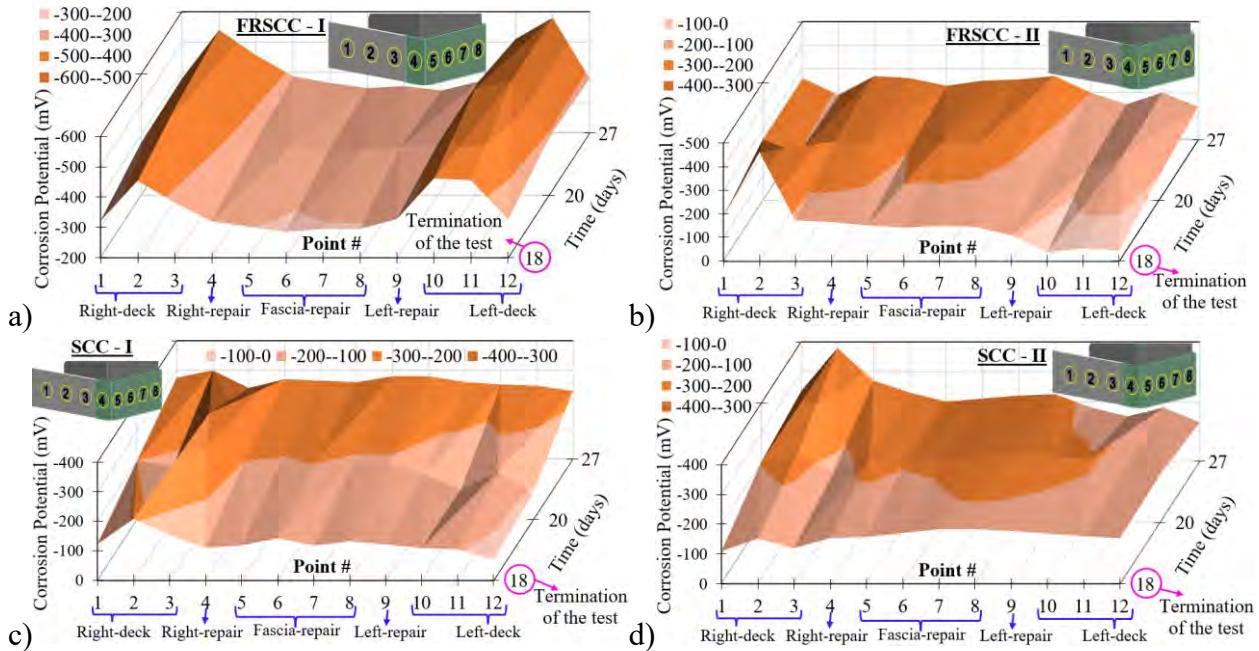
Fig. 6.25 3D surface plots for the half-cell potential measurements taken from the repair specimens after the test is terminated: a) measurements around the fascia side I on FRSCC specimen; b) measurements around the fascia side II on FRSCC specimen; c) measurements around the fascia side I on SCC specimen; and d) measurements around the fascia side II on SCC specimen

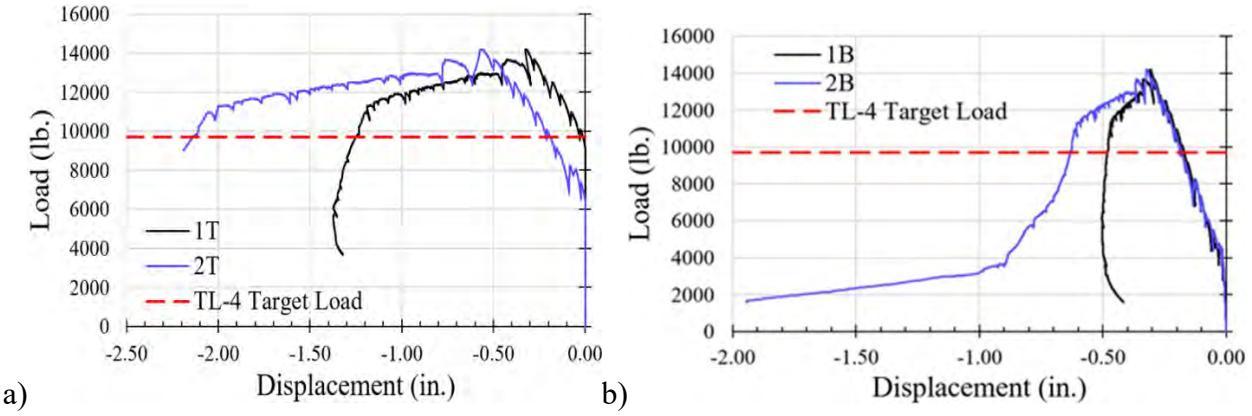
The average load versus lateral displacement response is reported in Fig. 6.26a. Recall that there were two horizontal LVDTs in each specimen (one on each side). To report the average response the average measurements from each horizontally placed LVDT were used. The horizontal dashed red line represents the load capacity of the specimen that is equivalent to a TL-4 barrier crashworthiness in a full-scale bridge. The load versus lateral displacement response was such that in the initial stages there was an increase in load with no measurable lateral displacement (i.e. the induced lateral displacements were outside the sensitivity range of the LVDTs). This is attributed to the large uncracked flexural stiffness of the barrier to deck assembly. Once cracking occurred and the flexural stiffness reduced, the horizontally placed LVDTs started to report measurable lateral displacements. The overall response could be characterized by a linear elastic response of the uncracked subassembly, vertical cracking of the deck caused by bending moments and axial tension, formation of additional vertical cracks in the deck including one near the inside face of the barrier, yielding of the reinforcement, formation of a critical diagonal crack, which intercepted the vertical crack near the inside face of the barrier, attainment of a maximum lateral load capacity, and provision of notable post-peak lateral load capacity. The test specimen that featured the FRSCC repair performed rather similarly with control specimen. Fig. 6.26a suggests that the FRSCC repair resulted in a stiffer response compared to the test specimen that featured the SCC repair. Side I (corroded side) in FRSCC specimen performed better than side II (uncorroded side) despite featuring higher half-cell potential readings as illustrated in Fig. 6.27a.

Side I (corroded side) performed similarly and better than side II (uncorroded side) (Fig. 6.26b). Therefore, the induced accelerated corrosion did not undermine the stiffness or capacity of the barrier deck assembly.

Fig. 6.27 Measured load versus a) horizontal (at the top of the barrier), and b) vertical displacement (at the bottom of the barrier) relationship for FRSCC – side I (1T/1B) versus side II (2T/2B)

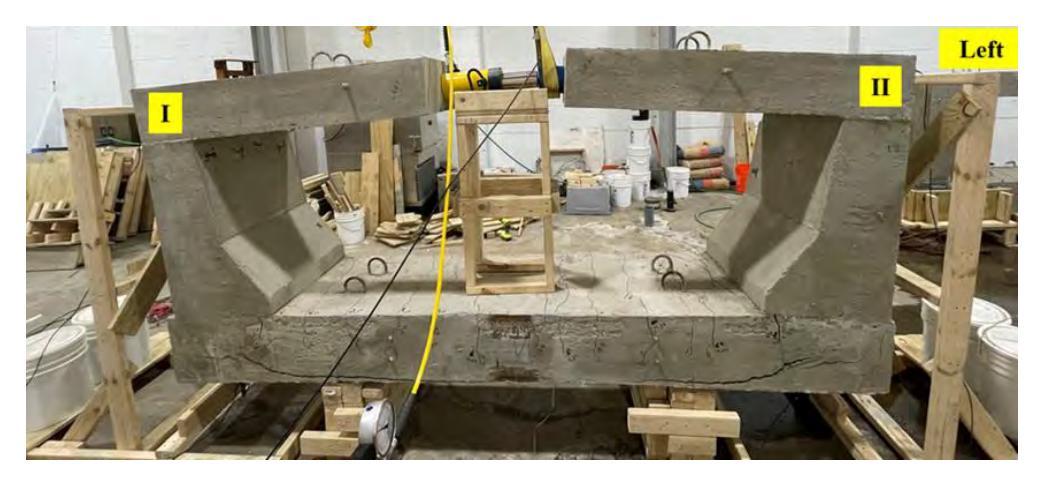
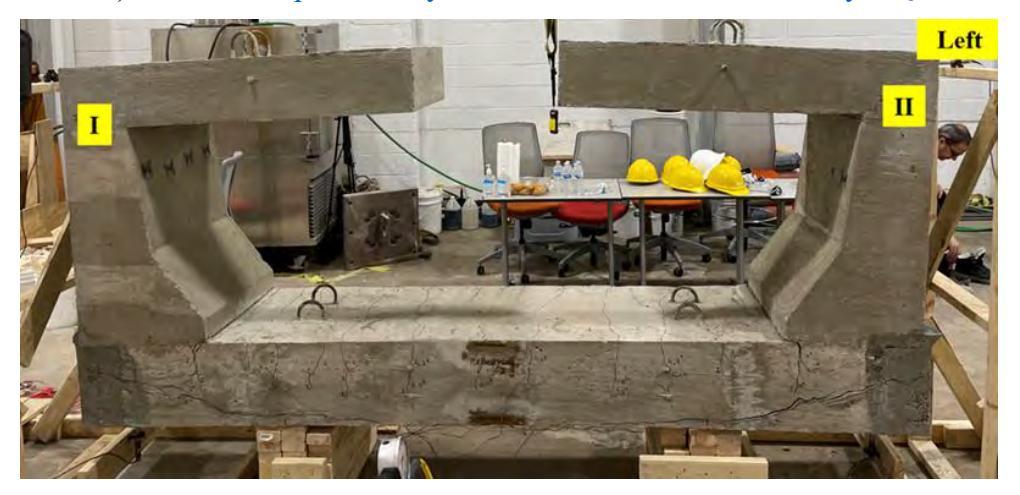
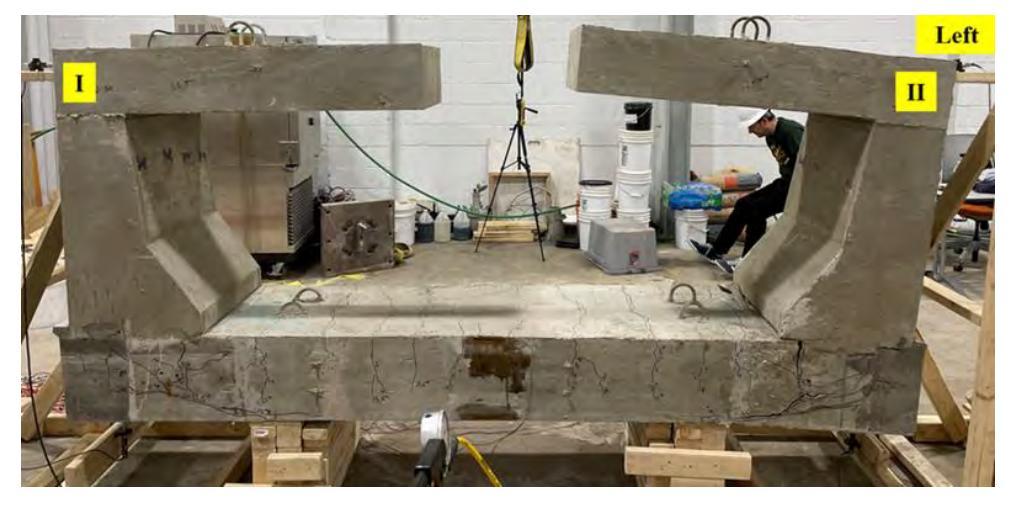
Ultimate cracks patterns for all tested specimens were overall similar and are illustrated in Fig. 6.28. All cracks occurred in the deck. No cracks were observed in the barrier suggesting hinging behavior at the deck to barrier interface. Since the deck portion between the barriers is subject to constant tension and moment, the first cracks precipitated in the deck between the barrier in no particular order with respect to their location. That is, the first crack occurred in the region that provided the least tensile resistance considering the heterogeneity of deck concrete. These cracks were vertical flexural and axial tension cracks as would be expected since the principal tensile stress trajectories in the tensile deck region are horizontal. As the load intensified, the axial tension and flexural cracks, which started at the top of the deck, propagated towards the bottom of the deck. In all specimens, there was a vertical crack in the deck in the vicinity of the inside face of the barrier. This crack was later intercepted by a critical diagonal crack that precipitated failure. This critical diagonal crack aligns with the principle compressive stress trajectories – recall that there is a concentrated moment and tension force at each end of the deck. This critical diagonal crack crossed the repaired interface in the repair specimens suggesting comparable performance to the control specimen. In addition, the presence of the repair interface did not appear to affect the crack pattern. Crack patterns in the deck were also similar in all three specimens suggesting no change in the transfer of load from the barrier to the deck despite the repaired connections. Fig. 6.29 illustrates the condition of the tested specimen after failure. Links are also provided for accelerated test videos.

Fig. 6.29 Photographs and video links for all three tested specimens – photographs are taken after failure: a) Control, b) SCC, c) FRSCC

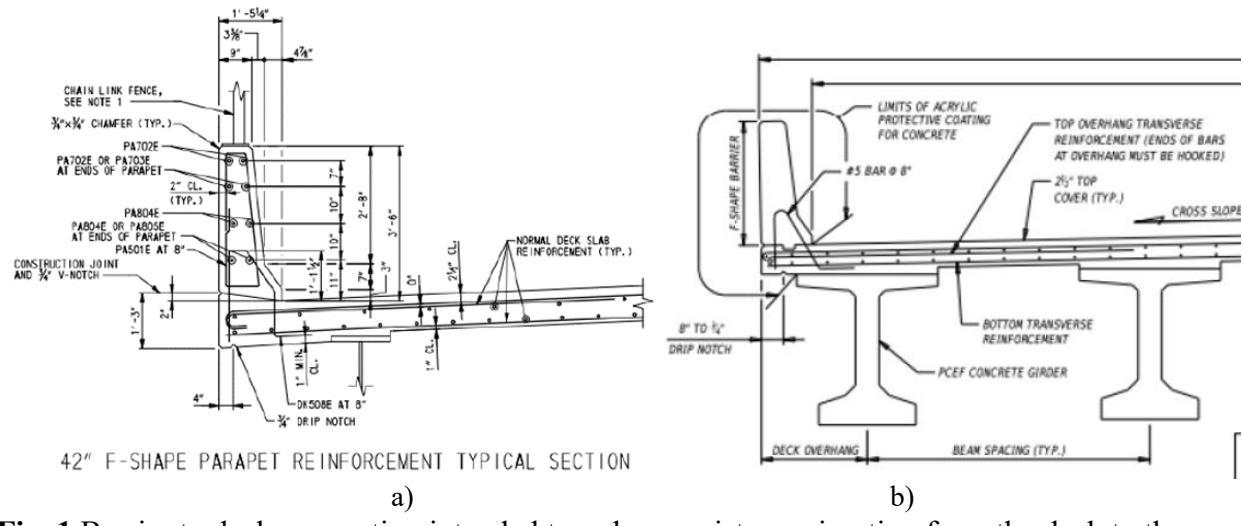
Fig. 1 Barrier to deck connection intended to reduce moisture migration from the deck to the fascia using: a) a <u>sloped top deck surface</u>, and b) <u>suppressed shear key</u>

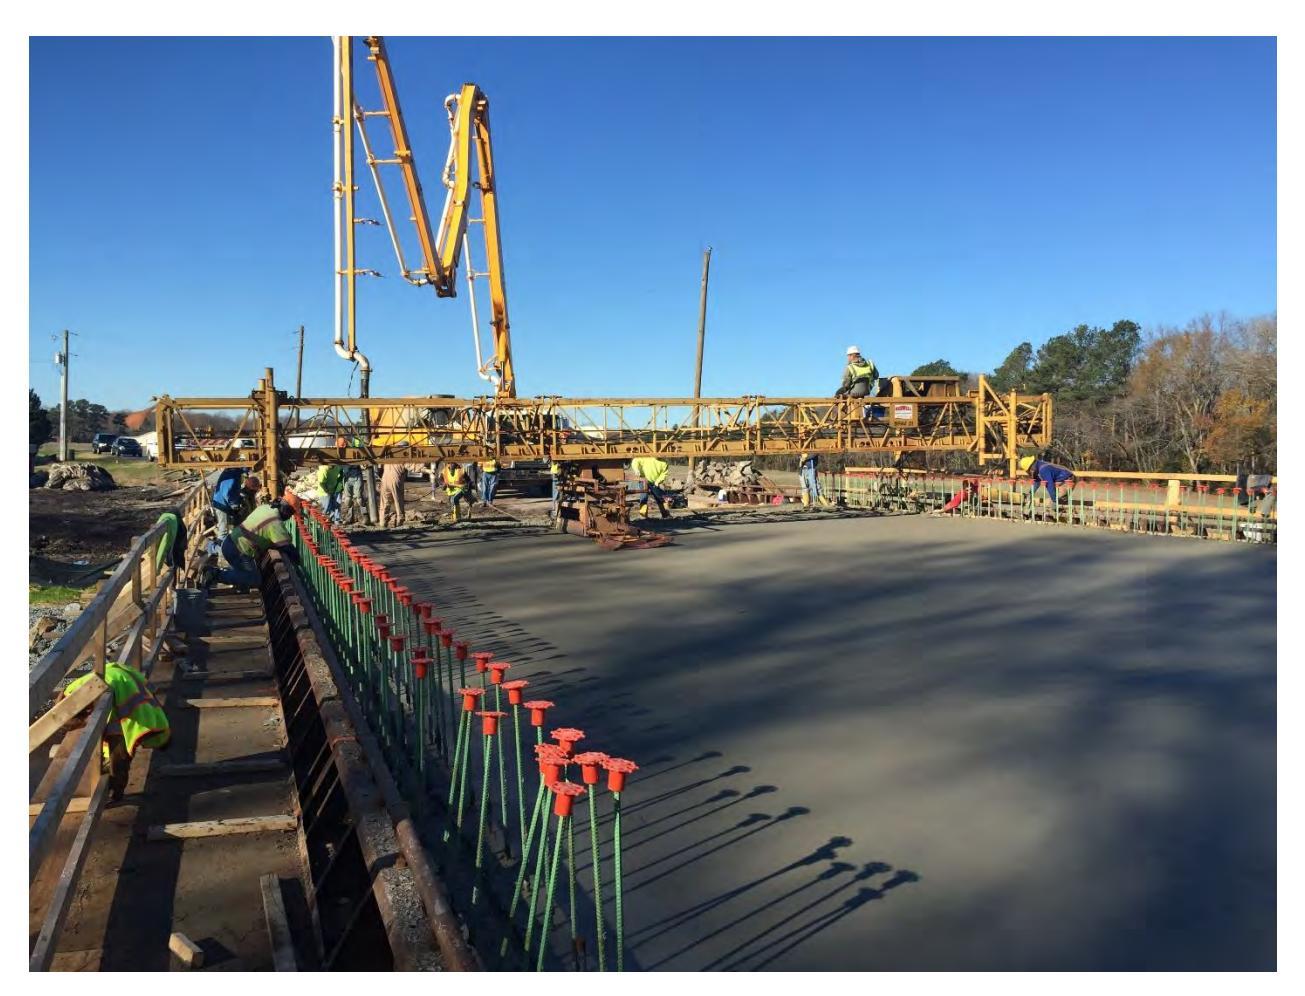
General View of Bidwell with rebar tying deck up into future concrete bridge rail.

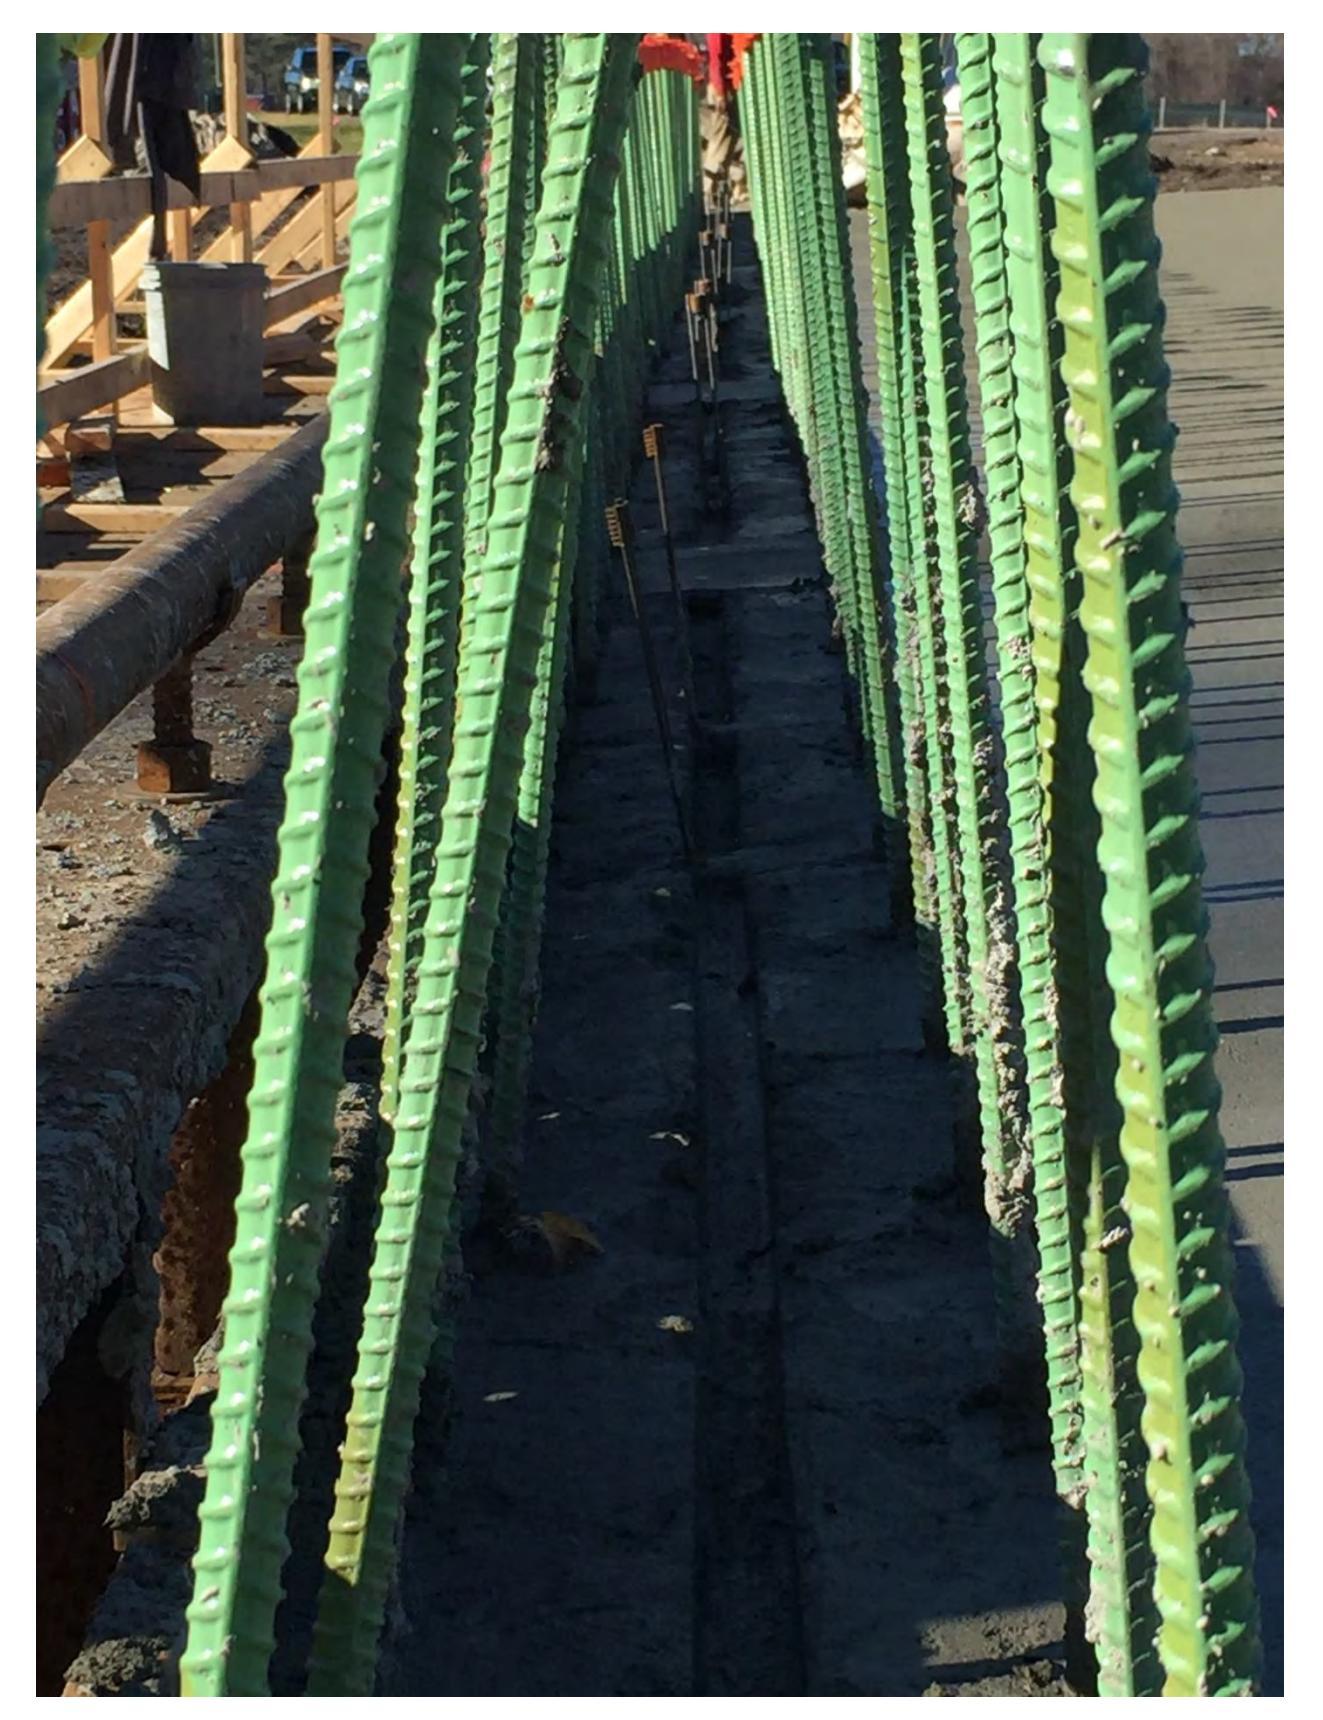
Close-up of shear key at concrete deck/rail base interface.

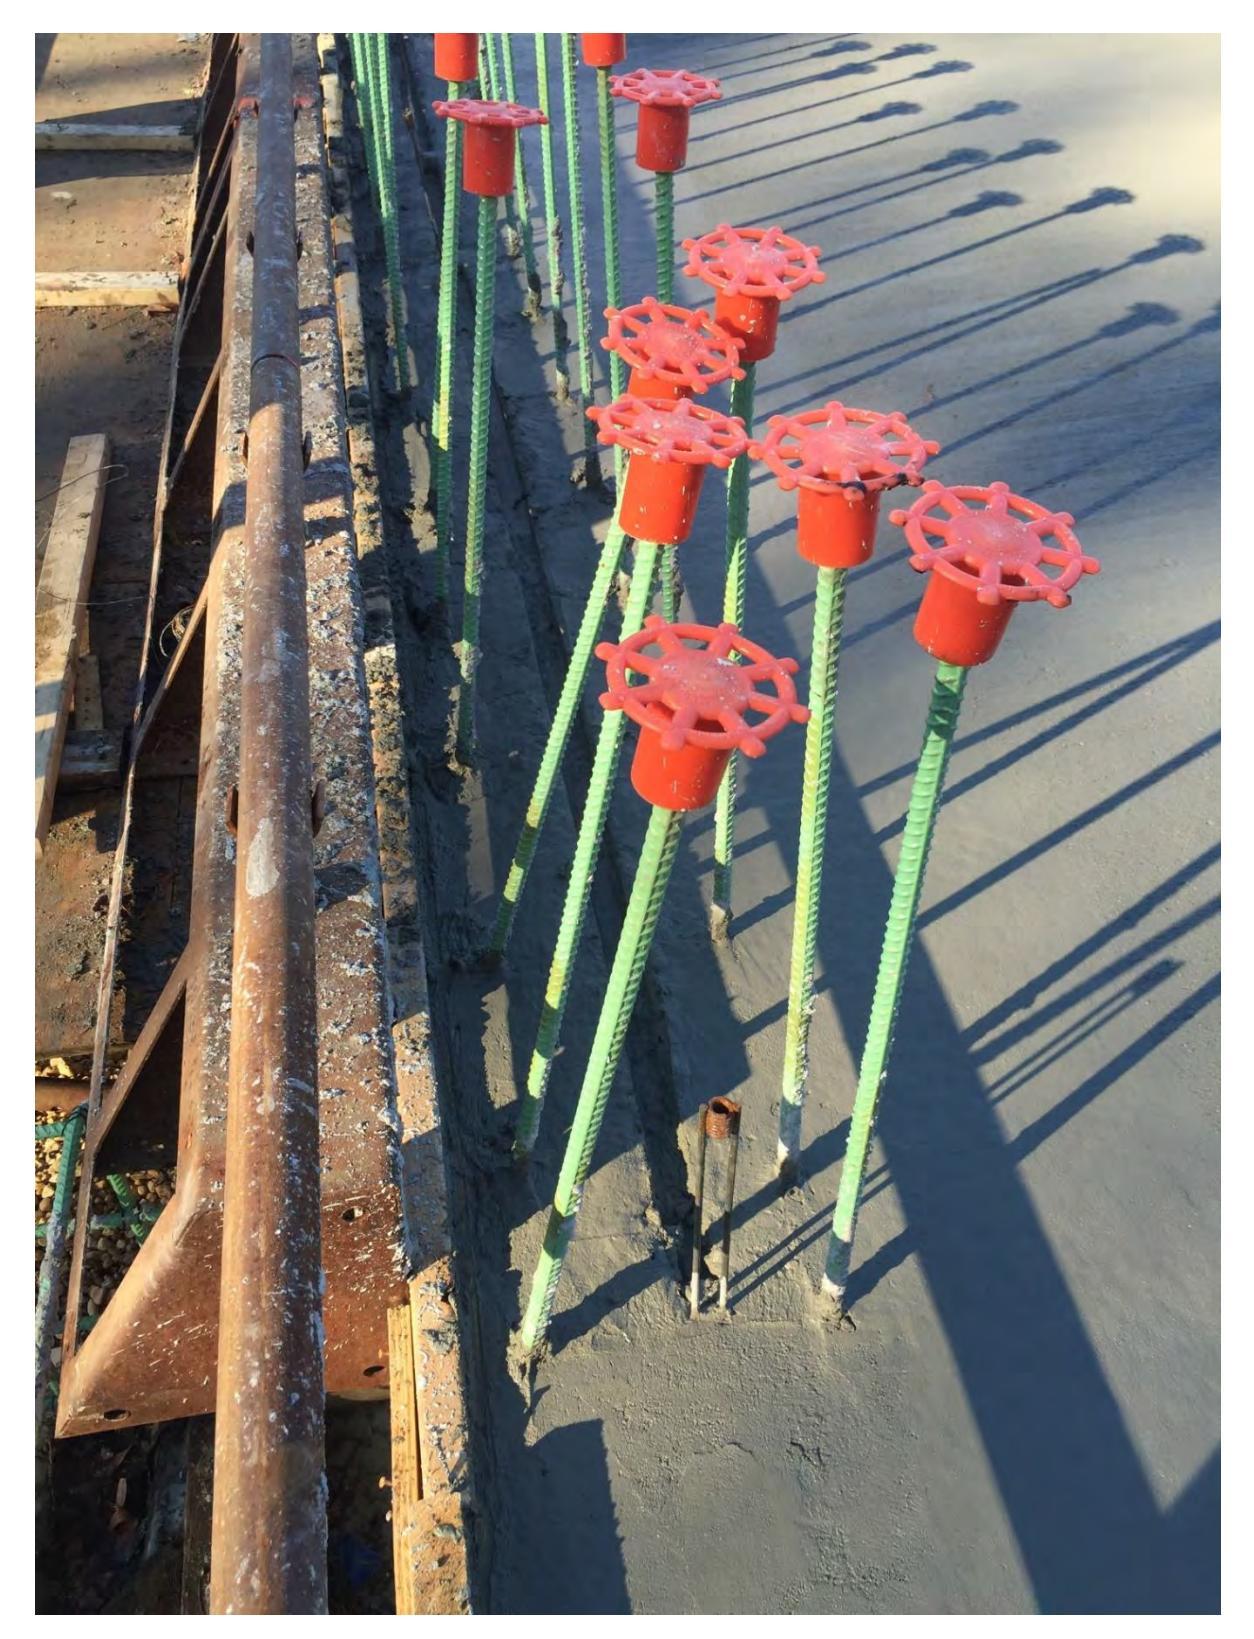
Close-up of shear key at concrete deck/rail base interface.

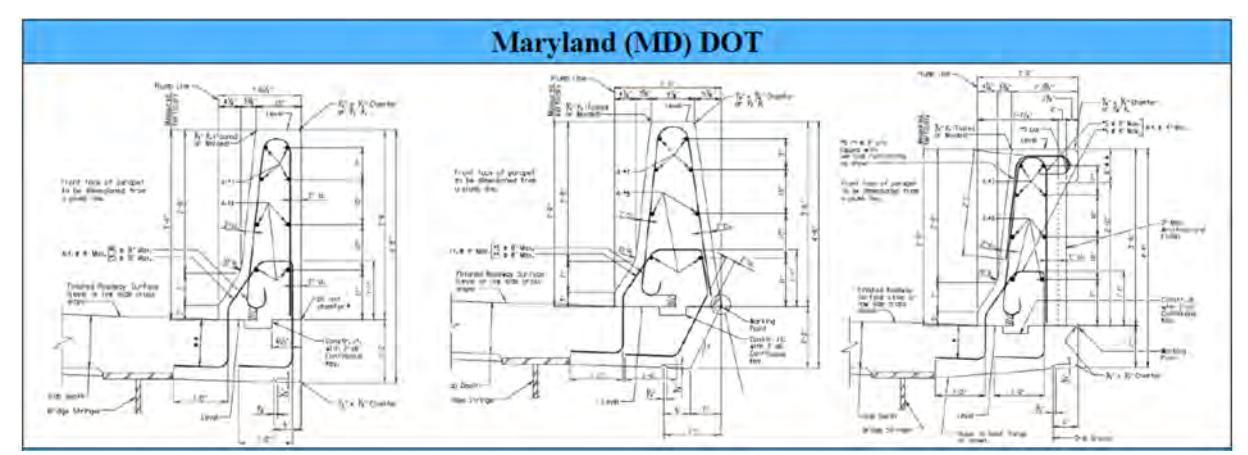
Fig. 1 Barrier to deck connections intended to reduce moisture migration from the deck to the fascia using a suppressed shear key connection

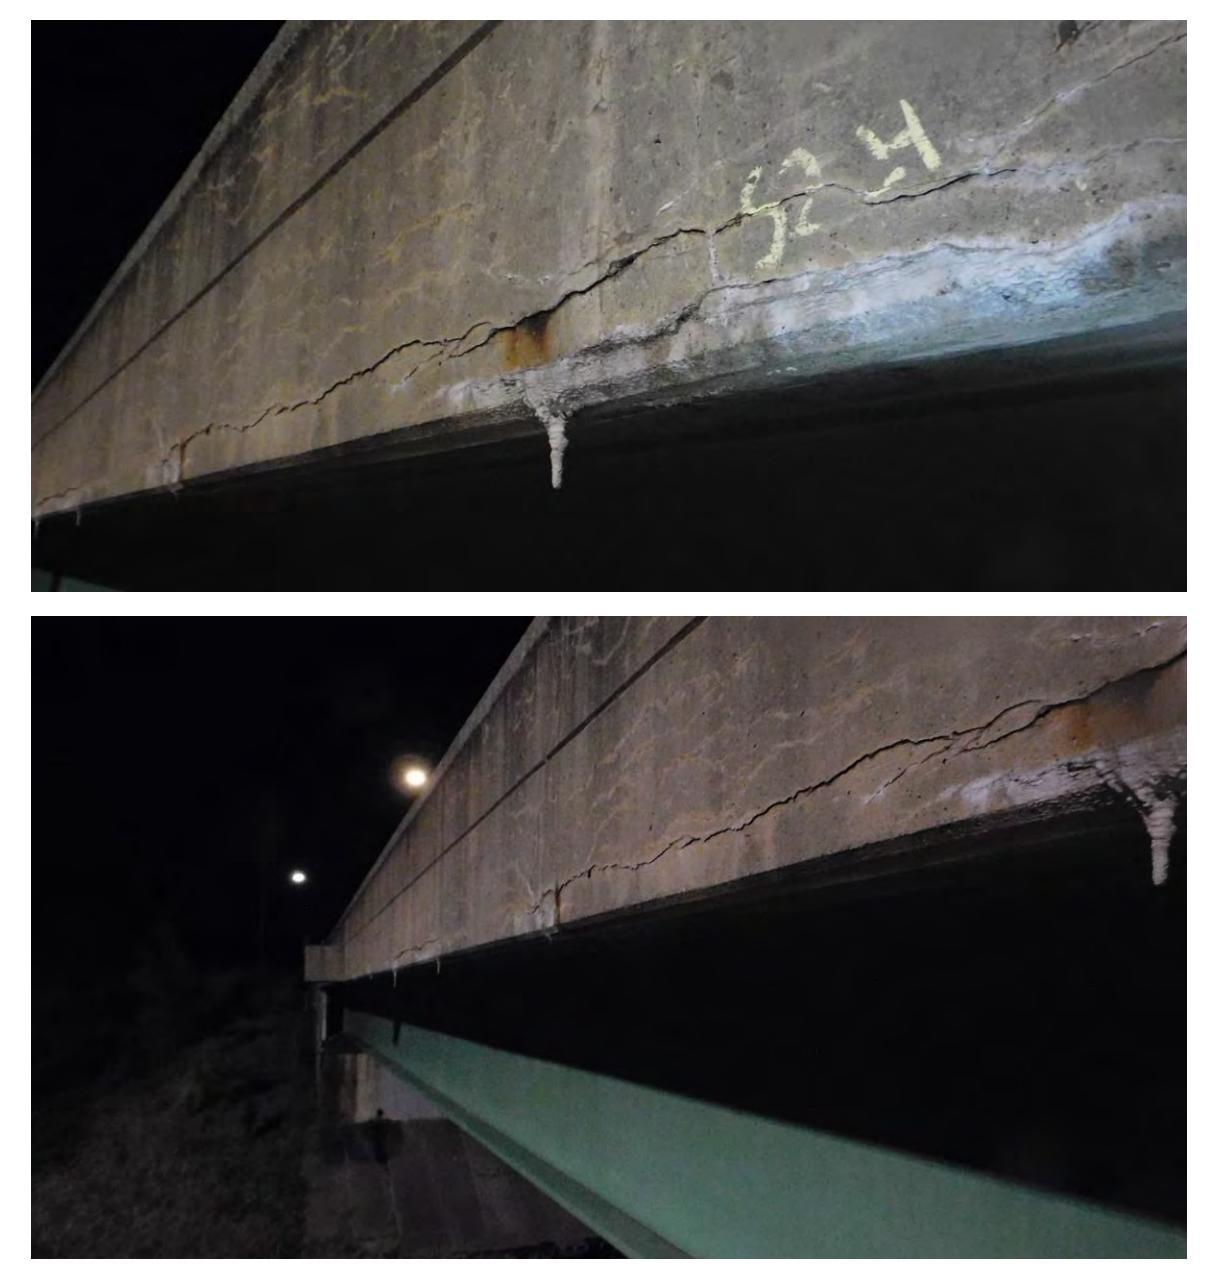
<u>Question 2:</u> In bridges where these details have been implemented, have you observed any deterioration in the bridge deck fascia? Yes, I have been informed that we still do have this problem on some of our bridges (see attached picture). This being a cold joint between the parapet and deck, water does make its way through. If the key was reversed and went up, this possibly could help slow down the migration of water seepage. Also, not sure how good a job contractors are doing at putting the bonding agent along this joint before they pour which could be another contributing factor.

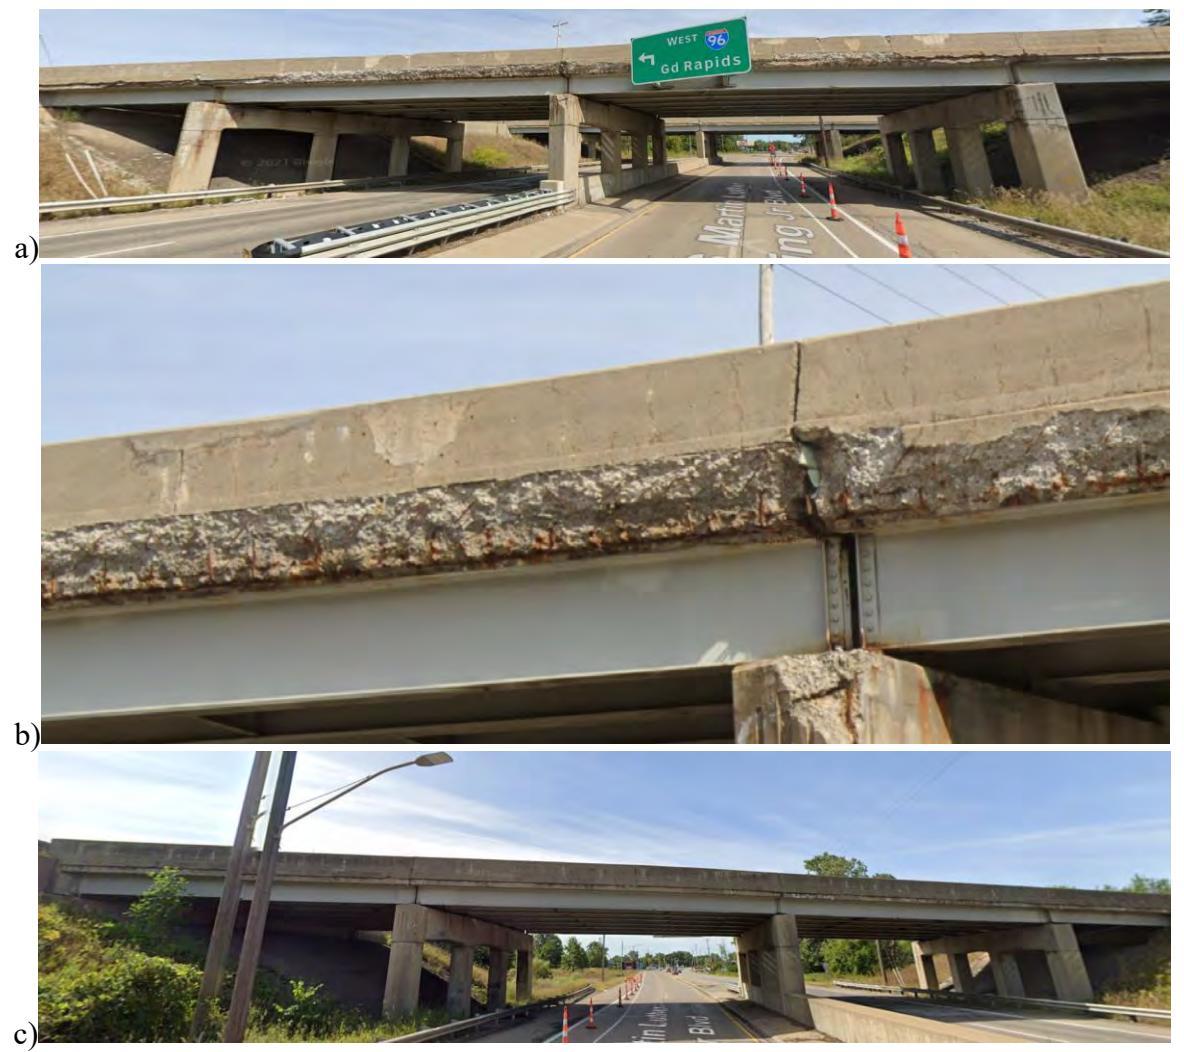
Fig. D.1 I-96 EB over M-99: a-b) lower side; c) upper side

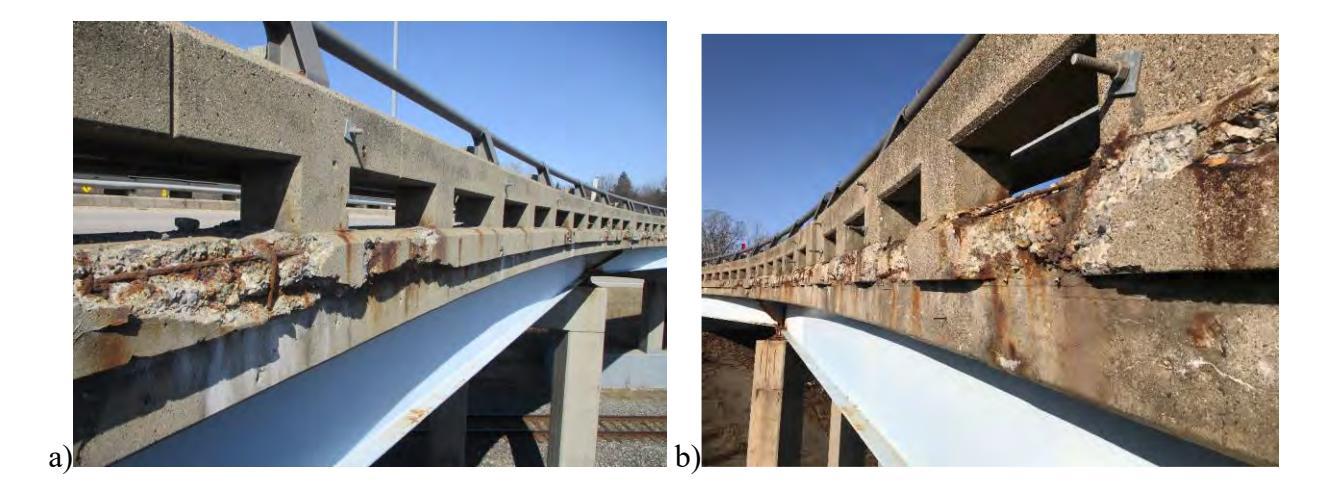
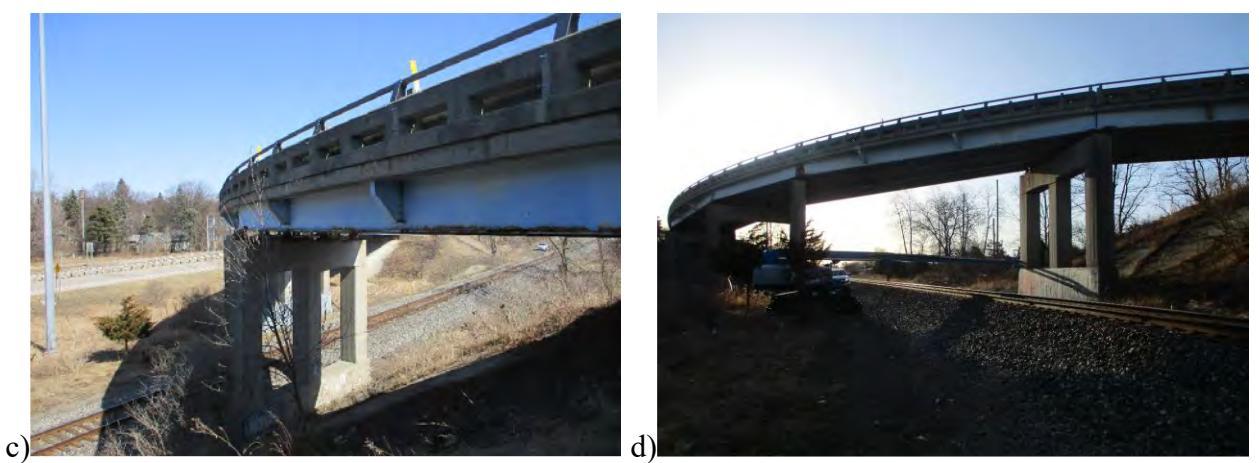
Fig. D.2 I-496 WB Ramp over CSX Railroad: a-b) lower side; c-d) upper side (obtained from MDOT inspection report conducted on 3/19/2021)

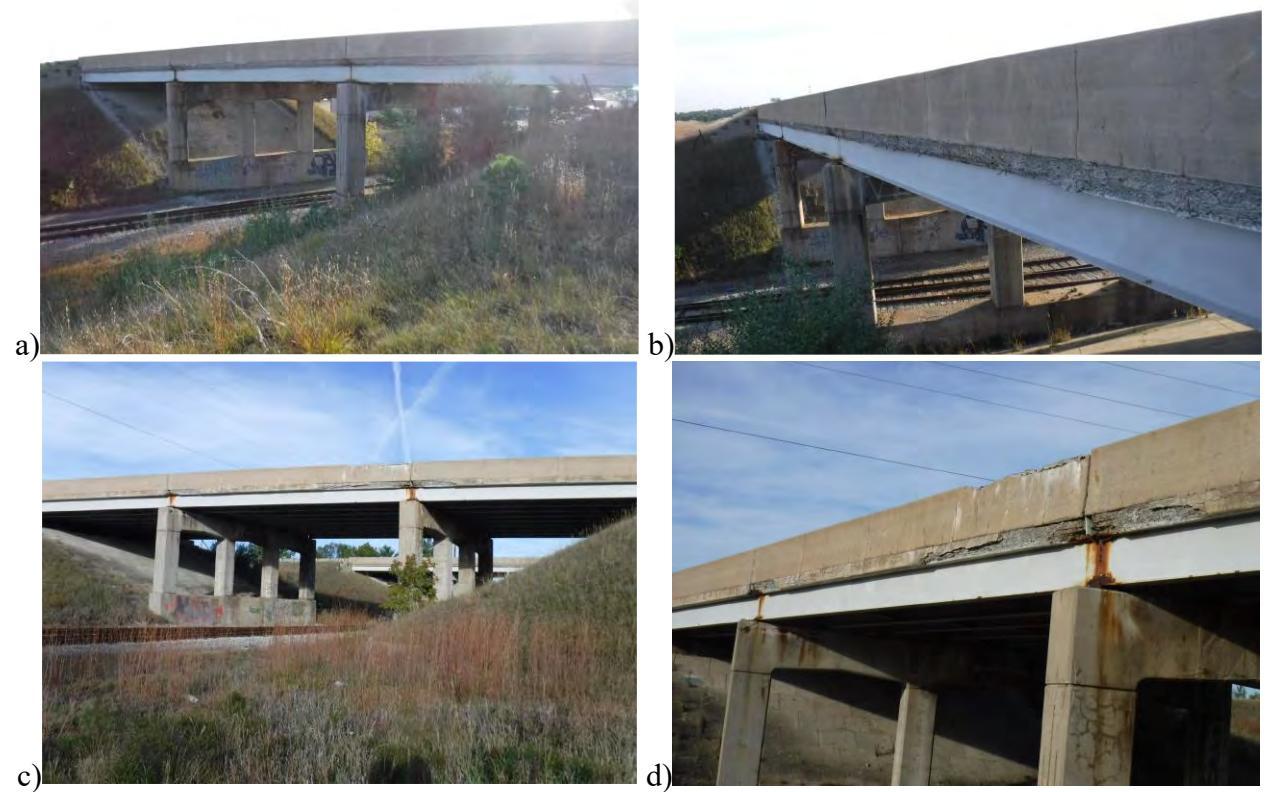
Fig. D.3 I-75 NB over Lake State Railroad: a-b) lower side; c-d) upper side (obtained from MDOT inspection report conducted on 09/27/2021)

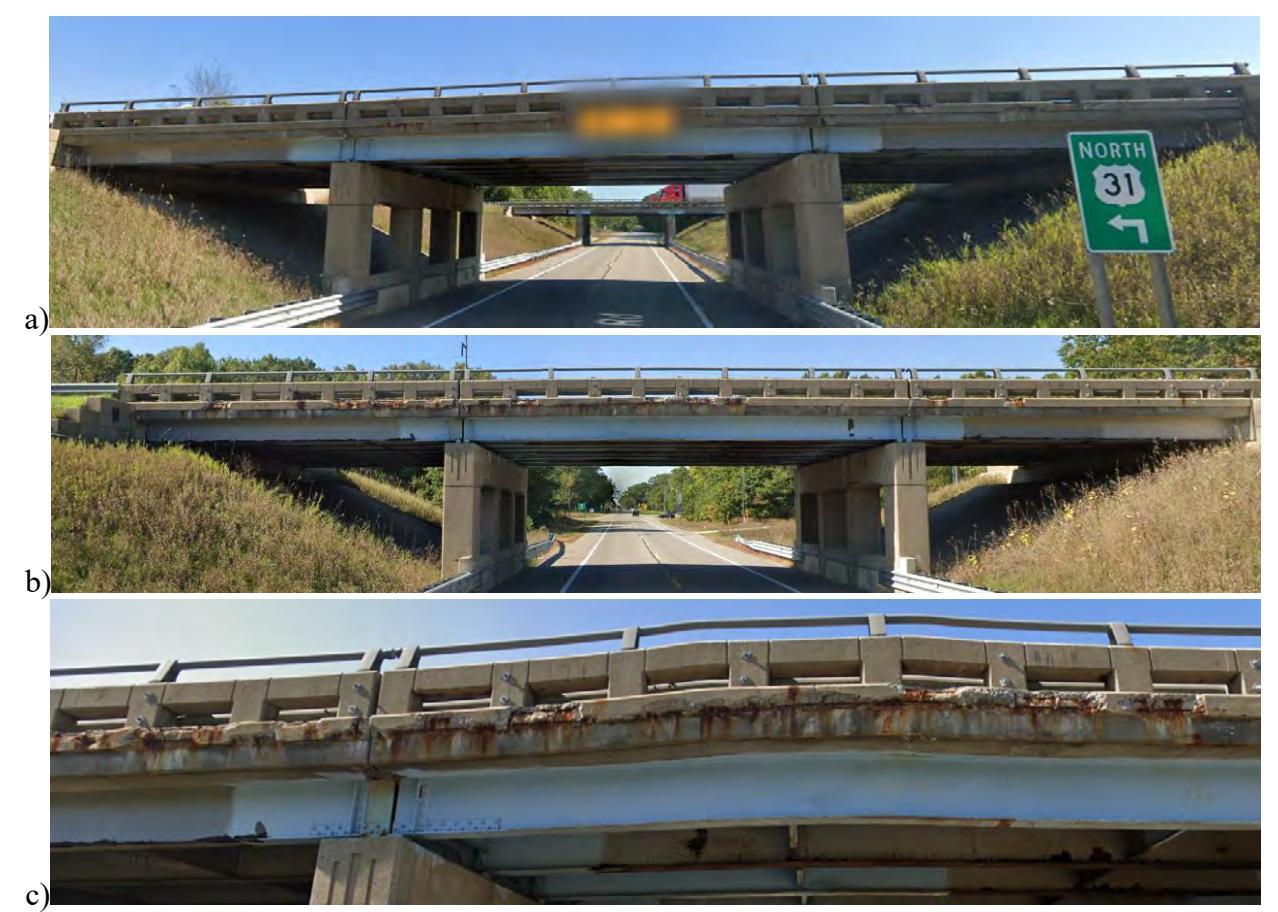
Fig. D.4 US-31 SB US-31 Business Route: a) lower side; b-c) upper side
