Repair of Bridge Deck Fascias OR22-002

Final Report

09/30/2023

> **Prepared By:** Furkan Cakmak Fatmir Menkulasi Christopher Eamon Hwai-Chung Wu

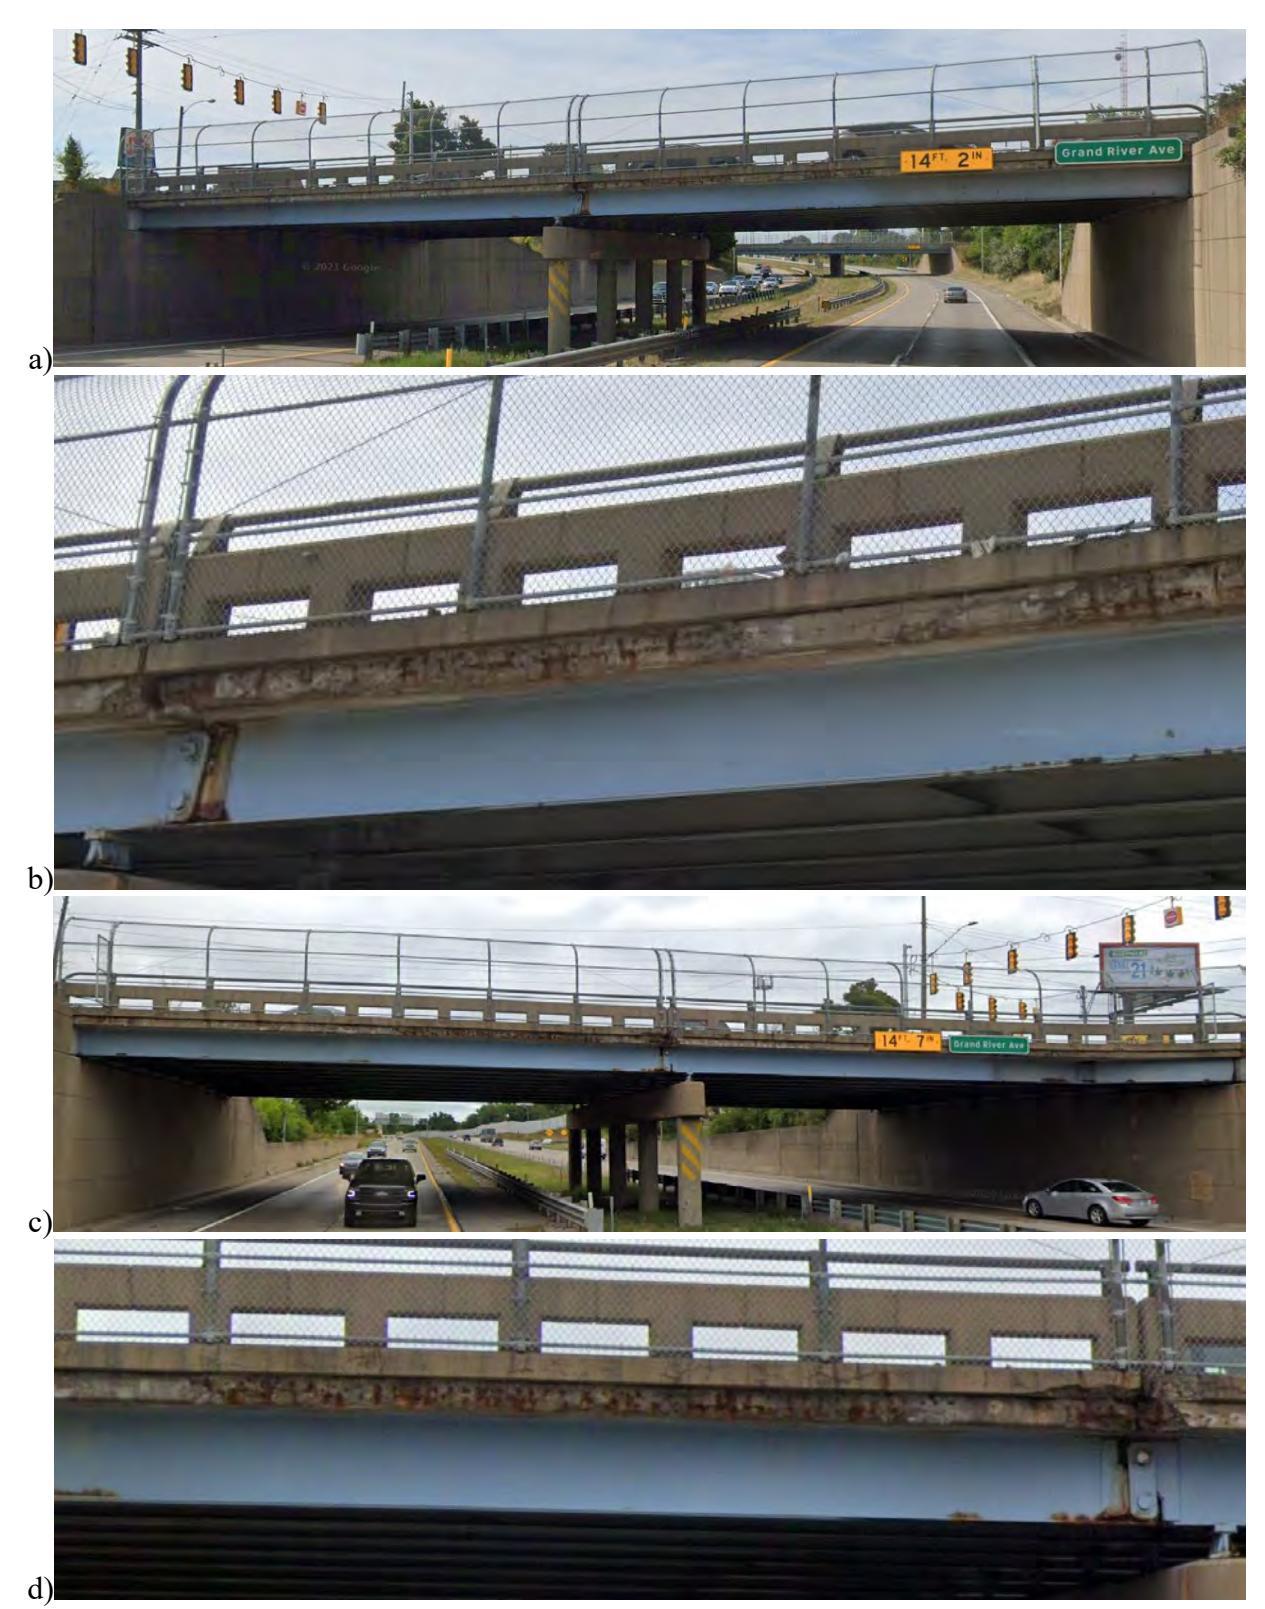
Fig. D.5 M-43 WB (Grand River) over US-127: a-b) lower side; c-d) upper side

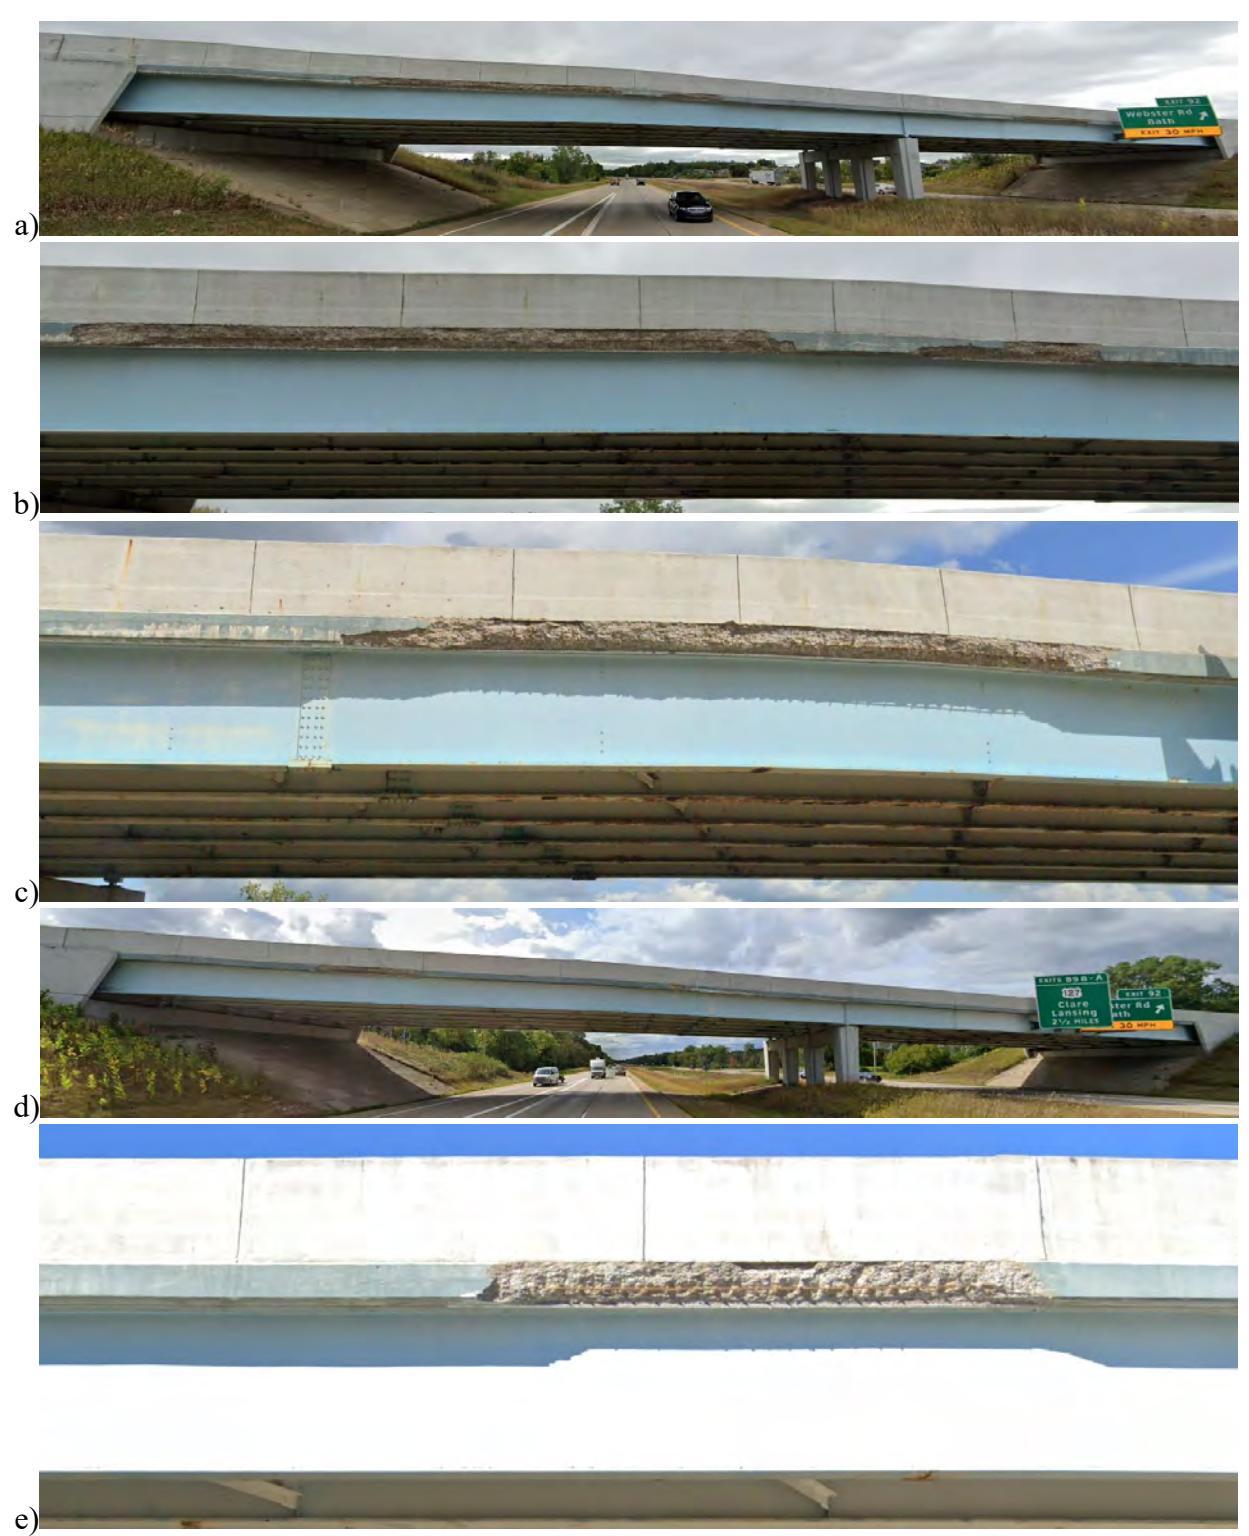
Fig. D.6 Webster Rd. over I-69: a-c) lower side; d-e) upper side

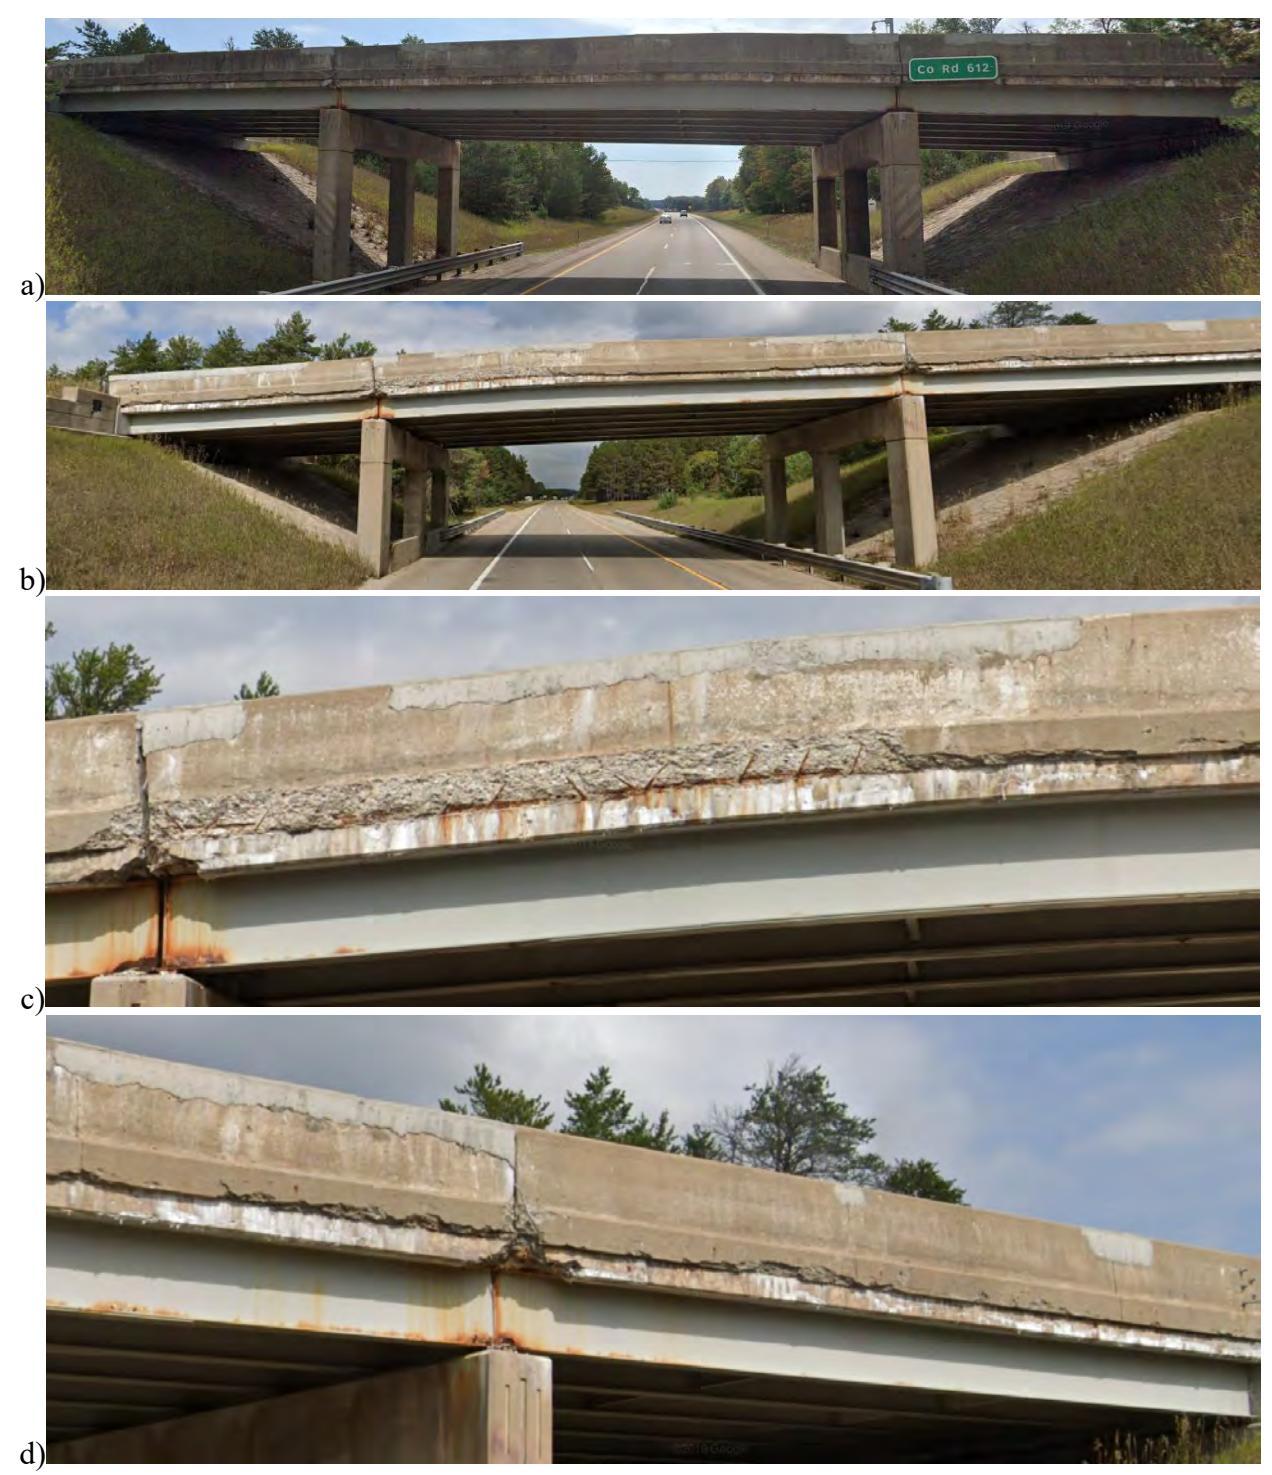
Fig. D.7 County Rd. 612 over I-75 SB: a) lower side; b-d) upper side

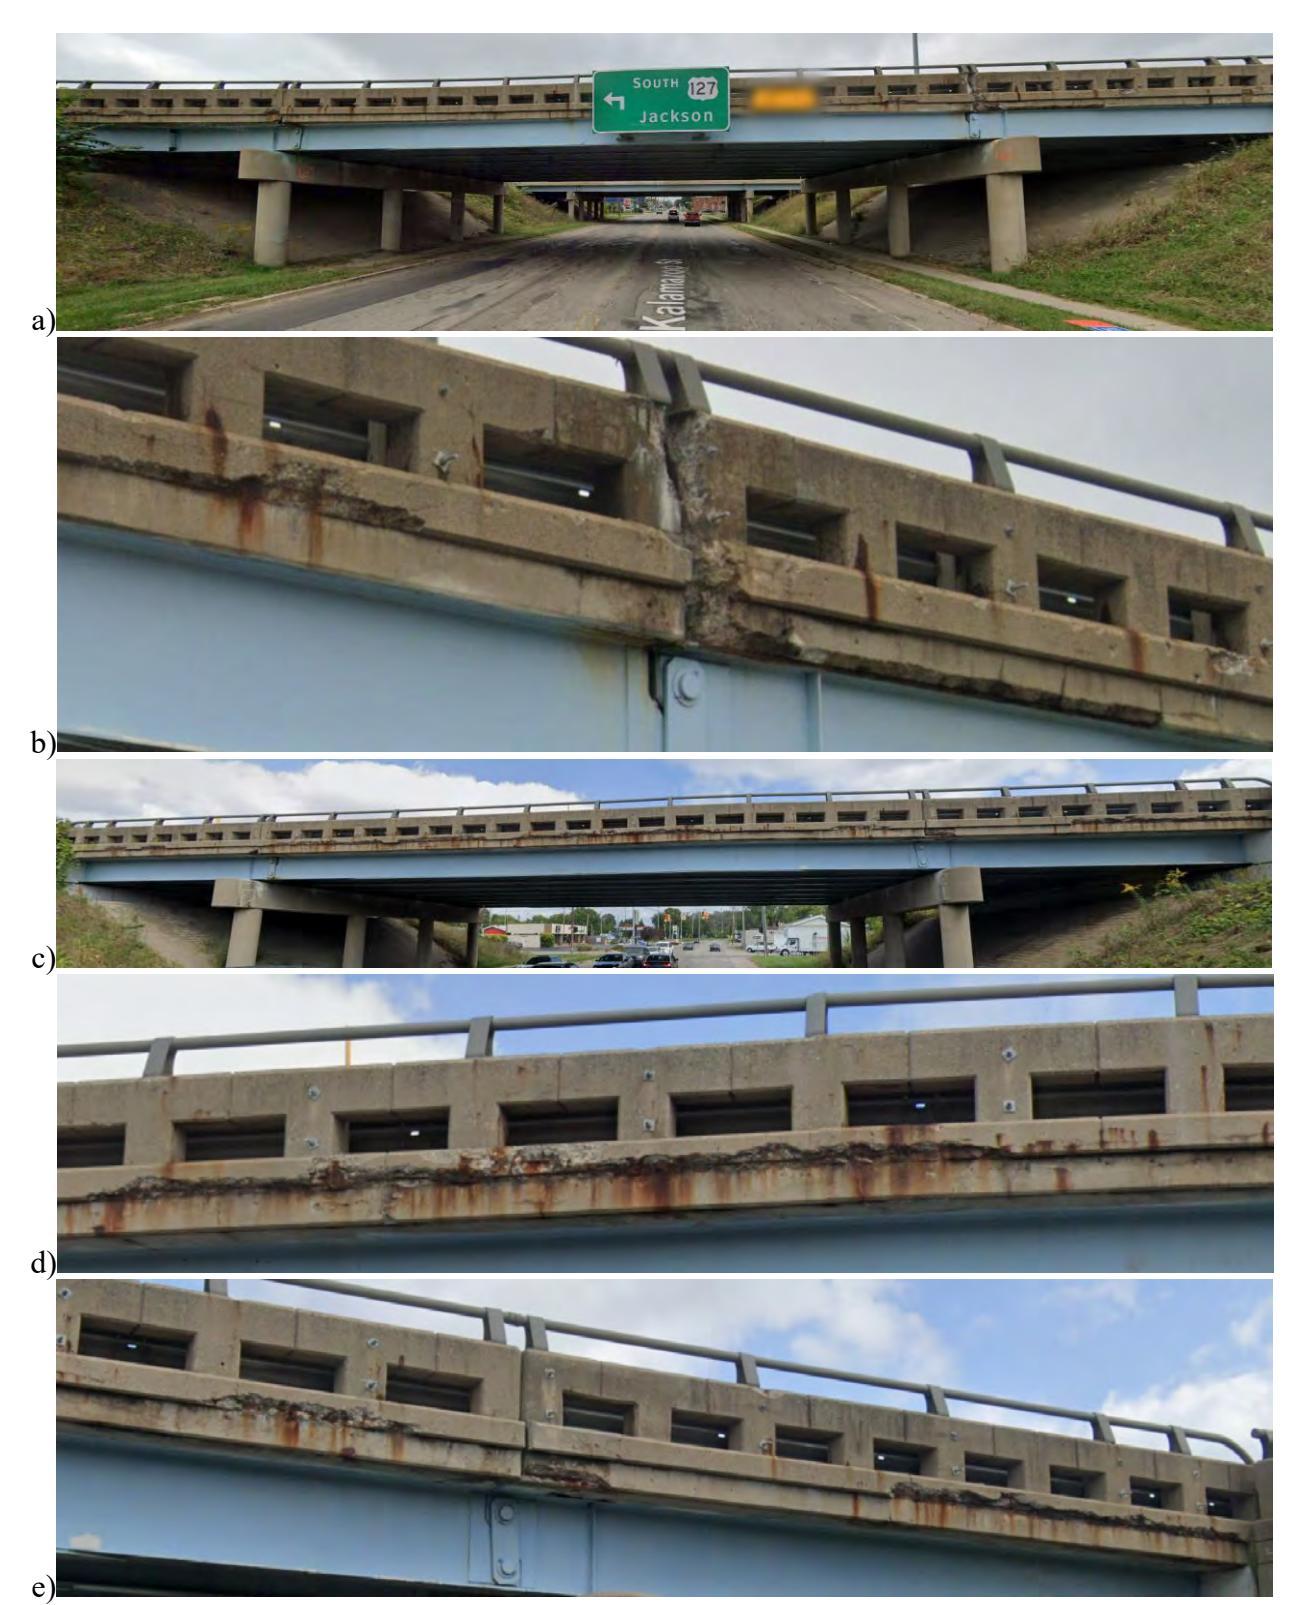
Fig. D.8 US-127 NB over Kalamazoo St.: a-b) lower side; c-e) upper side

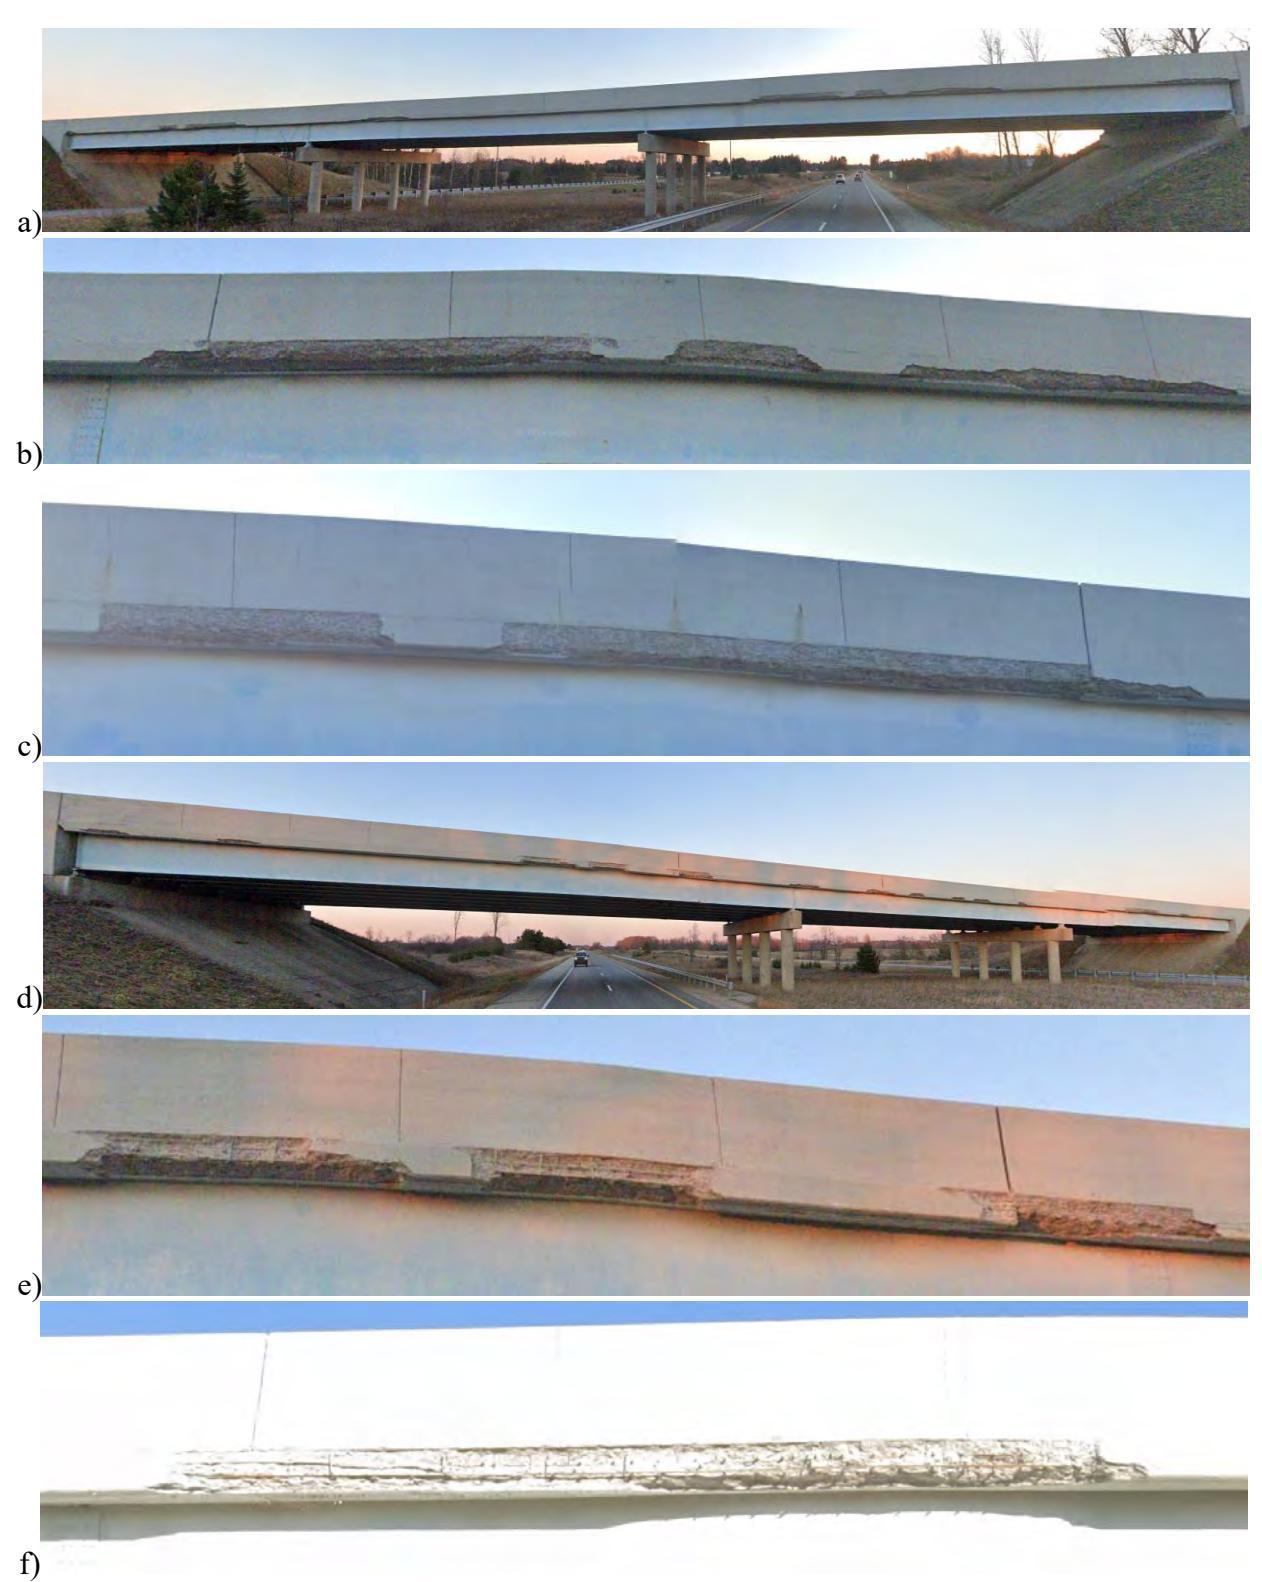
Fig. D.10 Luther Rd. over US-131: a-c) lower side; d-f) upper side

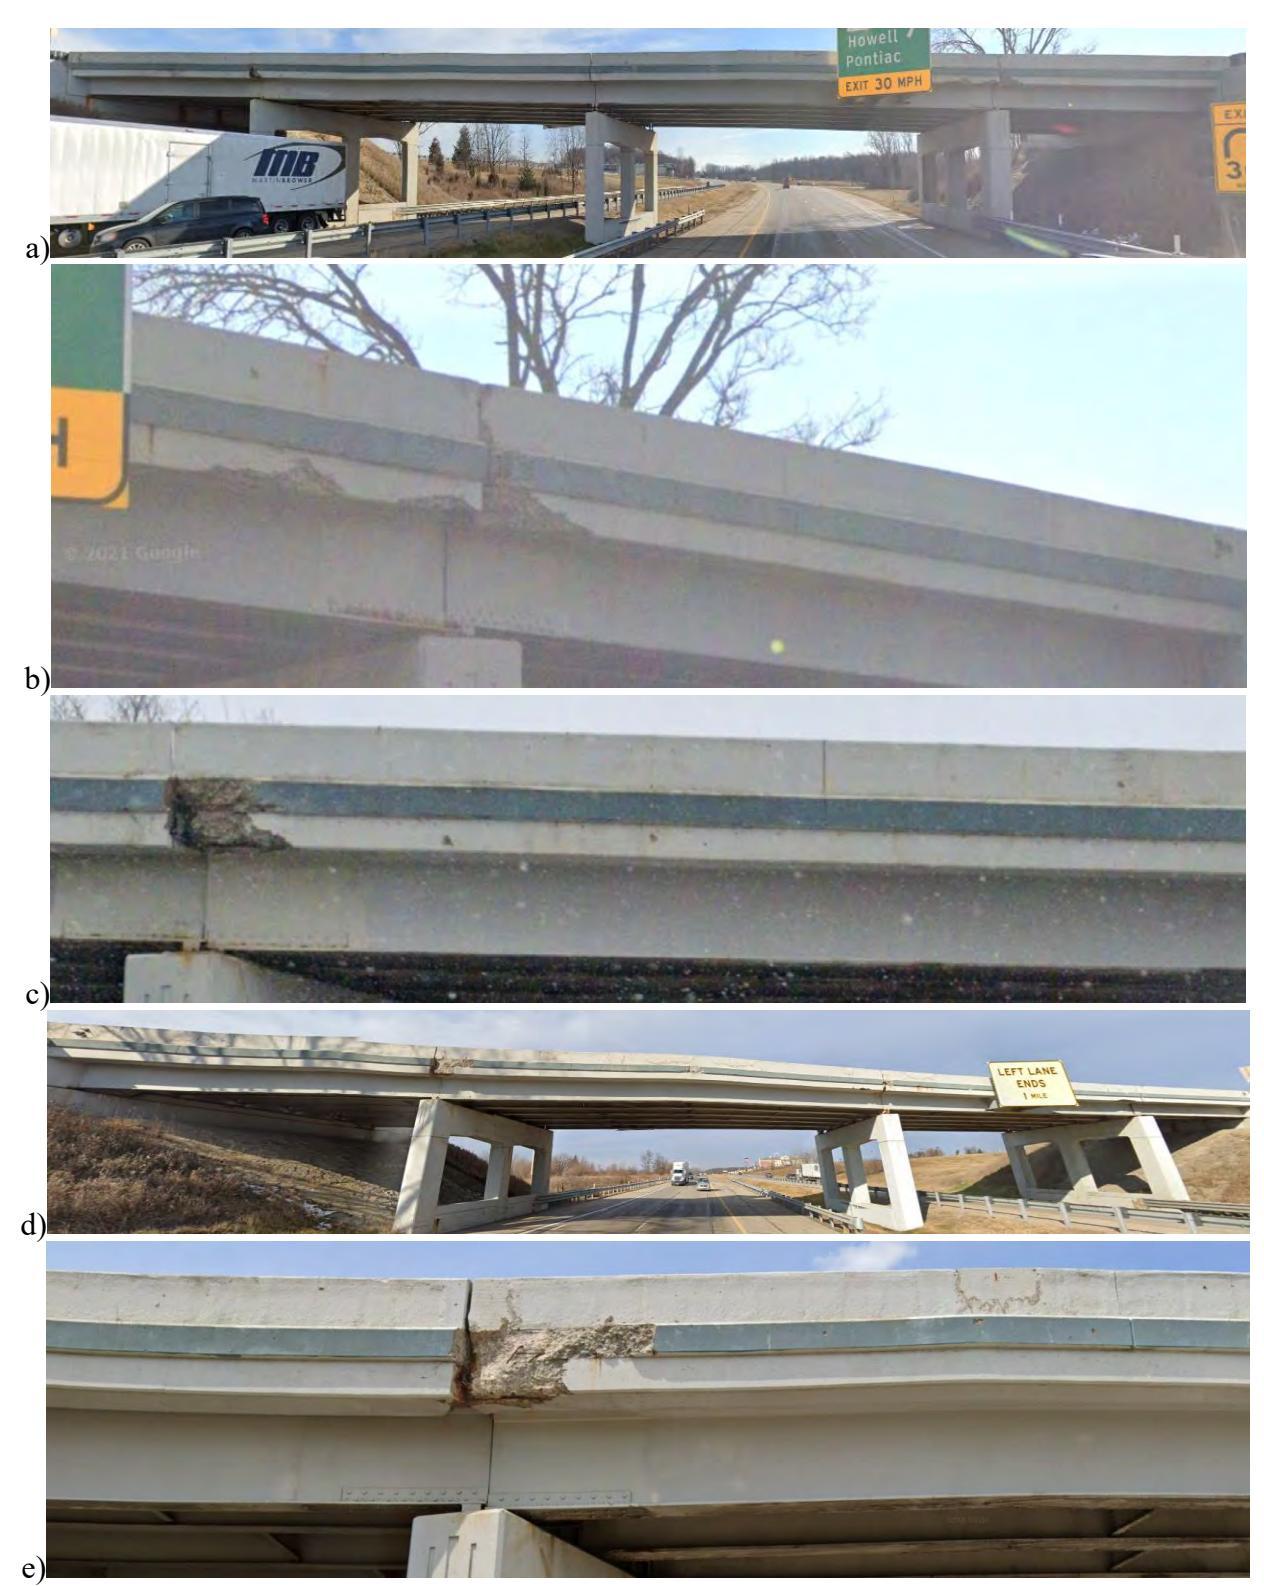
Fig. D.11 M-59 / I-96 Bl. over I-96: a-c) lower side; d-e) upper side

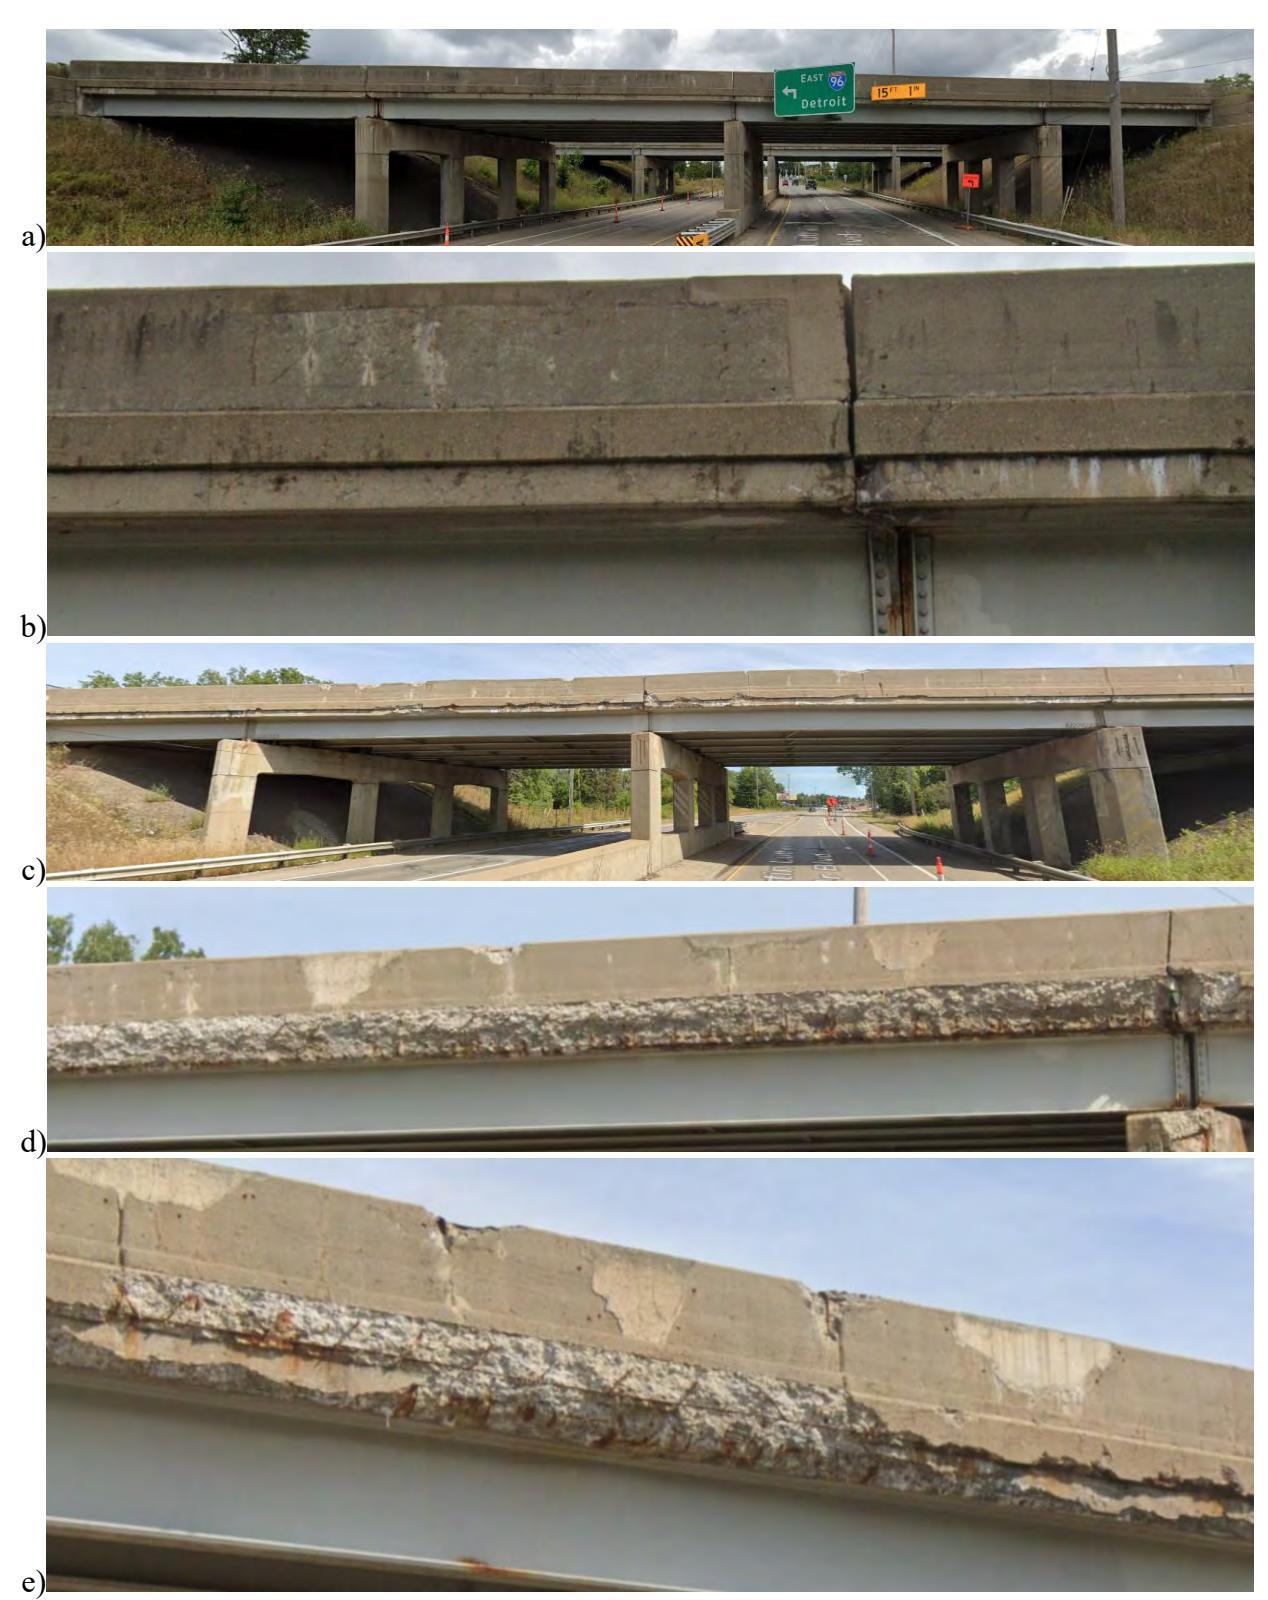
Fig. D.12 I-96 WB over M-99: a-b) lower side; c-e) upper side

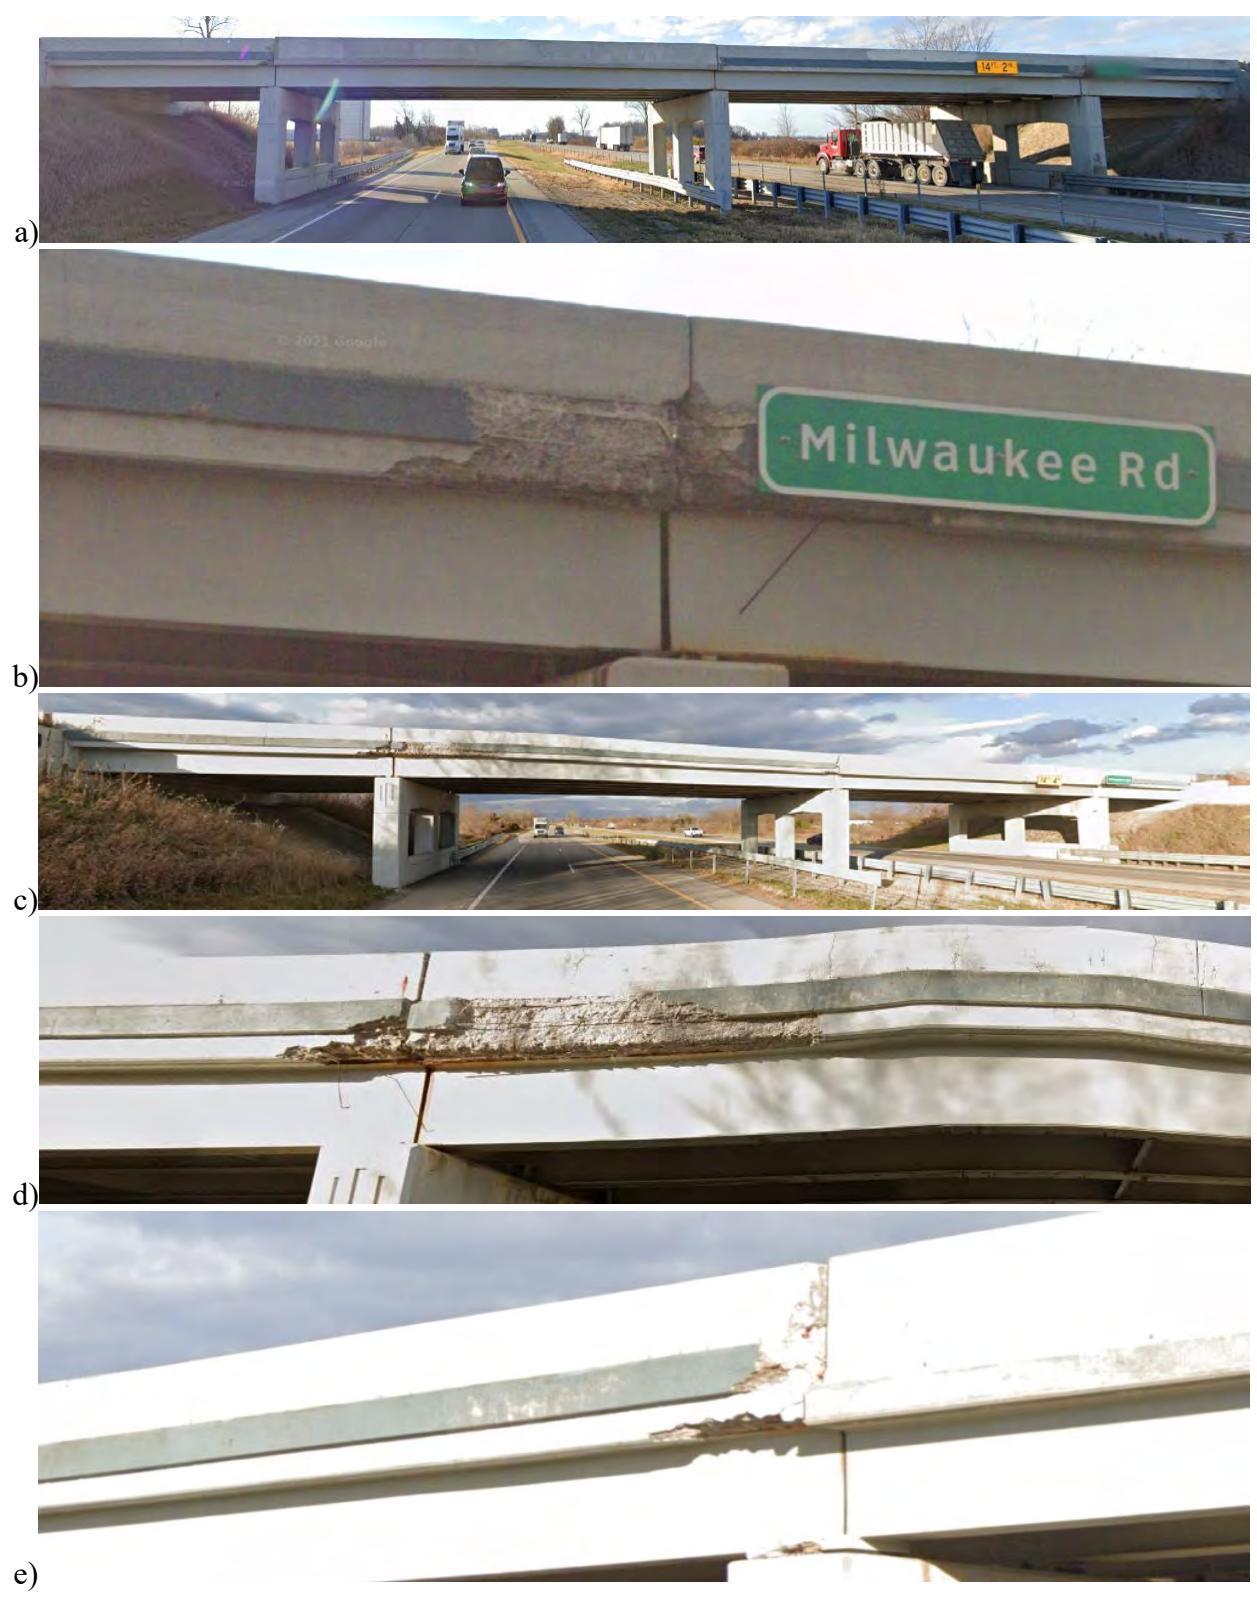
Fig. D.13 Milwaukee Rd. over US-23: a-b) lower side; c-e) upper side

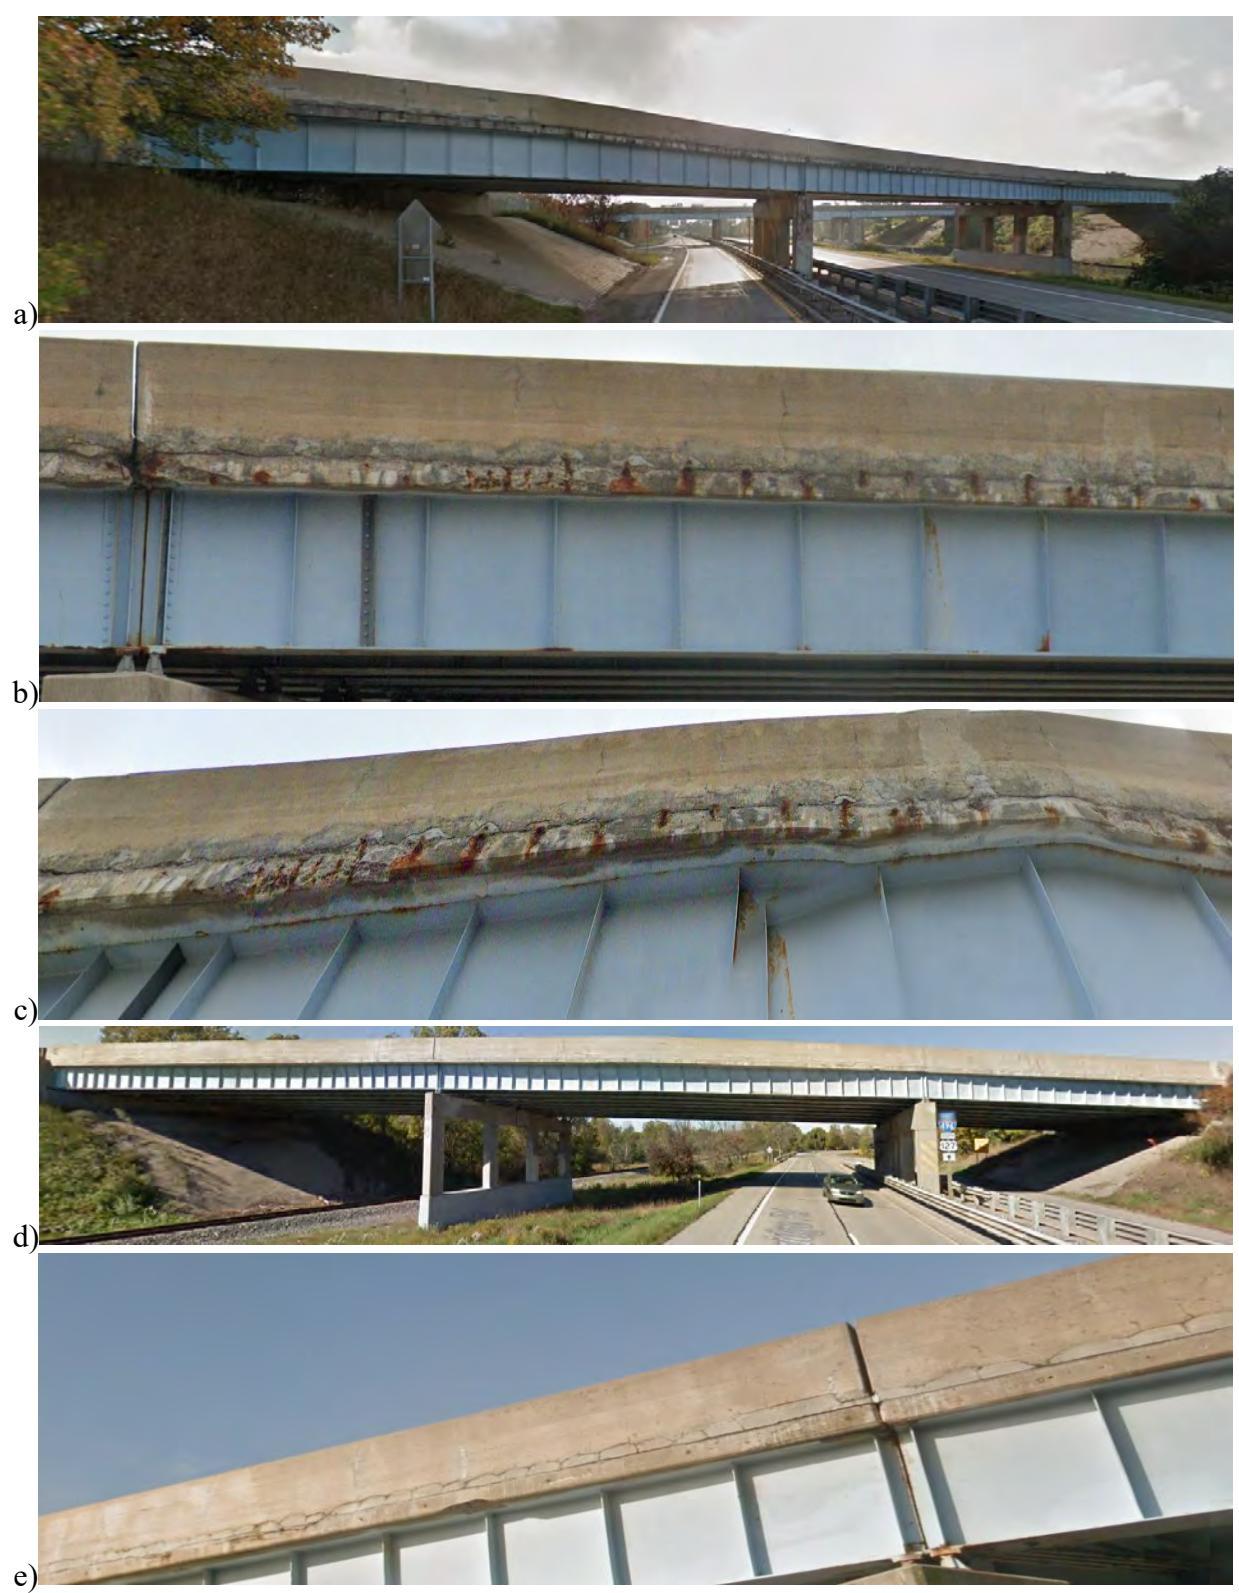
Fig. D.14 I-496 EB over CSX Railroad & Trowbridge Ramp: a-c) lower side; d-e) upper side

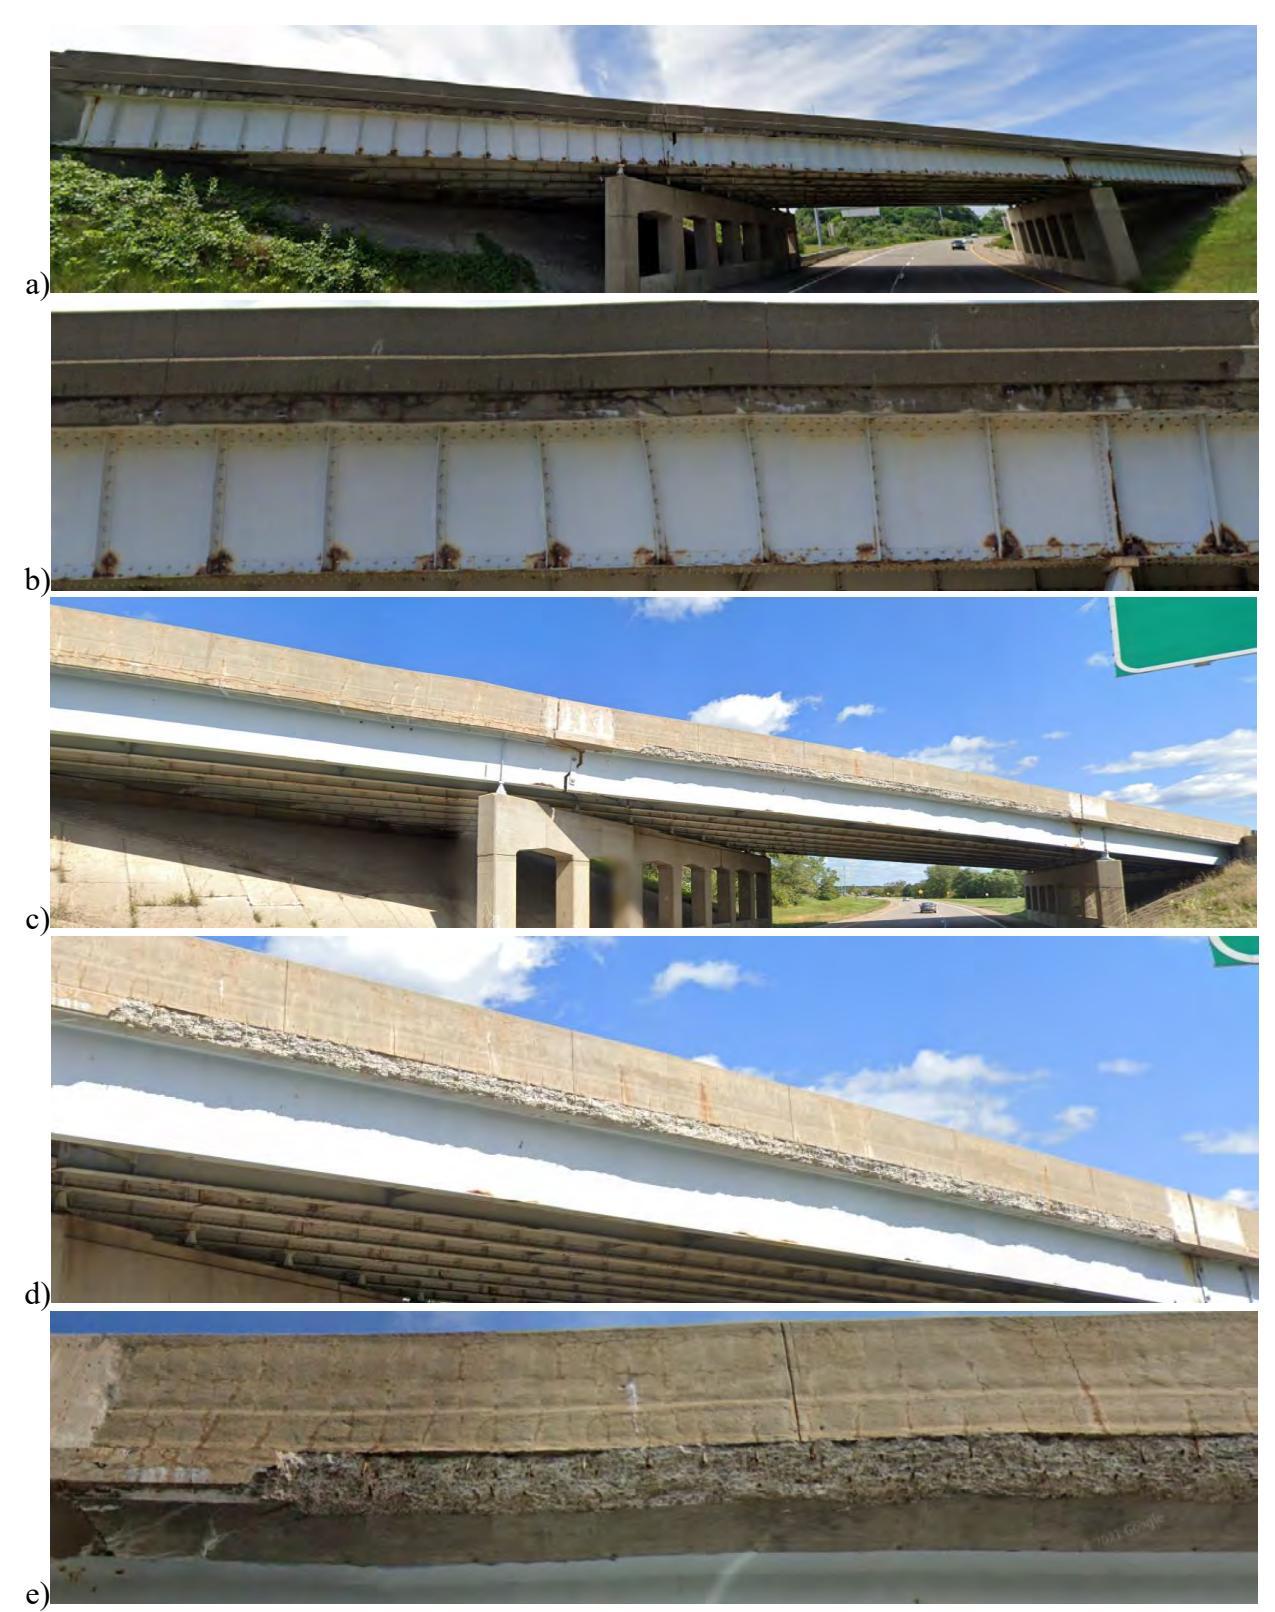
Fig. D.15 I-296 WB connector over I-96 EB: a-b) lower side; c-e) upper side

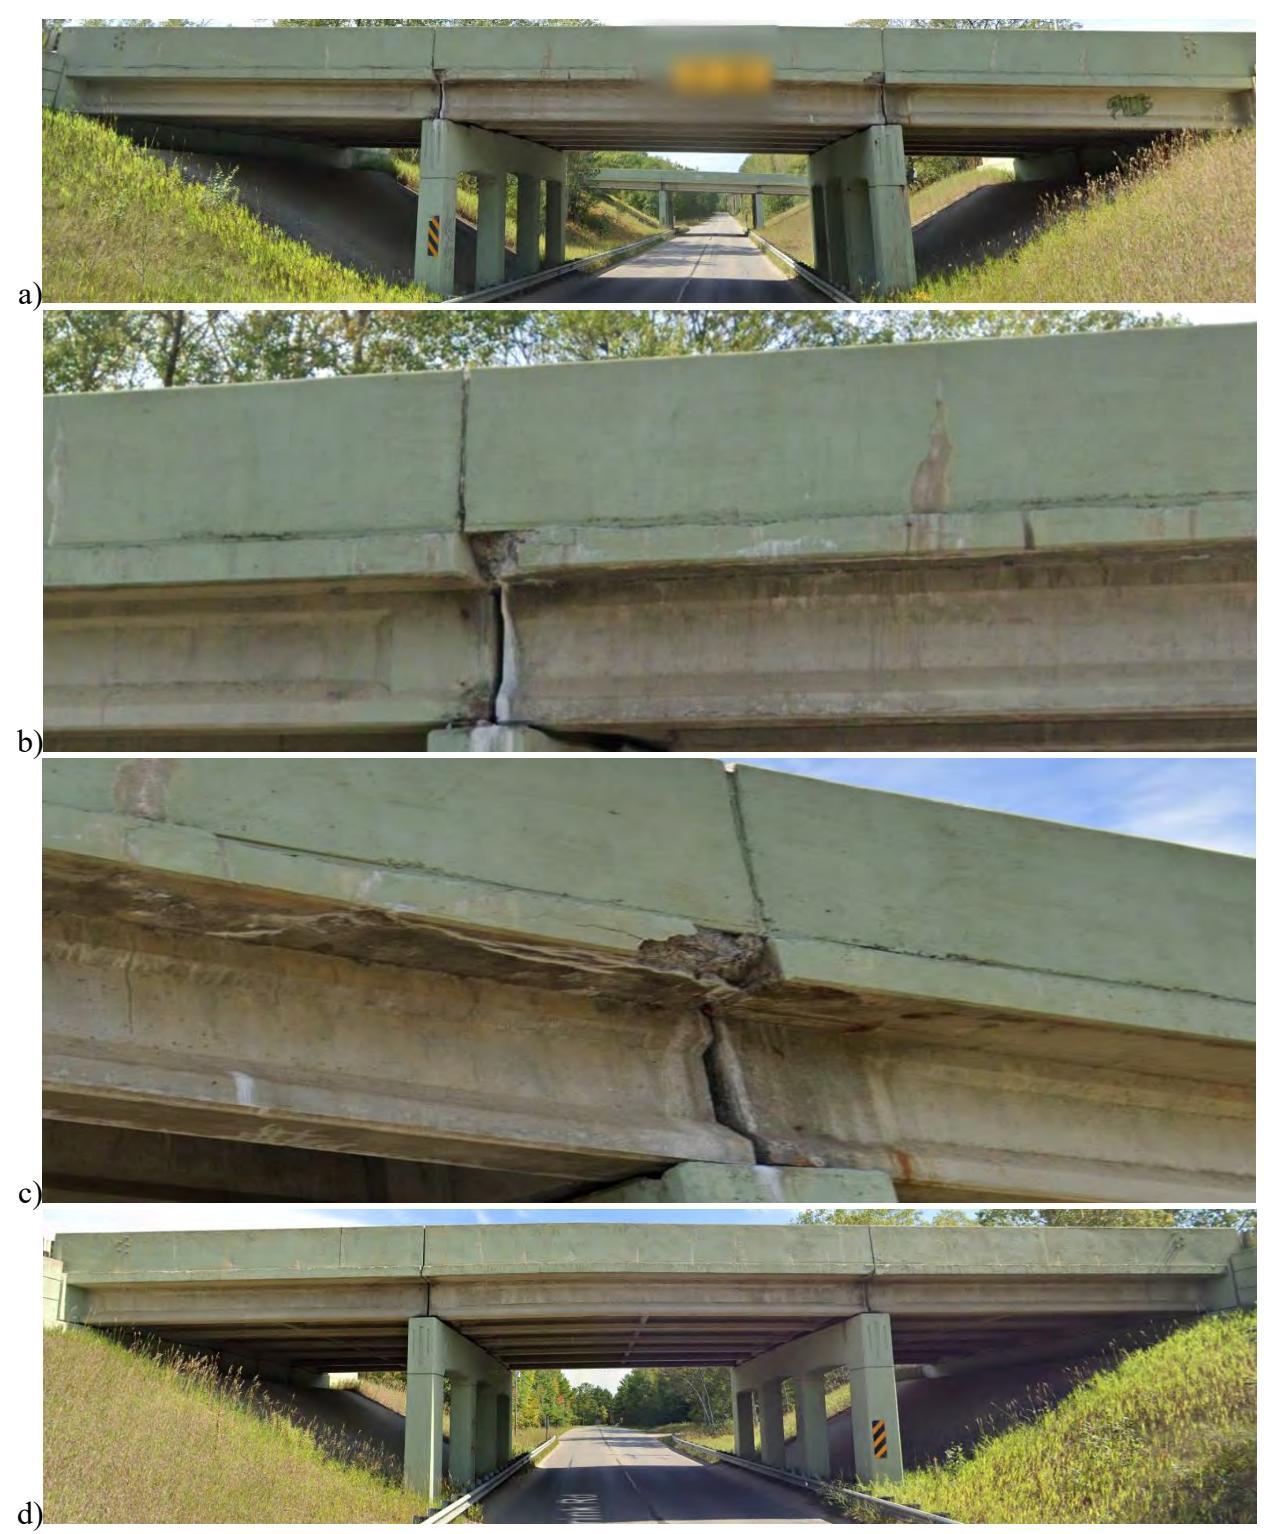
Fig. D.16 I-75 NB over Charles Brink: a-c) lower side; d) upper side
