Repair of Bridge Deck Fascias OR22-002

Final Report

09/30/2023

> **Prepared By:** Furkan Cakmak Fatmir Menkulasi Christopher Eamon Hwai-Chung Wu

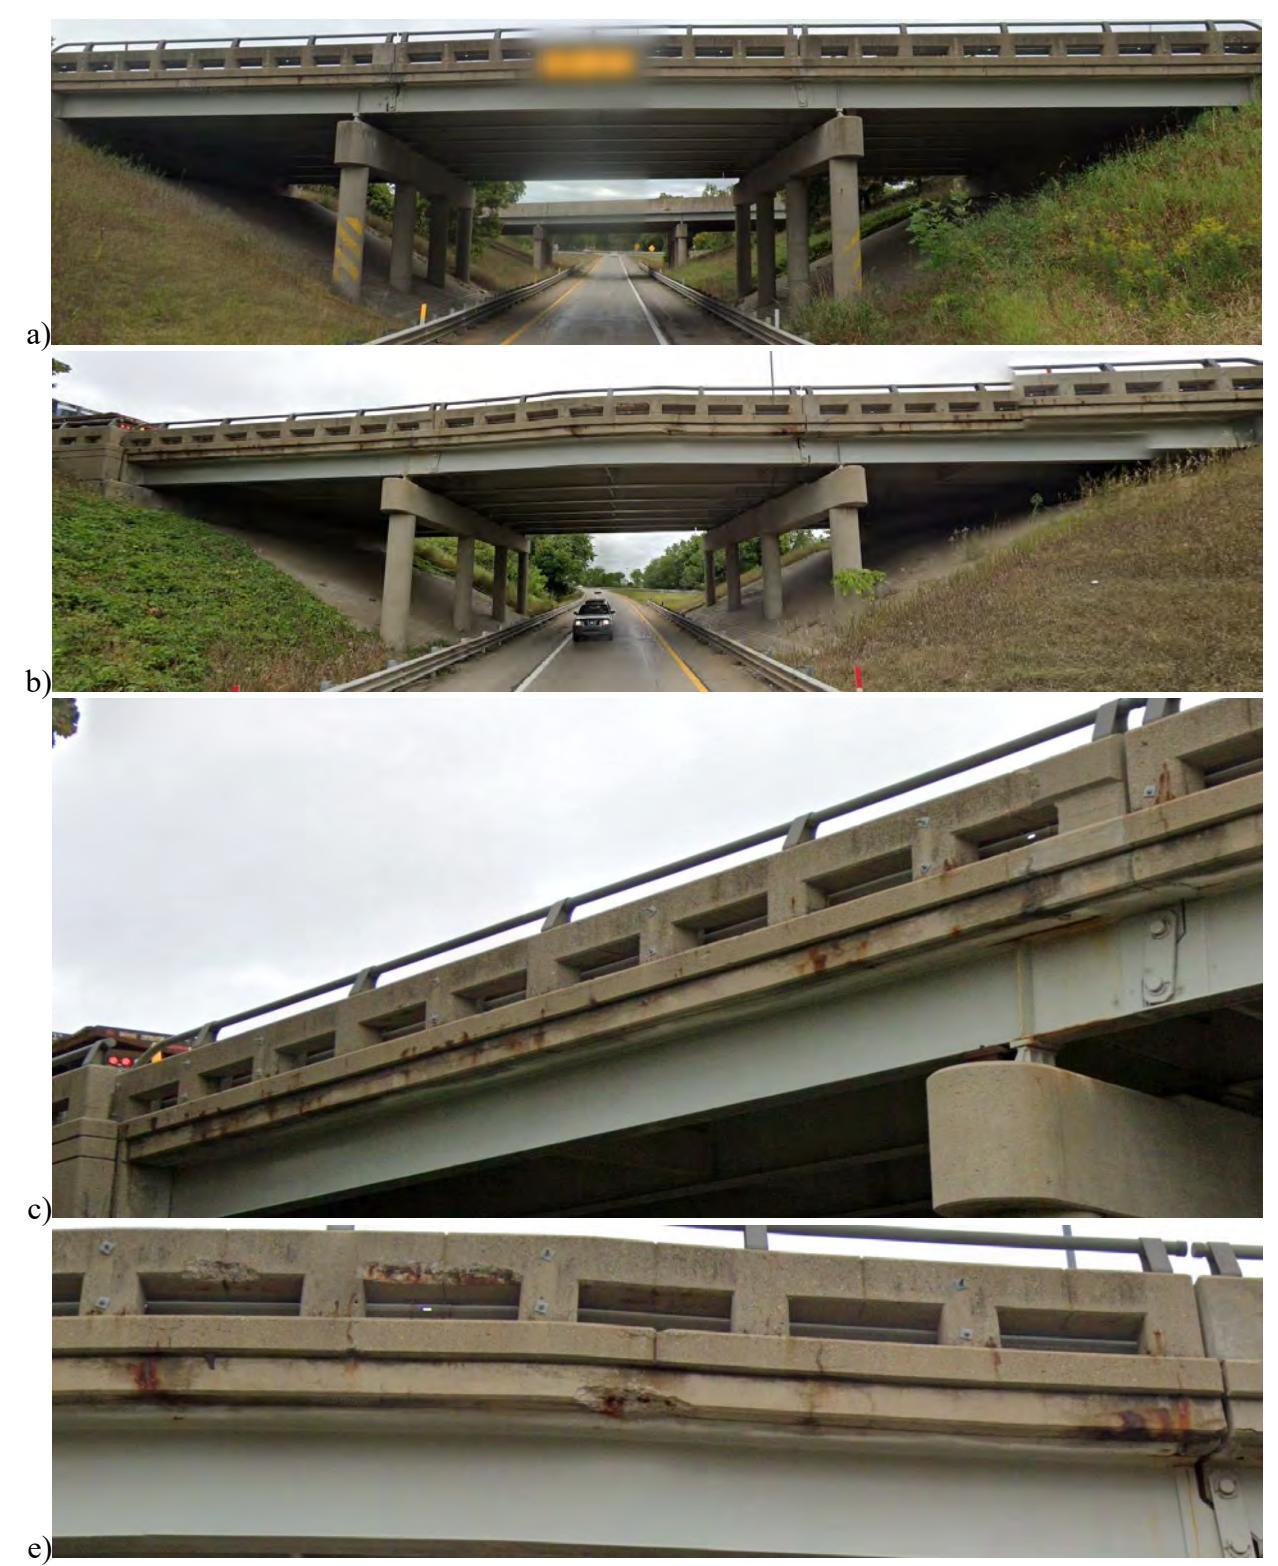
Fig. D.17 I-496 WB over US-127 SB Ramp: a) lower side; b-e) upper side

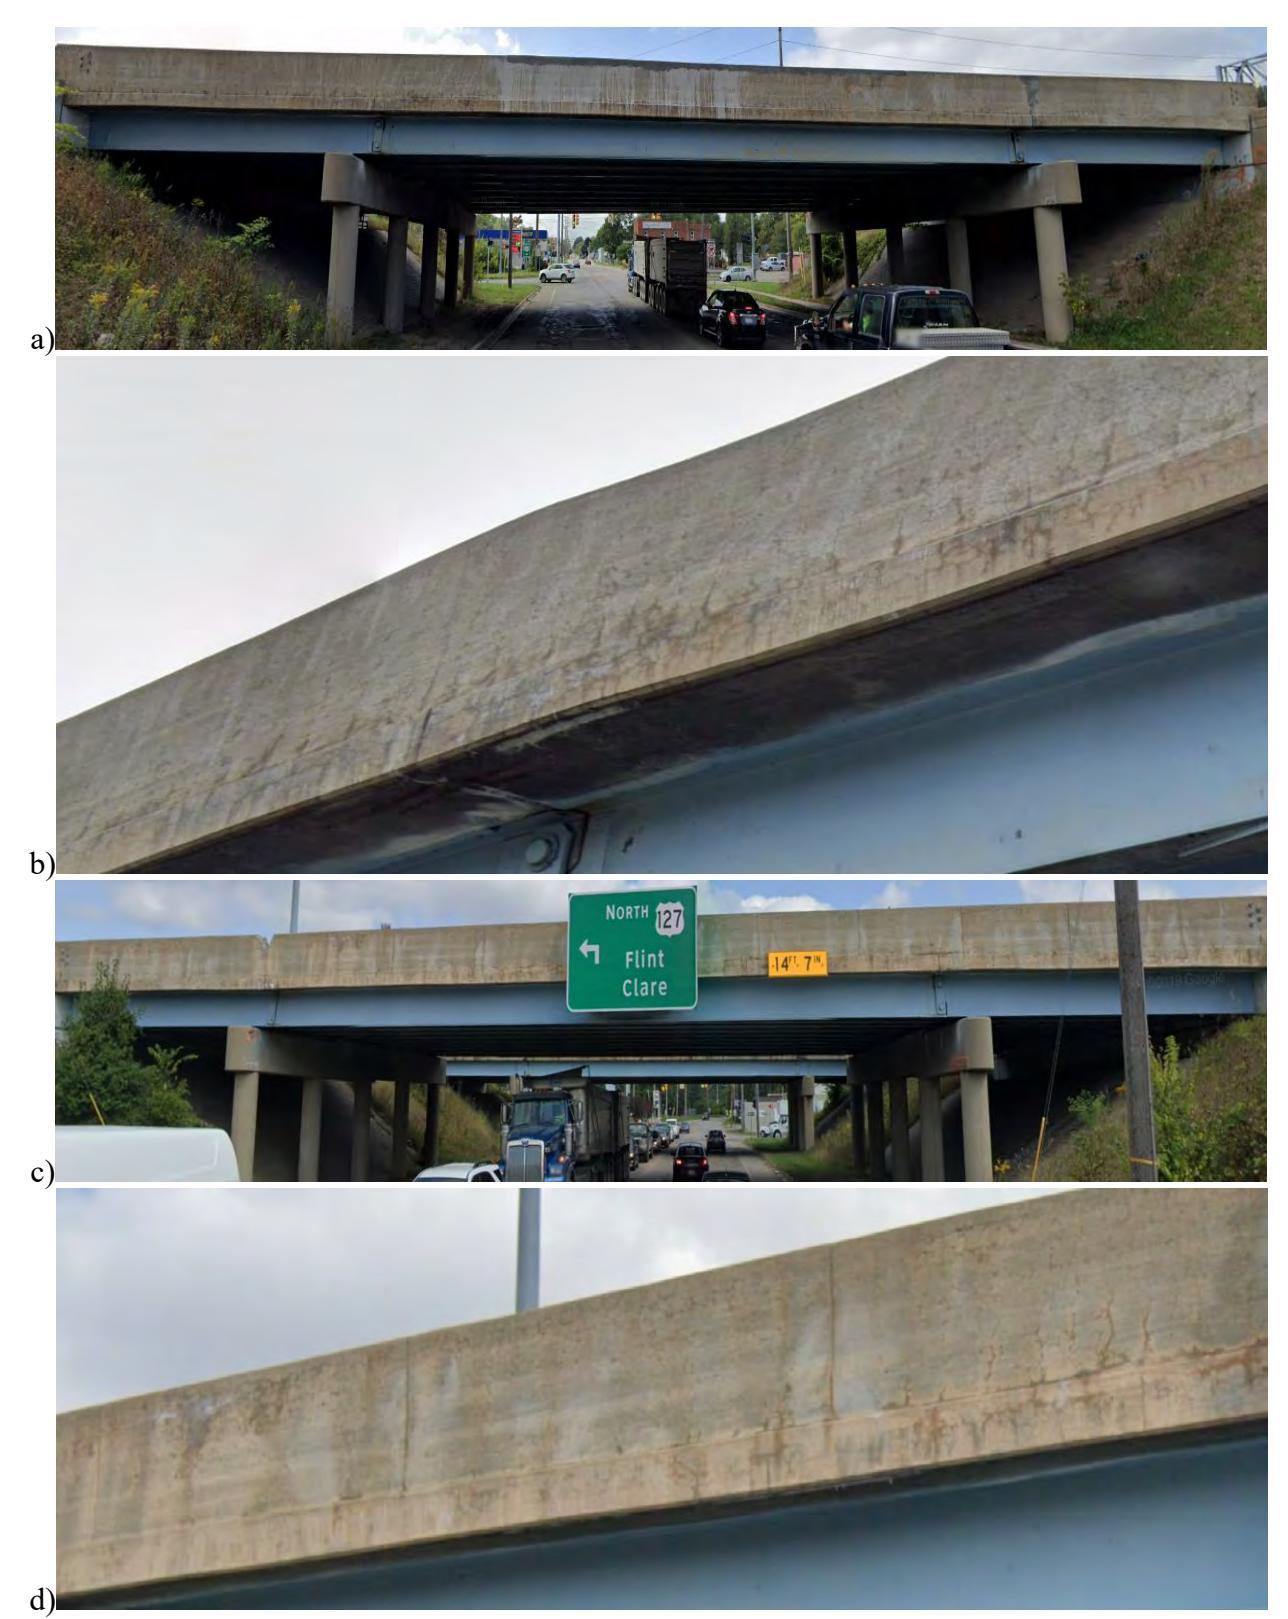
Fig. D.18 US-127 SB over Kalamazoo St.: a-b) lower side; c-d) upper side

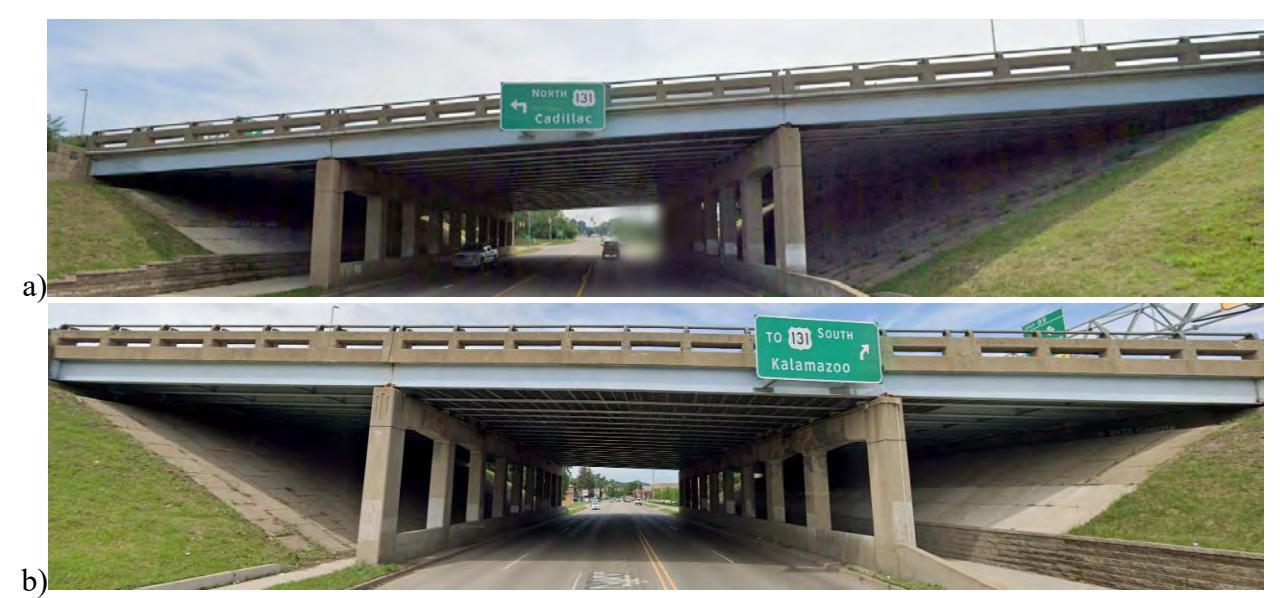
Fig. D.19 I-296WB / US-131 over Ann St.: a) lower side; b) upper side

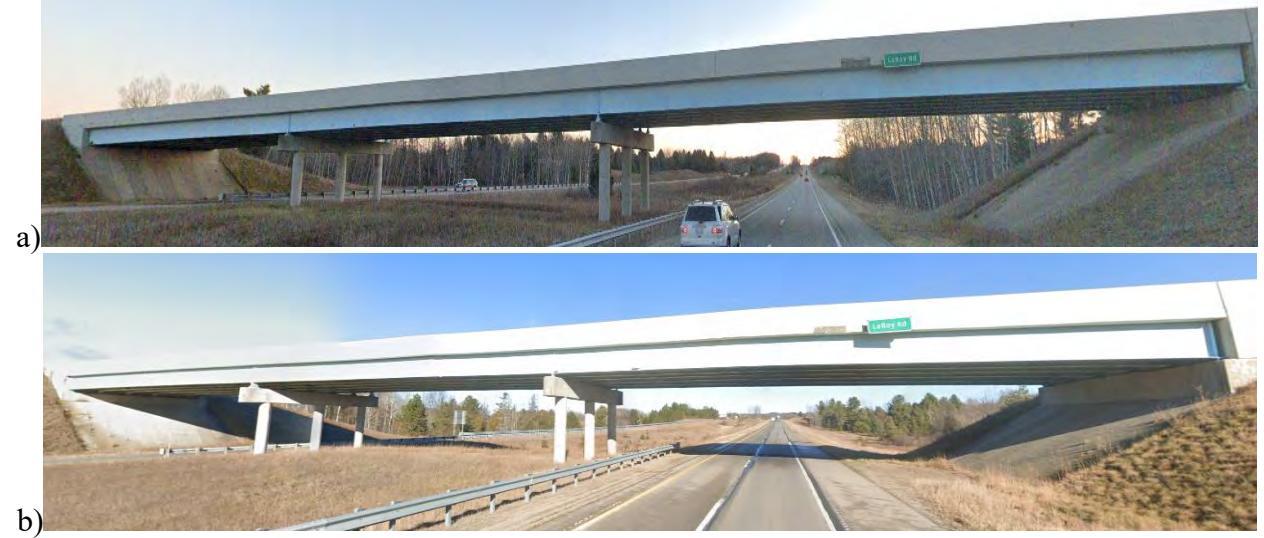
Fig. D.20 Leroy Rd. over US-131: a) lower side; b) upper side

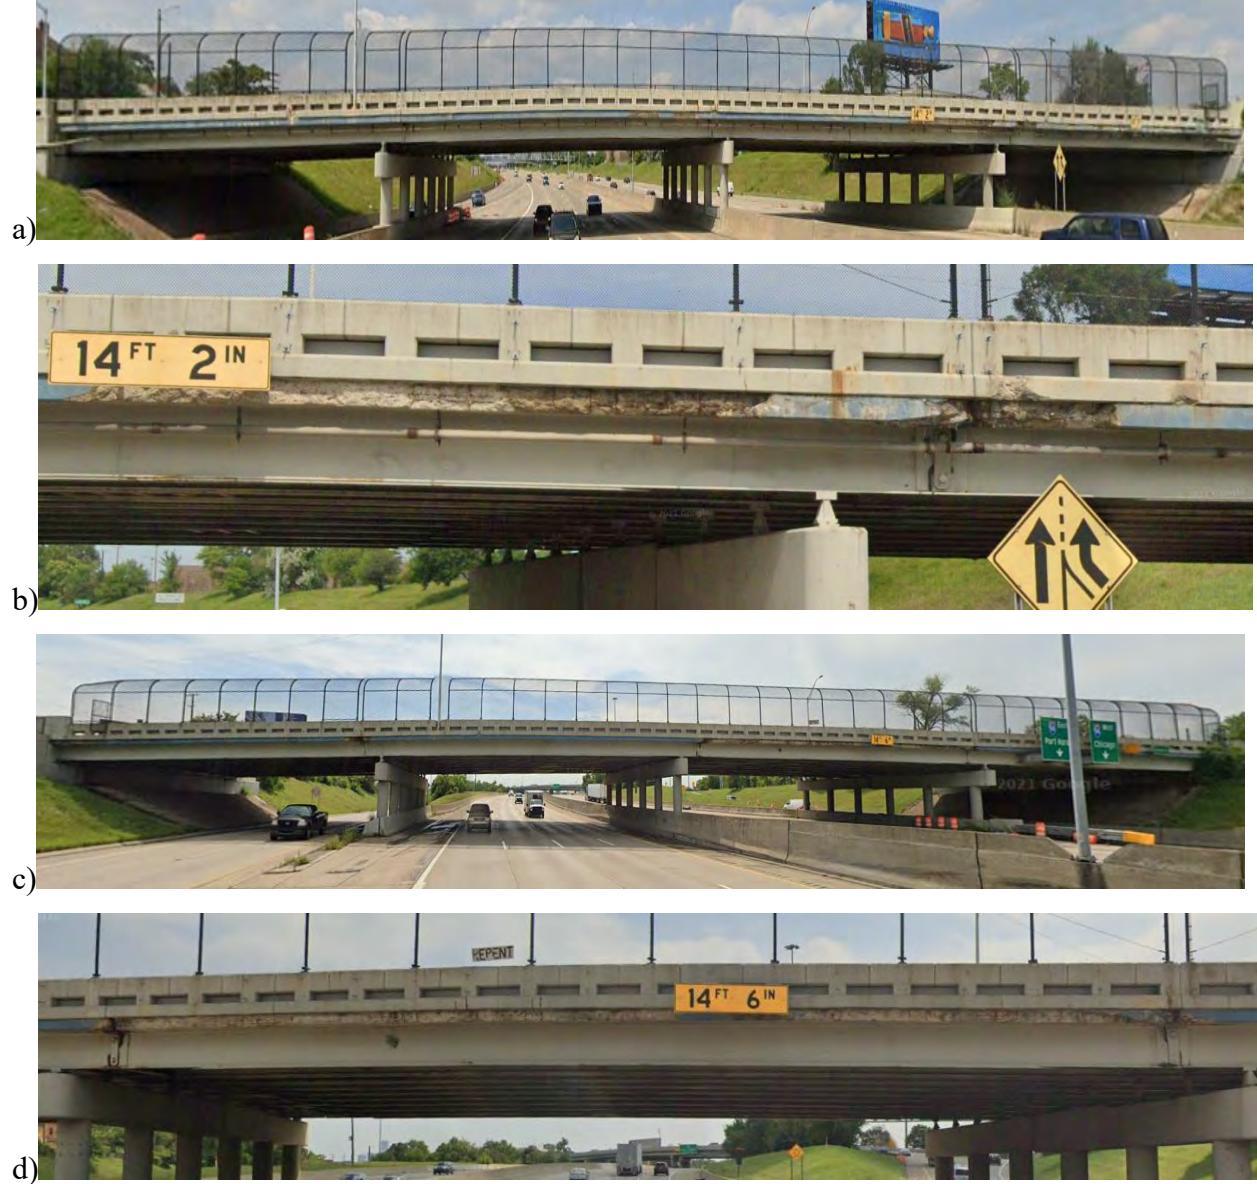
Fig. D.21 McGraw Ave. over I-96 in Detroit: a-b) lower side; c-d) upper side

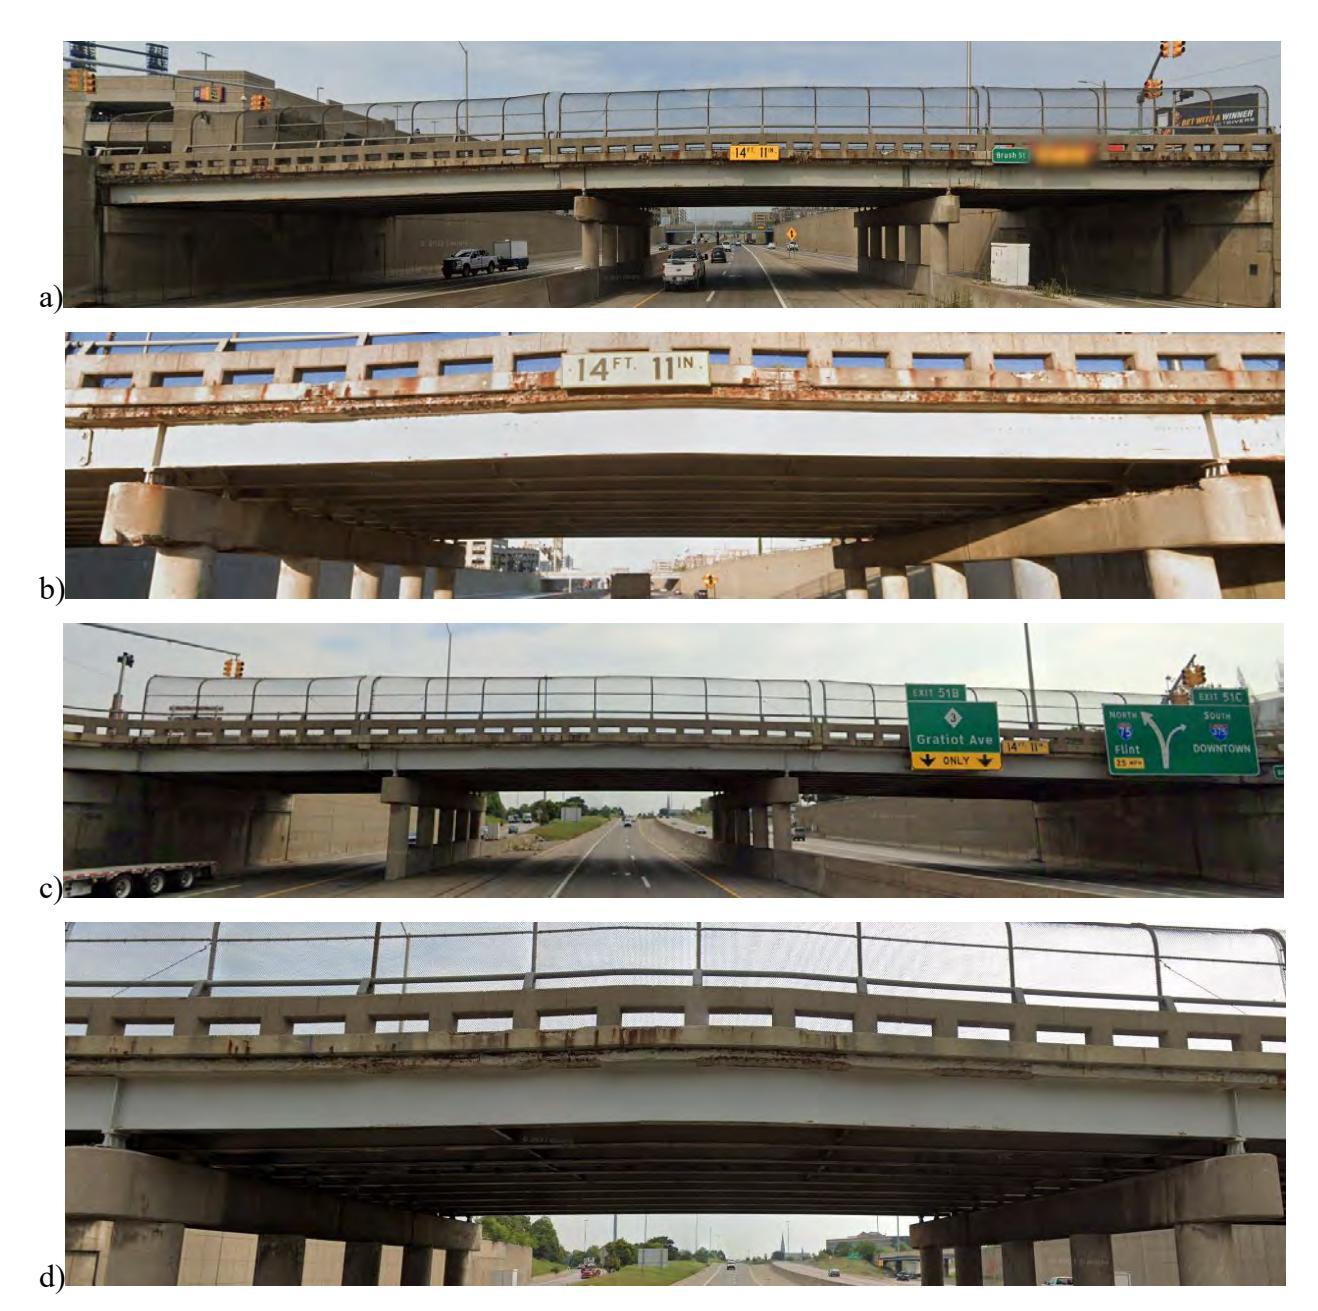
Fig. D.22 Brush St. over I-75: a-b) lower side; c-d) upper side

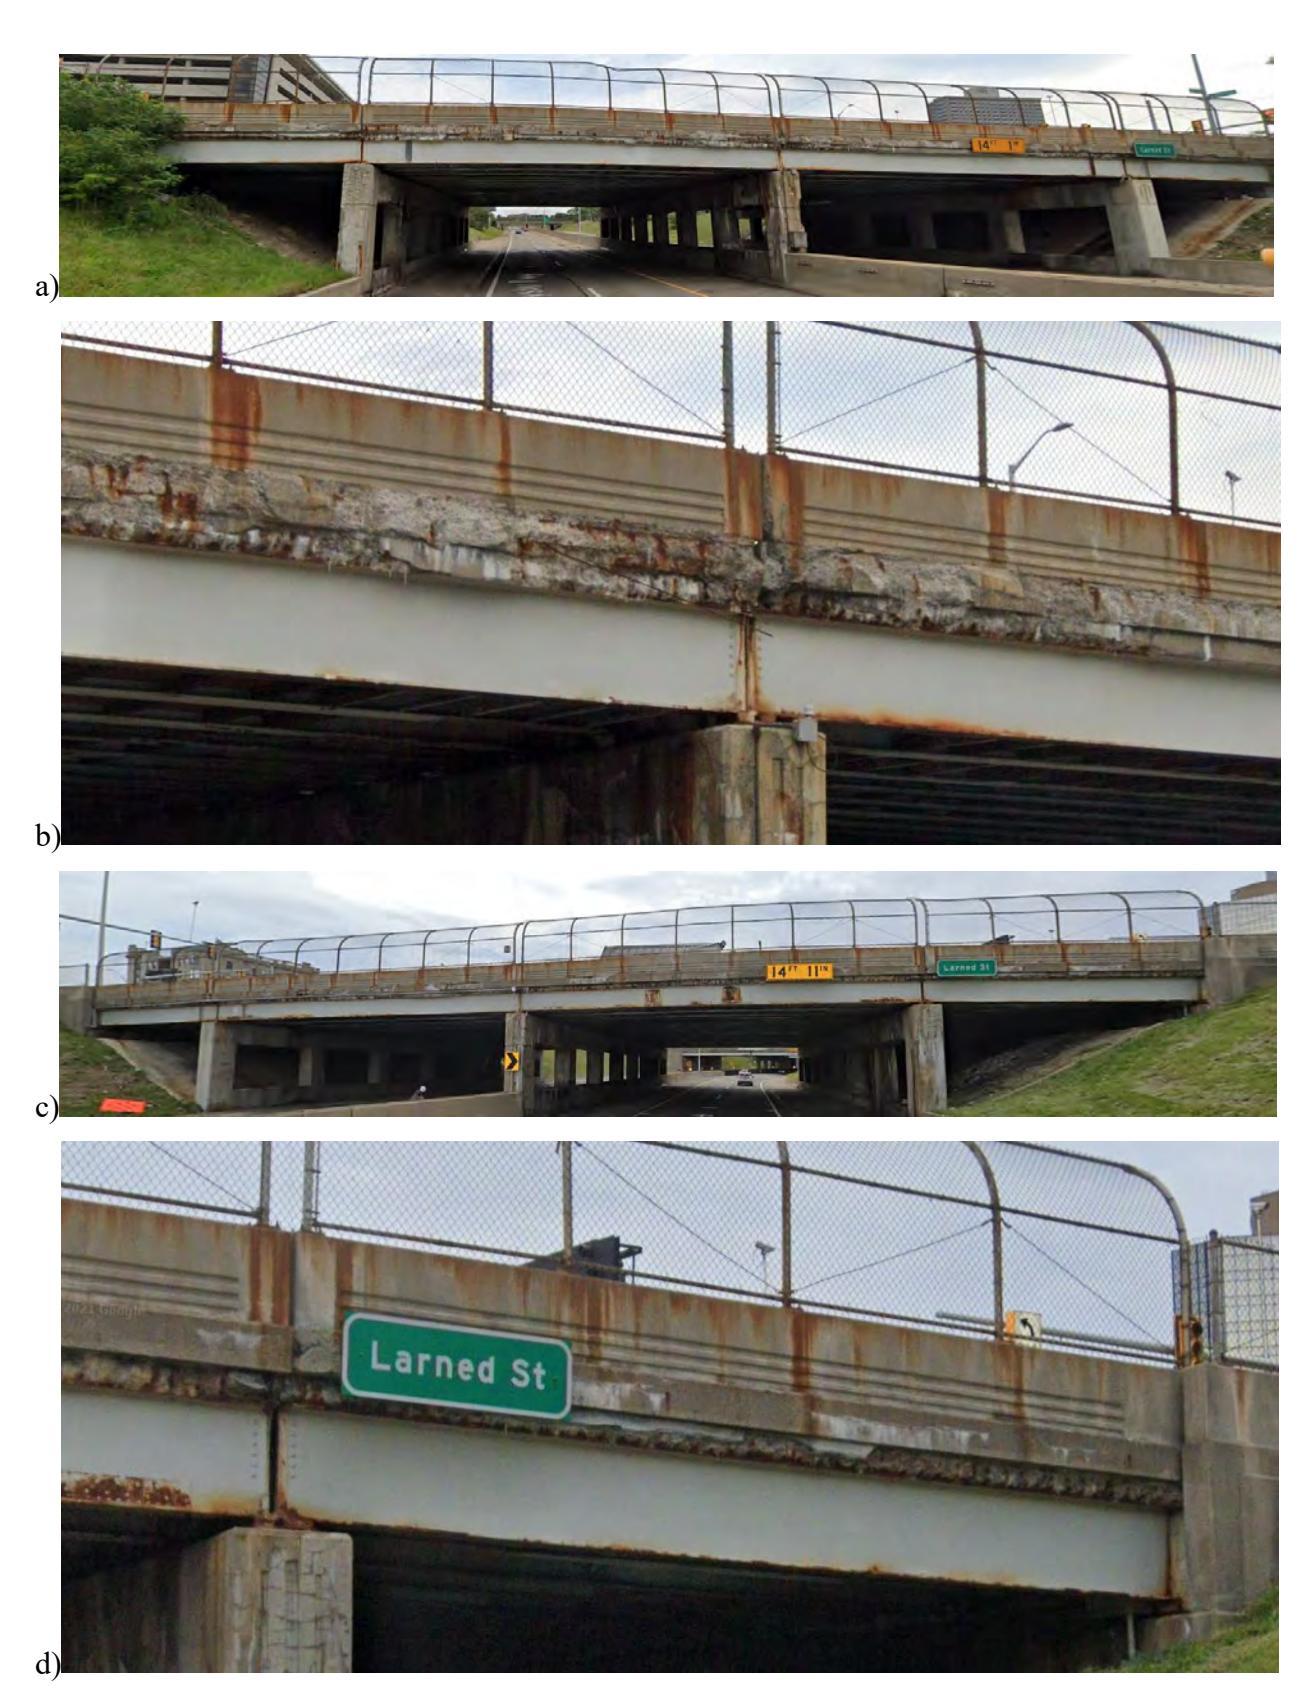
Fig. D.23 Larned St. over I-375: a-b) lower side; c-d) upper side

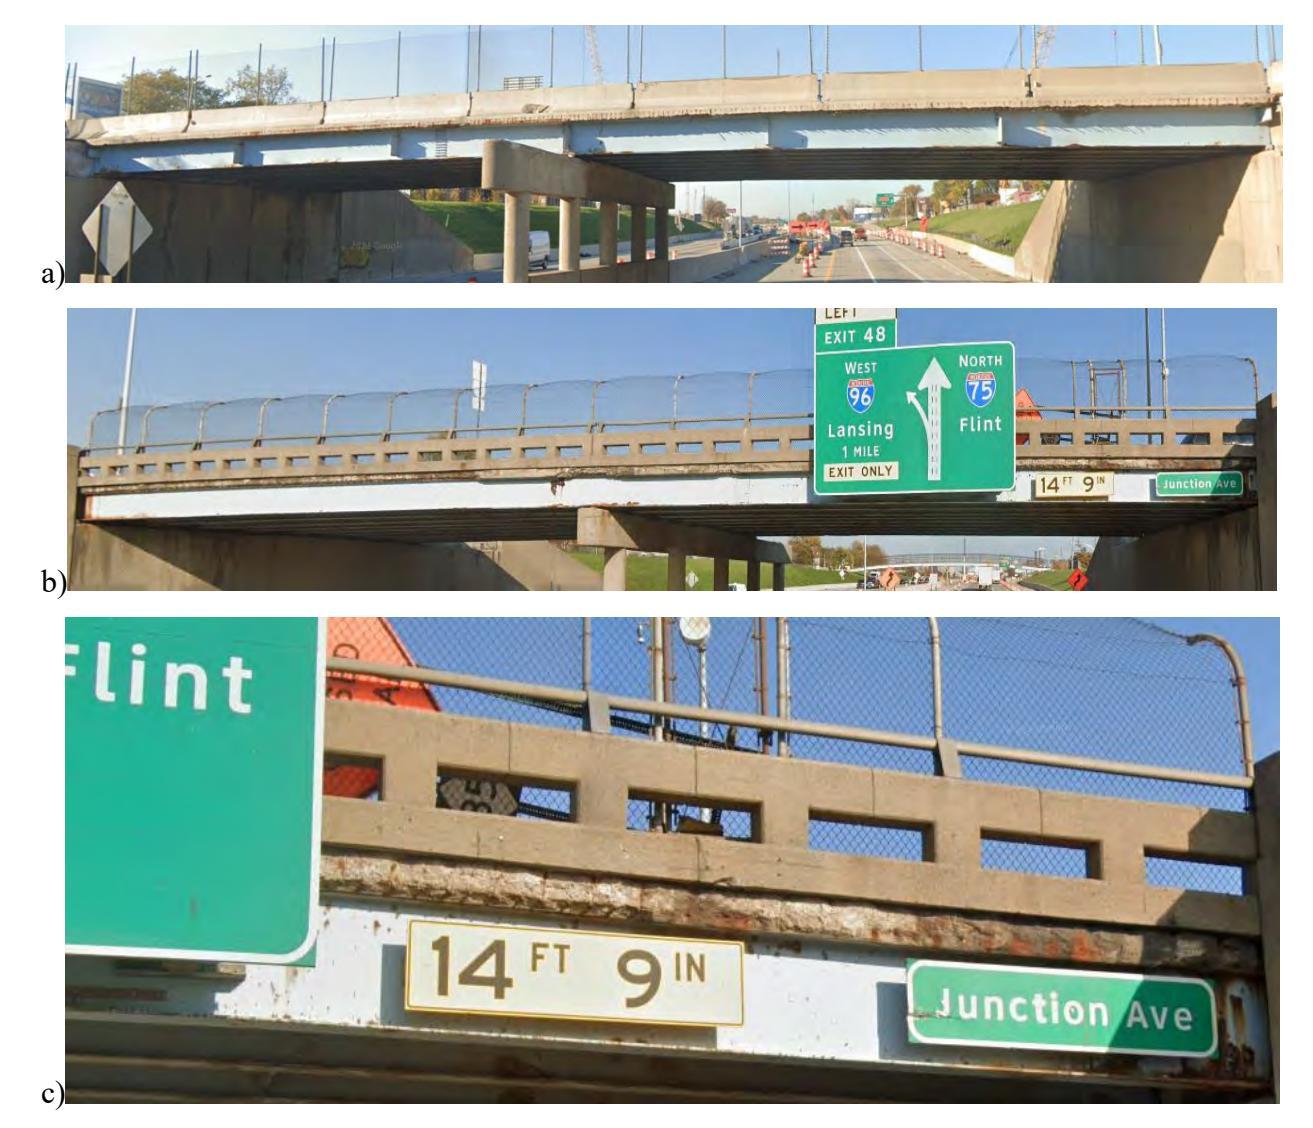
Fig. D.24 Junction Ave. over I-75: a) lower side; b-c) upper side

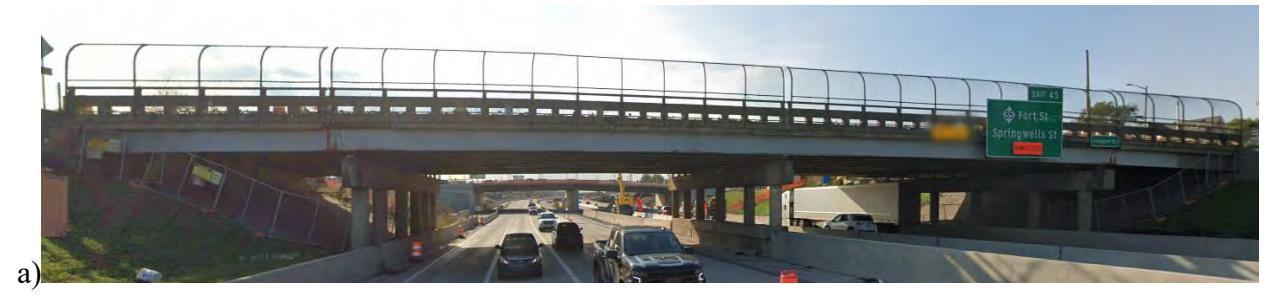
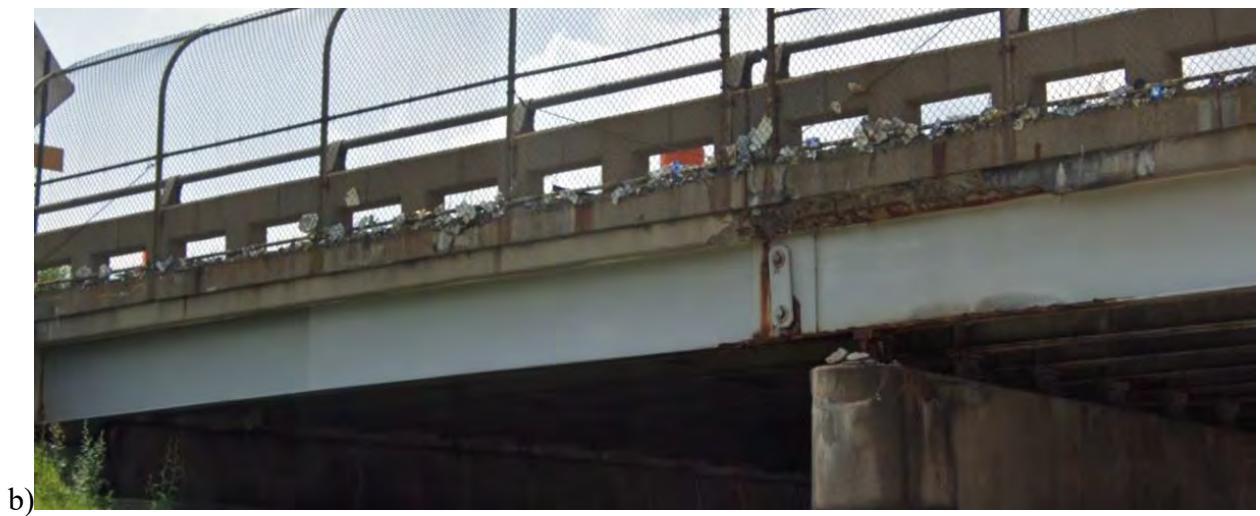
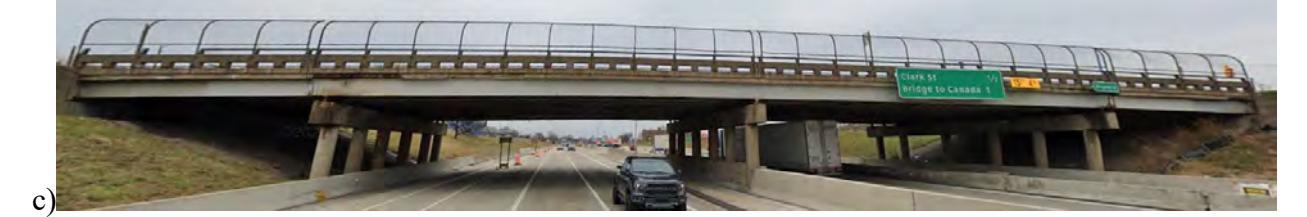
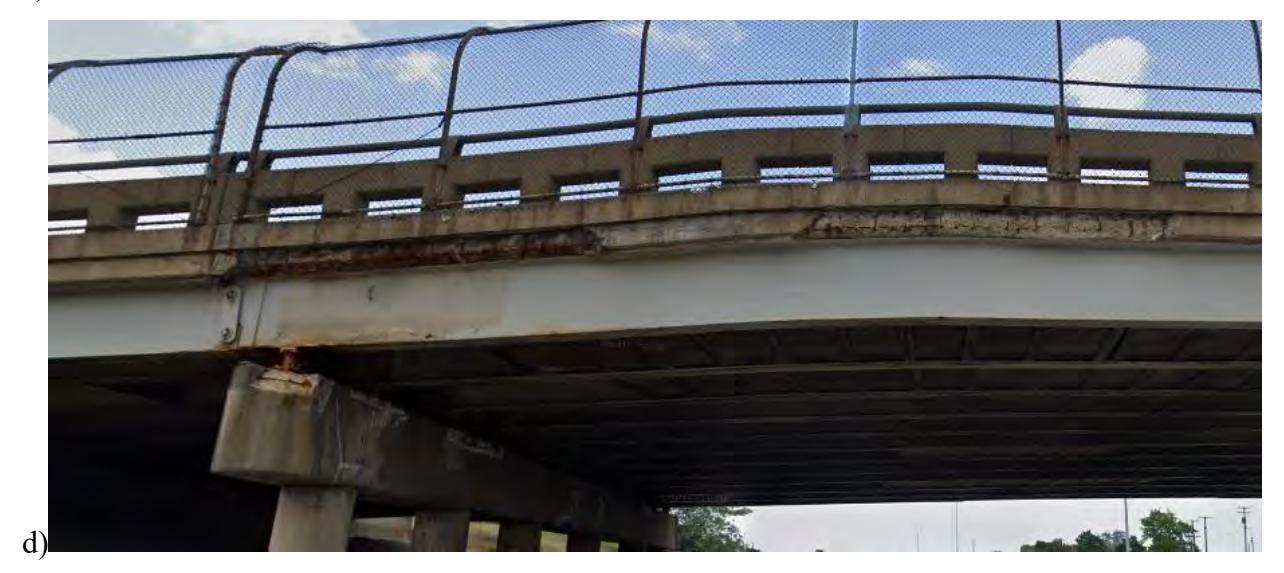
Fig. D.25 Dragoon St. over I-75: a-b) lower side; c-d) upper side

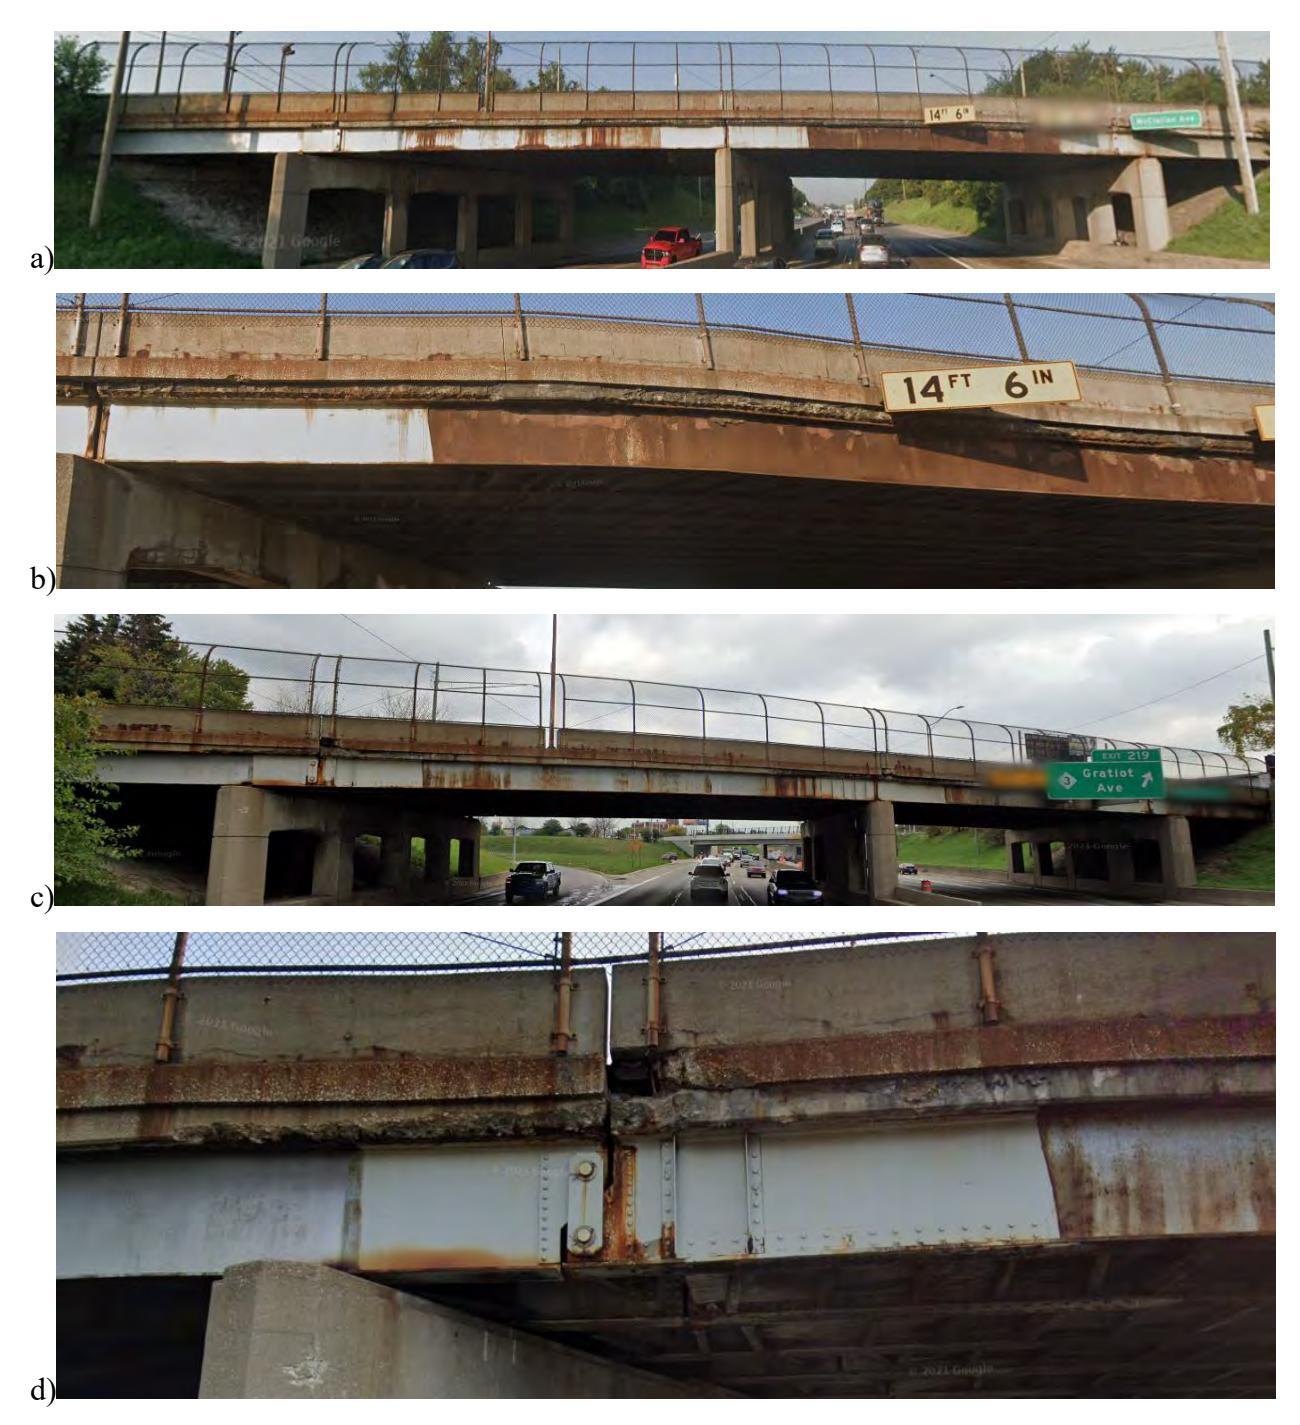
Fig. D.26 McClellan Ave. over I-94: a-b) lower side; c-d) upper side

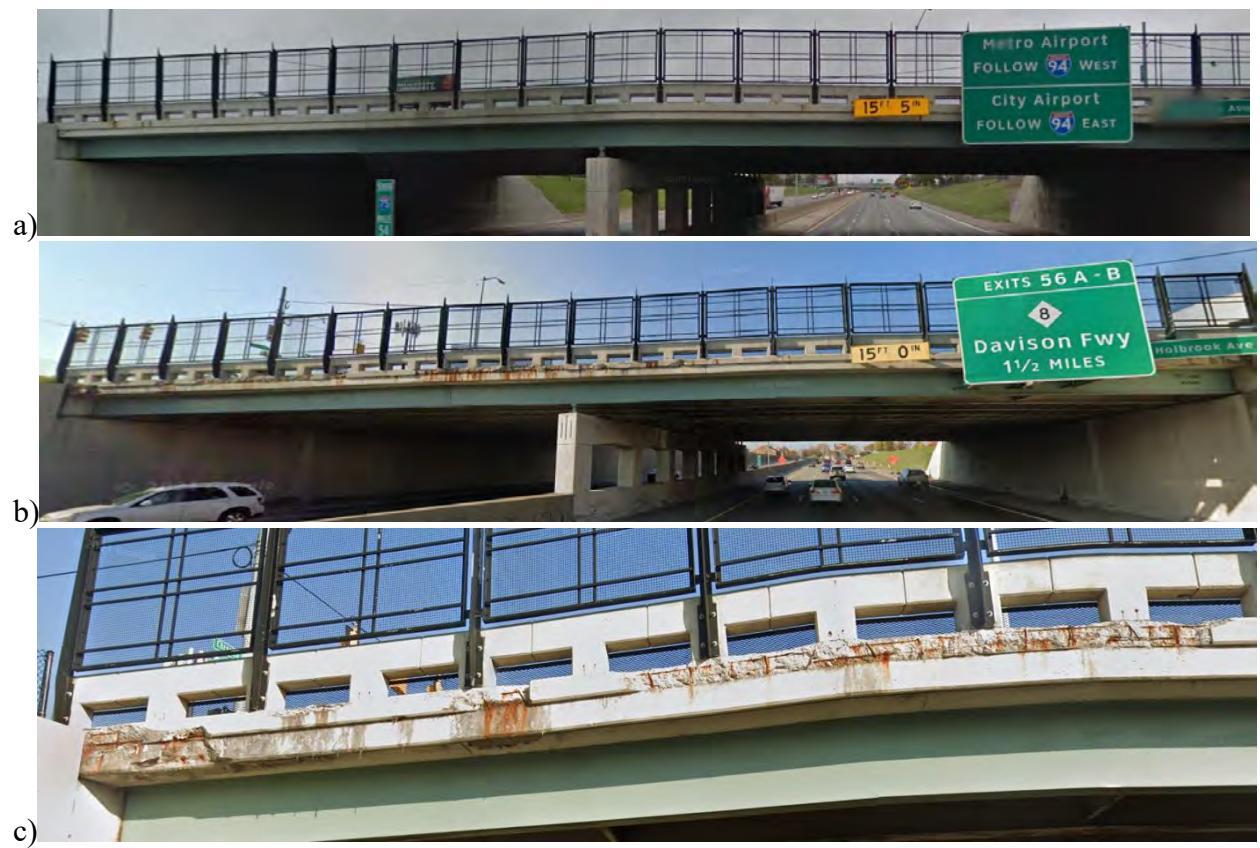
Fig. D.27 Holbrook Ave. over I-75: a) lower side; b-c) upper side

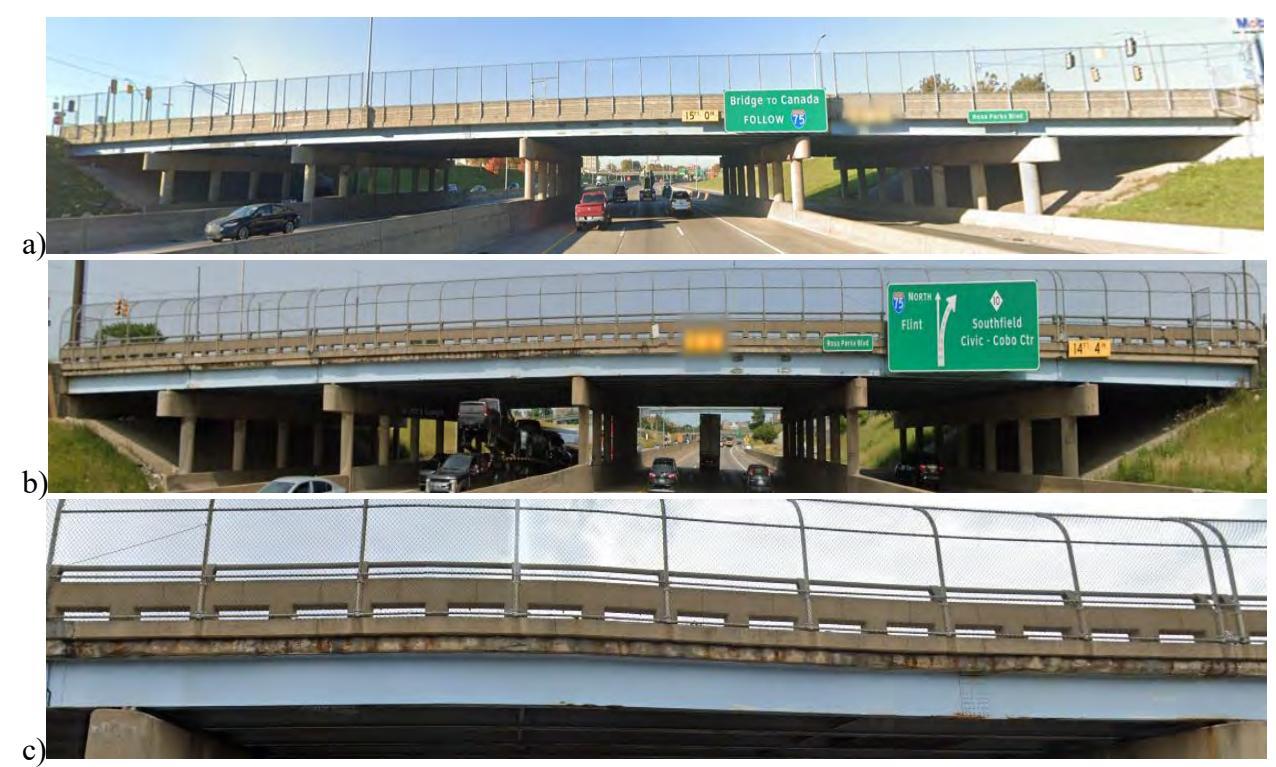
Fig. D.28 Rosa Parks Blvd. over I-75: a) lower side; b-c) upper side

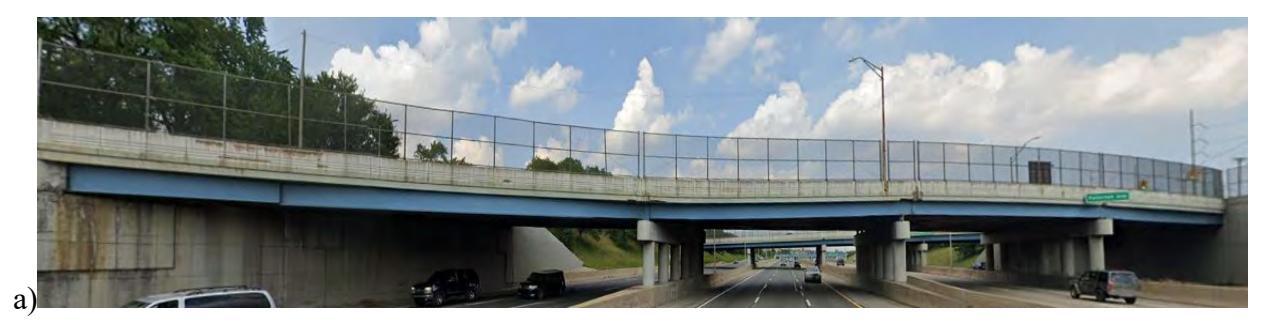
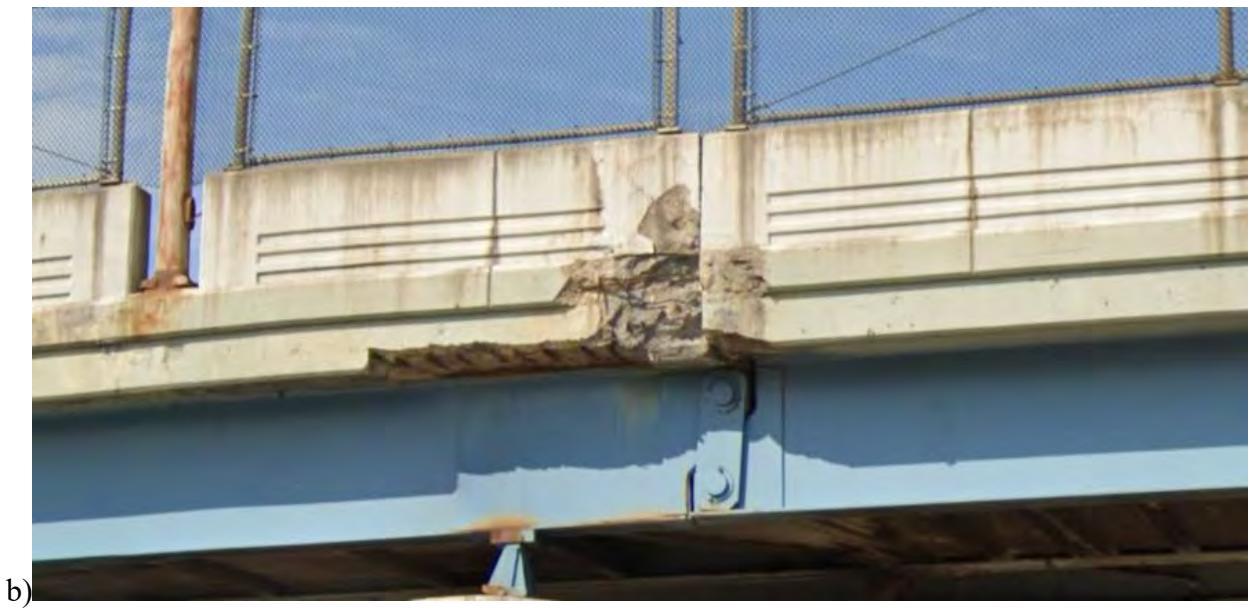
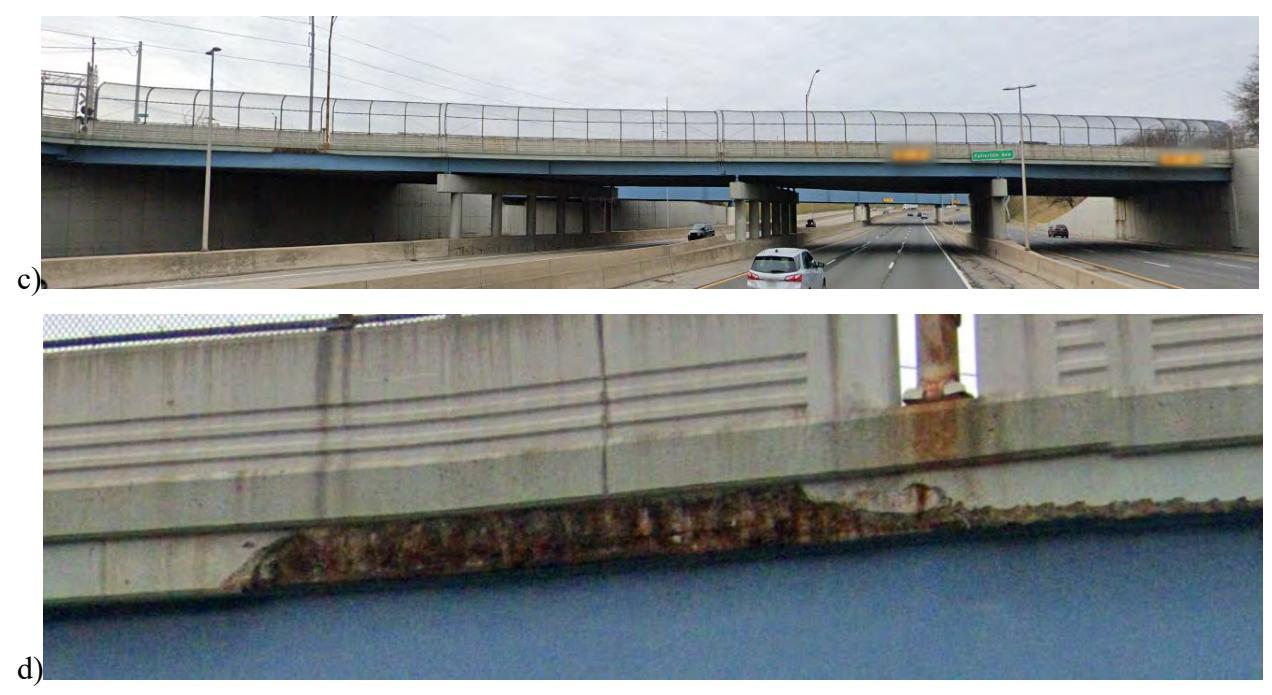
Fig. D.29 Fullerton Ave. over I -96: a-b) lower side; c-d) upper side

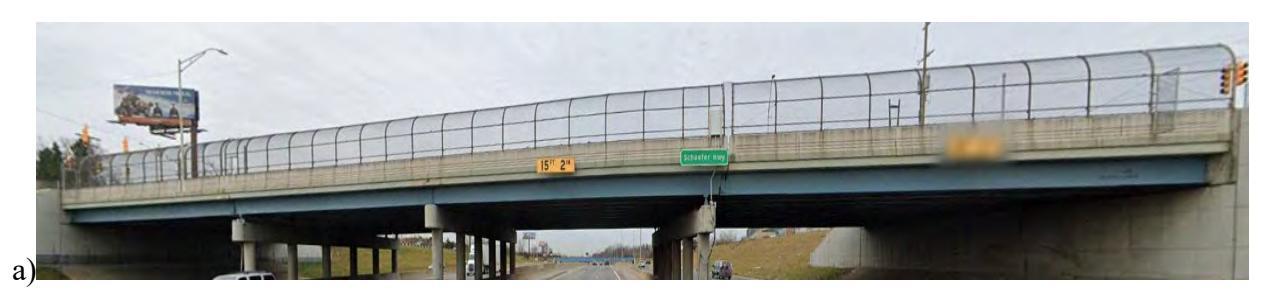
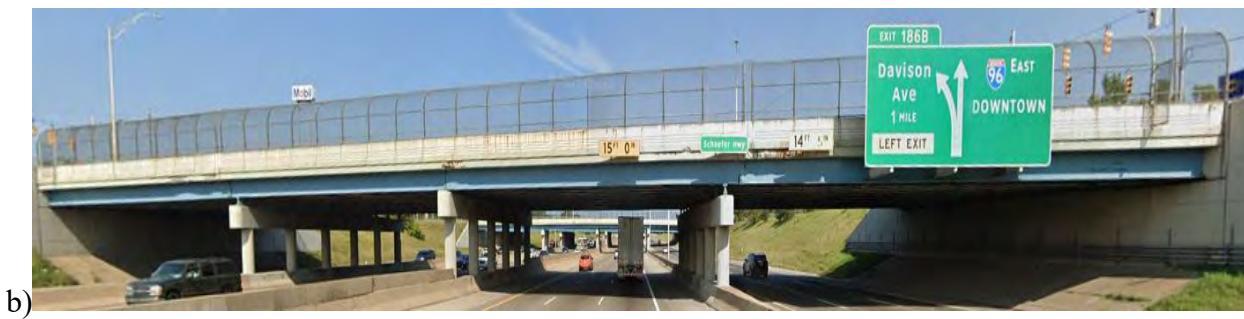
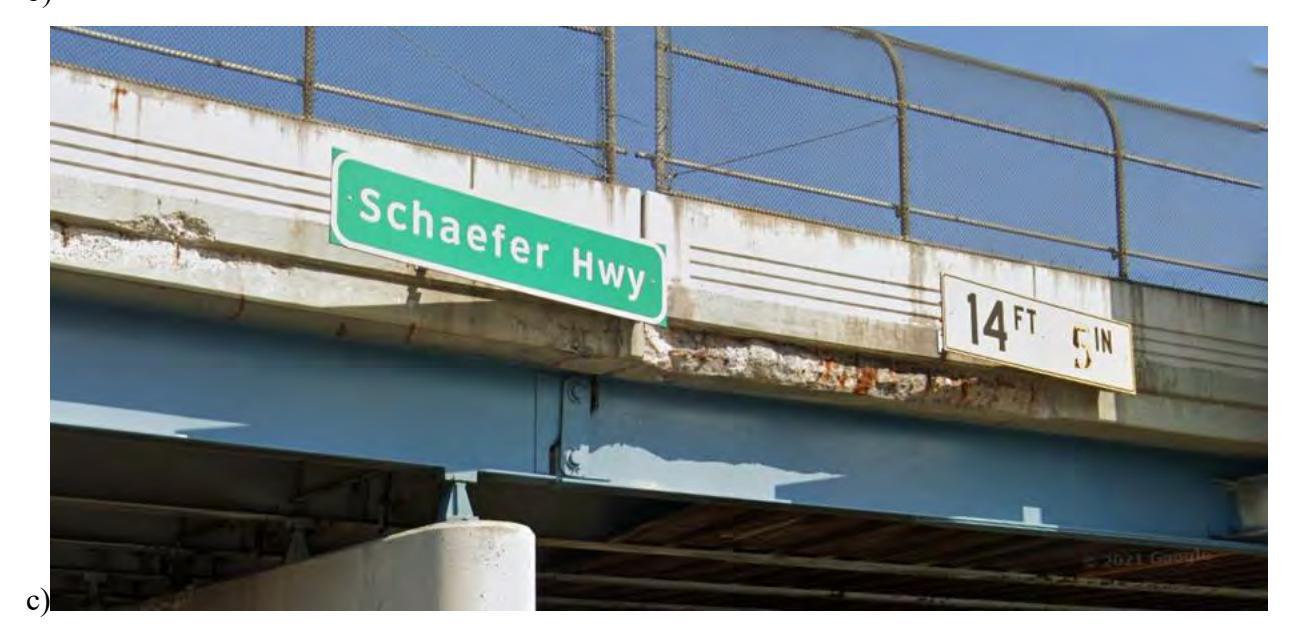
Fig. D.30 Schaefer Rd. over I-96: a-b) lower side; c-d) upper side
