Repair of Bridge Deck Fascias OR22-002

Final Report

09/30/2023

> **Prepared By:** Furkan Cakmak Fatmir Menkulasi Christopher Eamon Hwai-Chung Wu

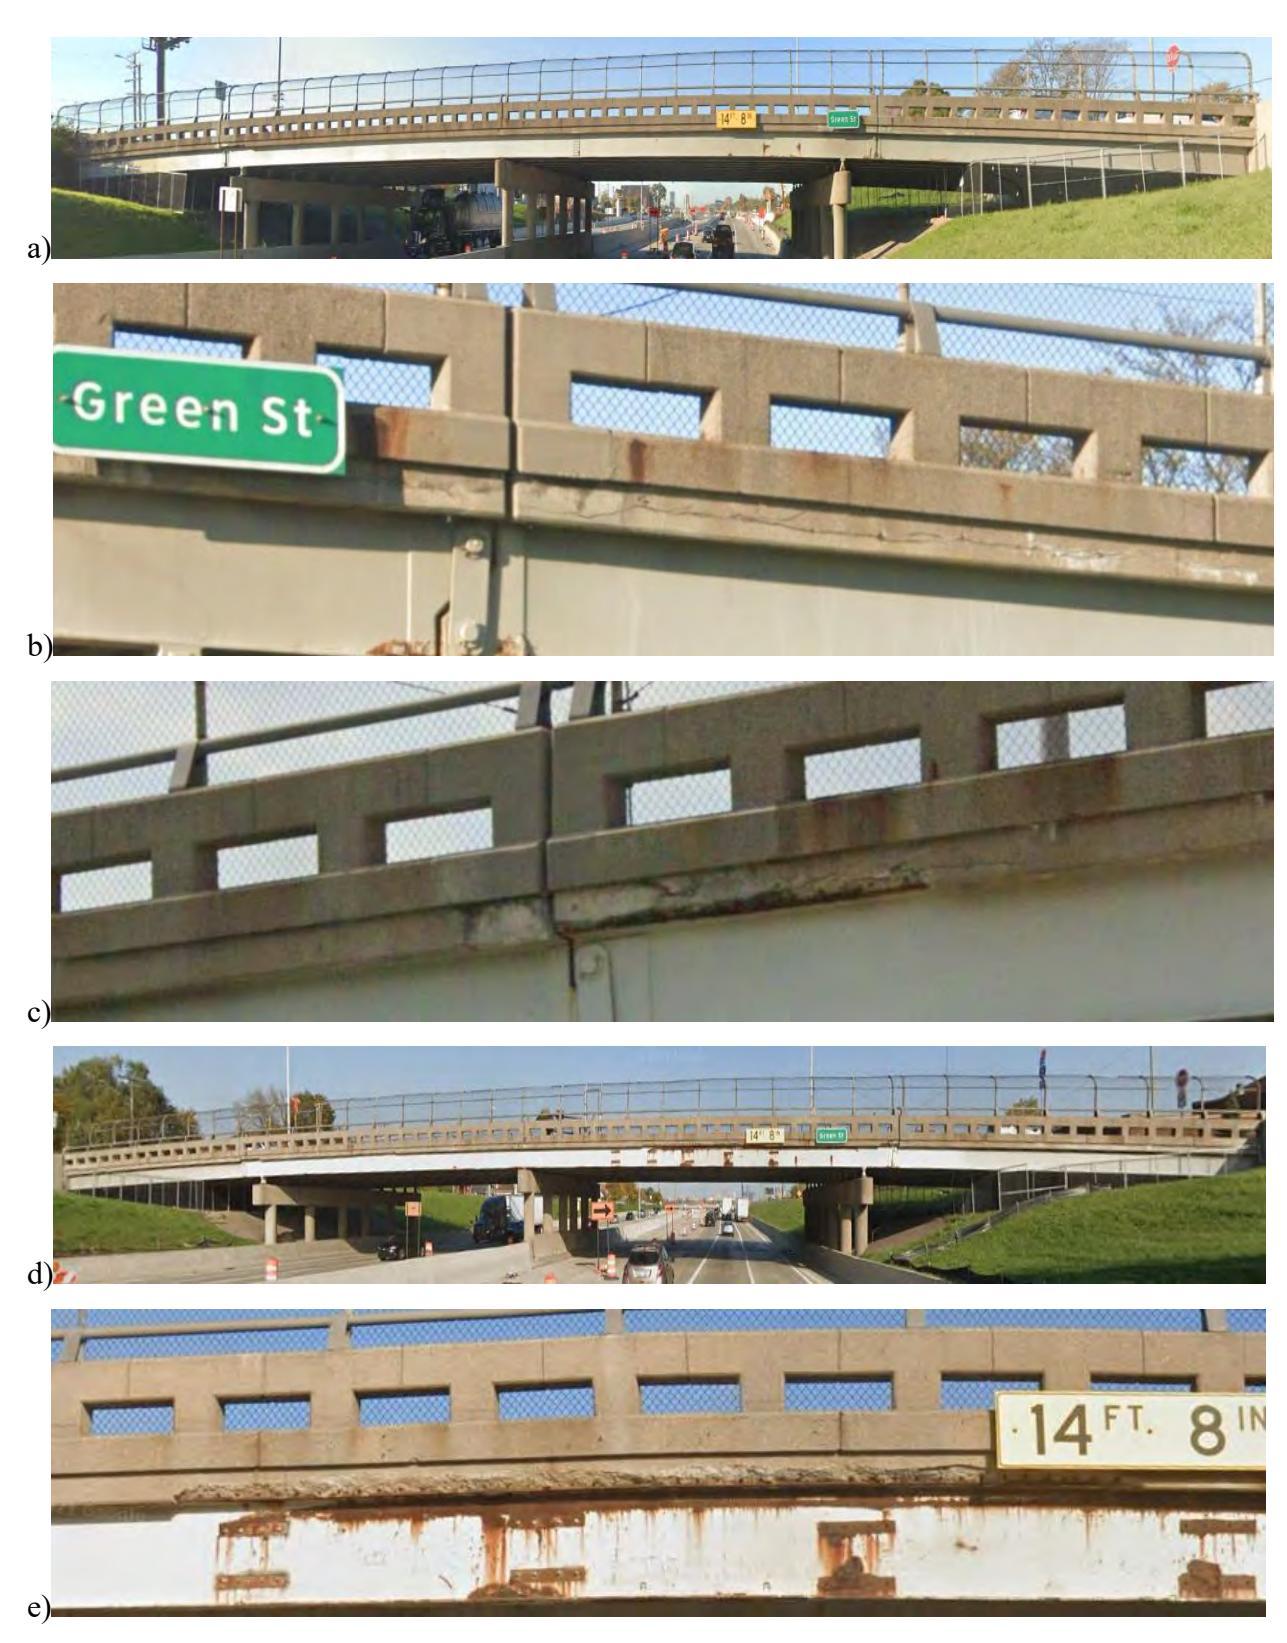
Fig. D.31 Green Ave. Over I-75: a-c) lower side; d-e) upper side

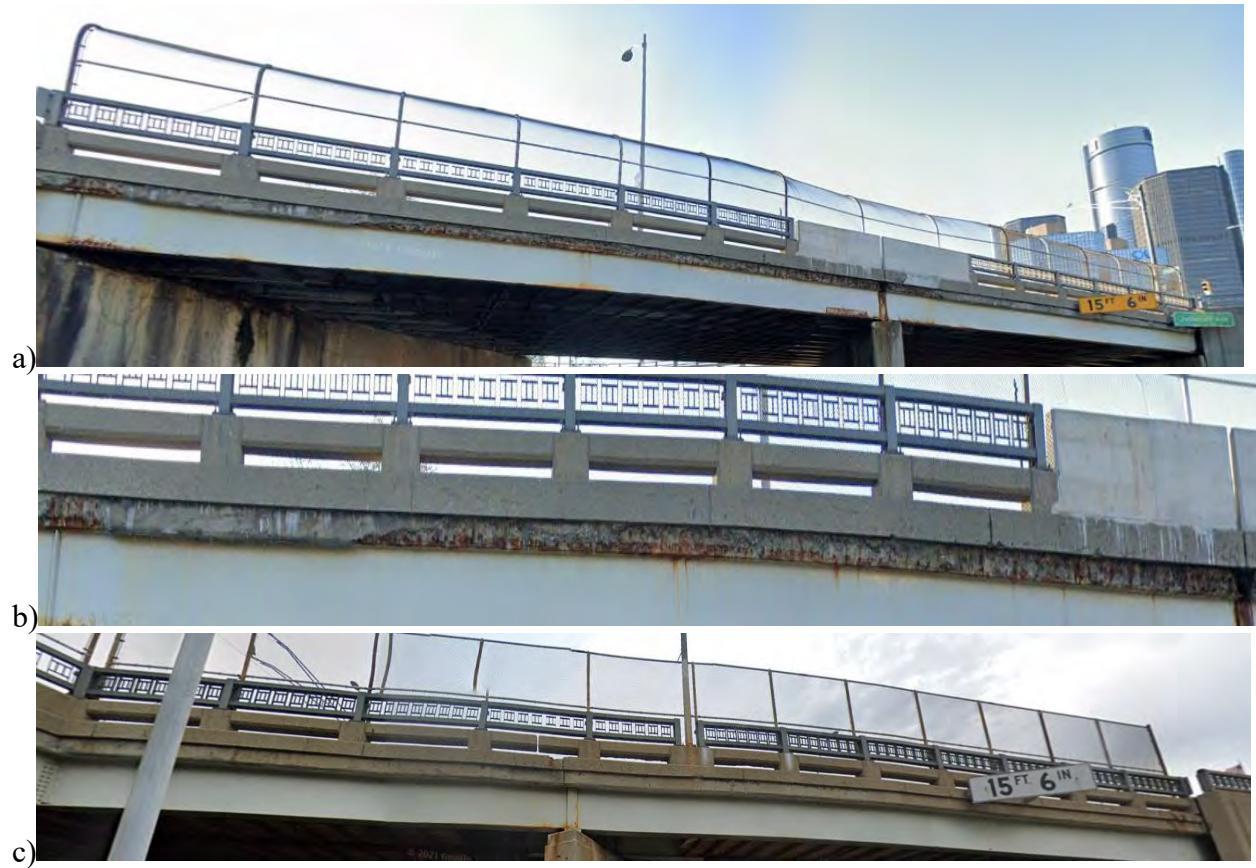
Fig. D.32 E Jefferson Ave. over I-375: a-b) lower side; c) upper side

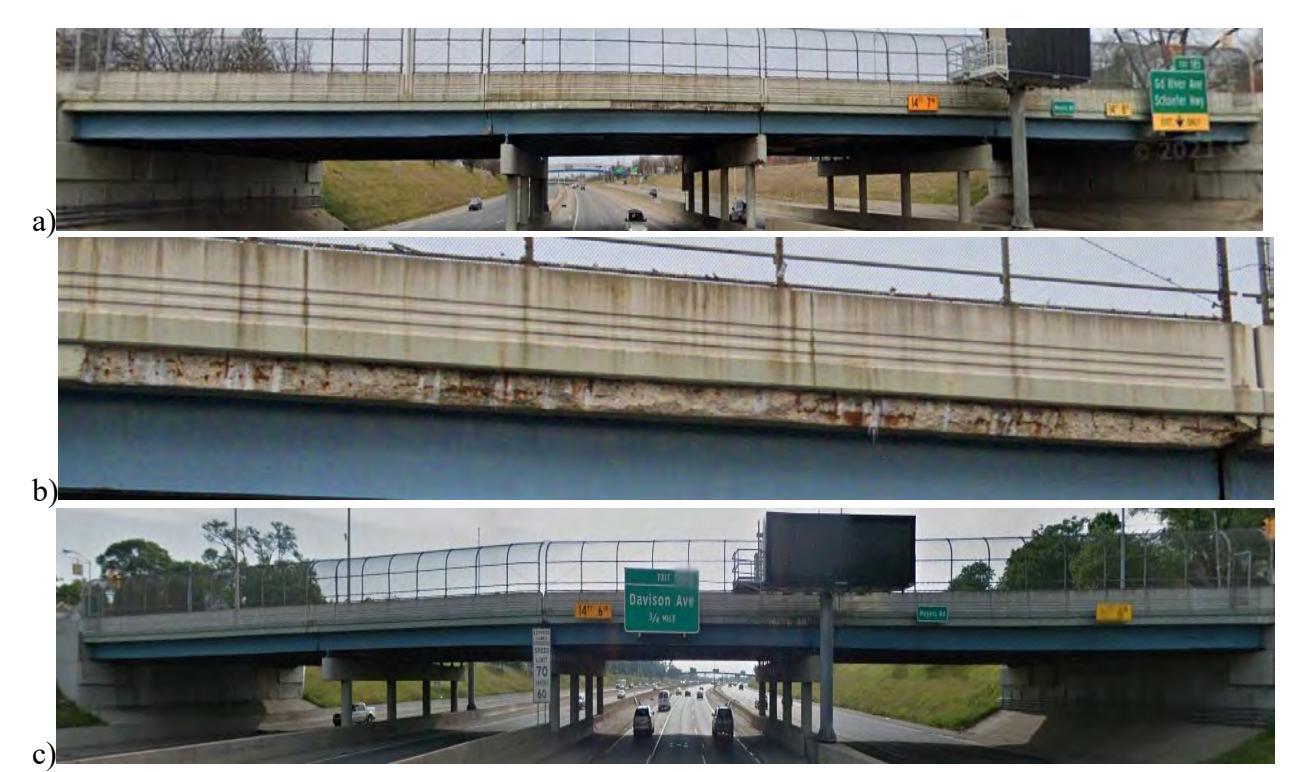
Fig. D.33 Meyers Rd. over I-96: a-b) lower side; c-d) upper side
